NGU Report 2008.049

Field studies of unstable slopes in Sunndalen
Valley

Report no.: 2008.049		ISSN 0800-3416	Grading: Open
Title: Field studies of unstable slopes in Sunndalen Valley			
Authors: Saintot, A., Böhme, M., Redfield, T., Dahle, H.		Client: Møre og Romsdal Fylke	
County: Møre og Romsdal		Commune: Sunndalsøra	
Map-sheet name (M=1:250.000) Ålesund, Røros		Map-sheet no. and -name (M=1:50.000)	
Deposit name and grid-reference:		Number of pages: 26	Price (NOK): 190
Fieldwork carried out: 2007		Date of report: August 2008	Project no.: 309900
		Person responsible: <i>Lars A. Blitner</i>	
Summary: <p>Following a helicopter survey of the slopes along the Sunndalen valley and the surroundings in spring 2007, four sites have been selected for further field studies. Two sites, (Gikling and Ottem), were mapped during summer 2007. GPS points for yearly monitoring were emplaced at Gikling. The volume of the unstable slope may be as much as 100 Mm³. At Ottem, a slope instability of about 2 Mm³ was mapped in detail. Scree deposits comprising large blocks along the slope are also unstable. GPS monitoring points were selected at Ottem and will be set out in 2008. Also at Ottem, another

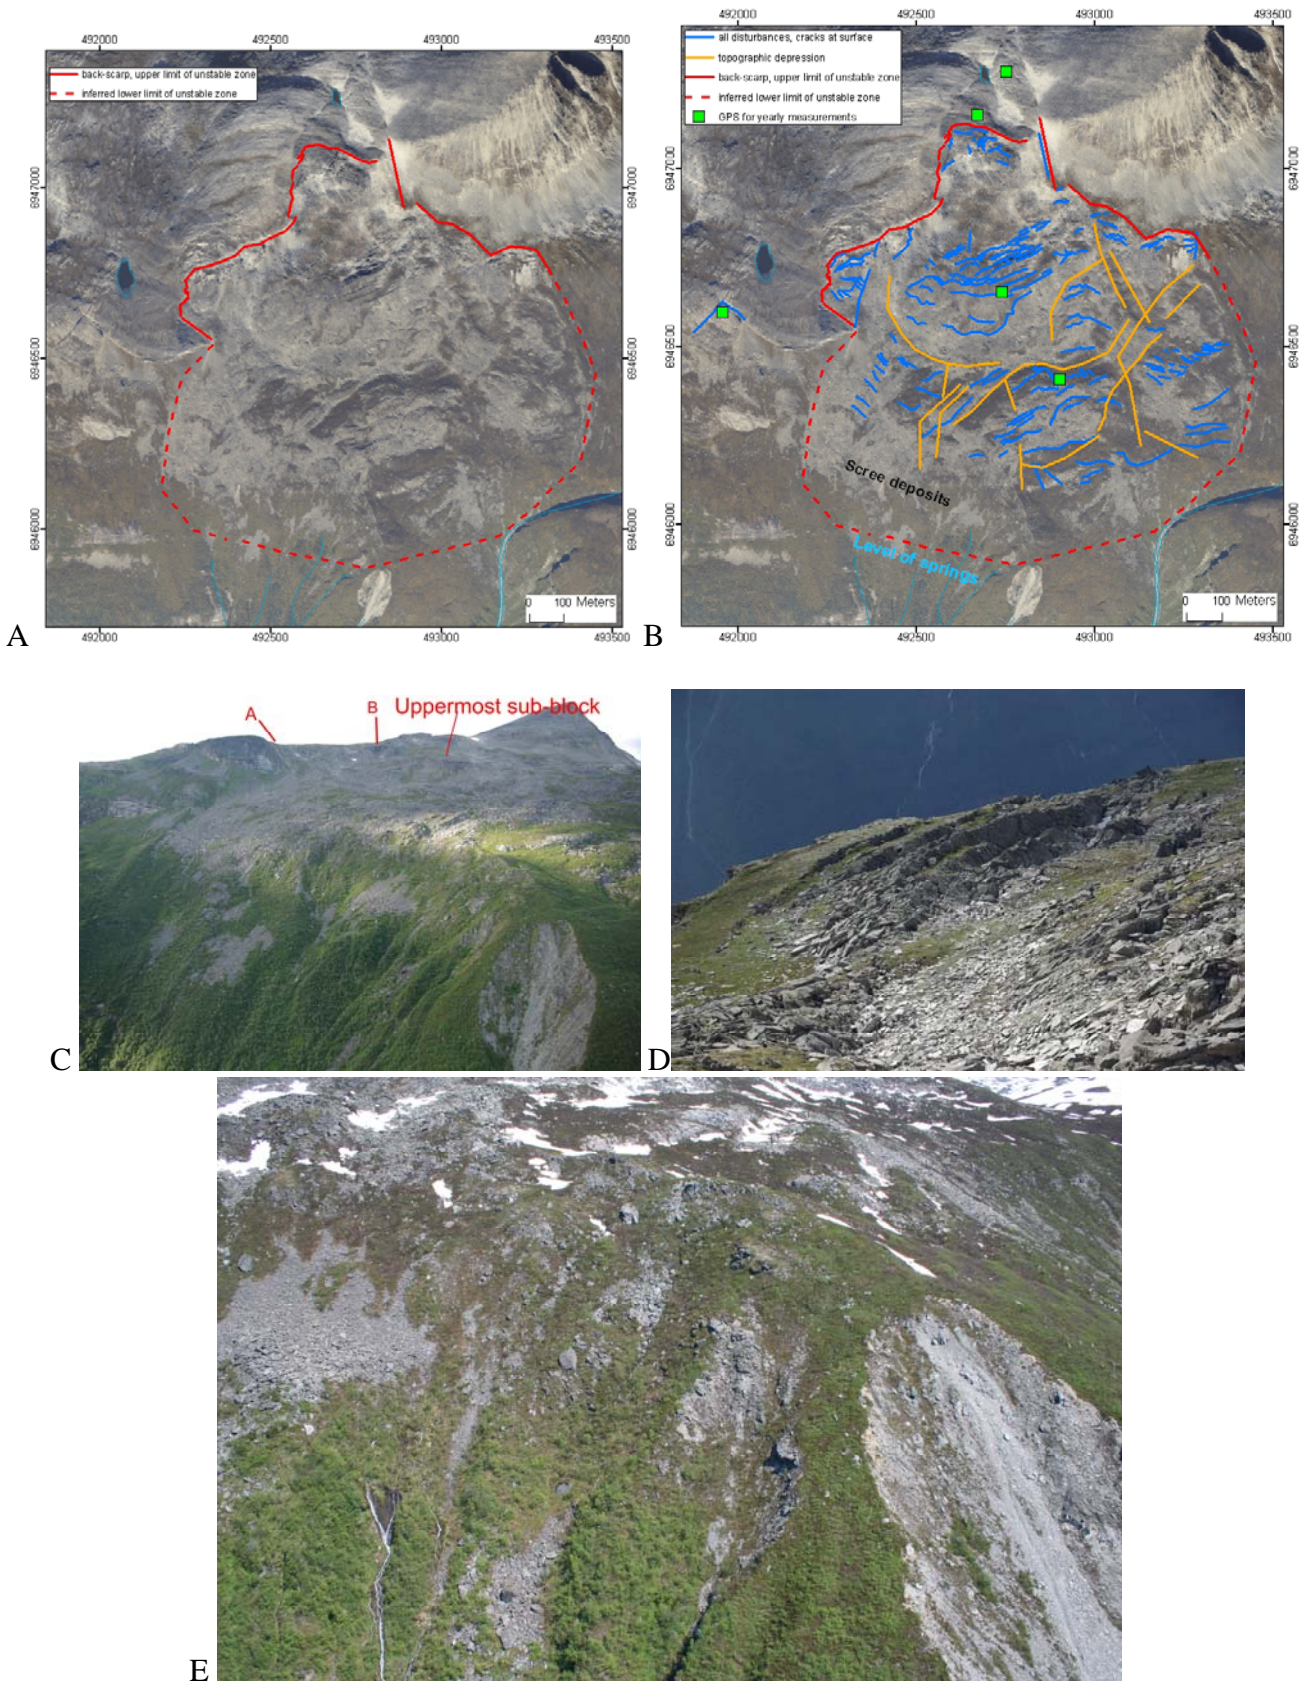
The unstable portions of the Gikling site have been divided into several (sometimes tilted and/or rotated) sub-blocks limited by large topographic depressions (Figure 3B and Figure 4). The density of opened cracks is very high; consequently, GPS points for yearly monitoring were established in 2007 (Figure 3).

Figure 3. A and B, Orthophotos (www.norgebilder.no) B, mapping of the structures of the large slope instability of Gikling and the GPS points set in 2007 for yearly monitoring of possible motion. C, picture from helicopter toward the north of the slope instability of Gikling. Red block letters refer to the uppermost boundaries of the slope instability as on the map of Figure 4. D, picture of the ENE-WSW cracks within the uppermost sub-block (view to the S) (the sub-block is located on picture of Figure 3C). E, Horizontal level of springs at about 800 m high (view to the NE).

The lowest limit of the instability is not yet well constrained. However, a semi-horizontal line of springs is observed at about 800 m altitude (Figure 3E) and may mark the basal level of the slope instability. Therefore, the volume of the entire slope instability may be greater than 100 Mm³. Geophysical investigations are recommended in order to determine the geometry of the structures at depth and to identify the basal plane of instability.

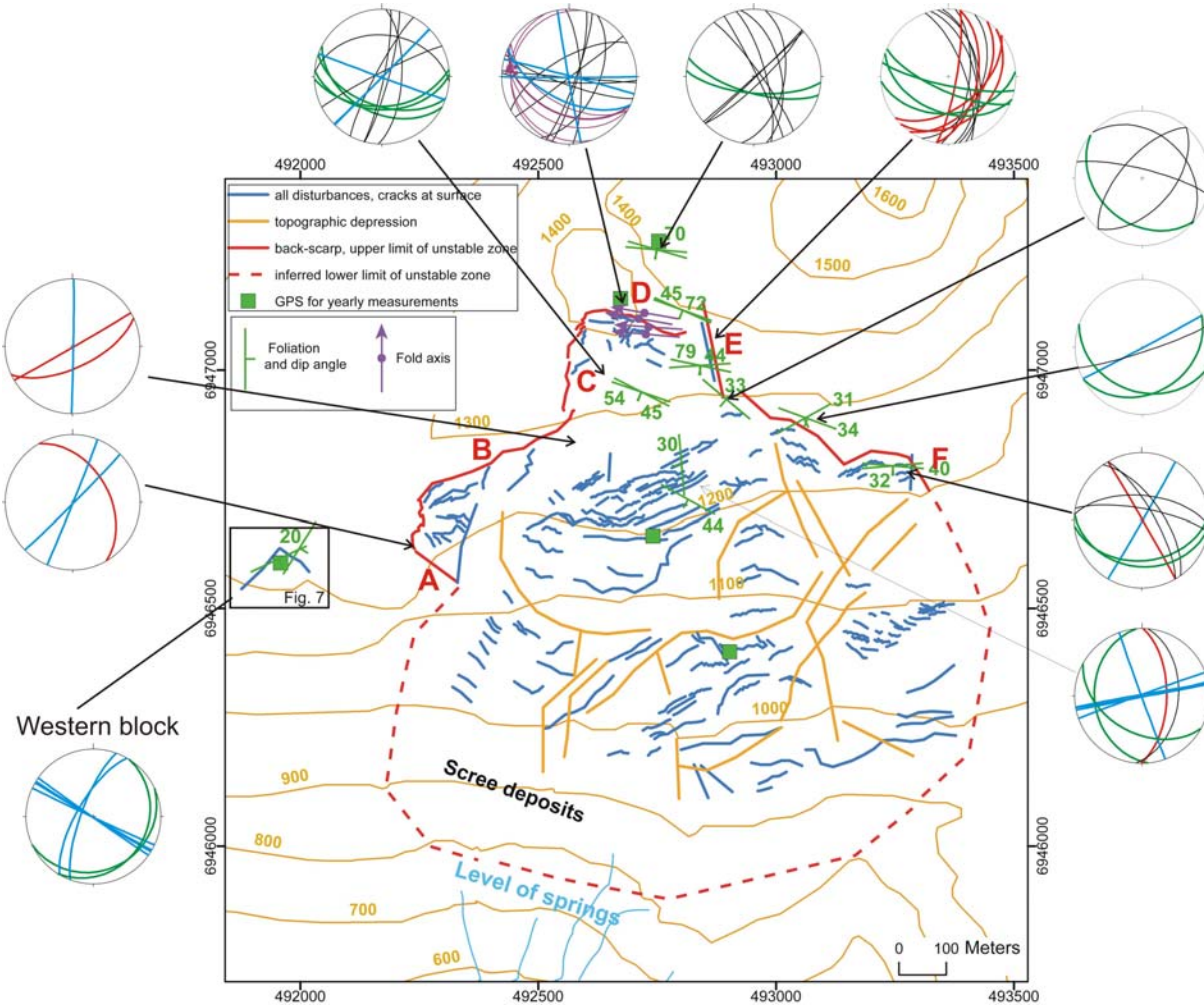
The gneissic foliation is generally shallowly-dipping to the south, in places at angles approaching that of the mean topographic slope (Figure 4). Field observation suggests the uppermost limit of the slope instability to be coincident with a spatial arrangement of pre-existing structures that mark the boundary between the unstable and stable parts of the slope. (See block letters along the solid red line on Figure 4). The segments of this limit marked A, B, E and F on Figure 4 correspond to pre-existing faults (Figure 5A, B and C). Segment D (indicated on Figure 4) is the uppermost limit that we have observed. It is a wide zone of new fractures that are localized along a zone of small amplitude folds; the fracture planes are oriented parallel to the fold axes (Figure 5D). Segment C (Figure 4) is a crack several meters wide and deep, which displays stepped walls. The steps are formed by the planes of the south-dipping foliation and N-S trending steep fractures.

Figure 4. Detailed structural mapping of the large slope instability of Gikling and stereoplots of field measurements. Keys for stereoplots: metamorphic foliation in green, open fractures and large cracks in blue, old faults in red, fold planes and fold axes (stars) in purple, joints in black (measurements are listed in Appendix 1). In the black rectangle, location of the western block of Gikling illustrated on Figure 7.

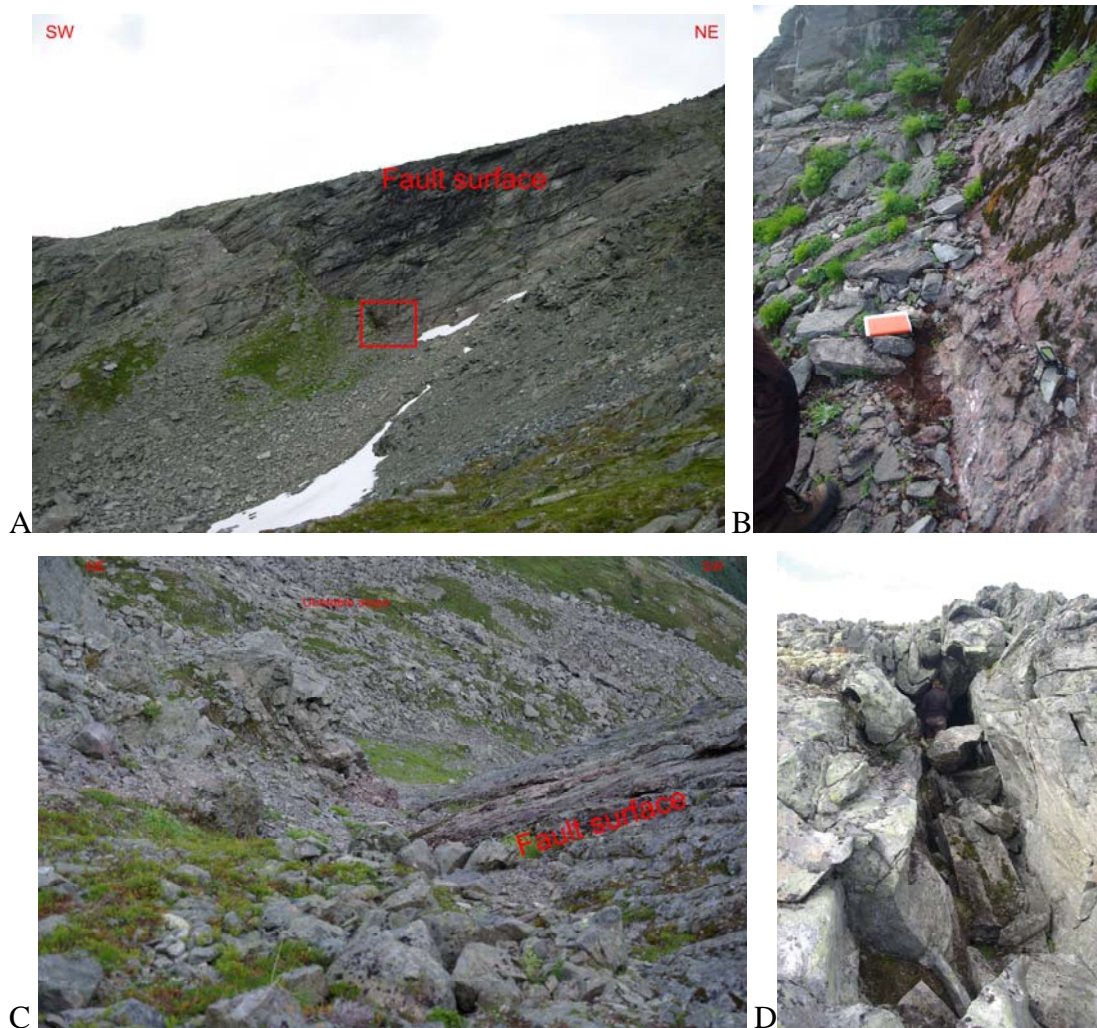
Figure 5. Pictures illustrating the reactivation of pre-existing structures that limit the slope instability. A, The limit of the unstable slope (segment B on Figure 4) as a reactivated pre-existing fault with gouge and breccia. B, Close-up of the fault with gouge and breccia (red frame on photo A) C, Reactivated pre-existing NE dipping fault (segment A as referred to Figure 4) marks a sharp border between the unstable and stable slopes. D, Localization of segment D (as referred to Figure 4) along a zone of small amplitude folds, the newly formed gravitational fractures at this place trend parallel to the azimuth of fold axes (view to west).

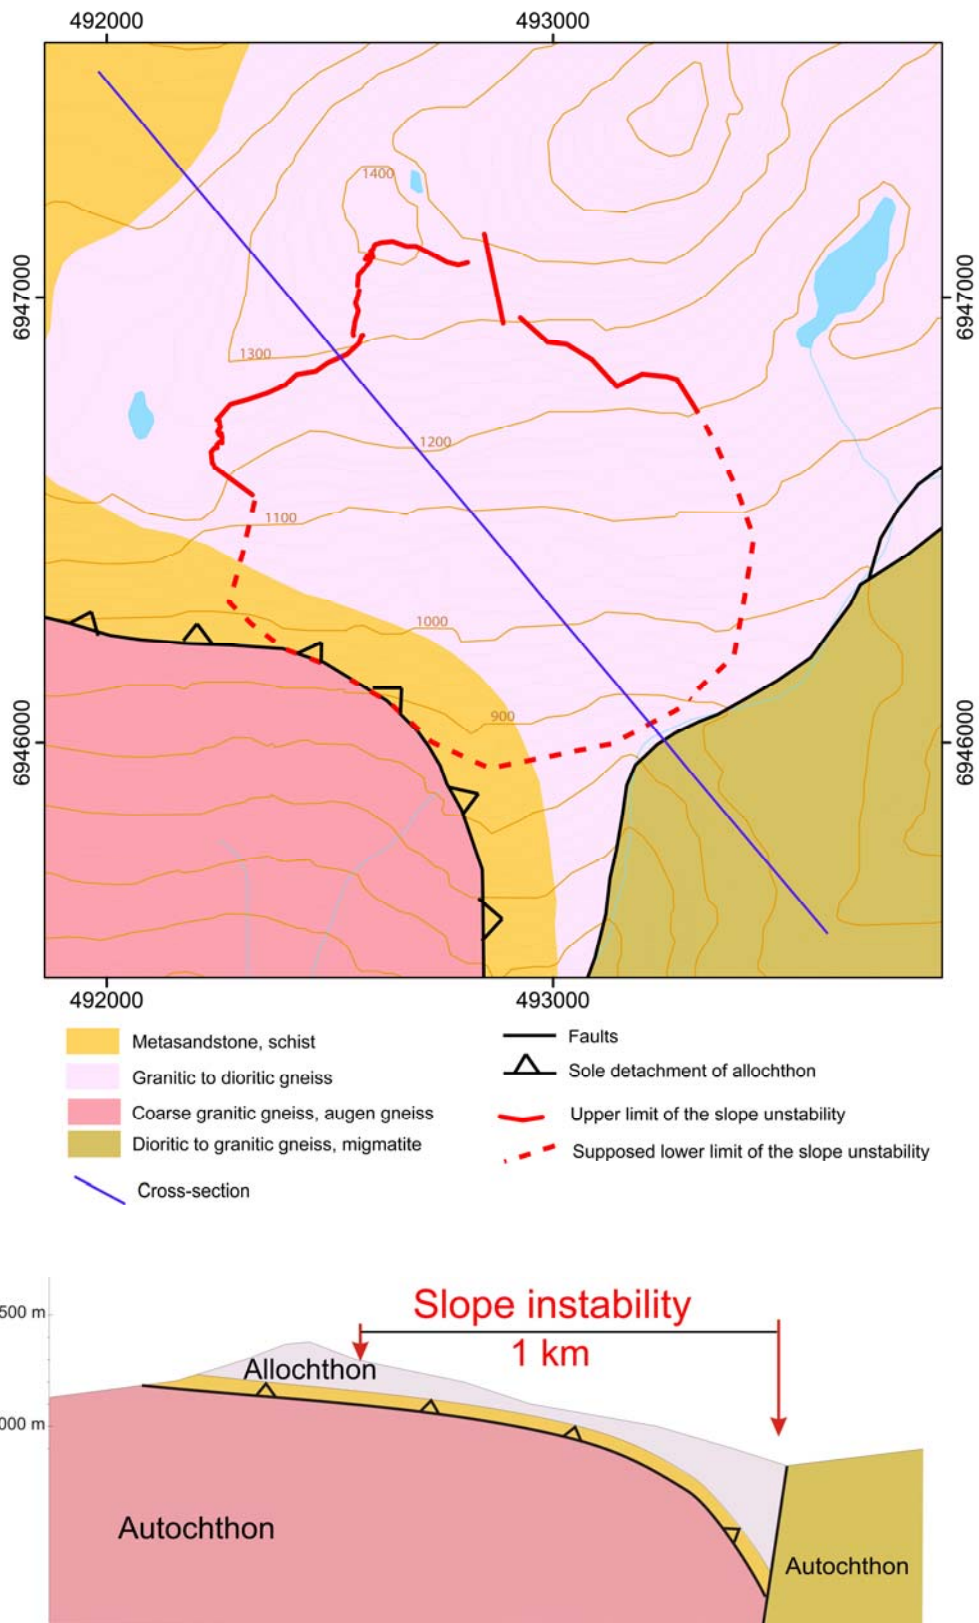
The genesis of the gravitational slope instability may reflect the allochthonous gneissic unit within which it developed (Figure 6). The springs at about 800 m a.s.l. may represent the trace of the basal glide plane. The springs also coincide closely with the sole detachment of the allochthon, which is composed of metasandstones and schists (Figure 6). The detachment may have developed within a weak zone that localized the base of the slope instability and acts as an aquifer.

In addition, a steep- to vertical fault zone lies at the eastern foot of the unstable zone. It separates the two autochthonous units of the valley and also limits the allochthonous sheet to the east (Figure 6). Gikling is therefore in a very peculiar structural setting that may be responsible for a weakening (perhaps by fracturing and enhanced weathering) of the gneiss unit, rendering the slope more vulnerable to gravitational forces.

Figure 6. Geological map (Tveten et al., 1998) and cross-section showing the peculiar tectonic setting of the slope instability of Gikling.

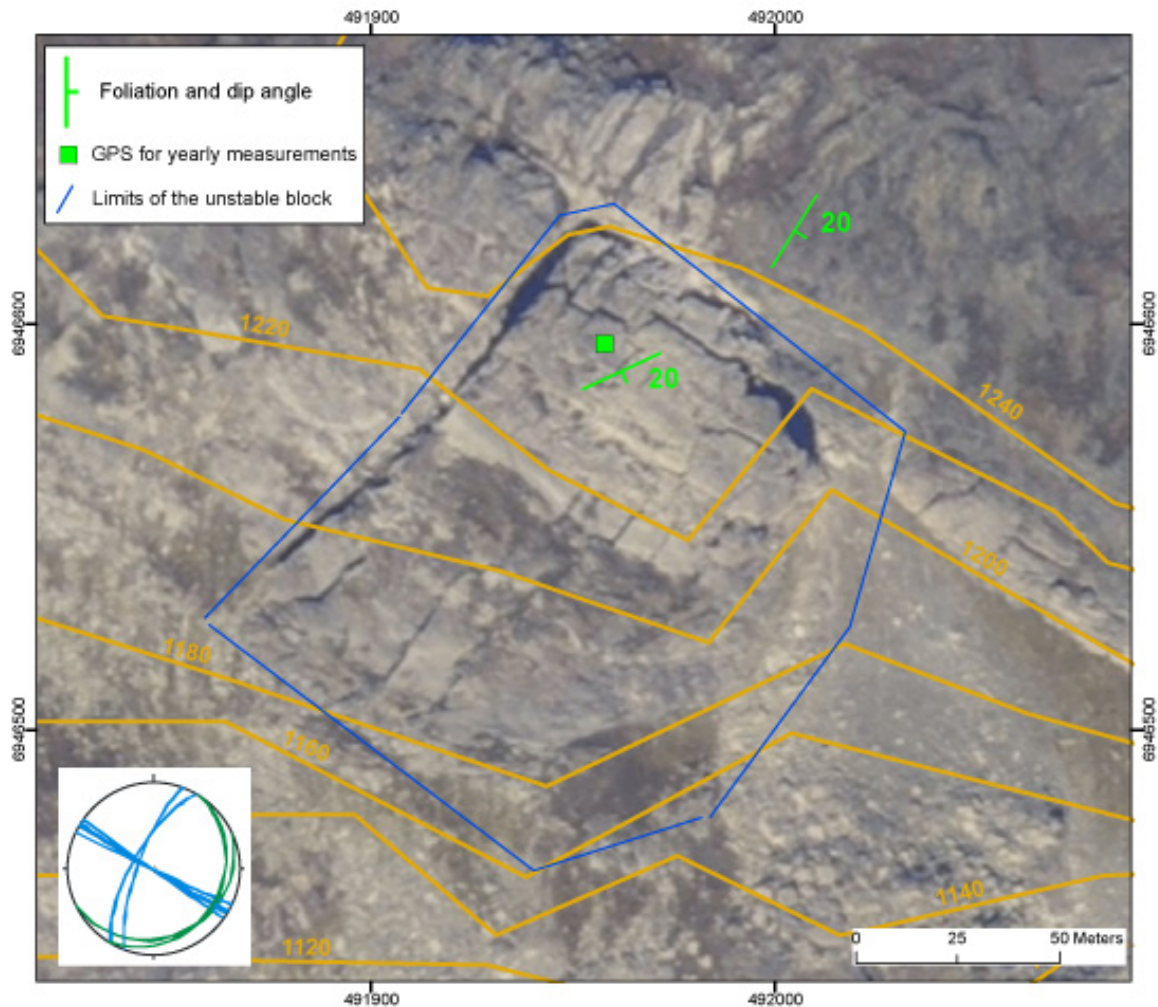
On the western part of the area lies an unstable block on the edge of the scarp (located on Figure 4 as 'Western block'). This was identified during a reconnaissance study by Henderson & Saintot (2007). The stereoplot of structures measured at the site shows the two regional sets

of vertical fractures and (in green) the shallow dipping foliation (Figure 7). The vertical fractures are largely opened inside the unstable block and the foliation may likely be reactivated as a basal sliding plane. The total volume is estimated to be approximately 0,7 Mm³.

Figure 7. Orthophoto (www.norgebilder.no) of the 'western block' of Gikling (located on map of Figure 4). Stereoplot of structures measured at this site: the destabilization of the volume occurs along the two regional sets of joints (in blue on the stereoplot), the shallow dipping foliation (in green on the stereoplot) probably acts as a basal sliding plane. The volume of the whole block is approximately 0,7 Mm³.

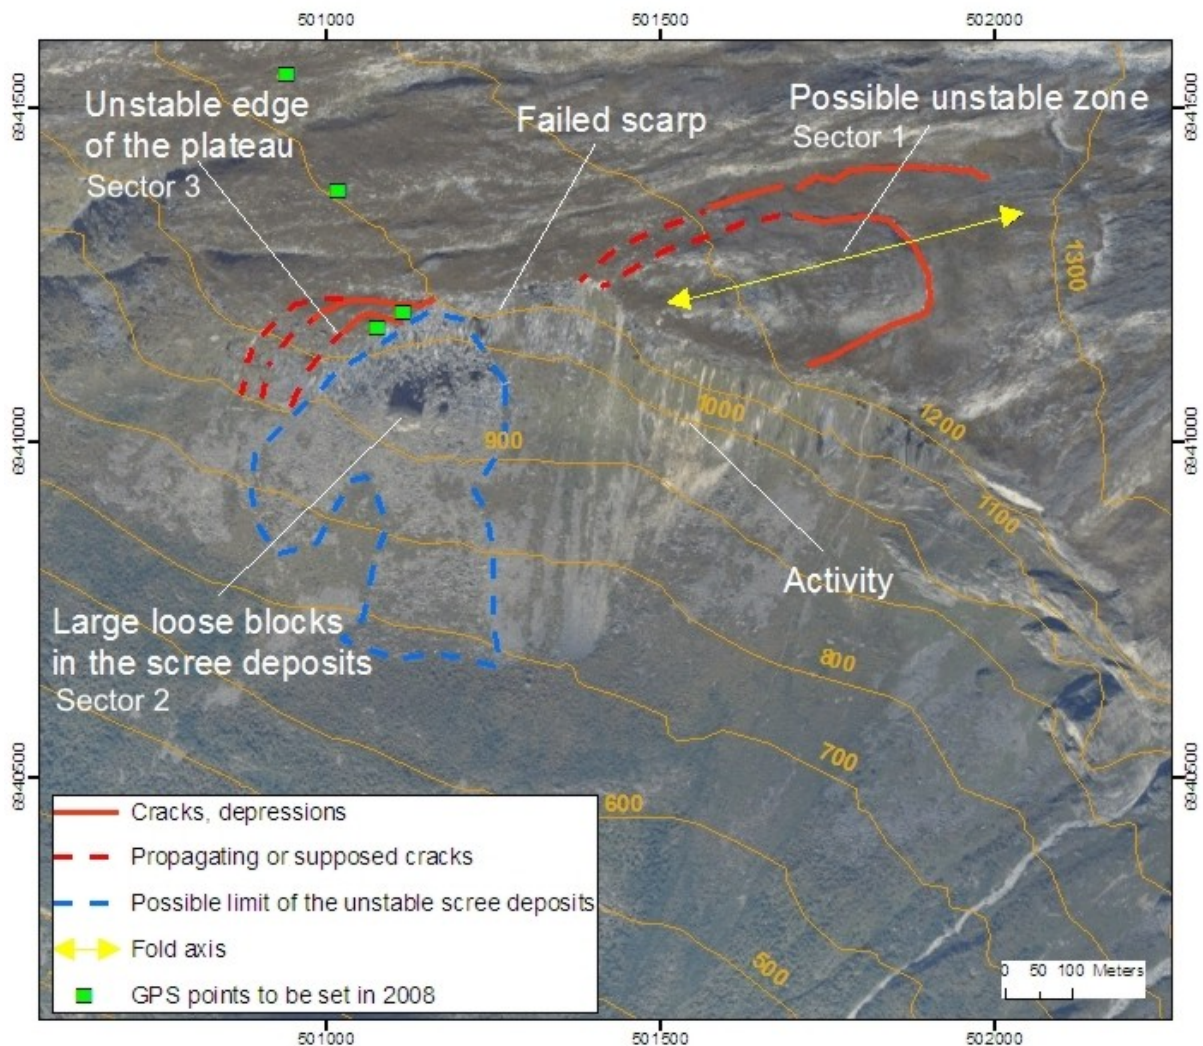
The Ottem instability can be divided in three main sectors (Figure 8), each developed in autochthonous Precambrian gneisses.

The first zone is a large curved, depressed and fractured area that lies on the edge of the plateau to the east of the initially investigated area (sector 1 on Figure 8). This area has not been fully documented. The face of this zone displays recent rockfall activity, evidenced by

fresh rock surfaces along the cliff (Figure 8). If a gravitational instability has developed at the rear of the active scarp, it may have been localized along a fold hinge. This sector will require field investigations along the circular depression on the plateau in 2008.

The second unstable sector consists of scree deposits from previous failures from the edge of the plateau (sector 2 on Figure 8). These slope deposits cover a surface of approximately 125 000 m² on a slope dipping at 35 degrees. They contain large loose blocks that could potentially be remobilized (Figure 8, Figure 9A).

Figure 8. Orthophoto (www.norgebilder.no) of the unstable slope of Ottem and maps of structures. On the eastern part of the studied area, a fold hinge localizes a possible large unstable zone (sector 1). Part of the scarp has already failed and the scree deposits on the slope are unstable loose material that comprises large blocks (sector 2). The western edge of the plateau at about 1000 m a.s.l. is unstable (sector 3) and cracks developed from east to west at the back.

The third unstable sector is a large block at the edge of the plateau at 1000 m a.s.l. that was investigated during the field campaign in August 2007 (sector 3 on Figure 8). The block has partially collapsed downslope by several meters. The limiting back-crack is well developed and opened on its eastern side. It forms an asymmetric graben-like structure ~5 m wide with an offset of the collapsing block ~5 meters downward (Figure 9A and B). The northern wall of the crack is stepped along a pre-existing system of roughly NNE-SSW and E-W joints

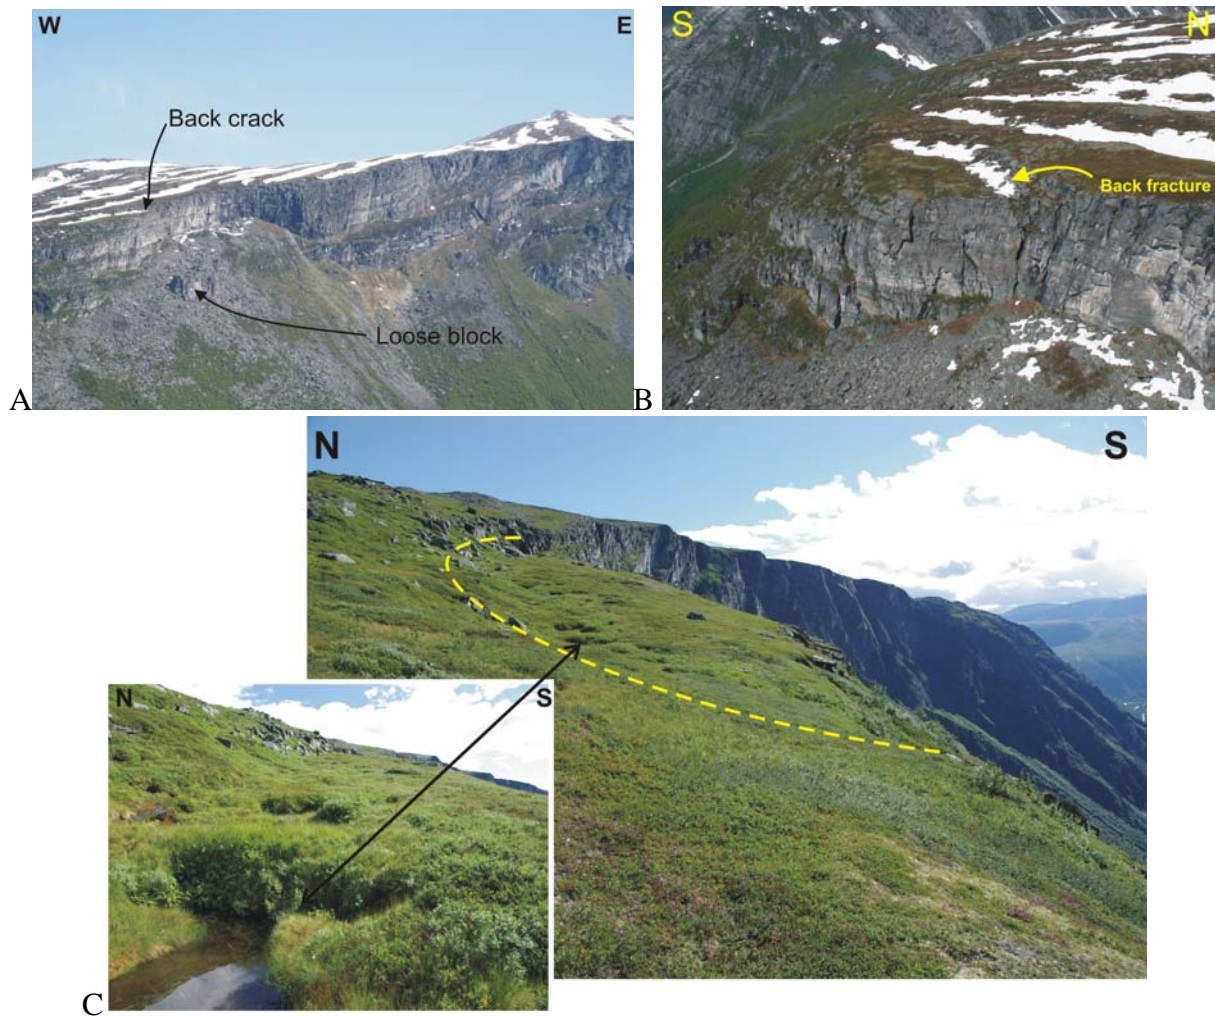
Figure 9. Field photos. A, view of the face of the unstable zone (sectors 2 and 3 of Figure 8). B, view parallel to the propagating back-fracture at the back of the unstable block (sector 3 of Figure 8). Note the large opening of the crack seen along the cliff. C, the collapsing unstable block (sector 3) with the back-crack underlined in yellow. The back-crack is well developed and opened on its eastern side whereas on the western side it is a linear depression highlighted by a series of small ponds.

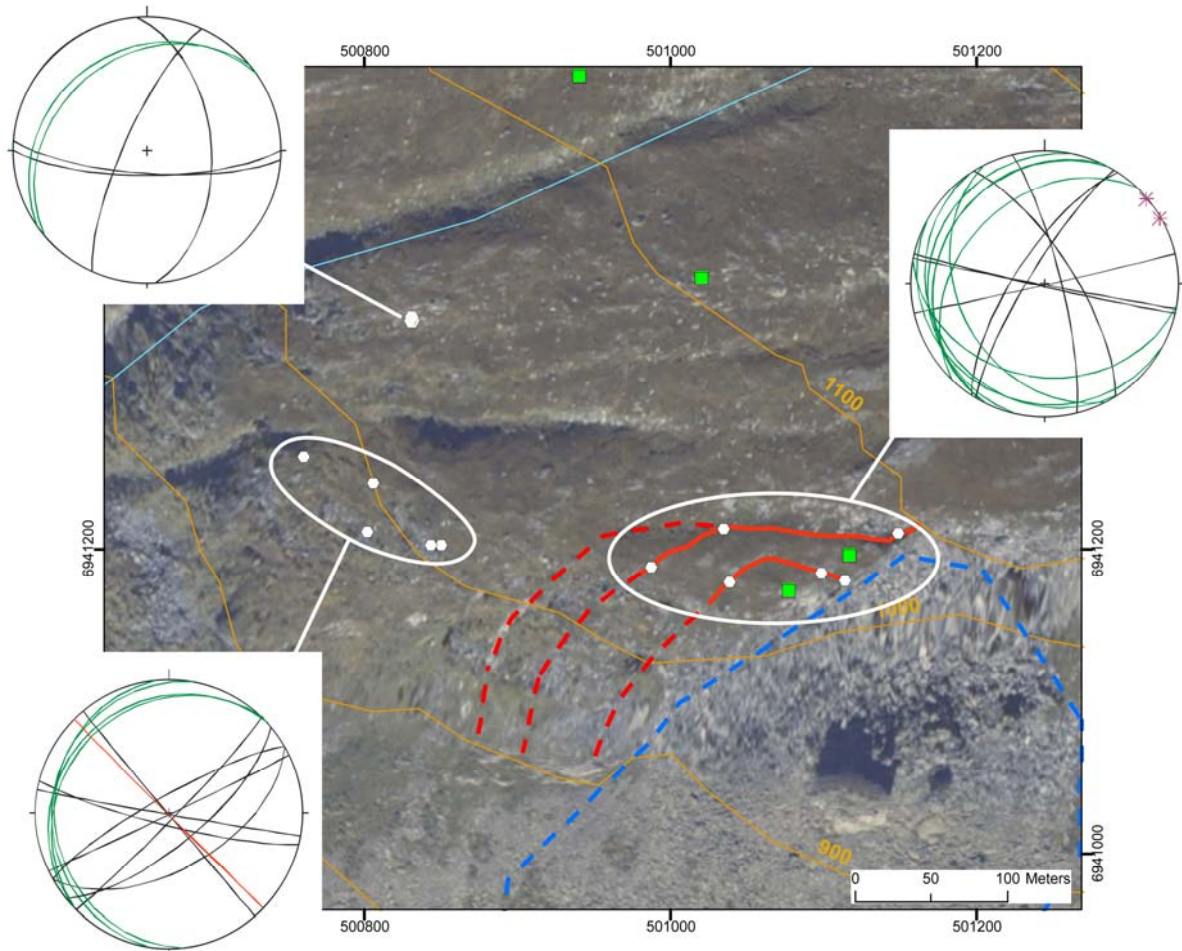
(stereoplot of Figure 10). During fieldwork we identified a zone of small amplitude folds adjacent to where the back-crack has developed (Figure 10). Elsewhere, the foliation is gently

dipping to the west and north-west (stereoplot of Figure 10). Failure along the edge of the plateau propagated from east to west, with evidence of previous failure(s) east of the unstable block along the same structure forming the back-crack (Figure 8). Therefore, to the west, the back-crack becomes a discrete depression highlighted by a series of small ponds (Figure 9C). The observation of the water levels in the ponds constitutes an easy monitoring method. A drop of water level of the ponds may be the result of new or expanding openings of the subjacent fractures (i.e. the back-crack), possibly related to accelerated or ongoing displacement of the unstable block. Although their levels may also fluctuate for other reasons (precipitation, snowmelt, etc), we propose that the water level of the ponds be regularly observed as a proxy for possible instability. The maximum volume of the collapsing block is estimated to be 1 Mm^3 . Many open fractures parallel to the main back-crack are expressed at the surface of the large block by steps in the topography. At least one large sub-block can be shown to disintegrate into many smaller blocks in the direction of the escarpment. Also, the westernmost limit of the unstable zone may be enlarged to a discrete linear depression that we have observed on the field (Figure 10). If so, the volume of the unstable zone may be 2 Mm^3 .

Figure 10. Stereoplots of structural data collected at Ottem on the unstable block of sector 3 (see Figure 8). Locations of field measurements as white dots; GPS points to be established in 2008 as green squares; legend for stereoplots as in Figure 4 (measurements are listed in Appendix 1). The red lines are the limits of the block. The dashed lines are the depressions seen in the field and are the supposed limits of the blocks.

Four GPS positions should be established in 2008 on this unstable zone for yearly monitoring of movement (Figure 10).

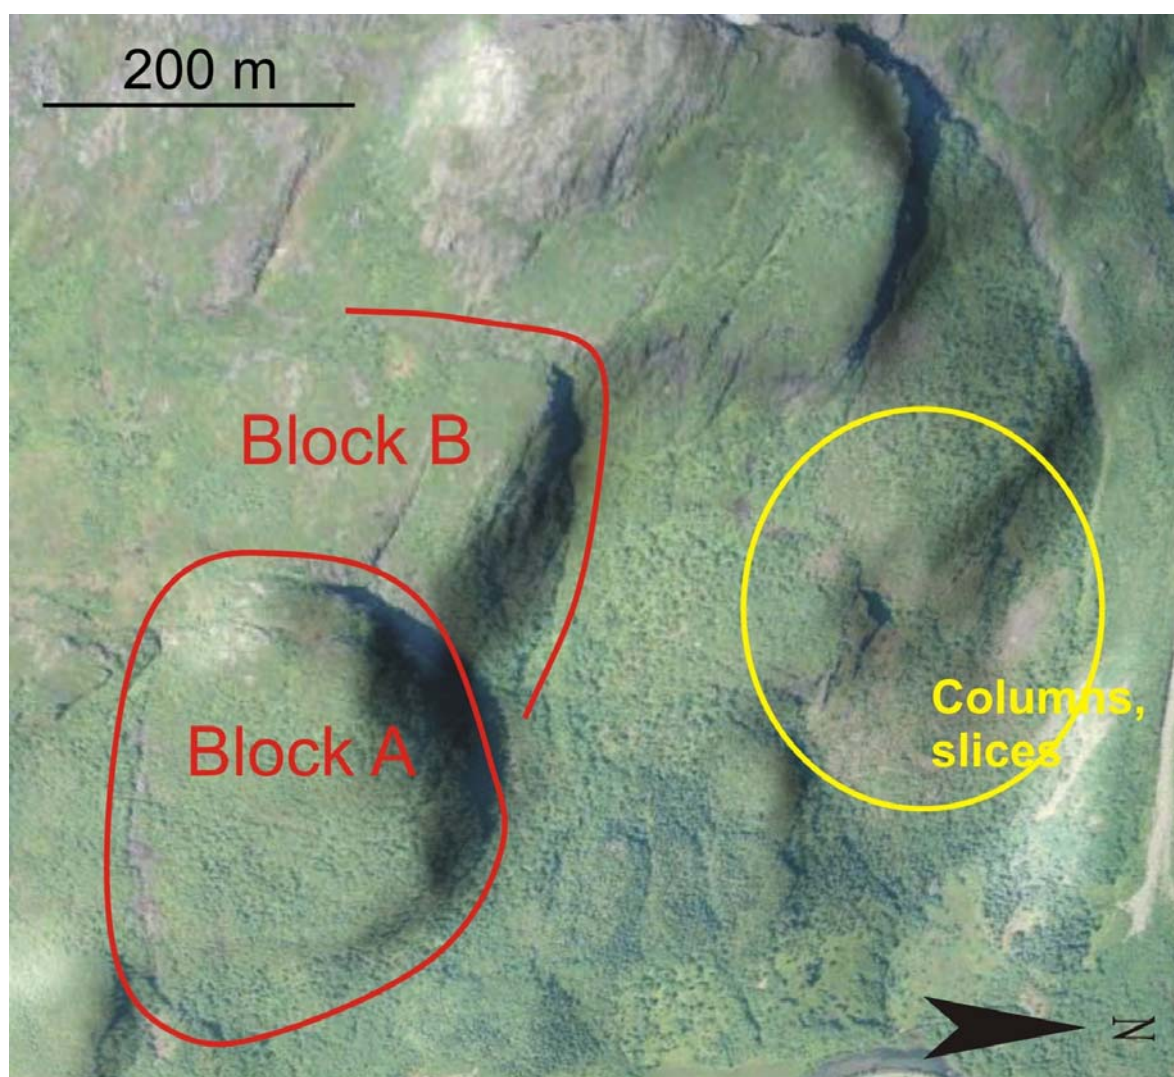
The potential slope instabilities appear to be of two types, localized in two different zones (Figure 11 and Figure 12A). In the first zone, two large unstable blocks, labelled A and B on Figure 11 and Figure 12A, may possibly have slid along opened shallow dipping planes parallel to foliation and toward the valley. Within block A, between the two blocks and at the back of block B, 50 to 60 degrees east-dipping open fractures may have accommodated displacement. Block A may have a total volume above 5 Mm^3 ; initial inspection suggests its detachment from the slope may be more advanced than that of block B (see on Figure 11). In the second zone, along the southern side of an E-W tributary river, several large columns or slices appear to have detached from the slope along NW-SE cracks (Figure 11 and Figure 12C, D and E). Their volumes are estimated to be approximately $0,25 \text{ Mm}^3$.

Figure 11. General top view of the site of Hårstad (from www.norgei3d.no). In the northern zone, the failure of the slope consists of columns and slices toward an E-W trending tributary river. On the southern zone, large blocks slid eastward toward the main valley on shallow east-dipping foliation, detachment of block A being more advanced than for block B.

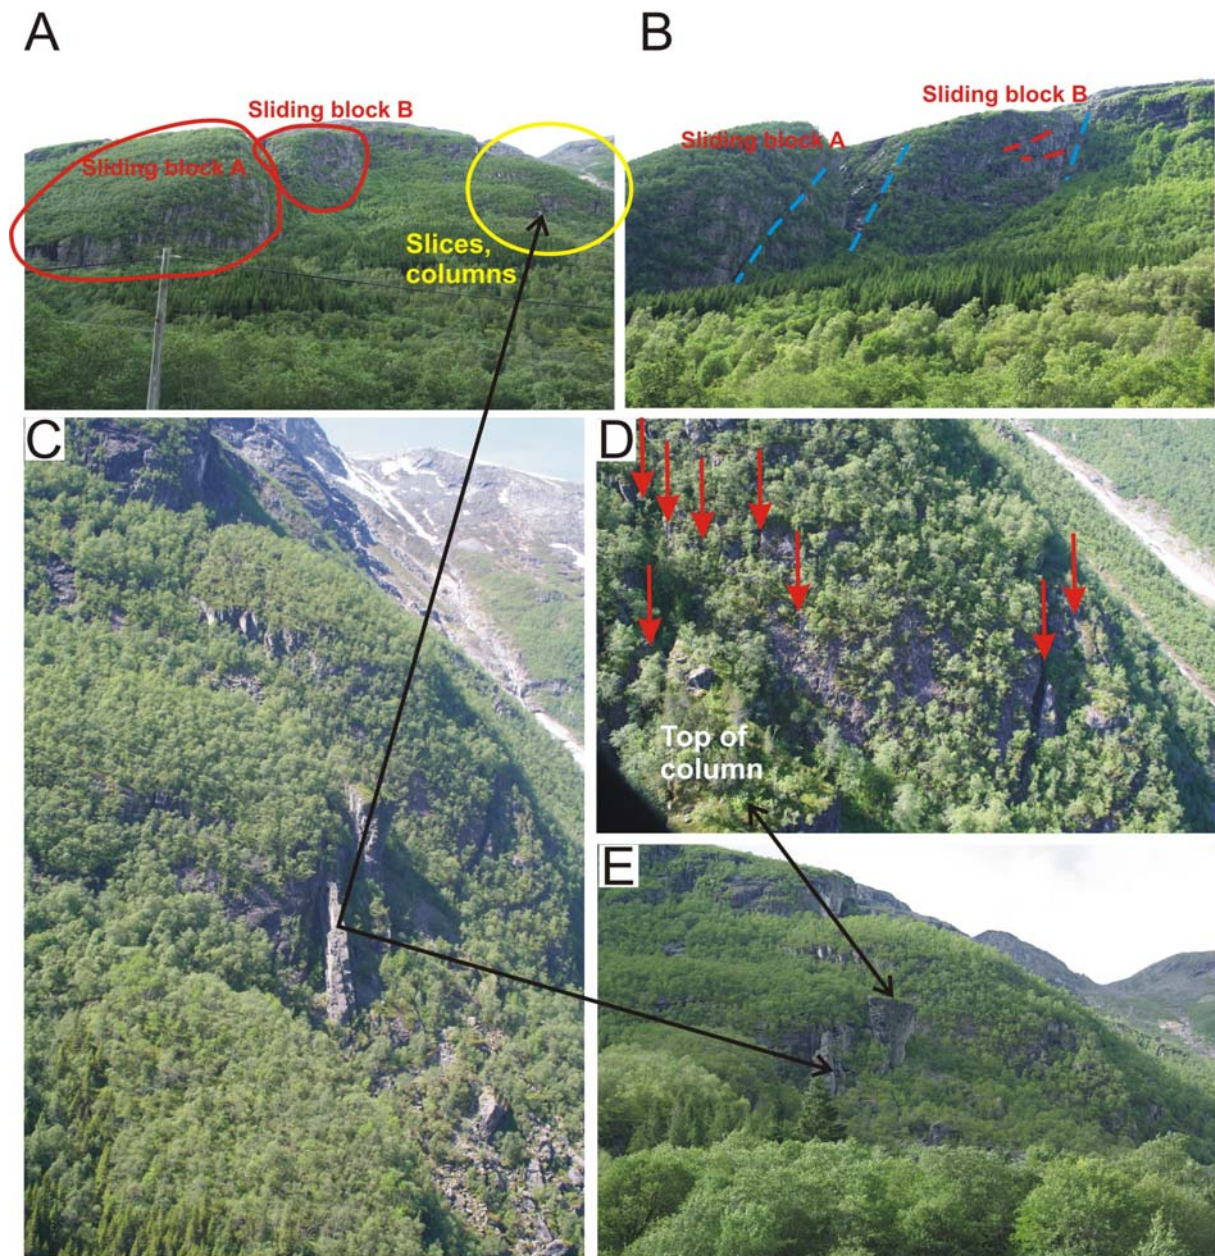
Figure 12. A, Some photos that give an overview of the site of Hårstad with the two types of instabilities (as for Figure 11, North is to the right). B, sliding blocks along reactivated shallow dipping foliation planes (in red dashed lines); open steep fractures (in blue dashed lines) testify to displacement. C, general view of the slices and columns that detached toward an E-W gully. D, NW-SE cracks (at the tip of the red arrows) along which the slices and columns detached. E, view of the large columns that detached toward the E-W gully with volumes of approximately $0,25 \text{ Mm}^3$.

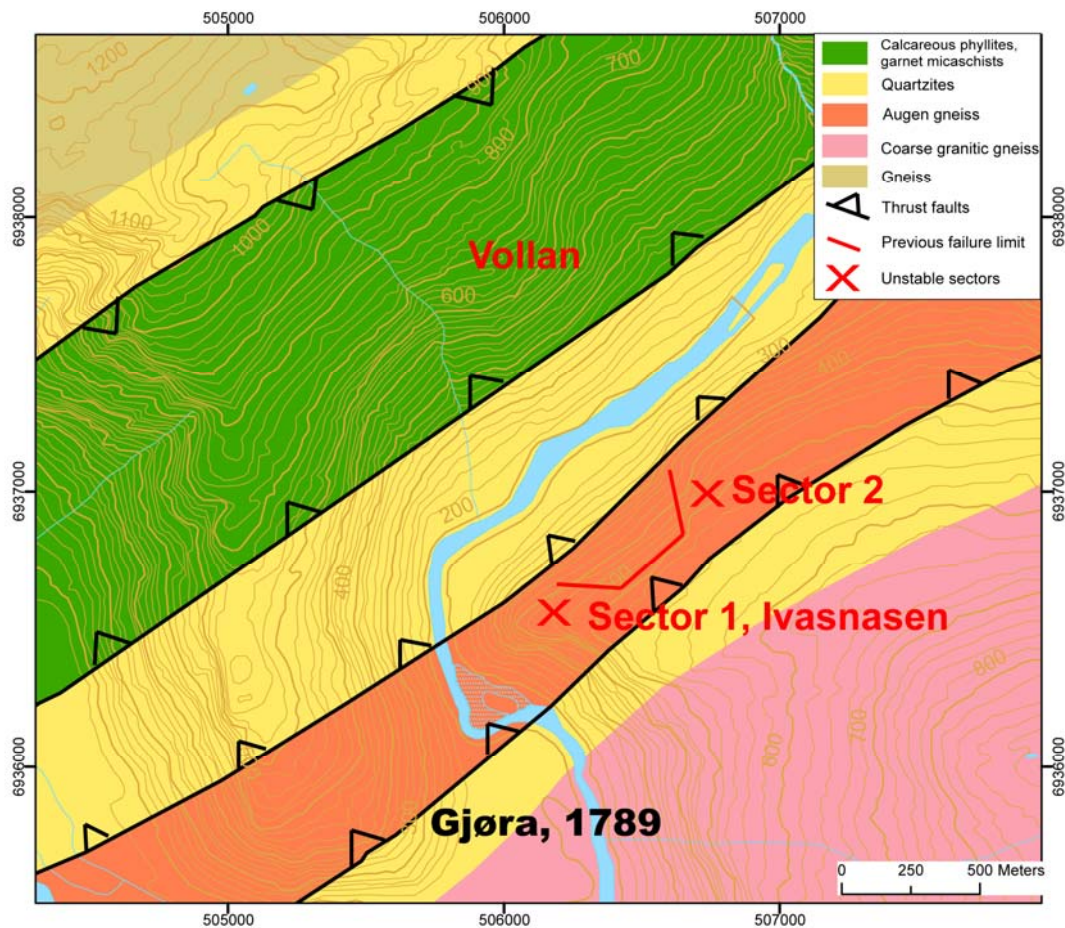
The geological map of the area shows that the unstable area lies in a zone of intense tectonic deformation where several thrust units were emplaced during Caledonian times (Figure 13). Such a site will be an important natural laboratory to study the role of the pre-existing

structures in the development of slope instabilities. The slope instability itself is underlain by allochthonous augen gneiss. The site displays an old slide with a maximum failed volume of 5 Mm³ (Figure 14A and B). The top of the failed volume was at approximately 500 m a.s.l. and the bottom of the valley is at 200 m a.s.l.. The limiting surface trends NE-SW, parallel to the thrust planes displayed on the geological map (Figure 13).

Figure 13. Geological map of Vollan and Ivasnasen surroundings (scale 1 /250 000, Nilsen, O. and Wolff, 1989). Note that sector 1 is a promontory in the topography called Ivasnasen, with three free borders that may favor the destabilization of the whole volume.

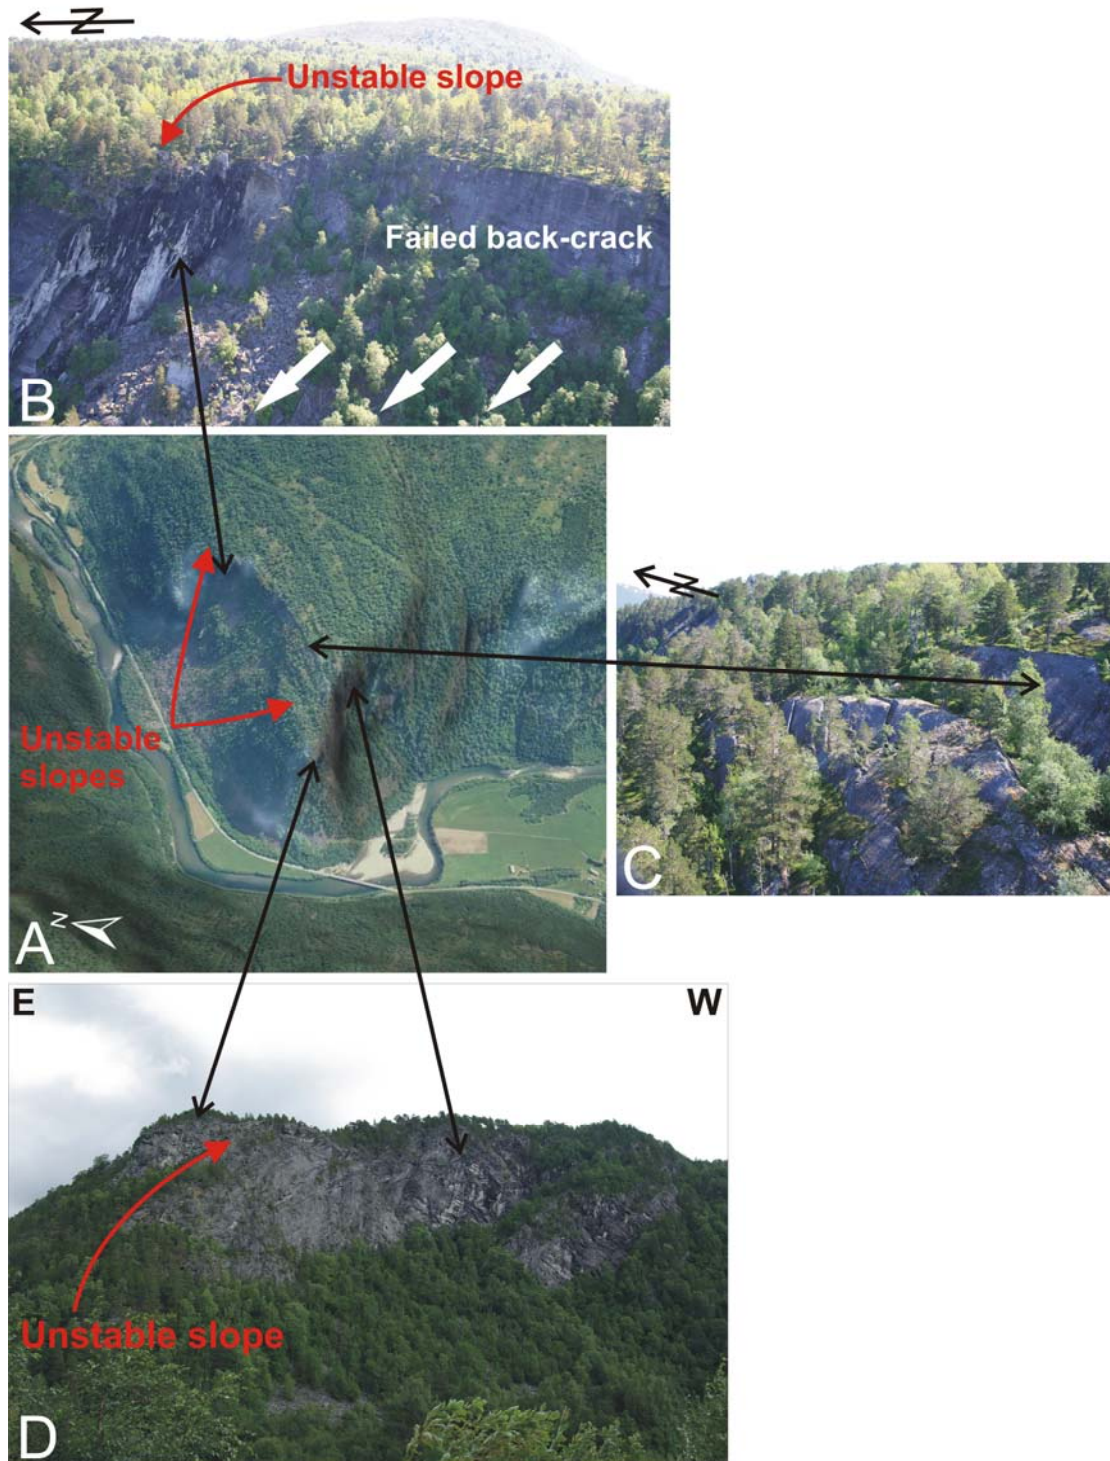
Extensive fractures appear to propagate from the previous failure limit towards the southwest and towards the northeast, possibly isolating two new unstable zones (sectors 1 and 2 on map of Figure 13 and displayed on photos of Figure 14A, B and C). The southwestern instability (sector 1) is coincident with the topographic promontory called Ivasnasen (Figure 14 A and D). The three free borders of the topographic promontory may favor the destabilization of the whole body. The estimated volume may be up to ~5 Mm³. The limits of the slope instability to the northeast (sector 2) are not known at this time, and will be mapped in 2008.

Figure 14. A, 3D view with orthophotos of the slope instability at Gjøra and Ivasnasen surroundings (www.norgei3d.no) and locations of the different parts of the instability. B, northeastern part of the limit of the previous failed volume and slope instability that propagates towards the north-east (sector 2 of Figure 13). C, southwestern slope instability called Ivasnasen (sector 1, Figure 13) and open NE-SW fractures that have propagated from the failed back-crack. D, southern face of Ivasnasen, the southwestern slope instability (sector 1 of Figure 13). The rock face displays ductile folds but also brittle structures. A detailed mapping of the site will be performed in 2008.

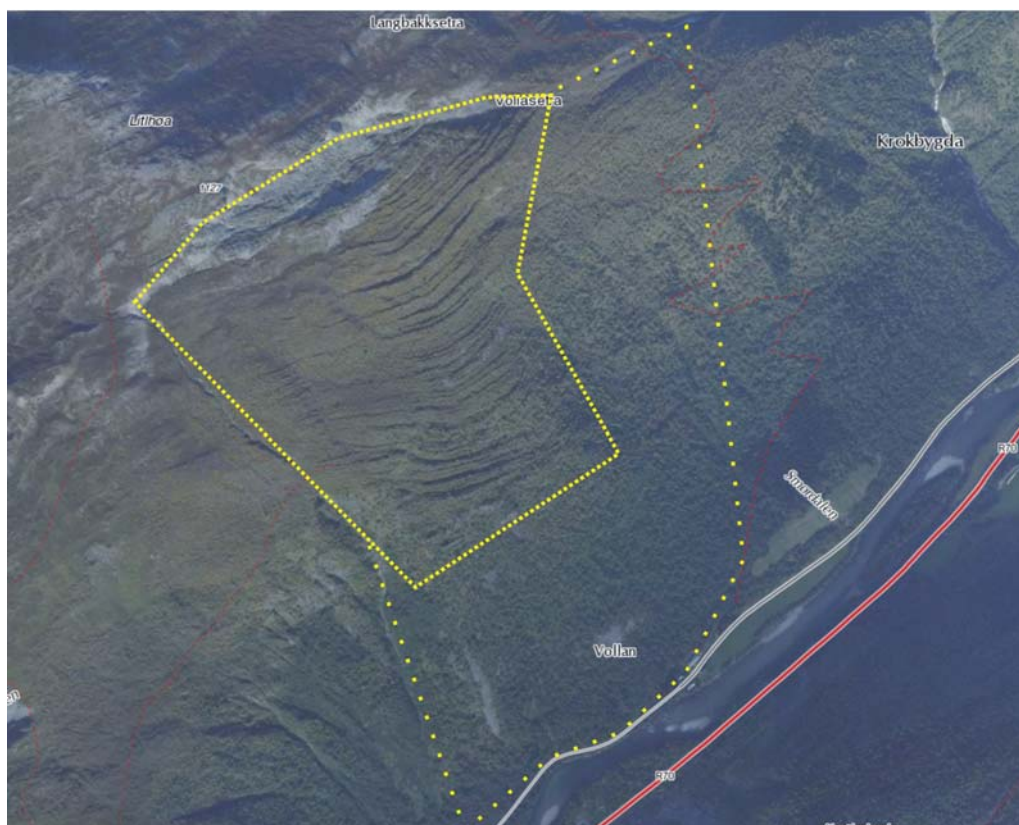
This site was located during an aerial photograph survey of the Sunndalen valley. Figure 15 shows an aerial photograph with the potential minimum and maximum extent of the large potential slope instability, 1 and 2 km², respectively. Fieldwork will be performed at this site in 2008 for a detailed mapping of the structures and to fix the volume of the instability.

Based solely on the width of the back scarp, the horizontal displacement may be in the order of 100 m. Given the arcuate shape of the cracks that have developed within the instability, it appears that most of the displacement was accommodated by creep as a 'semi-ductile downward flow' (Figure 15). Towards the valley floor, a cover of scree deposits is observed, which may indicate that parts of the slope have already failed. The deposits are probably responsible for the deviation of the stream of the river south of the instability (Figure 15). These deposits may also cover the toe of the largest unstable area (Figure 15).

Figure 15. Aerial photograph of the Vollan site with indications of minimum and maximum boundaries of the slope instability. (www.norgebilder.no)
