NGU Report 2008.049

Field studies of unstable slopes in Sunndalen
Valley

Report no.: 2008.049		ISSN 0800-3416	Grading: Open
Title: Field studies of unstable slopes in Sunndalen Valley			
Authors: Saintot, A., Böhme, M., Redfield, T., Dahle, H.		Client: Møre og Romsdal Fylke	
County: Møre og Romsdal		Commune: Sunndalsøra	
Map-sheet name (M=1:250.000) Ålesund, Røros		Map-sheet no. and -name (M=1:50.000)	
Deposit name and grid-reference:		Number of pages: 26	Price (NOK): 190
Fieldwork carried out: 2007		Date of report: August 2008	Project no.: 309900
		Person responsible: <i>Lars A. Blitner</i>	
Summary: <p>Following a helicopter survey of the slopes along the Sunndalen valley and the surroundings in spring 2007, four sites have been selected for further field studies. Two sites, (Gikling and Ottem), were mapped during summer 2007. GPS points for yearly monitoring were emplaced at Gikling. The volume of the unstable slope may be as much as 100 Mm³. At Ottem, a slope instability of about 2 Mm³ was mapped in detail. Scree deposits comprising large blocks along the slope are also unstable. GPS monitoring points were selected at Ottem and will be set out in 2008. Also at Ottem, another

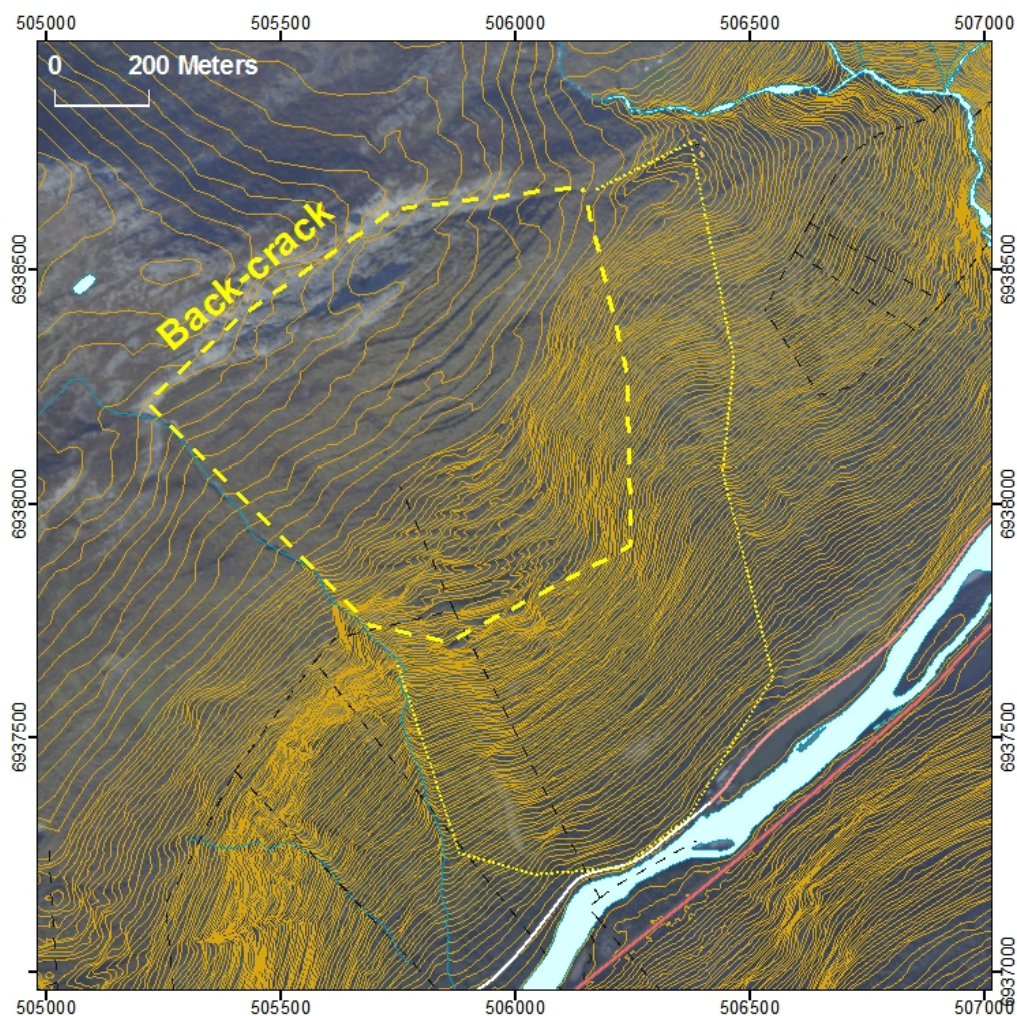
The top of the slide is located at approximately 1050 m above sea level, 850 m above the valley floor. The lower boundary of the minimum area is located 500-600 m a.s.l.. This also corresponds to a break in the shape of the slope with a shallow slope angle above this limit (<30 degrees) and a steep slope below it (Figure 16).

Figure 16. Topographic map of the Vollan site showing the break of the slope angle.
