NGU Report

**Structural mapping of potential rockslide  
sites in the Storfjorden area, western  
Norway: the influence of bedrock geology  
on hazard analysis**

| Report no.: 2006.052 | | ISSN 0800-3416 | | Grading: Open | |
| Authors:<br>Henderson, I.H.C., Saintot, A. & Derron, M.H. | | | Client:<br>Åknes/Tafjord prosjektet v/Stranda municipality | | |

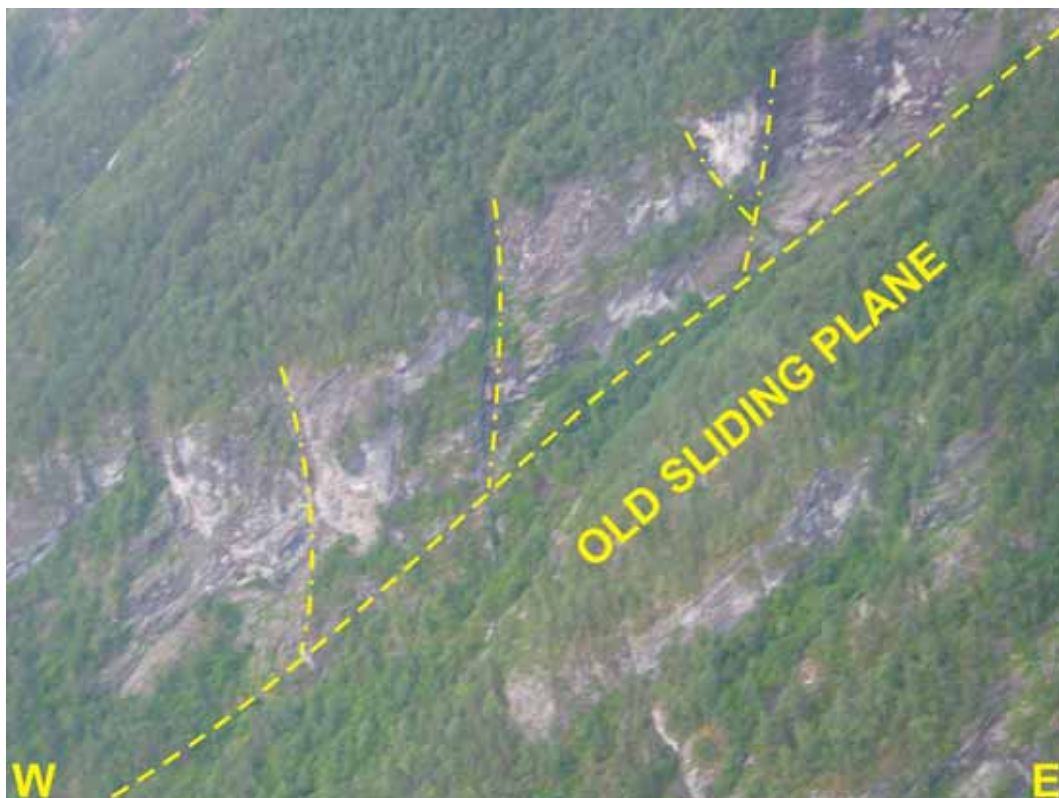
This site is on the west side of Sunnylvsfjorden approximately 9km south of Stranda and 5km north of Åkneset (see Figure 4). This site has been observed by helicopter only. No landing was possible. An approximately 80 metres high block is detached from the slope by a set of roughly N-S steep, open fractures and its base lies on a plane parallel to foliation and dipping some 40 degrees towards the fjord (Figure 5).

**Figure 5: Structures observed from helicopter at Site 2. It was not possible to land at this site.**

This low-angle plane is most probably a sliding plane. The extensional fractures, which separate the mountainside up into several large blocks, have obvious displacements up to several tens of centimetres or more. These extensional fractures detach onto the potential low-angle sliding plane, suggesting that movements on this structure has caused the extensional fractures in the hangingwall. Just to the north of the detached blocks is a low-angle slab, which probably represents an old sliding plane which has since been overgrown with trees. Extensive previous landslide

- *Several extensional fractures with inferred fjord-directed movement are observed. These delineate several large blocks with over 80m vertical height.*
- *A low-angle sliding plane is postulated at the base of these blocks, although was not observed due to the inaccessibility of the site.*
- *Because of the height of the involved mass, we consider a high priority to gain access to the site in the next field season.*

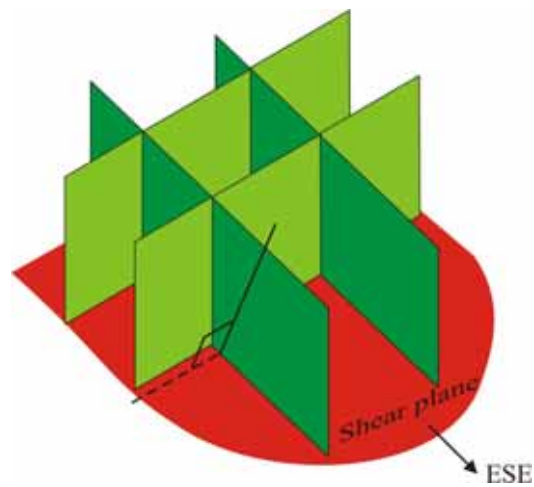
**Figure 7: Joints into the hanging wall to the Basal Shear Zone at Site 2b.**

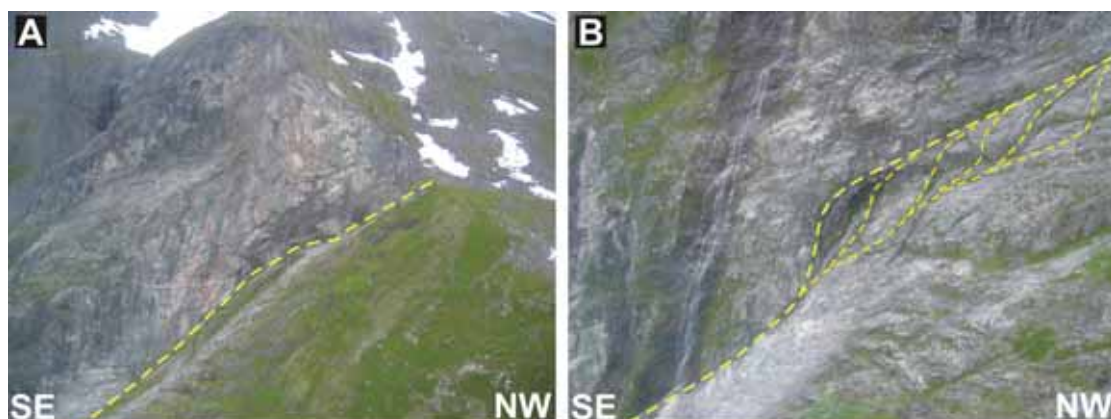
undulation along the fault plane, multiple faults are developed to form duplex-like structures (Figure 8B and Figure 9A). These develop as the irregular fault plane attempts to remove fault irregularities and produce a planar fault. Extensional fractures in the hangingwall are rare. However, they do occur as space accommodation structures where the low-angle sliding plane passes over a footwall ramp (Figure 8B and Figure 9B). However, these structures are extremely localised and do not affect the integrity of the hangingwall failure block. Indeed, the hanging wall block is not dissected by through-going extensional fractures, which suggests it consists of one contiguous block. Therefore, if the block was to fall, then it is likely that it would likely cause a larger tsunami as it would be less broken up under failure. Several observations suggest that this block is undergoing active movement:

**Figure 8: Large-scale structures observed from air at Site 2b. A-Large scale picture of the whole of Site 2b. The low-angle detachment (dashed yellow line) dips down towards the fjord and reaches the surface at the top. B,-Locally developed duplex-like structures where the fault plane is undulating.**

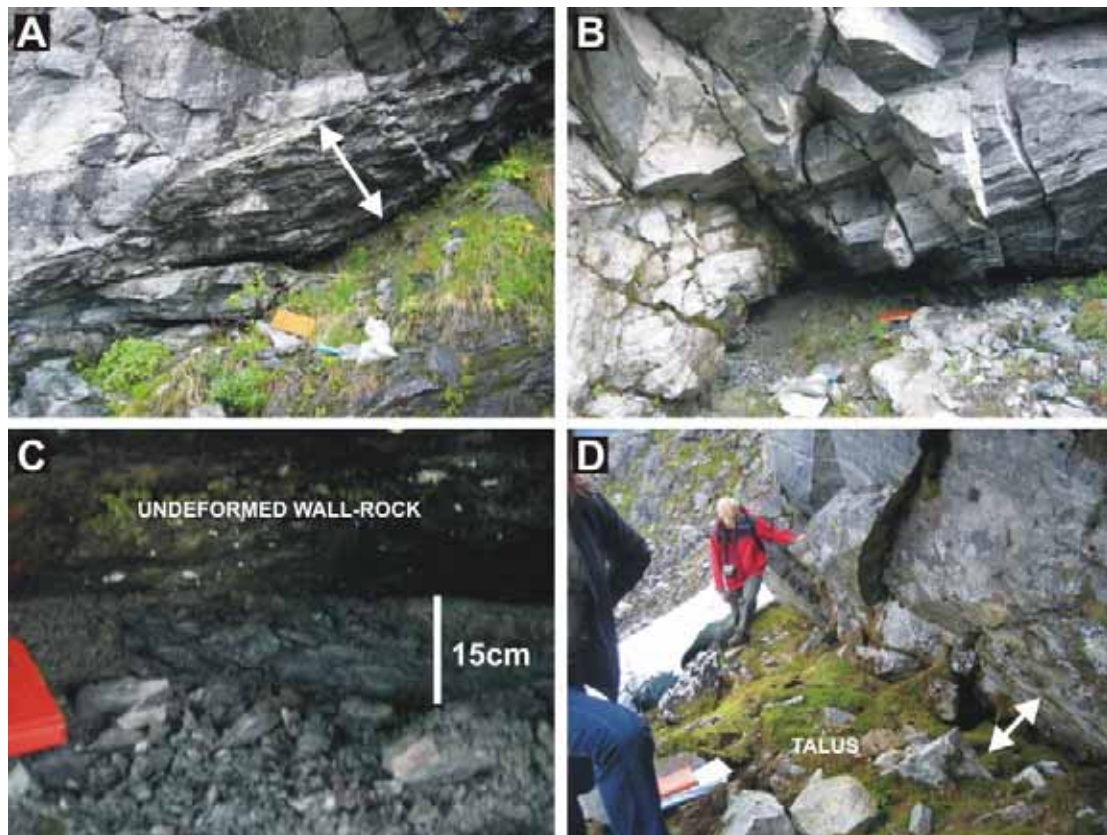
**Figure 9: Structures observed at Site 2b. A-Duplex-like structure in hangingwall of the low-angle sliding plane. B,-Localised extensional structures in the hangingwall to a low-angle sliding plane ramp structure. C-Detail of the discontinuous fault breccia developed along the low-angle sliding plane. D-Where the low-angle sliding plane reaches the surface, it is detached from the underlying talus slope. The displacement is 15 cm.**

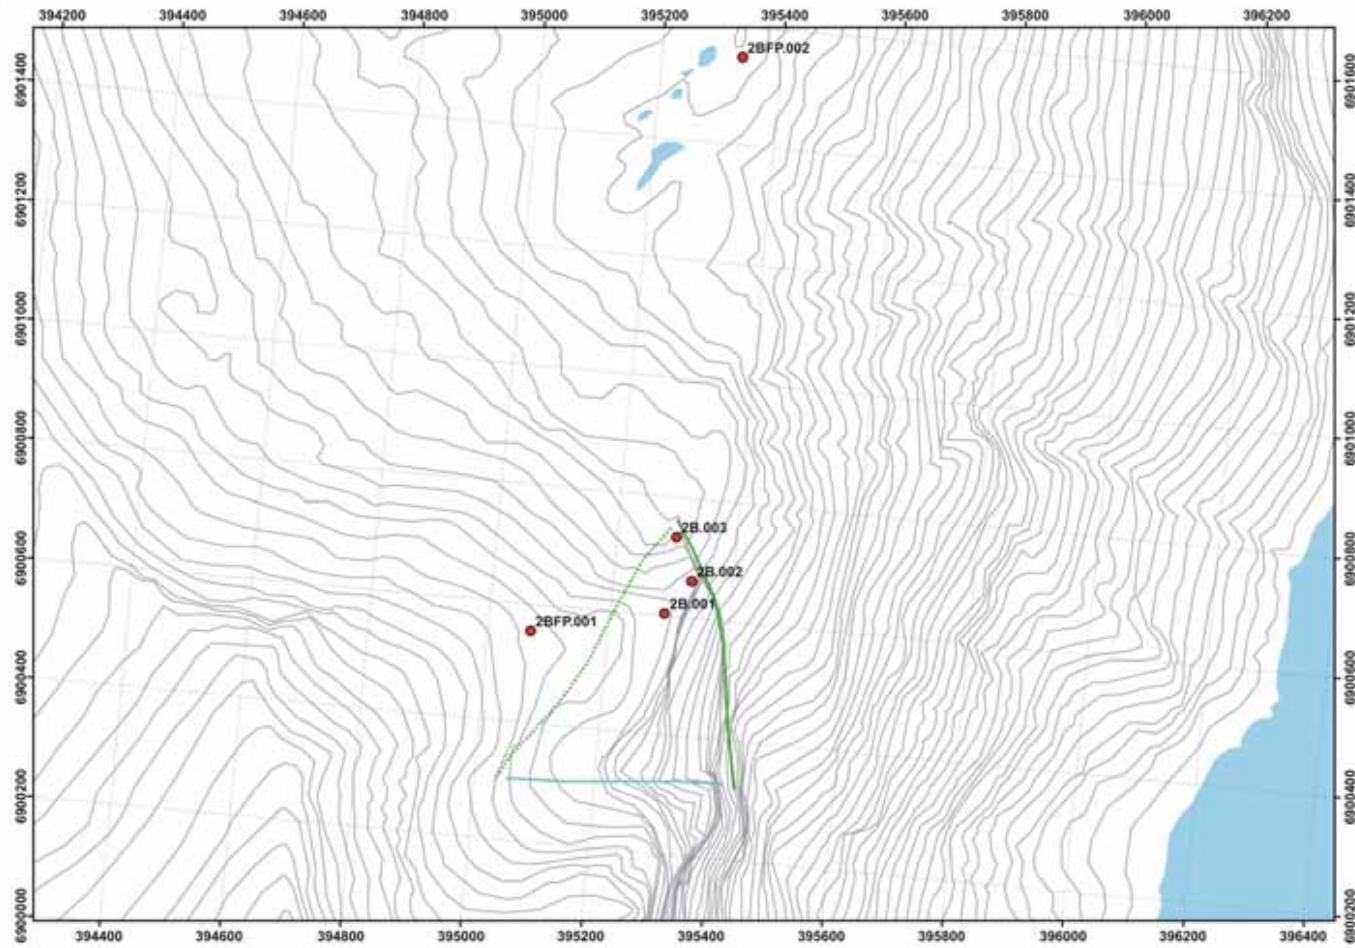
Figure 10: Topographic map showing location of GPS measurement points relative to the important structures. The solid green line is the basal shear zone. The dotted green line is its continuation intersecting the surface topography. The blue line is a postulated transfer fault which may detach the block.

- *A large, laterally continuous basal sliding plane is present at this site lying at the base of a large, apparently unstable block of  $1\text{Mm}^3$  estimated volume.*
- *Several lines of evidence suggest that movement on the basal sliding plane is recent and that the block is undergoing movement towards the fjord.*
- *There is no apparent back-crack at this site. This may suggest that this is a relatively new movement and a back crack has not yet had time to develop.*
- *5 GPS points have been set out on this block and will be measured again in 2006 to determine magnitude and pattern of movement.*

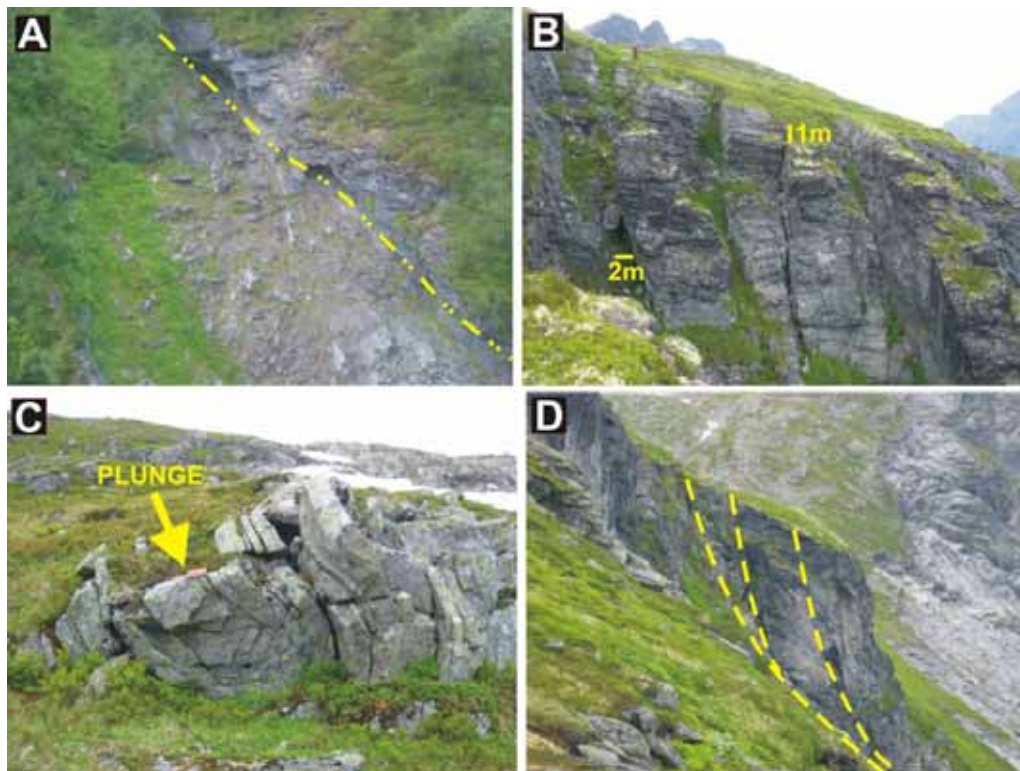
This site lies 1,5 km to the south of Åkneset on the same side of Sunnylvsfjorden, approximately 1000m above sea level. This site lies in a similar topographic position to Åkneset and displays remarkably very similar structures. A low-angle, fjord-dipping breccia zone is postulated at the base of the potential failure block although this has not been observed directly as the site was highly inaccessible. However, evidence suggests that an active sliding plane is present at the base of the block (Figure 11A). The potential failure block consists of at least seven column-shaped blocks. These are up to 50m wide and up to 80m high (Figure 11). These are separated by extensional fractures, which appear to have up to several metres of horizontal displacement. However, these are clearly inherited north-south striking structures, possibly of Devonian age (see Section 2.5.1) and may have been somewhat 'eroded-out' prior to displacement. Therefore several metres would be an upper limit to the horizontal displacement. Several metres of vertical displacement are also seen on some of the blocks (Figure 11B). A possible contributing factor to failure here is the presence of fjord-plunging small-folds in the granitic gneiss (see stereonet data in Figure 12). These have a trend of approximately  $100^\circ\text{N}$ , exactly parallel to the extensional direction of the column failure (i.e. perpendicular to the main set of

**Figure 11: Structures observed at Site 4. A-Potential low-angle sliding plane as observed from the air. It was not possible to land at this site but the broken nature of the rock and the development of a noticeable exfoliation 'shelf' strongly suggests the presence of a fault breccia. This zone appears to be the detachment zone for the extending blocks in the hangingwall seen in B. The supposed breccia zone dips at 25-35° towards the fjord. B-Extension of the mountainside along column failures. At least seven different columns with associated steep extensional fractures have been observed. C-Small-folds with a trend parallel to the extensional direction of the failure blocks and a plunge parallel to the maximum dip-direction of the postulated basal shear zone. These structures probably aid the development of a failure surface. D-Potential listric failure surfaces approximately 1km to the north of Site 4. This area has been named Site 4b and will be examined in the summer of 2006.**

- *This site displays structural types and geometries with similarities to those at Åkneset (Low-angle fjord-dipping shear plane, extensional fractures perpendicular to the movement direction).*
- *The site has a potential volume of 2-5 Mm<sup>3</sup>.*
- *A basal shear plane is not observed but is postulated from helicopter observations.*
- *No GPS points have been set out until a confirmation of a basal sliding plane has been made. This should be a priority for investigation during 2006, due to the large potential volume.*

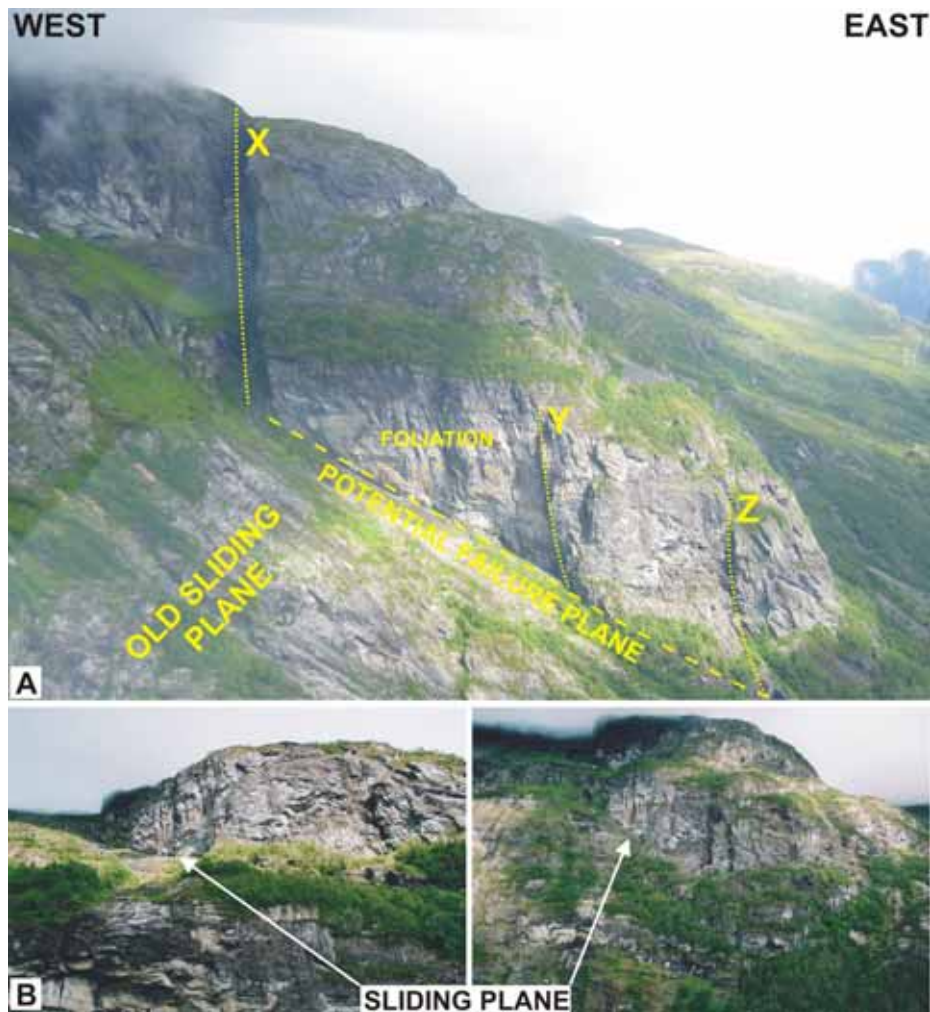
This site lies on the west side of Sunnylvsfjorden (UTM: 0389208, 6887980), approximately 5km south of Åkneset (see Figure 4), and lies approximately 700m metres above the fjord. Aerial photos were not available for this area; it was therefore not identified as a potential landslide area until fieldwork had begun. From the air several obvious critical structures can be observed (see Figure 13A). The key structure is a low-angle (25-40°) east-dipping plane. This structure dips towards Sunnylvsfjorden (Figure 13B). Above this basal plane, several large north-south striking extension fractures are present. Detailed field analyses were possible along the base of the identified block. Here a basal shear plane (BSP) with evidence of movement activity was identified (Figure 14). It partly follows the foliation that dips

Figure 13: Photos of structures seen from the air at Site 6b. A-The large back-extensional fracture, suggesting several metres cumulative displacement is seen at X. Several smaller NE-SW trending extensional fractures are seen at Y and Z. The major transfer fault is in the plane of the photo. For scale, the height of the back-extensional fracture is approximately 100m. B-Two views of the sliding/shear plane from the foot of the structure.

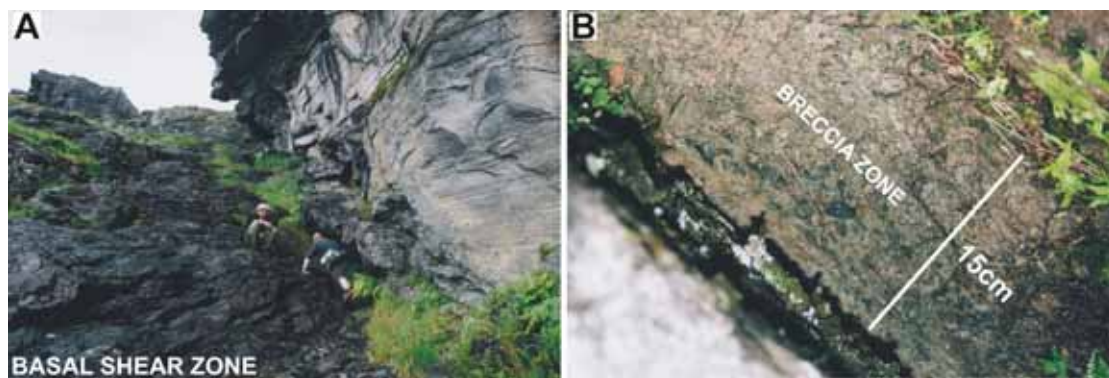
25-30° towards the fjord. However, in general the BSP cuts through the foliation at a shallow angle and a well developed 15cm thick fault breccia is observed (Figure 14B). It lies sub-parallel to the foliation (see stereonets Figure 15). NW-SE trending joints act as transfer faults (Figure 15). Two other systems of joints opened in the failure block (Figure 15); one trends NE-SW and the other trends N-S. The newly extensional structures are NE-SW (Y and Z on Figure 13A) with a trend perpendicular to the main slip direction (Figure 16). With the set of NW-SE fractures they form a system of joints geometrically consistent with the motion of the block (Figure 16). The main back-crack of 3 meters width (Figure 17) is an inherited extensional fracture, which trends N-S, similar to ultra-cataclastic fractures of Devonian age observed frequently in Vestlandet. Figure 17A shows one of these N-S epidotised faults reactivated as an extensional fracture. The extensional fractures detach onto the low-angle sliding plane suggesting their generation is related to movement on the plane (Figure 17C). Figure 18 is an example of newly formed NE-SW extensional shear structures in the failure block. To summarise, two trends of extensional fractures exist on site 6b (1) the first is a reactivation of old N-S trending structures and the main back-crack (X on Figure 13A) developed along such a trend and (2) the newly developed extensional structures trend NE-SW (Y and Z on Figure 13A) which is perpendicular to the movement. All of these extensional fractures within the hangingwall block detach onto the basal sliding plane and are not present in the footwall, suggesting that the hangingwall block is extending due to the movement on the basal shear plane.

Figure 14. Structures observed at Site 6b. A-Two views of the sliding plane. B-15cm thick breccia on the low-angle, east-dipping shear zone.

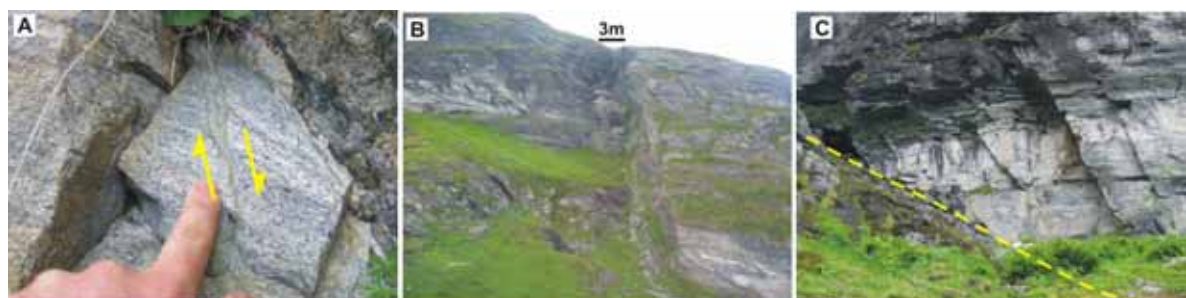
Figure 17: A-Extensional fractures are a reactivation of north-south trending epidotised cataclastic faults. B- View of the back-crack fracture. C-Extensional fractures in the potential failure block in the hanging wall to the low-angle sliding plane (in dashed yellow line).

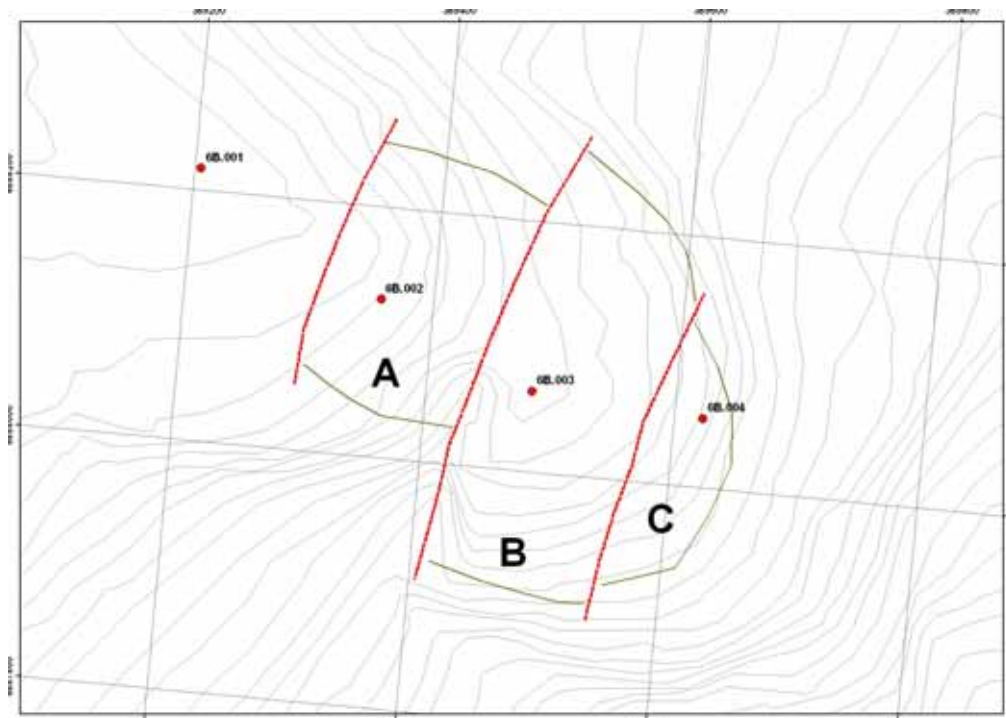
It was decided due to the apparent unstable nature of this block and the evidence for recent movement activity, that GPS monitoring equipment would be used. Figure 19 shows the location of the GPS points set out on this site. Mapping shows that the block is divided into three sub-blocks. Block B is the largest block and displays the most amount of movement activity, disintegration of the block by fracturing and gouge development. A single GPS point was set out on each block at the localities shown in Figure 19 and a single fixed point was set out approximately 100m west of the most westerly back-crack.

**Figure 19:** Map showing the position of GPS points at Site 6b relative to the different blocks. The UTM grid is 200m. The red lines represent extensional fractures which split the block up into three sub-blocks. The green lines mark the approximate limits of the blocks. Block B is considered the most dangerous as the back-crack on its western side is the biggest.

- *This site has developed identical structures to those observed at Åkneset (back-crack, opened fractures in the block, thick breccia along a low angle basal shear plane).*
- *A rough estimate of potential failure volume is  $4Mm^3$ . This volume will be refined after analysis of the LIDAR data in 2006.*
- *4 GPS points have been set out during summer 2005 and will be measured again in summer 2006 to determine the magnitude and kinematics of movement.*

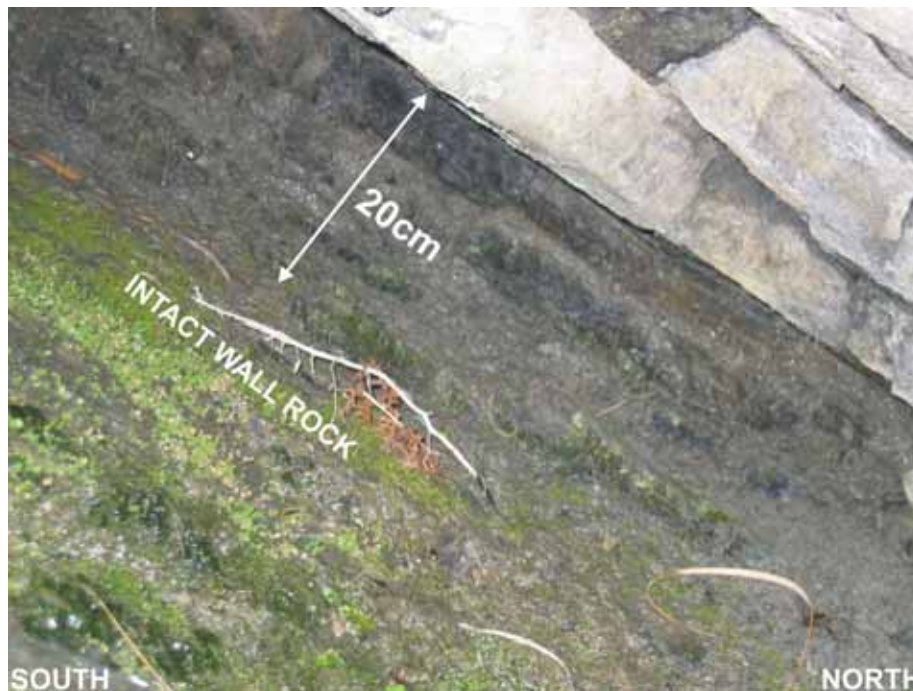
This site lies on the southern face of Geiranger Fjord, 5 km east of Hellesylt (Figure 4). The shear plane developed along the foliation dipping 20-30 degrees towards the fjord (Figure 20). A 20cm thick discontinuous gouge is developed along the shear plane, separating the unstable block from the stable rock underneath. A sample has been taken from this gouge to test for fault-rock strength. Two trends of joints are developed in the failure block (pale green and dark green on Figure 21). If the movement of the block is dip-slip on the shear plane then these two trends are those of transfer faults, parallel to the movement, and of back-crack fractures, with strikes perpendicular to the movement. Such newly formed system of joints in the failure block have also been observed at site 6B (Figure 16).

Figure 20: Fault gouge developed at Site 7b. The gouge is up to 20cm thick but is discontinuous along the fault plane. The contacts with the intact wall-rock are very sharp.

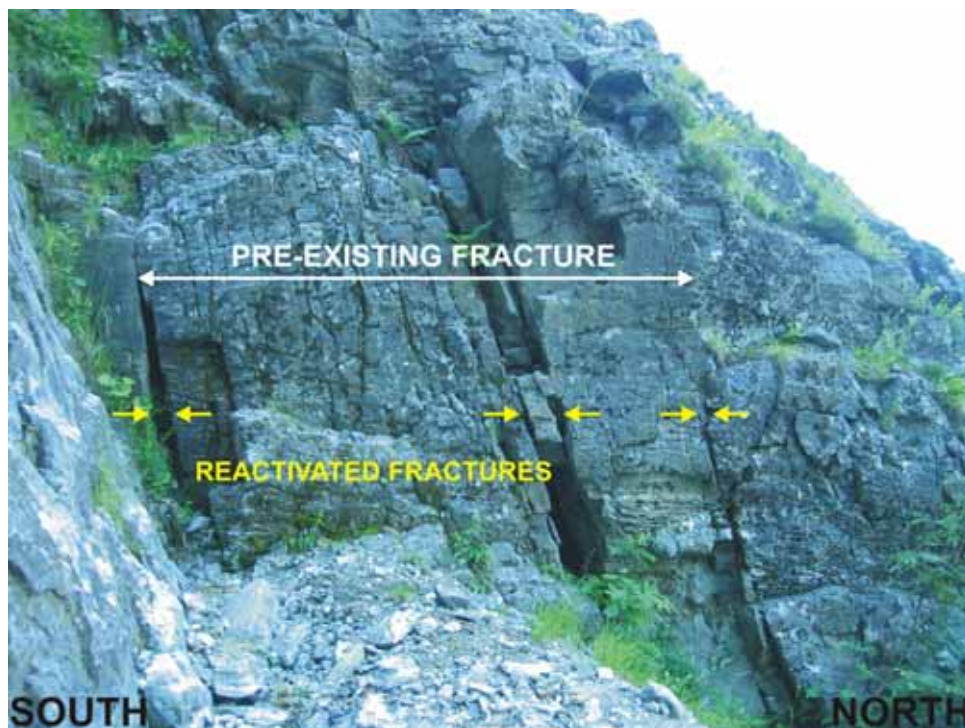
Site 9 is on the southern face of Geiranger Fjord, 10 km east of Hellesylt village. Several large E-W lineaments were observed from the aerial photos. Fieldwork demonstrates that these consist of large (several kilometres length, several hundred metres fault length and several metres wide) pre-existing fractures (Figure 22). The foliation at this site dips towards the fjord and extensional structures are developed in the sliding mass (Figure 23) guided by transfer faults parallel to the motion of the block (stereonet on Figure 24).

**Figure 22:** Steep pre-existing E-W trending fault zone at Site 9. The fault zone is 3m wide and consists of a 'damage zone' of many smaller fractures. These are partly cemented by quartz. This weak zone has been the focus for recent movement, producing three smaller fractures with both extensional and down-dip (fjord-directed) movement.

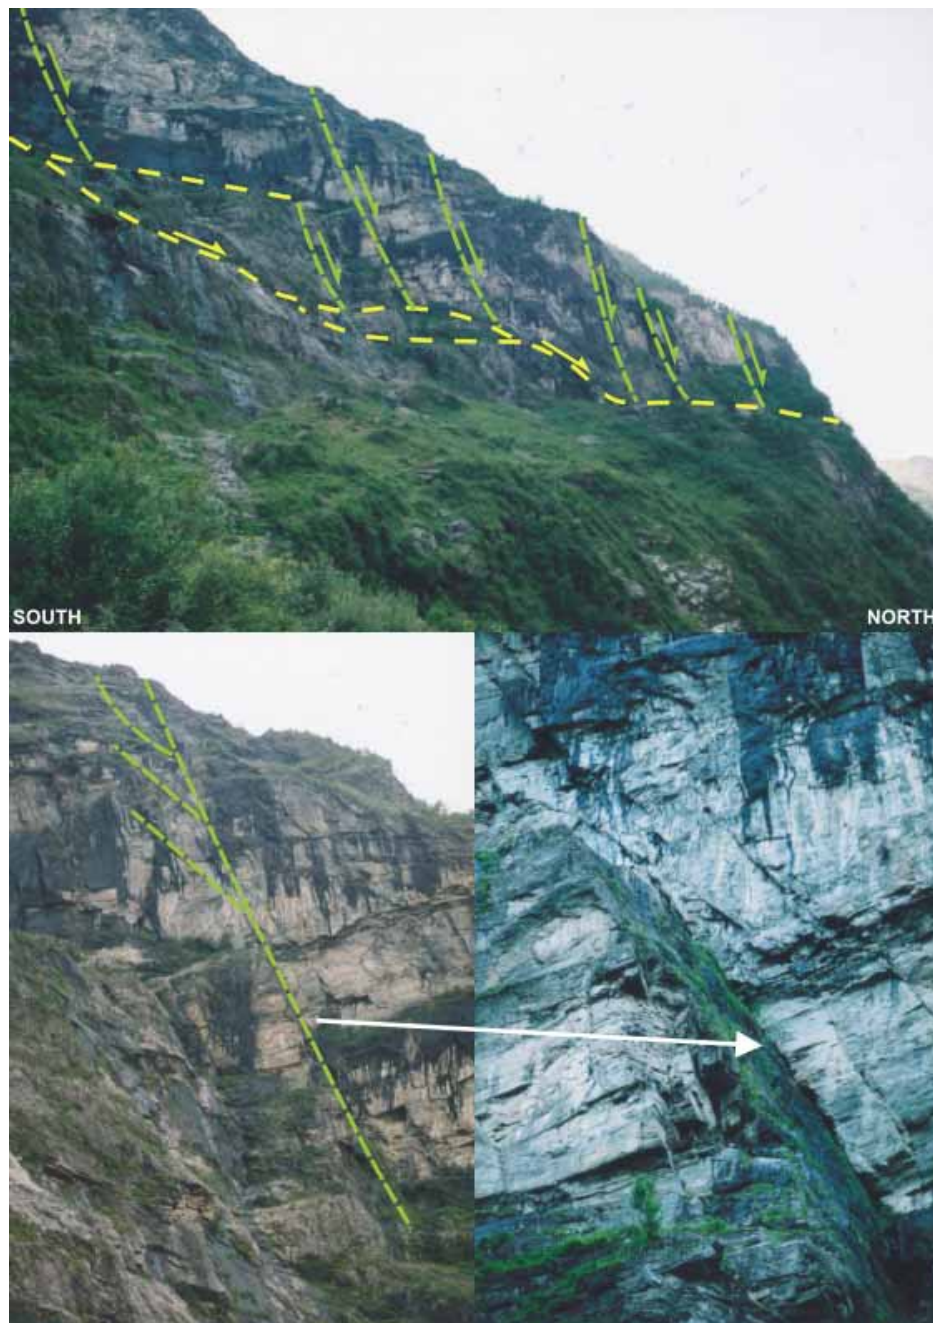
**Figure 23:** Several images and interpretation of Site 9. Extensional fractures are seen which are steeply-dipping towards the fjord. The foliation dips at shallow to moderate angles towards the fjord. We postulate shearing along the foliation to accommodate the extensional movement on the steep structures.

No direct evidence of the low-angle shearing planes at the base of the unstable block have been recognised. These were not observed in the field due to the inaccessibility of the area and the severity of the topography but such structures are postulated on

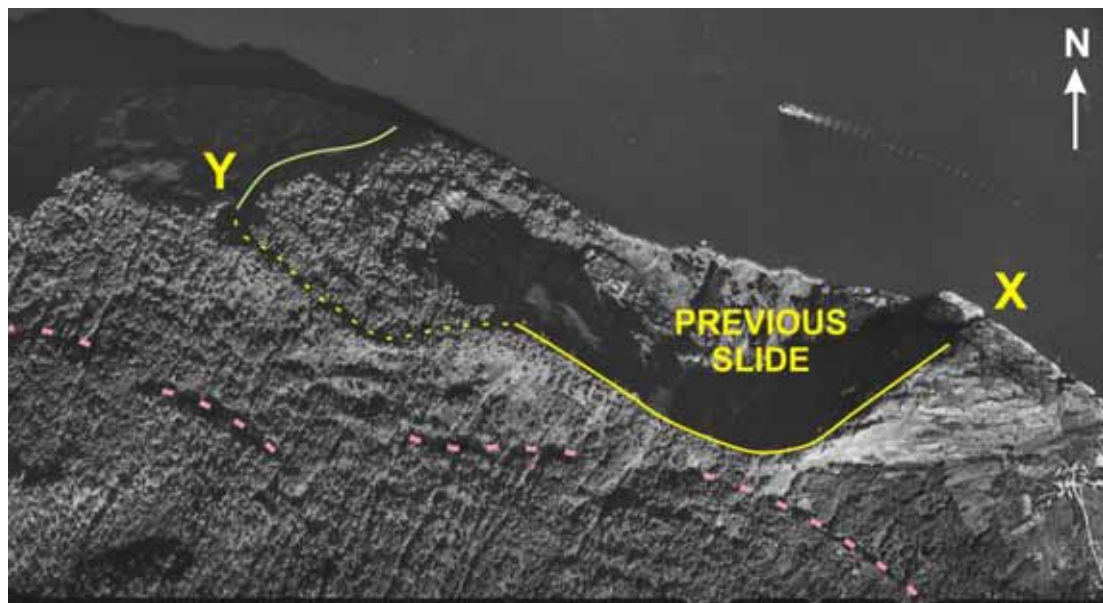
Figure 25: Aerial photo showing the presence of a partially obscured back escarpment at locality 10 (dotted yellow line). A previous slide has developed on the same structure (solid yellow line). The extension of this structure into a low-angle foliation parallel sliding plane is shown by the solid green line. Additional scarp structures are marked in red.

- *This area displays a potentially unstable block (with a tentatively estimated approximate volume of  $2Mm^3$ ) with the presence of a back escarpment produced by apparent extensional displacement along a steep fracture. Foliation dips  $20-35^\circ$  towards the fjord, providing ideal conditions for a rock-slide to occur. Extensive exfoliation planes are observed.*
- *This extensional structure becomes listric at its base and is parallel to the fjord-dipping foliation, which may cause or have caused shear sliding along the base of the valley side.*

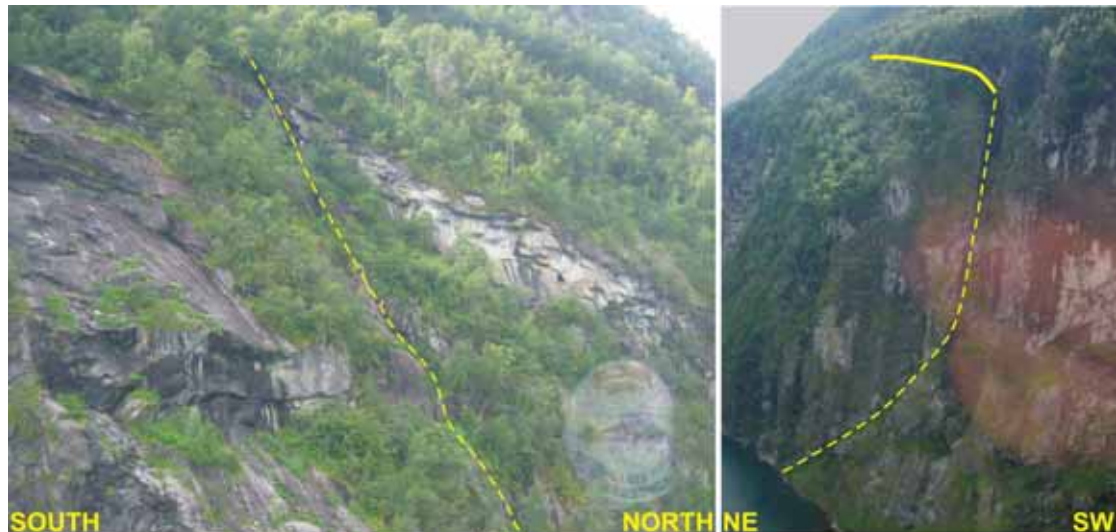
Firstly, the foliation appears to dip gently or at a moderate angle towards the fjord (Figure 26A). Indeed pronounced exfoliation is seen on some surfaces. This is cut through by a steeply dipping (towards the fjord) extensional fracture on the SW side of the block. Figure 26B shows the same fracture from the NE side and shows that this fracture flattens out towards its base and appears to be parallel to the foliation at the foot of the slope. At this locality it appears that there is a fjord-directed extension on this fracture which would result in a shearing displacement at the base of the structure sub-parallel to the foliation.

Figure 26: Structures observed at Site 10 from the air. A-Extensional structure (dashed line) seen from the east. The low-angle planes are exfoliation along the foliation. This is Point X on Figure 25. B-The same structure seen from the west. The extensional structure (dashed line) shallows with depth and is parallel to the foliation near sea-level. The solid line represents the back escarpment seen on Figure 25. This is point Y on Figure 25. It was not possible to land with the helicopter at this site.

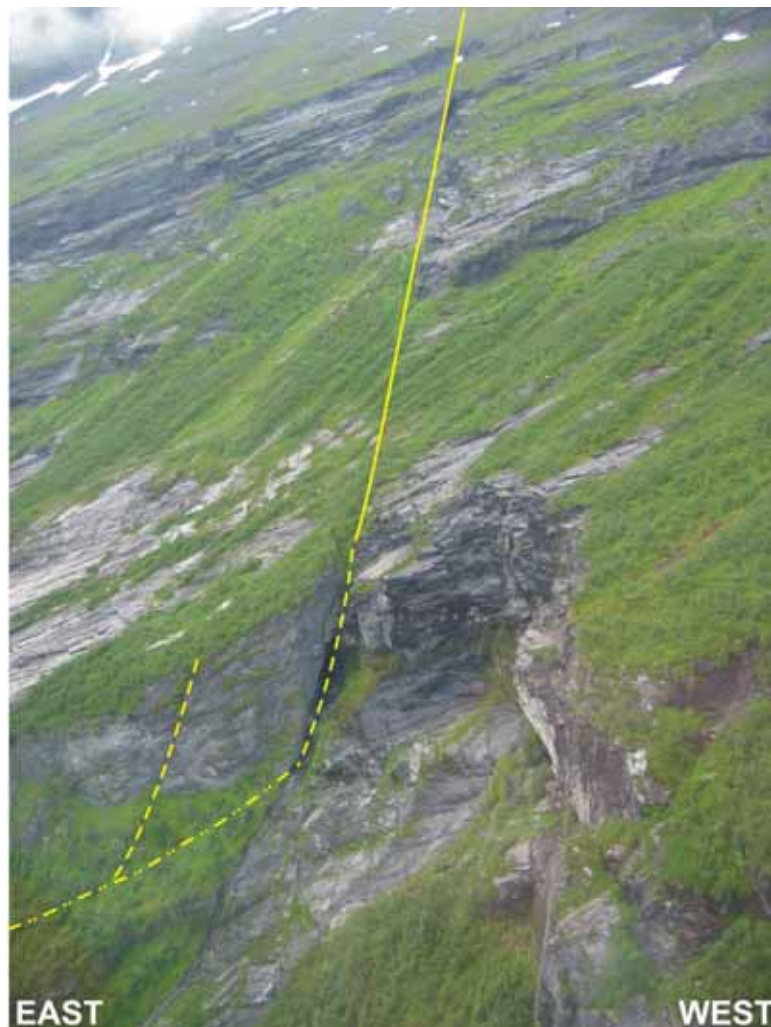
This site lies on the south side of Geirangerfjorden less than 1km directly west from the village of Geiranger and approximately 350m above sea level. The main characteristics of this site are a shallow (20-30°) east-dipping foliation towards the village of Geiranger. Several low-angle shear planes are developed sub-parallel to the foliation (Figure 27, Figure 28 and Figure 29). A steep, extensional fracture is developed at the western (back) margin of the potentially unstable block. This extensional back fracture appears to reactivate a long-lived regional N-S lineament

(Figure 27). It is difficult to determine the amount of displacement on this structure as the fracture has been further utilised as a river course and is partially 'eroded-out' (Figure 28B). However, the presence of a discontinuous fault-rock gouge along the main basal shear zone suggests that movement of the block has been recent. Several SW-NE pre-existing structures are apparent from the aerial photo interpretation and were observed in the field (Figure 28A and Figure 29) which delimit the potentially unstable block.

**Figure 27: Site 10b seen from the air. Clearly visible are the foliation gently dipping towards the fjord and the back extensional fracture (dashed line on right), which appears to be an inherited north-south lineament (solid line).**

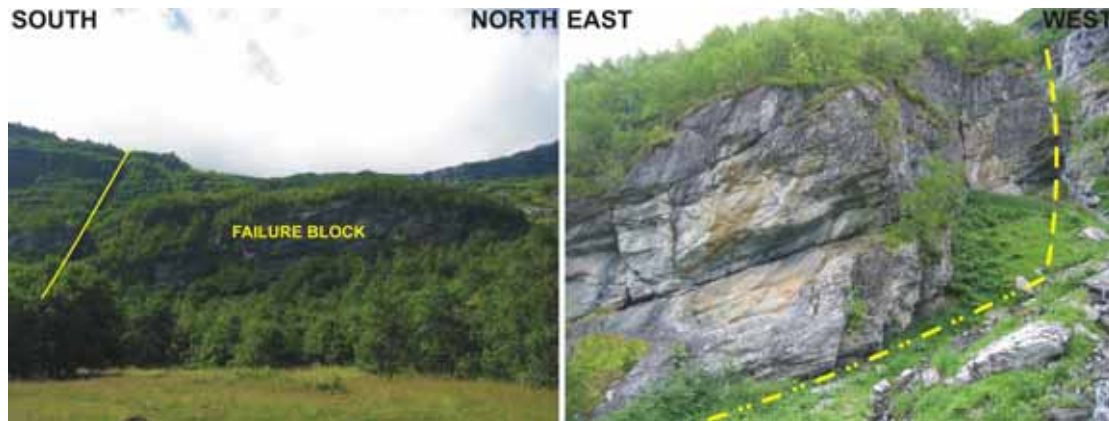
**Figure 28:** Structures observed at Site 10b. A-View uphill up the fall-line. A large open transfer fault is observed on the left (solid line). B-Large, steep extensional fracture to the right (dashed line) and a low-angle basal shear at the bottom (dot-dash line) parallel to foliation. Detailed examination revealed a discontinuous 5-10cm fault breccia along this structure. This has been sampled for analysis.

A set of steep, open joints developed in the failure block. The joint systems display a conjugate geometry. (purple on stereonet Figure 29). Their geometrical relationships with the shear plane are consistent with a newly-opened array of joints as a result of dip-slip sliding occurring on the basal shear plane (Figure 28B and Figure 30).

- *An unstable block has been developed at this site where foliation dips shallowly towards the fjord.*
- *Low-angle basal shear planes are developed sub-parallel to the foliation and recent movement along the shear structures is evidenced by the development of a fault-rock gouge and the presence of an extensional back-crack.*
- *Further work should be carried out to set out GPS points to determine the magnitude and direction of displacement.*

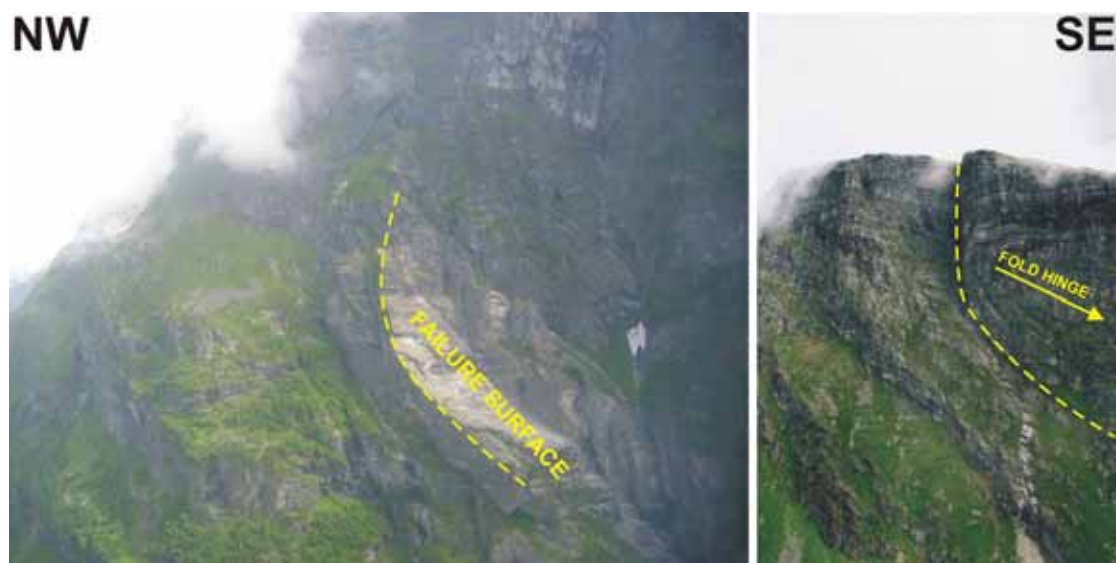
**Figure 31: Structural observations made from the helicopter at Site 11. A-Low-angle structures steepening up into listric structures. This location shows the position of a previous slide. These structures dip towards the fjord. B-Listric structures reactivating recumbent folds (extensional fracture at left in the core of an isoclinal fold).**

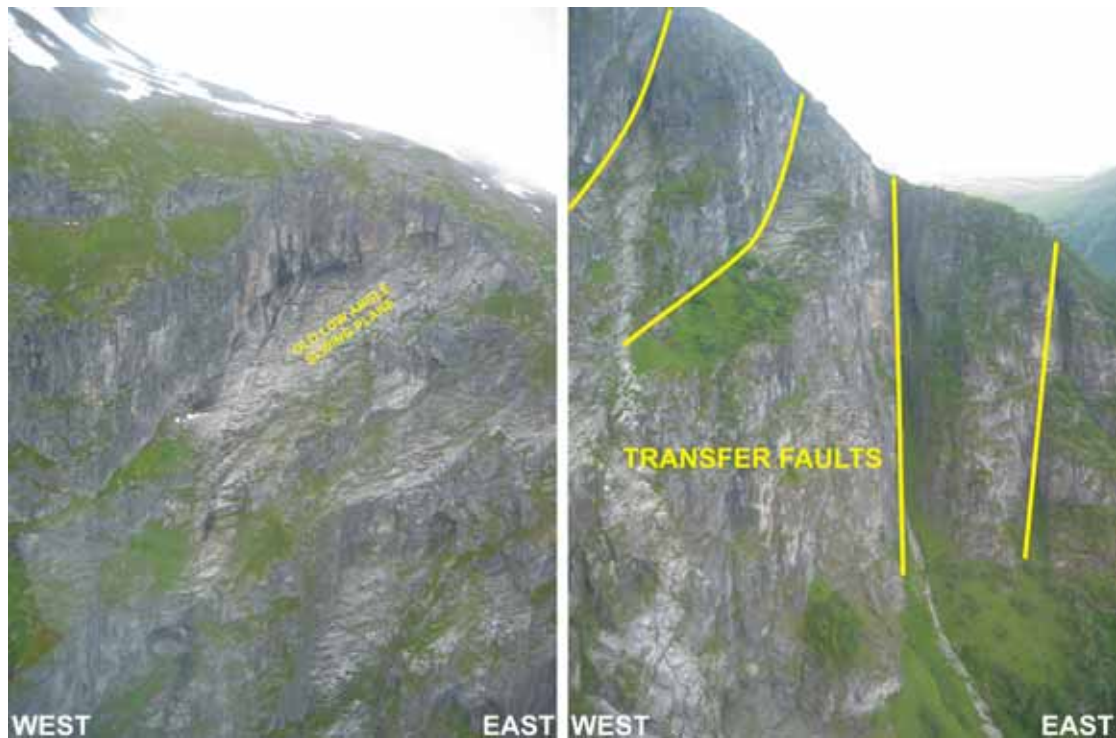
Figure 32: Structures observed at Site 12. A-Low-angle basal shear plane. It was not possible to visit this structure and therefore not possible to determine if a breccia is present on the structure. B-Steep transfer fault structures with a N-S strike which appear to be controlling structures for slope failure. These are most likely pre-existing structures.

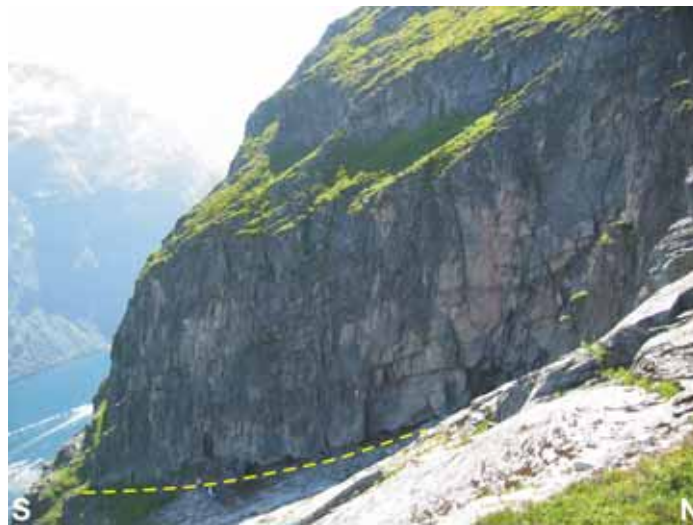
Figure 33: Structures observed in outcrop at Site 12. The dashed line is at the base of the postulated unstable block is interpreted as a low-angle sliding plane. The complex and dense suite of fractures and joints within the unstable block appears to stop at the base of the block, suggesting that their formation is related to the movement on the basal shear plane.

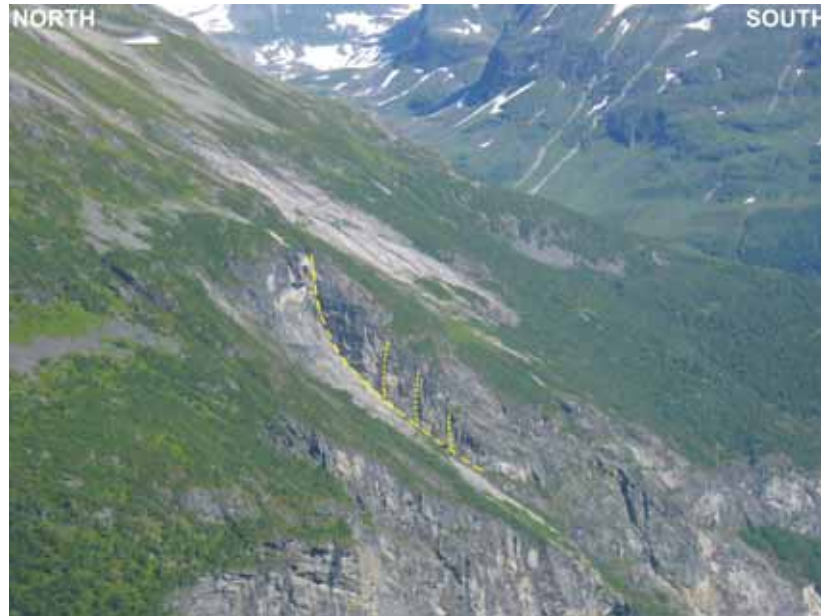
Figure 35: Structures observed at Site 12b. This site was only observed from a distance but a long, listric fault was observed (dashed line) steepening up into an extensional fracture on the left. This is accompanied by several extensional fractures detaching down onto the listric fault (dotted lines).

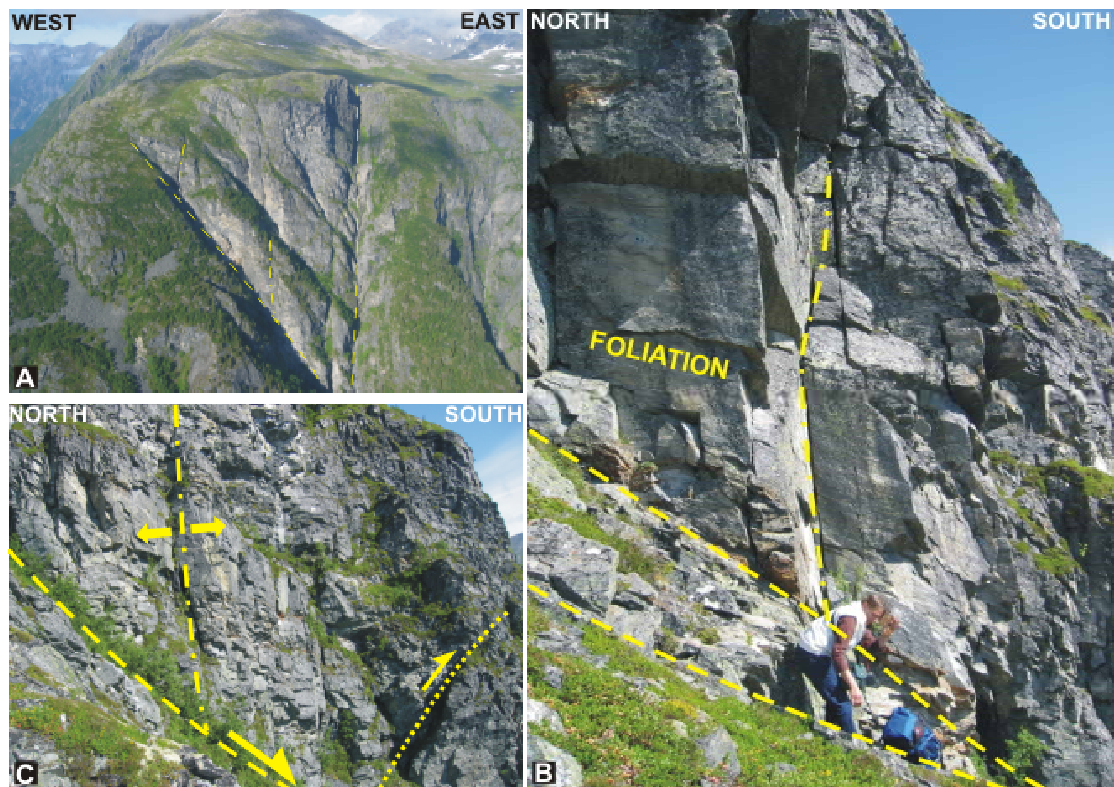
Figure 36: Structures observed at Site 13 along the scarp towards the fjord. A-NW-SE and N-S large sets of fractures seen from the helicopter. B-Foliation dipping towards the fjord and E-W large opened fractures. C-Reverse fault development against the downward motion of the block.

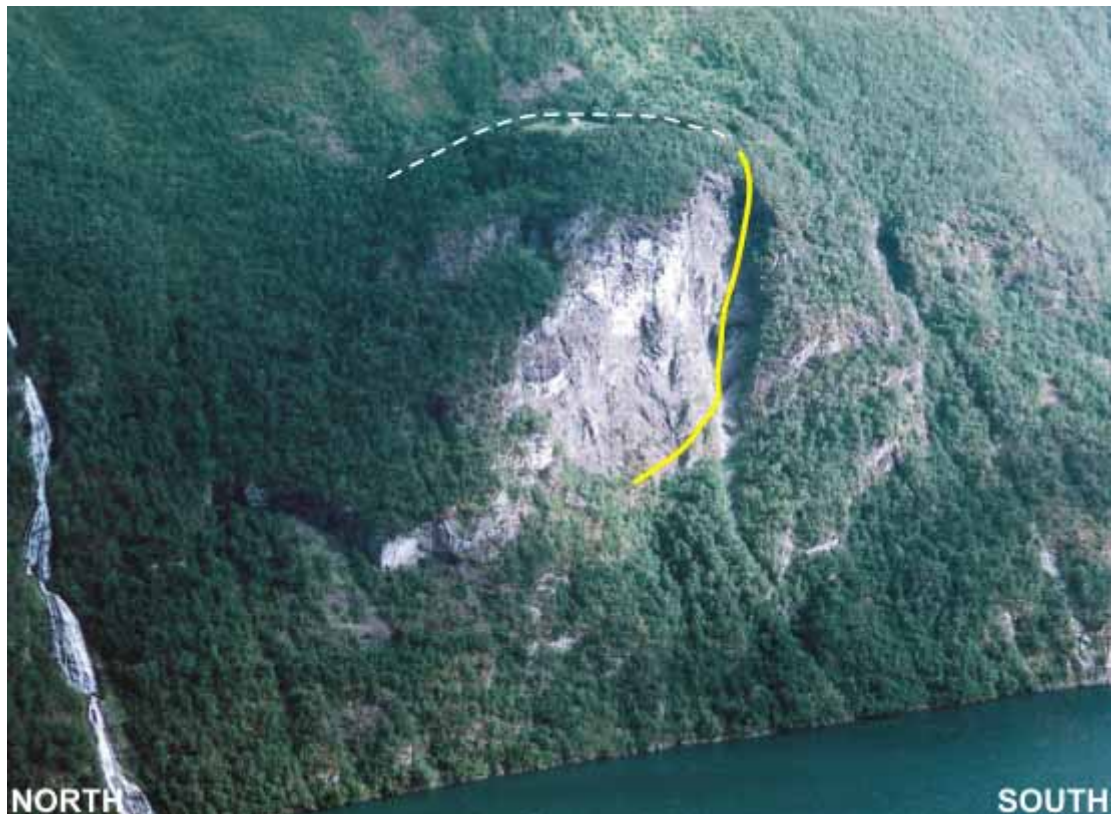
Figure 39: View of site 14b from the helicopter. The dashed white line represents the back extensional fracture. The solid yellow line marks the approximate position of the extension of this structure at depth. This structure appears to have a listric geometry and is therefore flattening out at depth. Clearly there has been some recent landslide activity in this area due to the presence of fresh rock surfaces.
