NGU Report

**Structural mapping of potential rockslide  
sites in the Storfjorden area, western  
Norway: the influence of bedrock geology  
on hazard analysis**

| Report no.: 2006.052 | | ISSN 0800-3416 | | Grading: Open | |
| Authors:<br>Henderson, I.H.C., Saintot, A. & Derron, M.H. | | | Client:<br>Åknes/Tafjord prosjektet v/Stranda municipality | | |

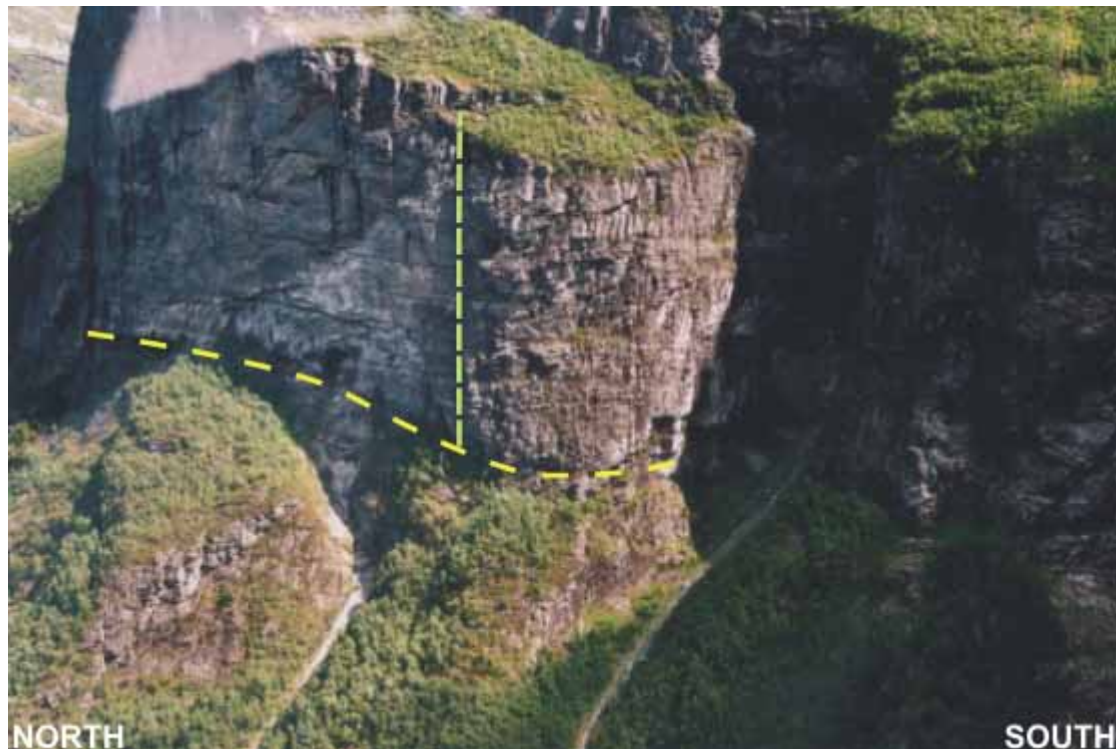
Figure 41: Development of a dense network of joints in a potentially unstable block at site 16. The steep, open fractures (a major one shown in green) appear to detach onto a shallow, fjord-dipping discontinuity (yellow).

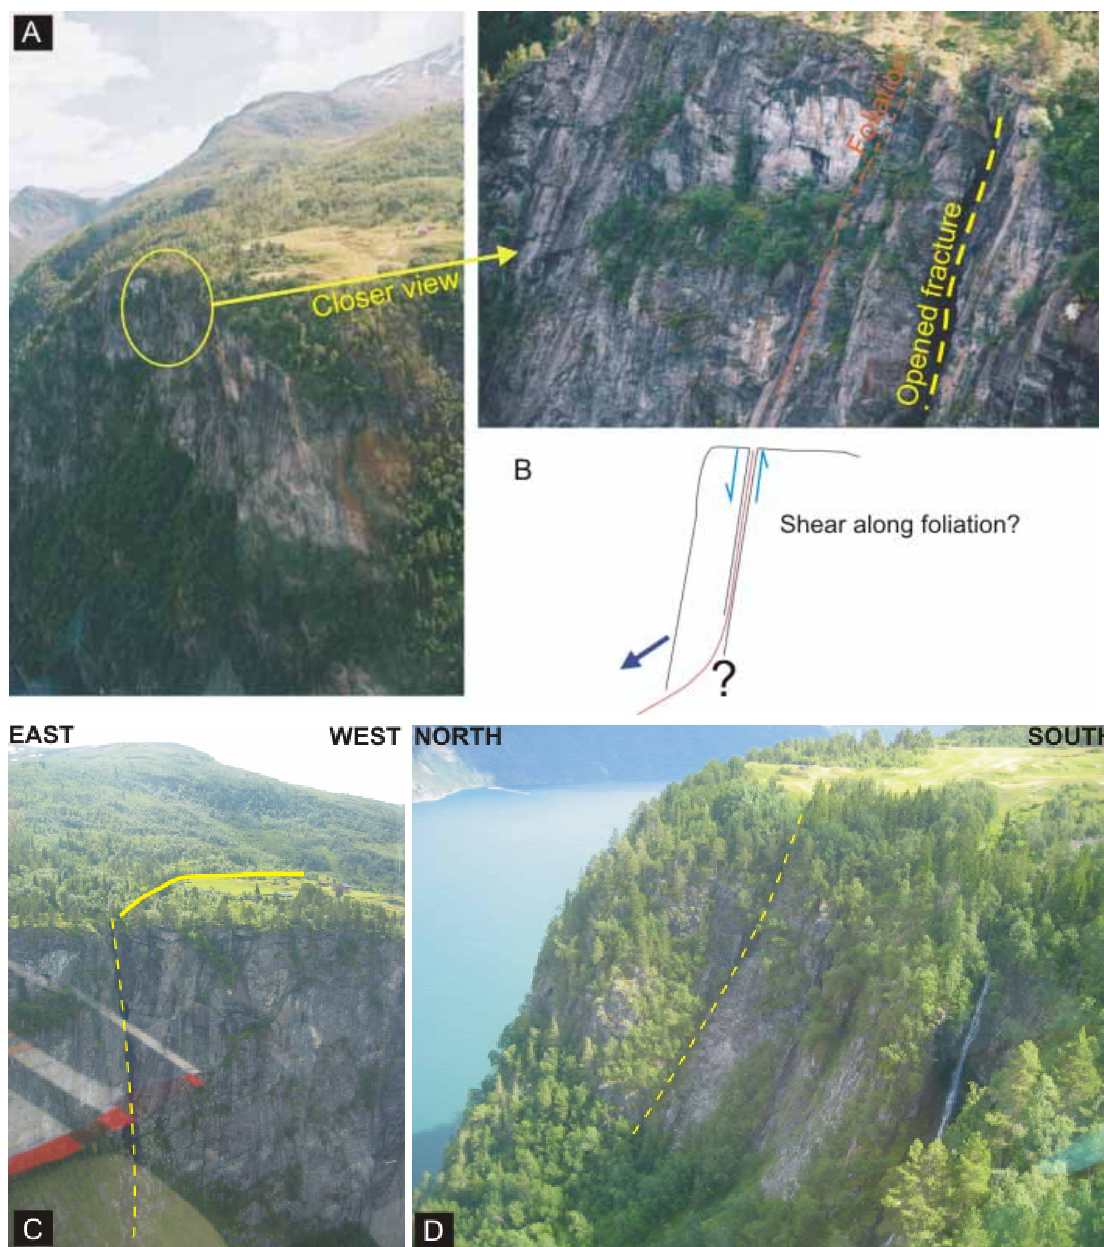
**Figure 42: Structures observed at Site 18. A-Steep foliation (orange) and fractures opened along the foliation. B- Hypothetical view of the rock failure process. C- Major E-W back fracture (solid yellow line) and foliation parallel extensional structure seen from the NE, D, major E-W extensional fracture seen from the west.**

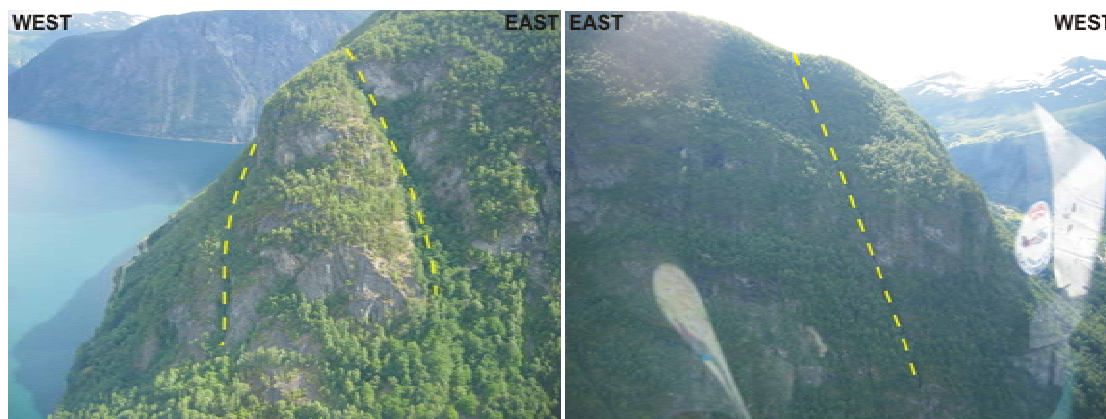
Figure 44: Structures observed from the air at Site 20.

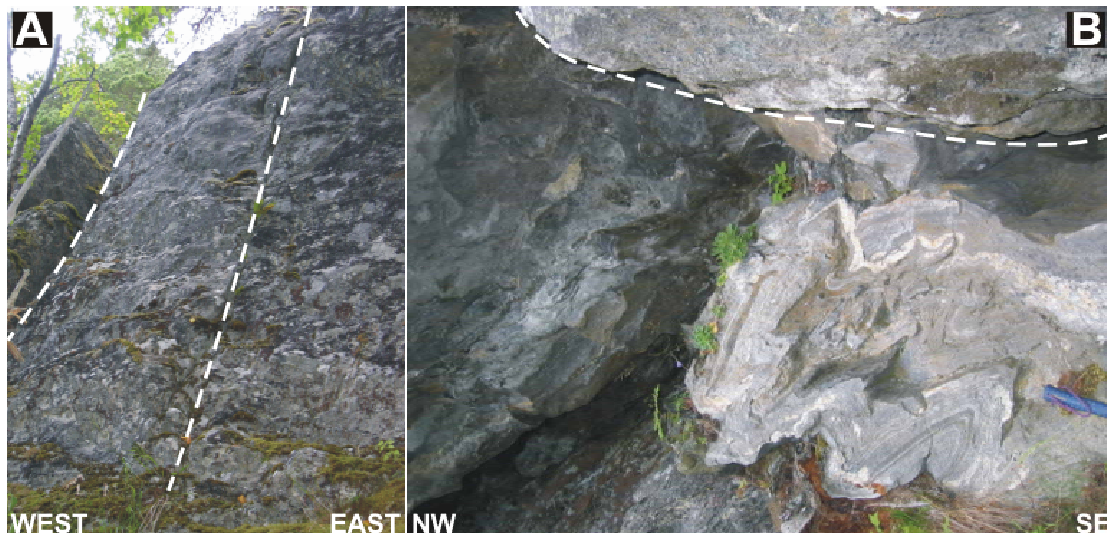
**Figure 46: Structures observed on the ground at Site 20. A-N-S extensional fractures which are most obvious from the helicopter (see Figure 44). These are pre-existing fractures which have been reactivated and now produce active rock-fall. B-Sliding plane dipping towards the SW. No fault-rock gouge is developed here but the rock-fall occurs along these low-angle planes and are detached on the extensional structures observed in A. The sliding plane is localised along a series of ductile small –folds.**

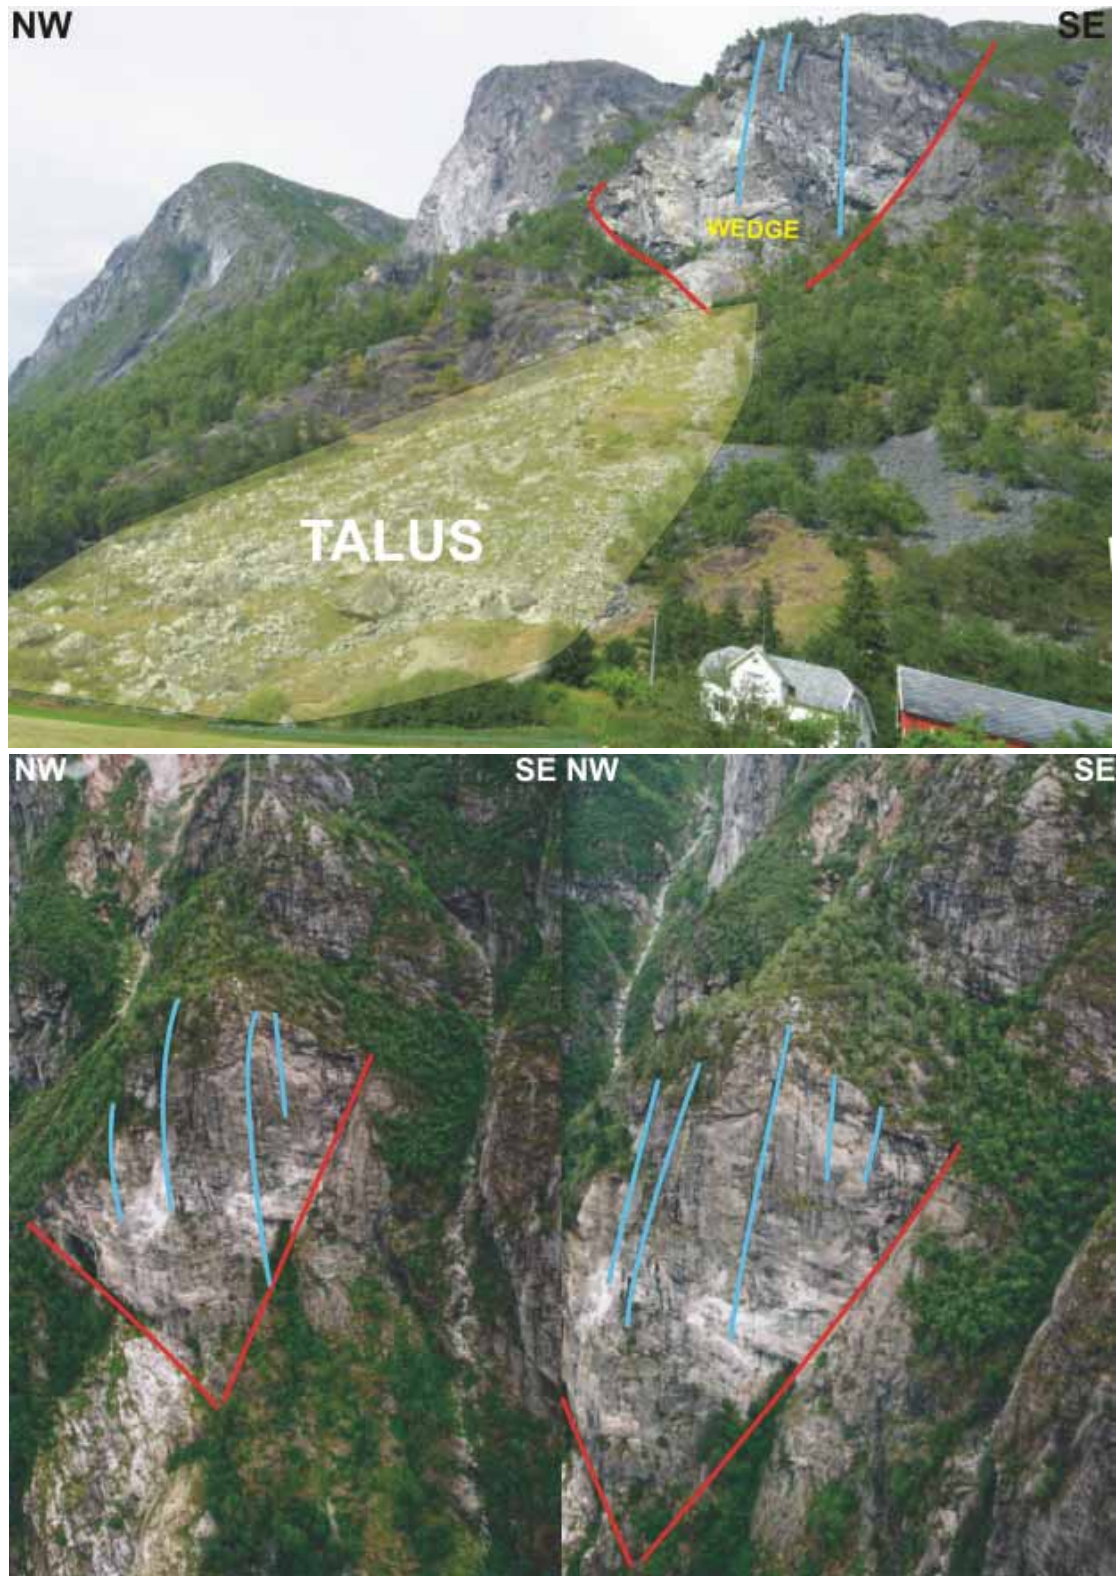
**Figure 47: (TOP) Photo montage image of Site 21. In this montage the image is foreshortened. (LEFT) Frontal view from the air (red lines as the two shear planes, blue lines as extensional fractures). (RIGHT) View of the southeastern shear plane (solid red line) of the wedge (in blue extensional fractures in the wedge).**

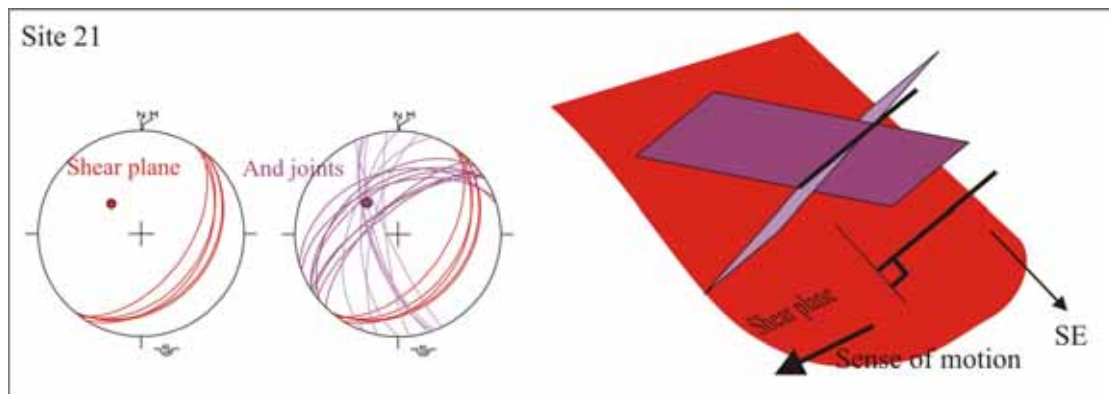
**Figure 50:** Joints developed in the hangingwall of the north-western part of the wedge. Note that the displacement is not dip-slip along the basal shear plane (the motion is accommodated by the two basal planes and is parallel to their intersection line; see Figure 48).

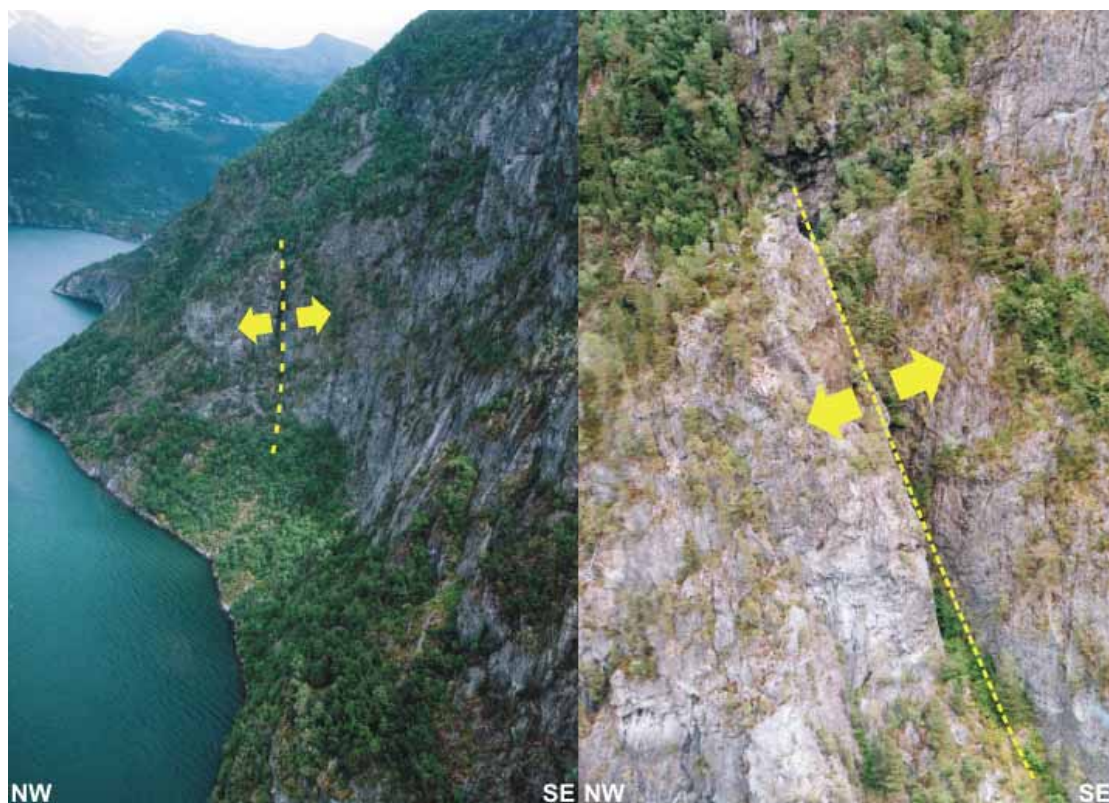
**Figure 51: Pictures from helicopter showing the toppling of rock masses. (LEFT) General view to the north of Site 22 near Norddal village. (RIGHT) Detail of a mass detached from the slope at site 22 (seen on A).**

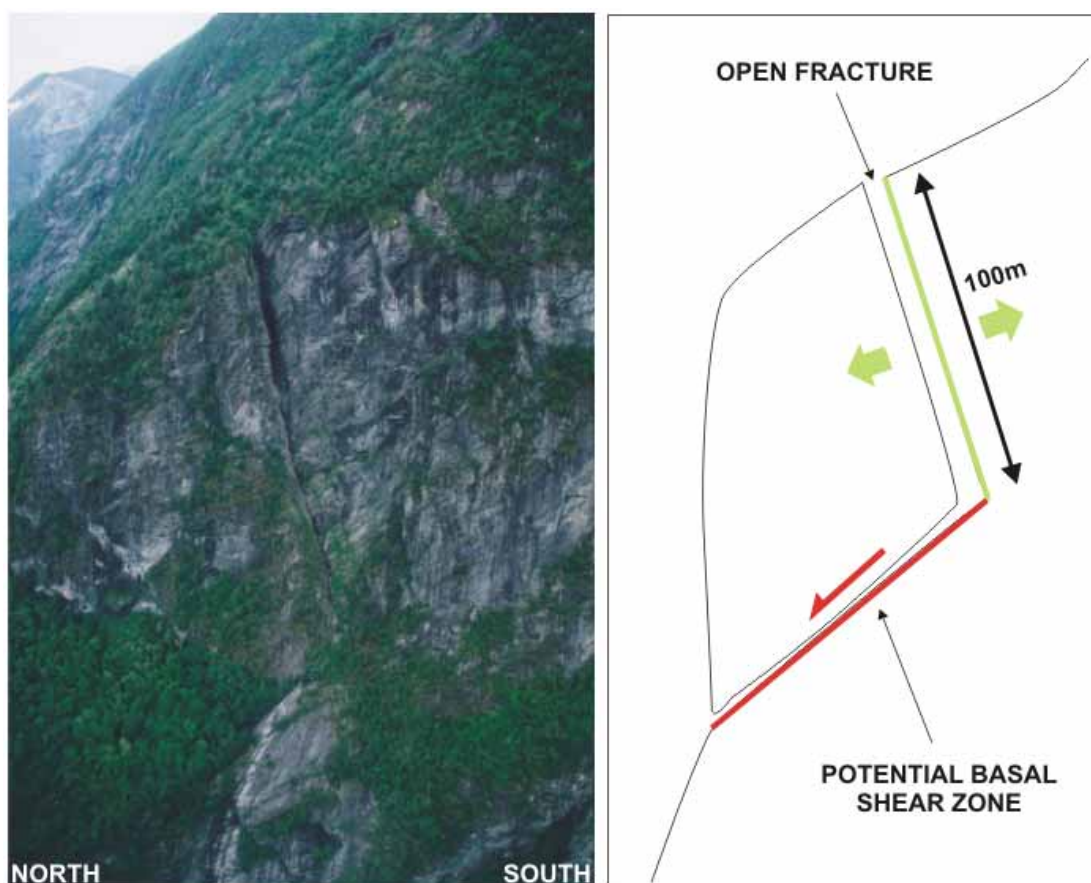
Figure 53. Structures observed from the helicopter at Site 27. It was not possible to land here. A large extensional 'back crack' (in green) was observed and possibly a low angle sliding plane (in red).

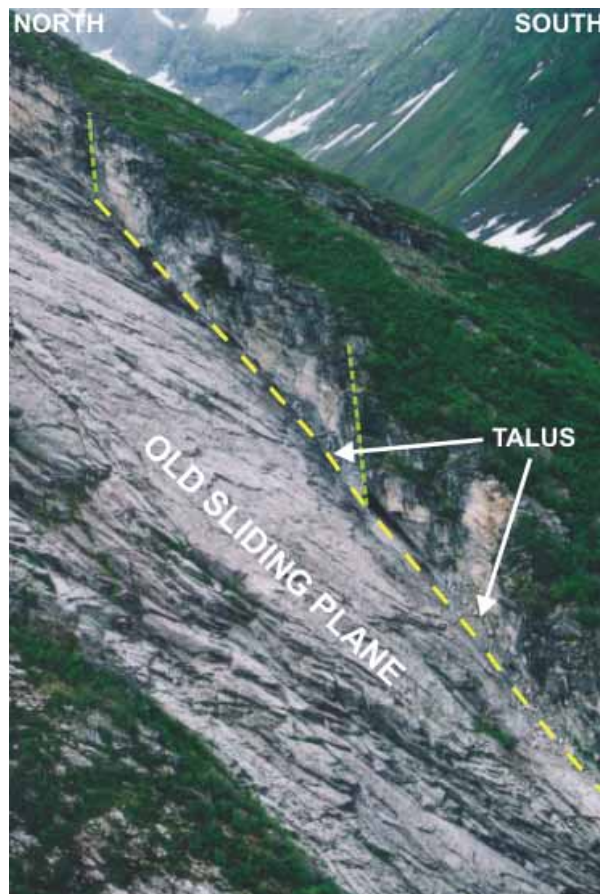
**Figure 54:** Structures observed from the helicopter at Site 38. The foliation dips moderately towards the valley along which sliding planes may have developed (yellow). Along the potential shearing plane a blocky talus can be observed and can be the result of rock disintegration subsequent to movement along the shear plane. There is some evidence for steep, extensional fractures (green) and the presence of an old sliding plane

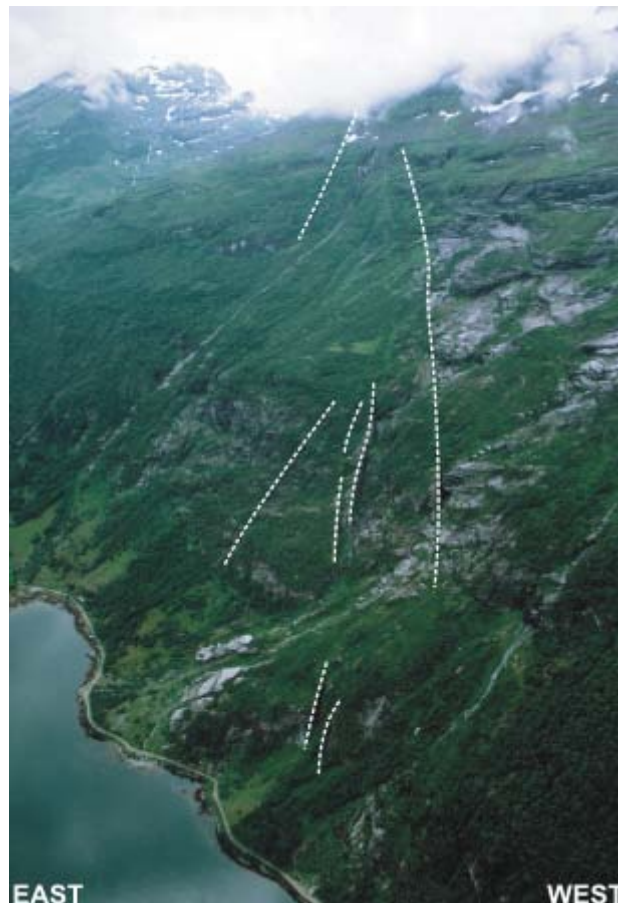
**Figure 55: Helicopter view between Homlung and Geiranger villages on the southern face of Geiranger Fjord, showing examples of major lineaments which are reopened and could be one of the controlling factors in the origin and development of a failure blocks.**
