Report no.: 2003.105		ISSN 0800-3416	Grading: Open	
Title: Evaluation of the use of PSInSAR for the monitoring of subsidence in Oslo region				
Authors: Dehls, J. F., Nordgulen, Ø.		Client: Oslo kommune (Friluftsetaten, Havnevesenet, Vann- og avløpsetaten, Plan- og bygningsetaten), Jernbaneverket (Region Øst)		
County: Oslo		Municipality: Oslo		
Map-sheet name (M=1:250.000) Oslo		Map-sheet no. and -name (M=1:50.000) 1814 I Asker, 1914 IV Oslo		
Deposit name and grid-reference:		Number of pages: 45	Price (NOK): 535	
		Map enclosures: 4		
Fieldwork carried out:	Date of report: 06.02.2004	Project no.: 3018.01	Person responsible:

Keywords:	subsidence		interferometry	
urban geology

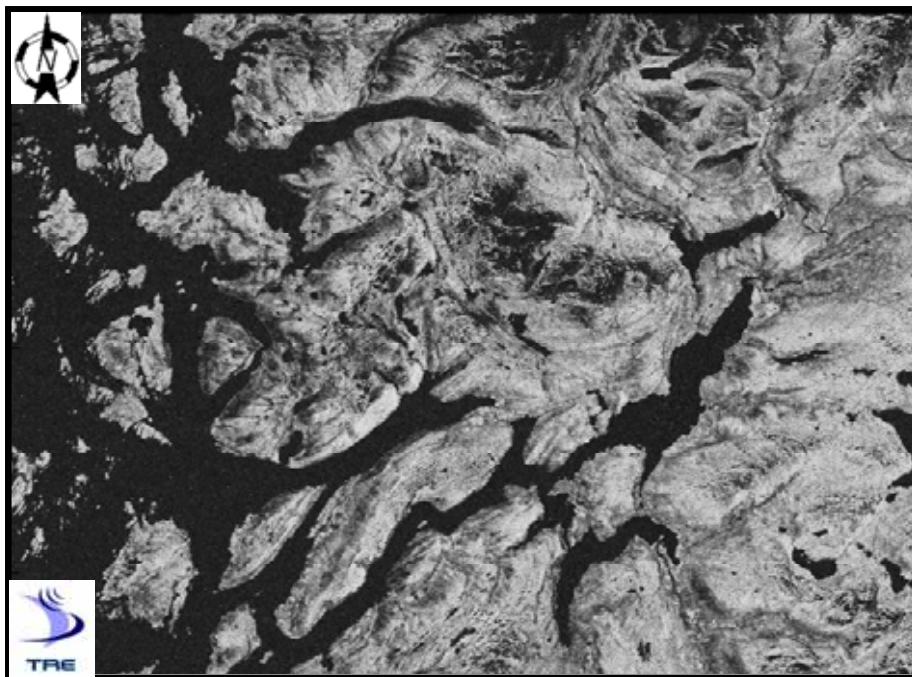
Figure 1. SAR image showing Ranafjorden and Svartisen glacier, July, 1995.

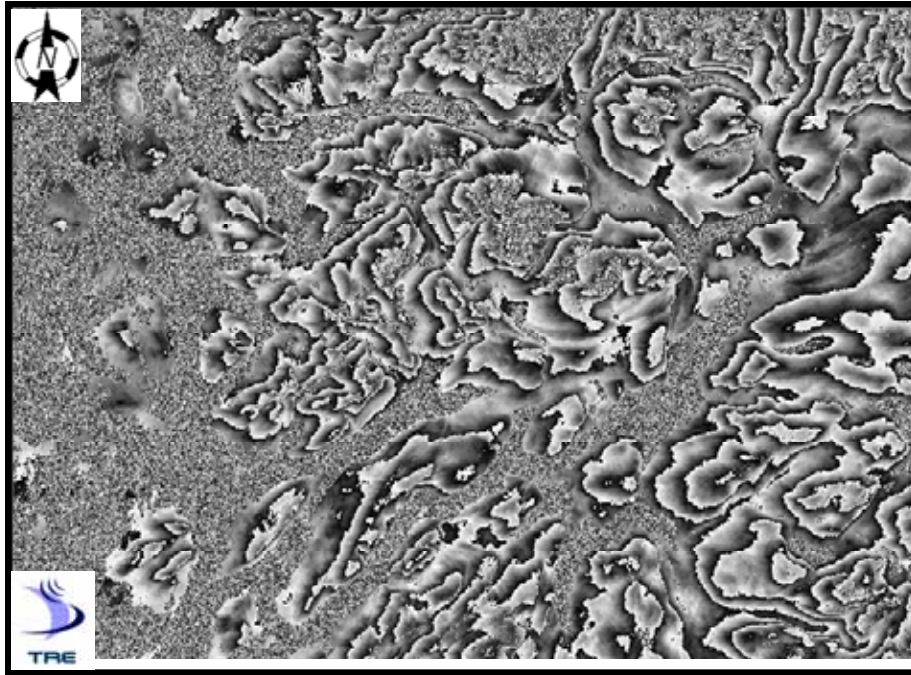
Figure 2. SAR interferograms obtained from a pair of images acquired July 15 and 16, 1995. The area is the same as Figure 1. Fringes are related to topography.

The second information recorded is the phase of the wave. ERS satellites have a radar wavelength of 5.66 cm. The phase of the wave upon return depends primarily on the distance between the satellite and the surface. It is also affected by changes in the atmosphere, but this is a very small effect. If two images are acquired of the same area from the exact same position, any difference in phase is due to movements of the ground surface toward or away from the satellite during the time between the two images. If two images are acquired from different positions within a small period of time, the difference in phase can be used to determine the surface topography (Figure 2). Differences in phase between two images are easily viewed by combining, or interfering, the two phase-images. In the resulting image, the waves will either reinforce or cancel one another, depending upon the relative phases. The resulting image is called an interferogram and contains concentric bands of colour, or fringes, that are related to topography and/or surface deformation.

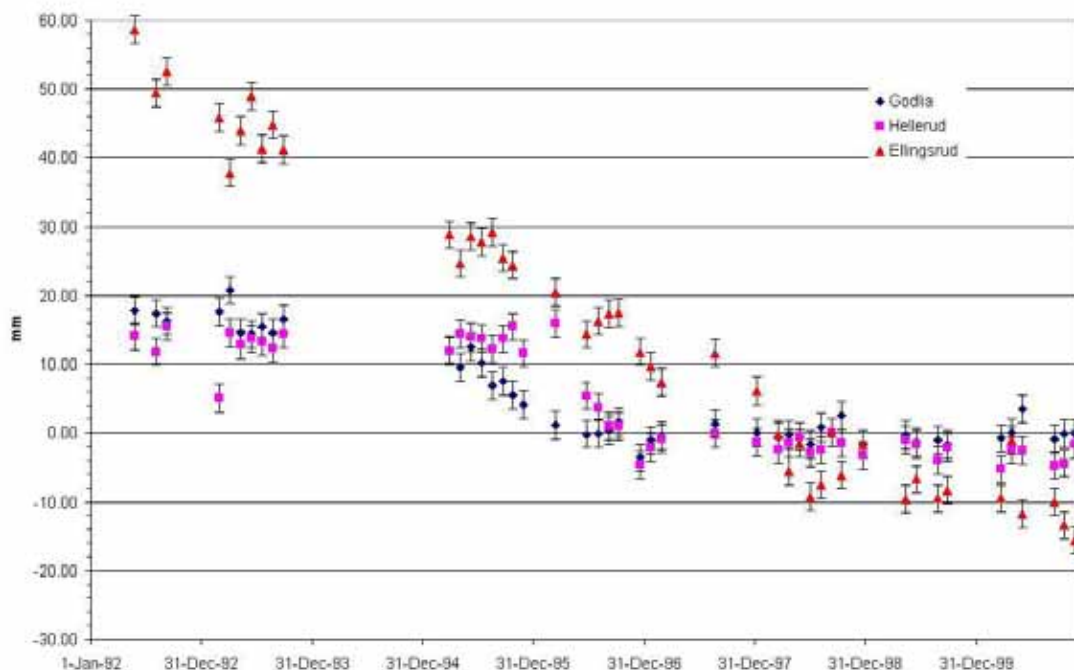
Figure 3. Displacement-time series for selected houses along the trace of the Romeriksporten tunnel. Accelerated subsidence in Hellerud and Godlia coincides with the time of tunnel construction in those areas. The subsidence in Ellingsrud shows no acceleration.

In order to identify subsidence related to the tunnelling activity, displacement-time series were generated for all points, including those with low coherence. These charts were then examined to identify non-linear displacement. Numerous houses show onset or acceleration of subsidence during the time of tunnelling. Indeed, subsidence in Godlia clearly began before subsidence in Hellerud (Figure 3). In other cases, ongoing subsidence shows no acceleration during the time of tunnelling. These results are discussed in more detail in section 3.6.

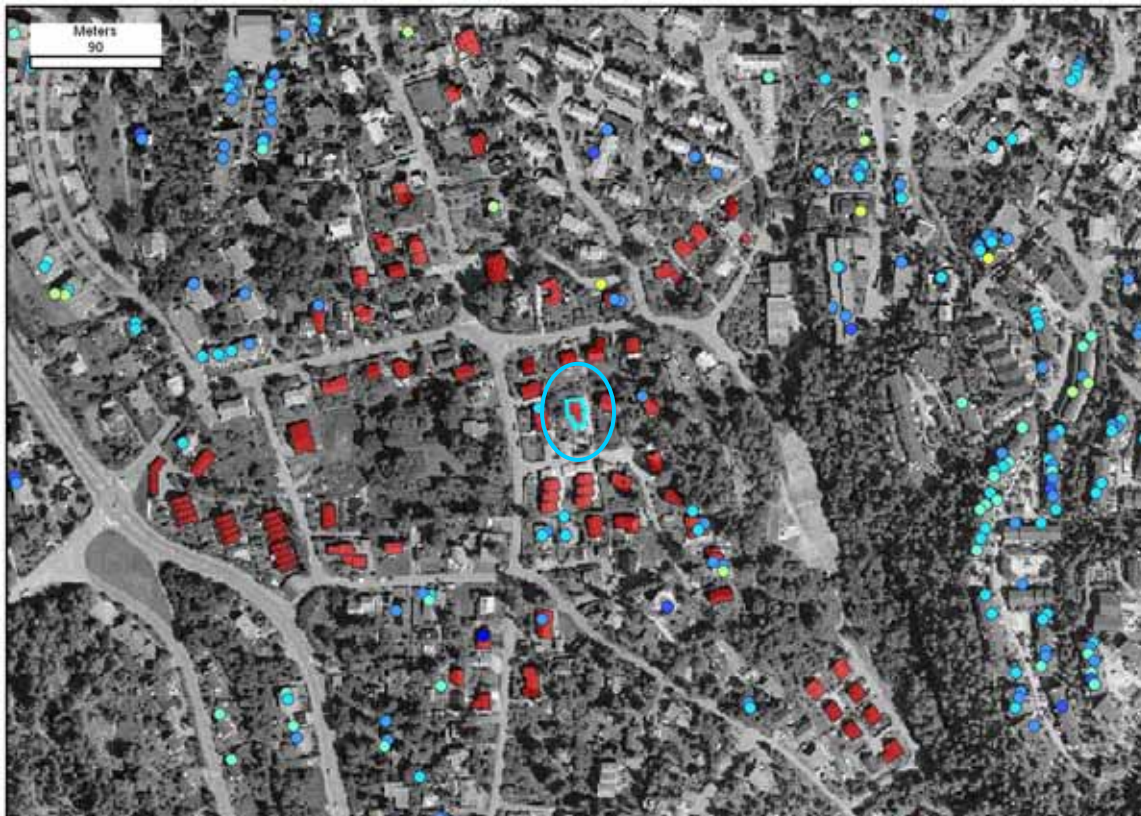
Figure 4. There is a very low density of PS (circles) in the region with the highest number of affected buildings (in red). In many cases, such as Hellerudveien 42B (circled in blue, see Figure 5) the rate of subsidence was too great for the method to work.

Figure 4 shows the location of houses in Hellerud where an independent study (Faggruppen for setningskader, 2002) has confirmed subsidence and damage due to the tunnelling activities. There is a clear reduction in PS density in the area most affected. There are several possible explanations for this.

- The rate of subsidence was great enough to lead to phase unwrapping error. In other words, displacement of more than one half wavelength took place between successive image acquisitions.
- The deformation led to a change in orientation of the scattering objects, leading to decorrelation. This could be the case where houses experienced significant tilting (Figure 5).
- Reconstruction or significant repairs during the period of analysis led to a change in the surface of the building. In other words, there were no *permanent* scatterers.

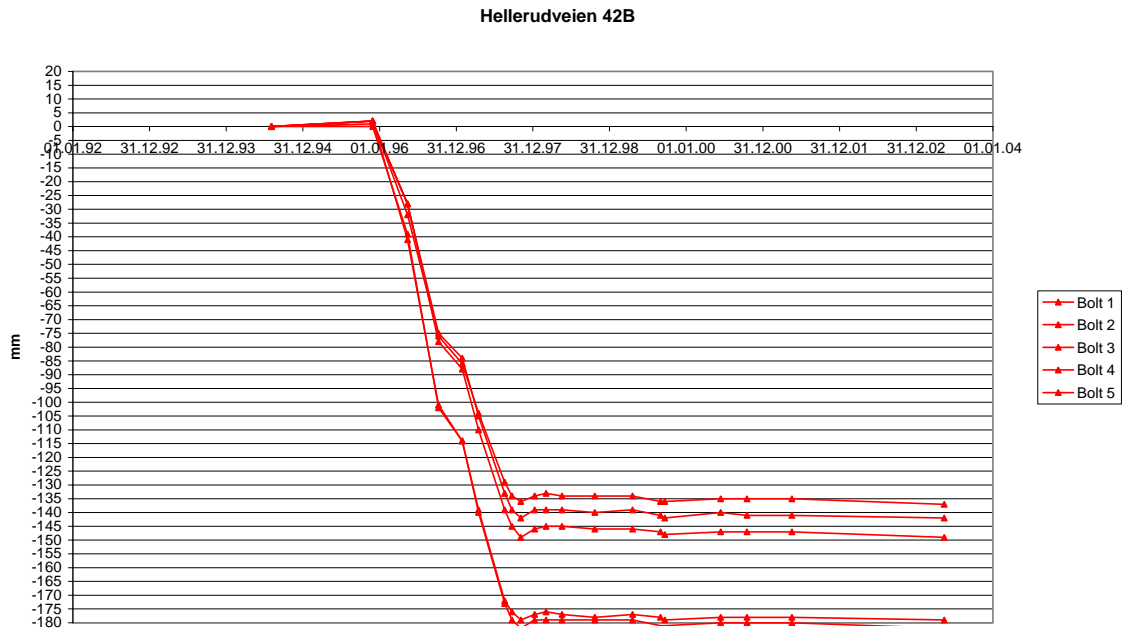
Figure 5. Measurements of subsidence in Hellerudveien 42B (circled in blue in Figure 4) obtained by levelling. The high rate of subsidence, combined with the tilting (bolts are on various corners of the building) made it impossible to identify any PS.

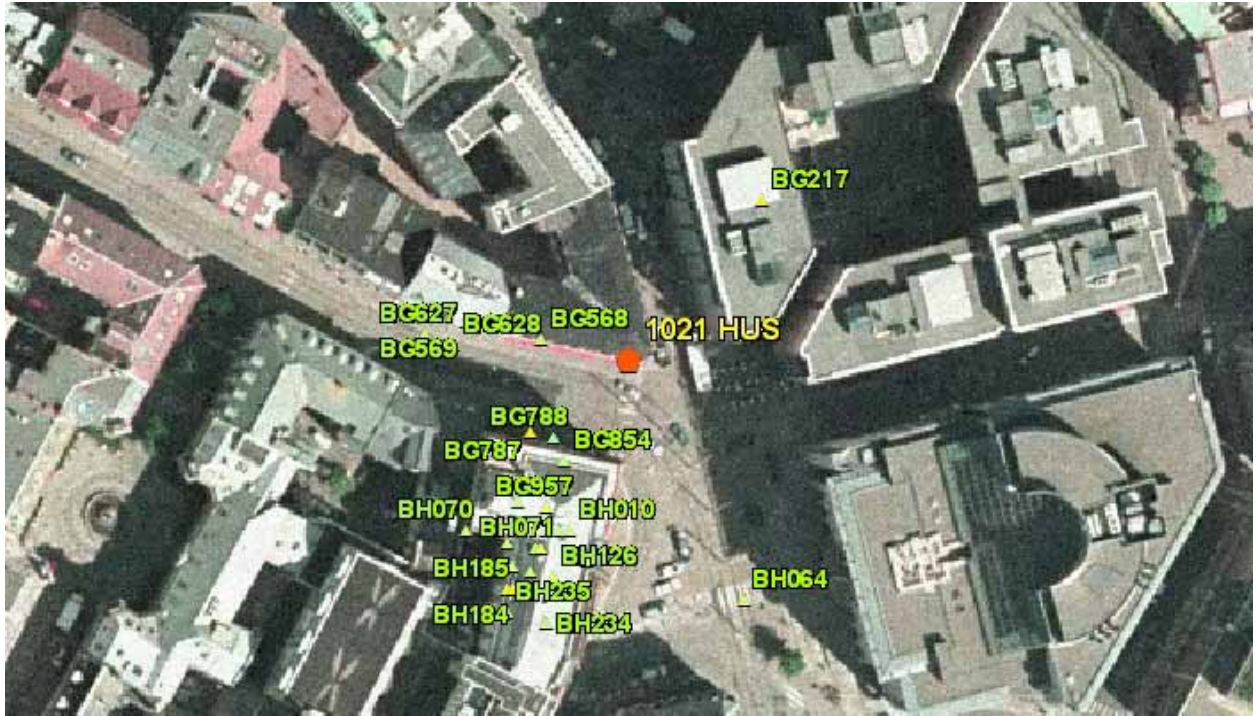
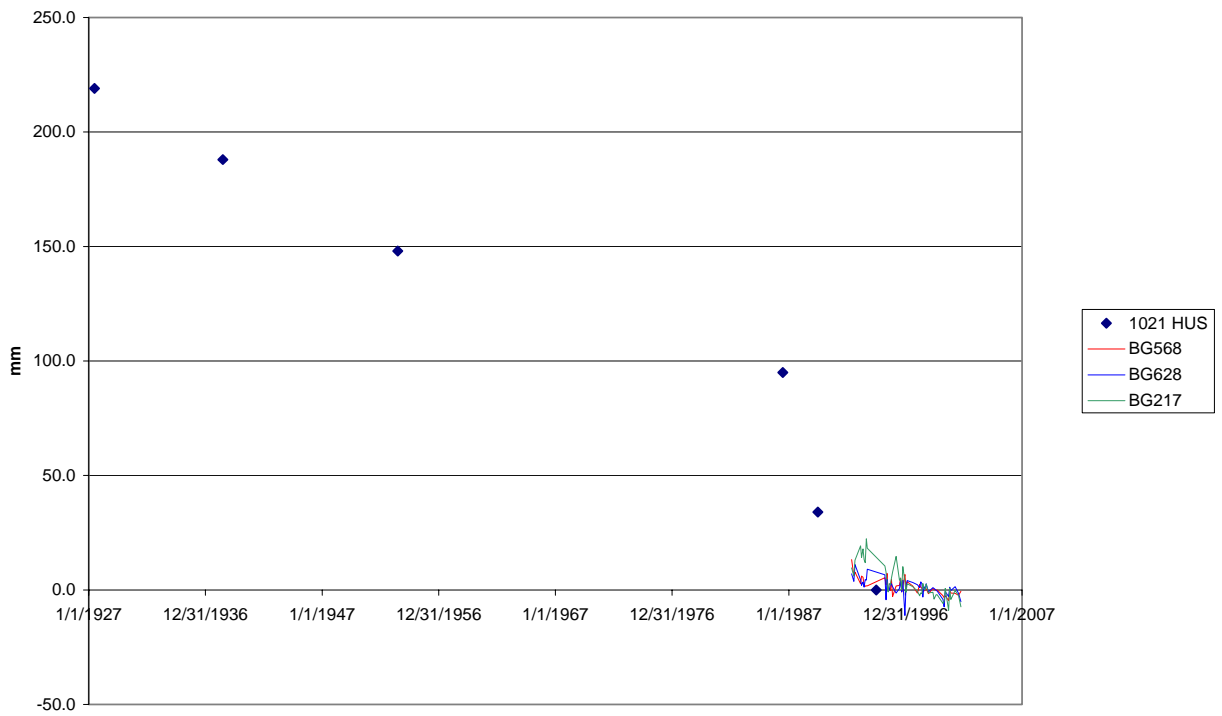
Figure 7. Displacement-time series for C.J. Hambros class 7 compared with historical subsidence measurements.

Figure 6 shows all the benchmarks that were within 100 metres of a PS, and all the PS that were within 100 metres of these benchmarks. The colour scale is the same for both sets of data. A general agreement is evident. However, there are some cases where the two values are quite different. Figures 7 and 8 show two examples. In both cases, the benchmark shows a marked acceleration prior to the current study, followed by a return to the historic subsidence rate.

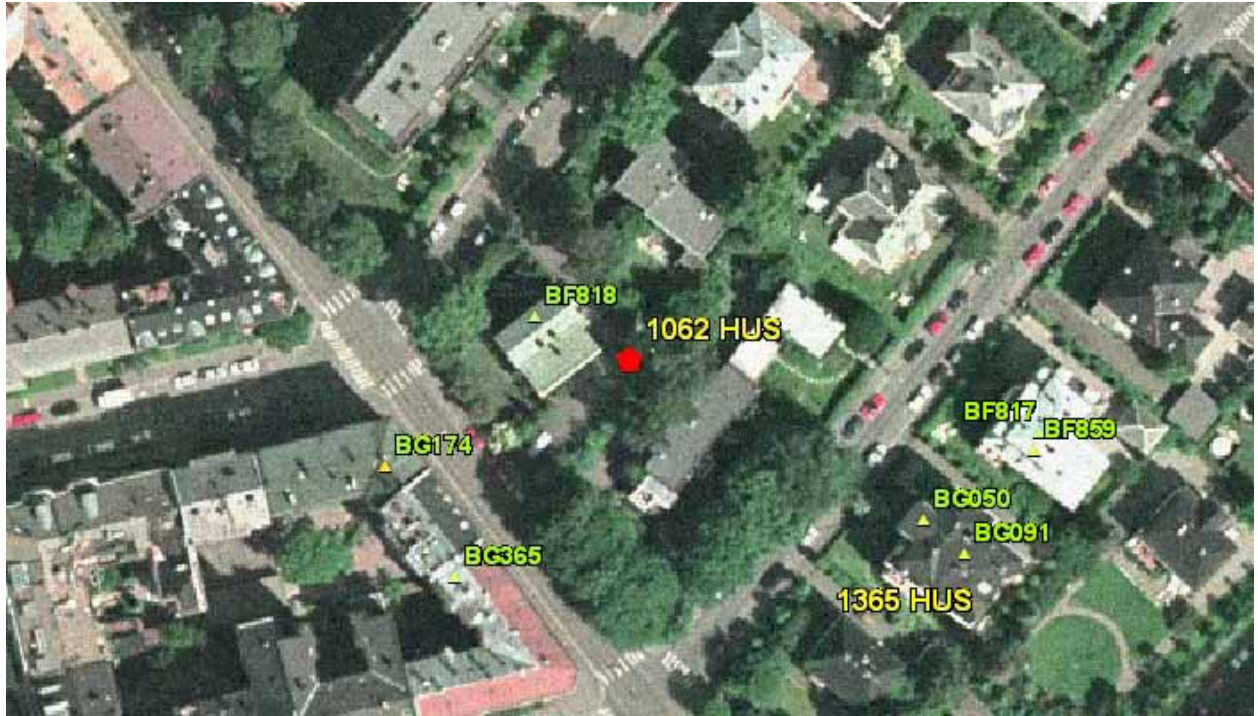
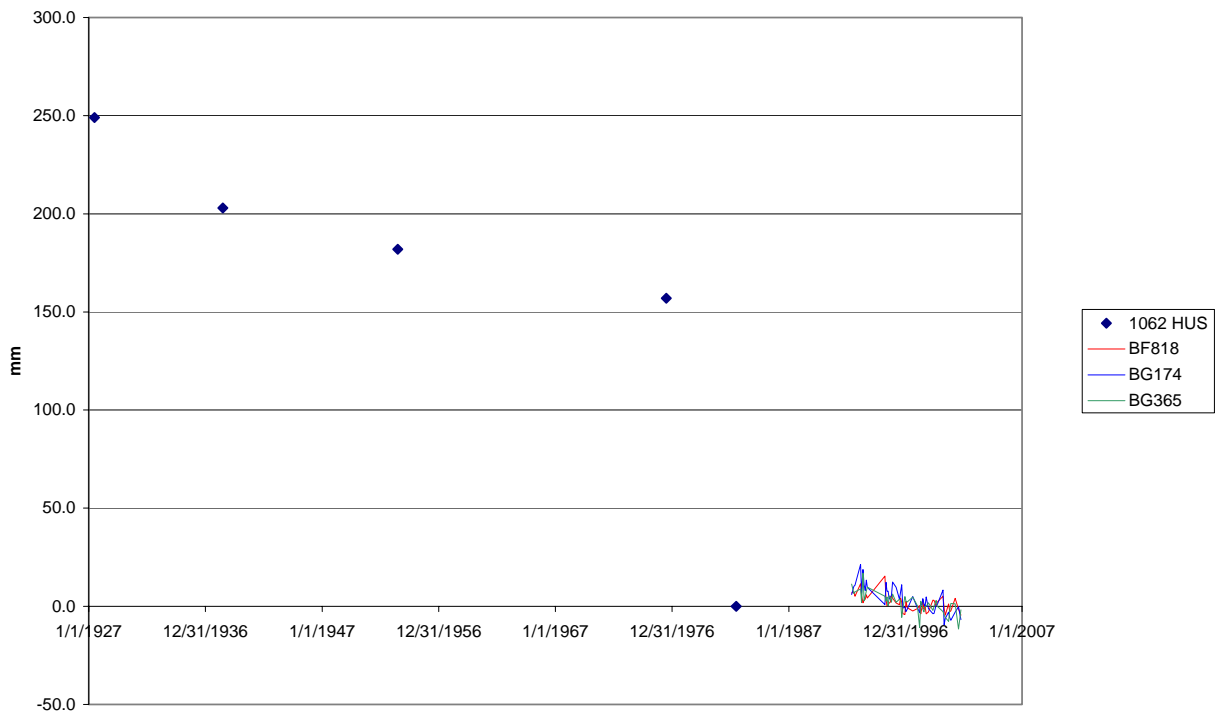
Figure 8. Displacement-time series for Frognerveien 47 compared with historical subsidence measurements.

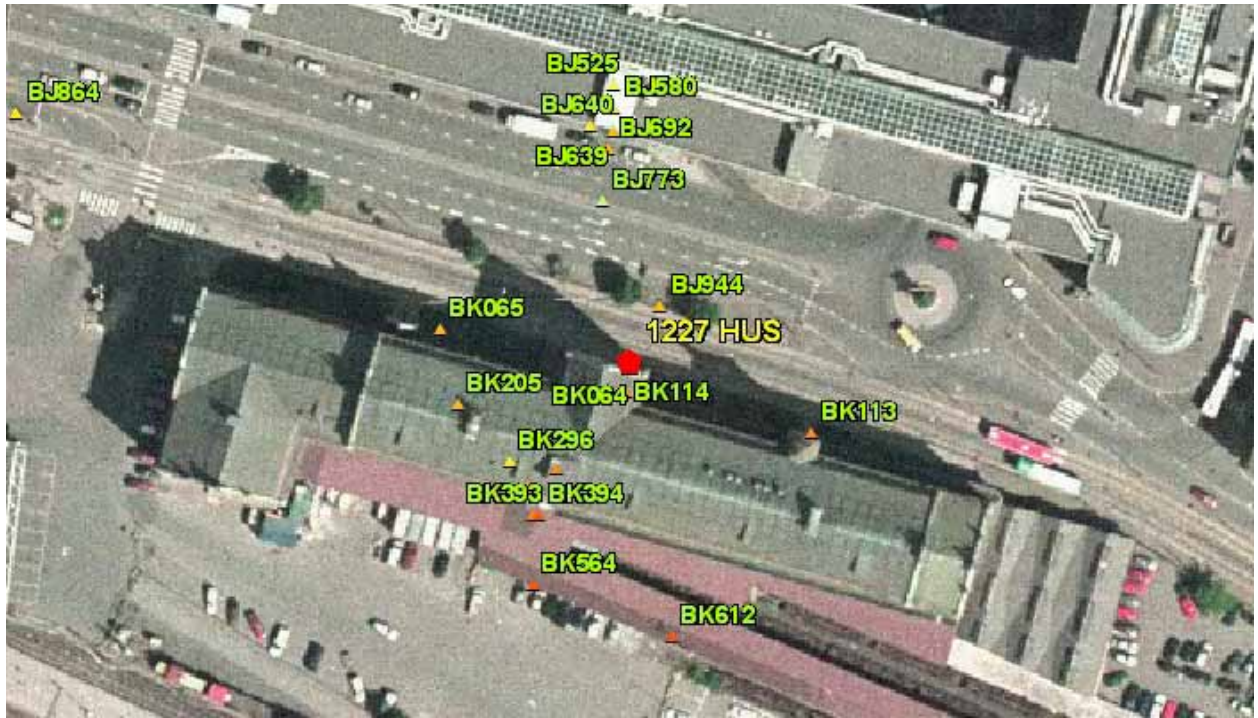
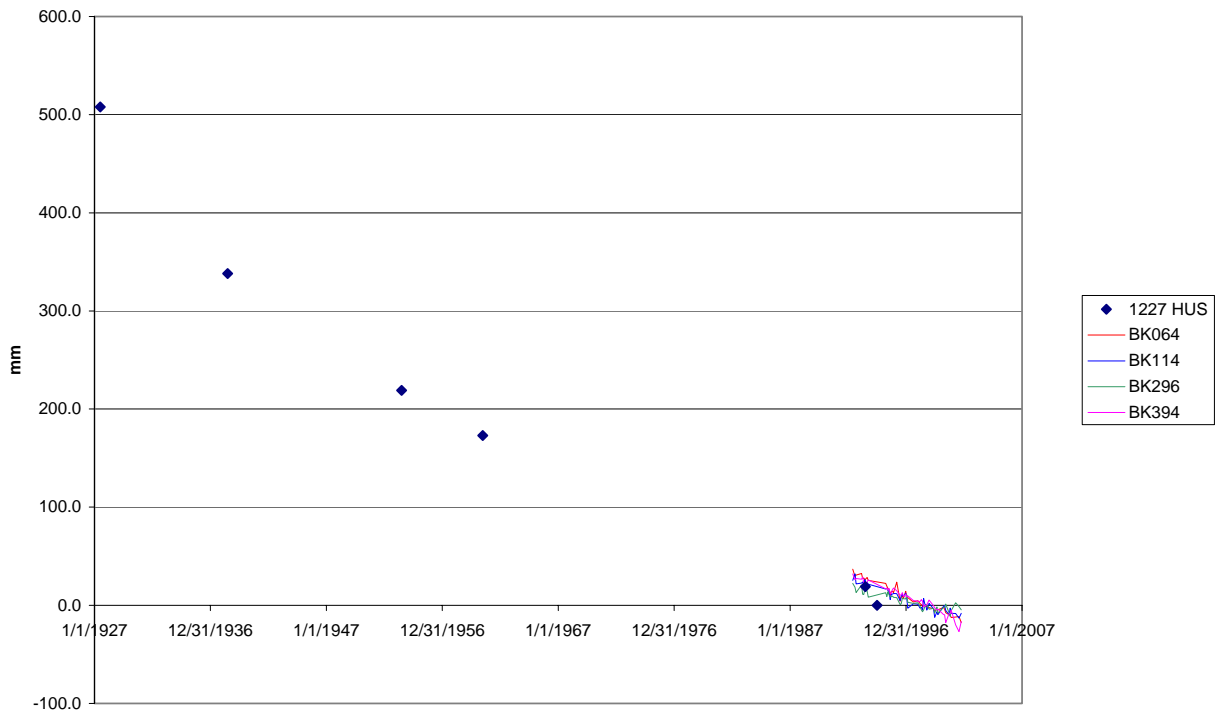
Figure 9. Displacement-time series for Schweigaards Gate 15 compared with historical subsidence measurements.

Figures 9 and 10 show more typical examples of the remainder of the benchmarks, with the current subsidence rates matching the historic rates.

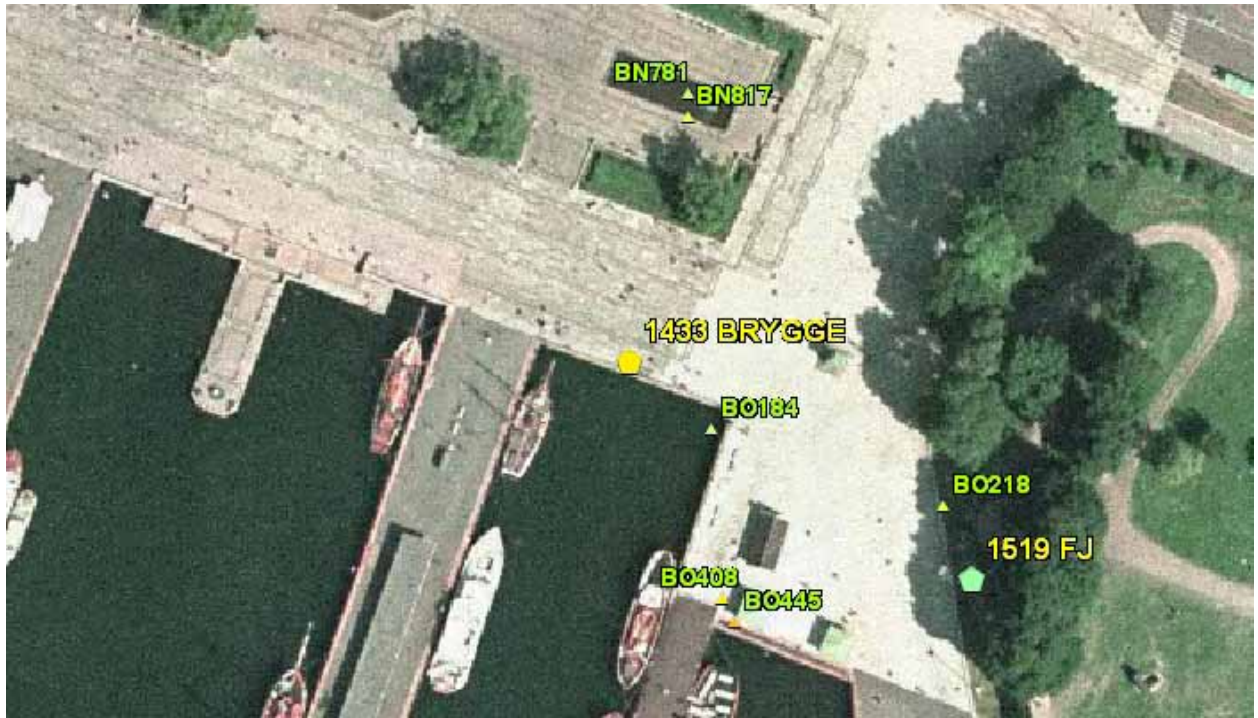
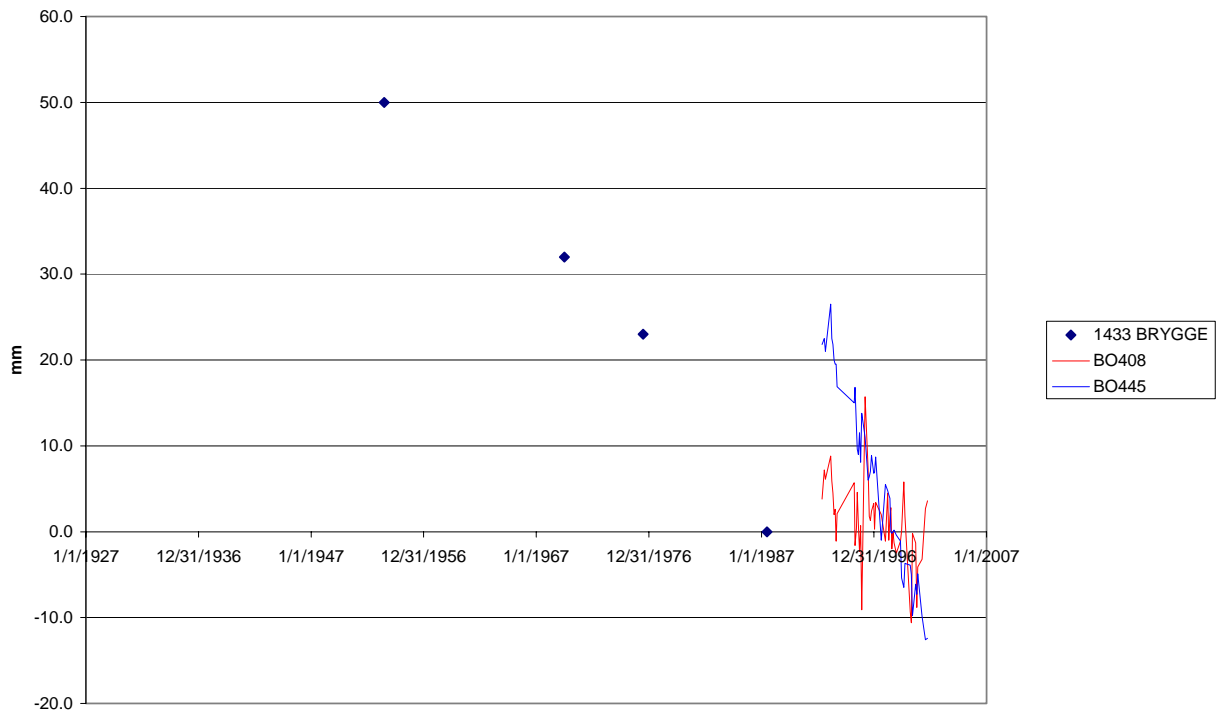
Figure 10. Displacement-time series for benchmark on Rådhusbrygge compared with historical subsidence measurements.

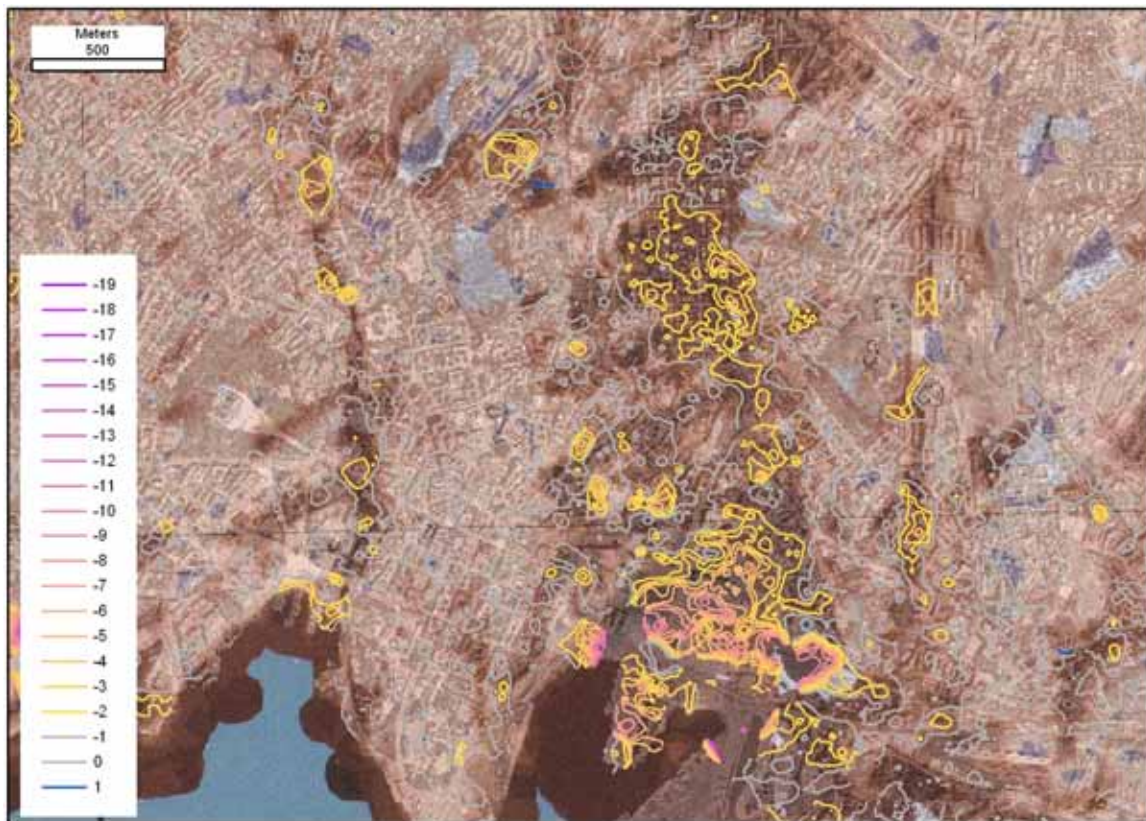
Figure 11. Subsidence contours derived from PS analysis overlain upon depth-to-basement image. There is a good general agreement between subsidence rates and the thickness of surficial deposits.

Figure 11 shows the subsidence contours overlain upon the depth-to-basement image. A general agreement is readily apparent. A closer look at Majorstua (Figure 12) confirms this pattern. A more quantitative comparison would be useful, however, that would require access to detailed depth-to-bedrock measurements in a point form. Naturally, there are other factors that influence the rate of subsidence as well, such as variations in pore-pressure, type of sediment and human activity.

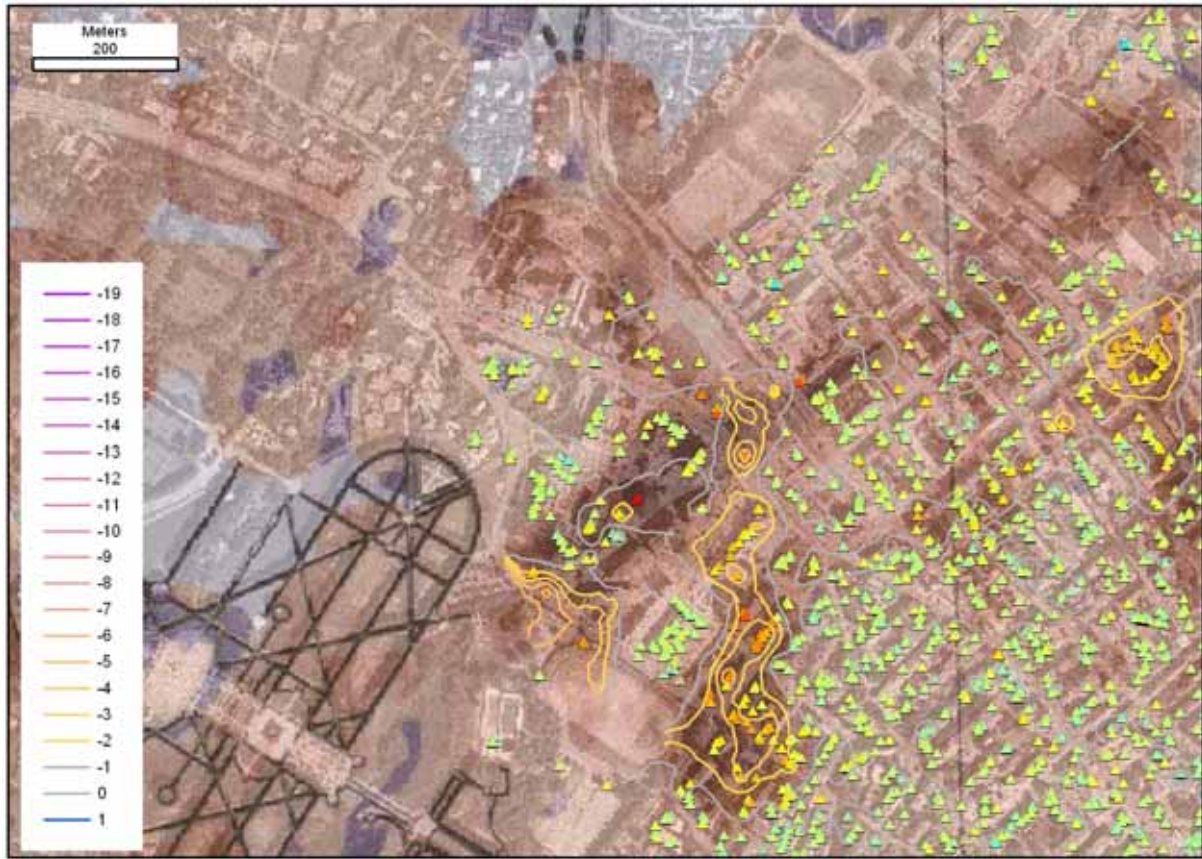
Figure 12. Subsidence contours derived from PS analysis overlain upon depth-to-basement image in the Majorstua area. No significant subsidence is evident in areas with shallow surficial deposits.

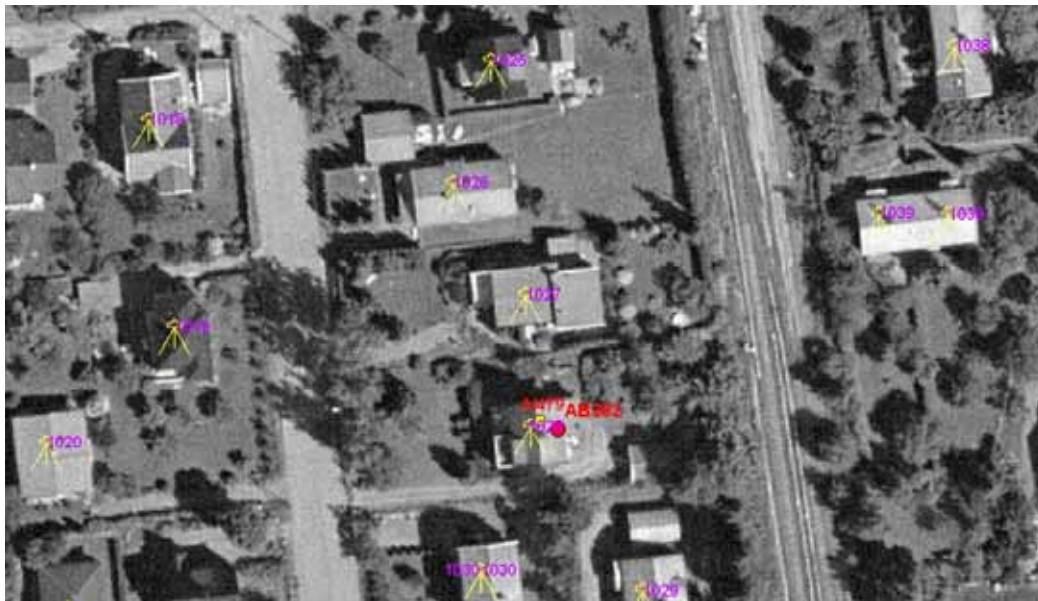
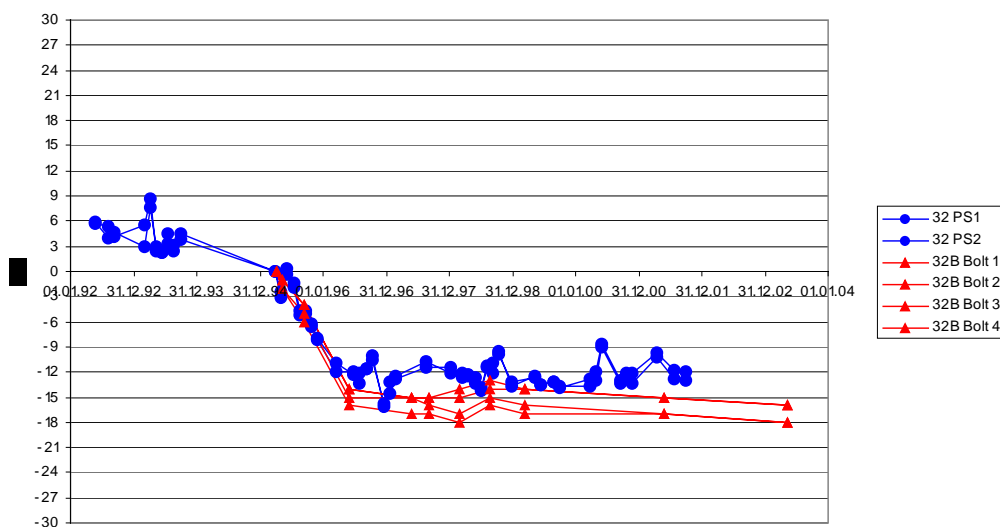
Låveveien 32, 32B

Figure 13. Subsidence measured in Låveveien 32B (centre of photo) by levelling compared with PS from Låveveien 32, next door (PS AI479, AB282). PS velocity is along the line of sight with the satellite (23° from vertical). The yellow symbols indicate buildings that were monitored using levelling.

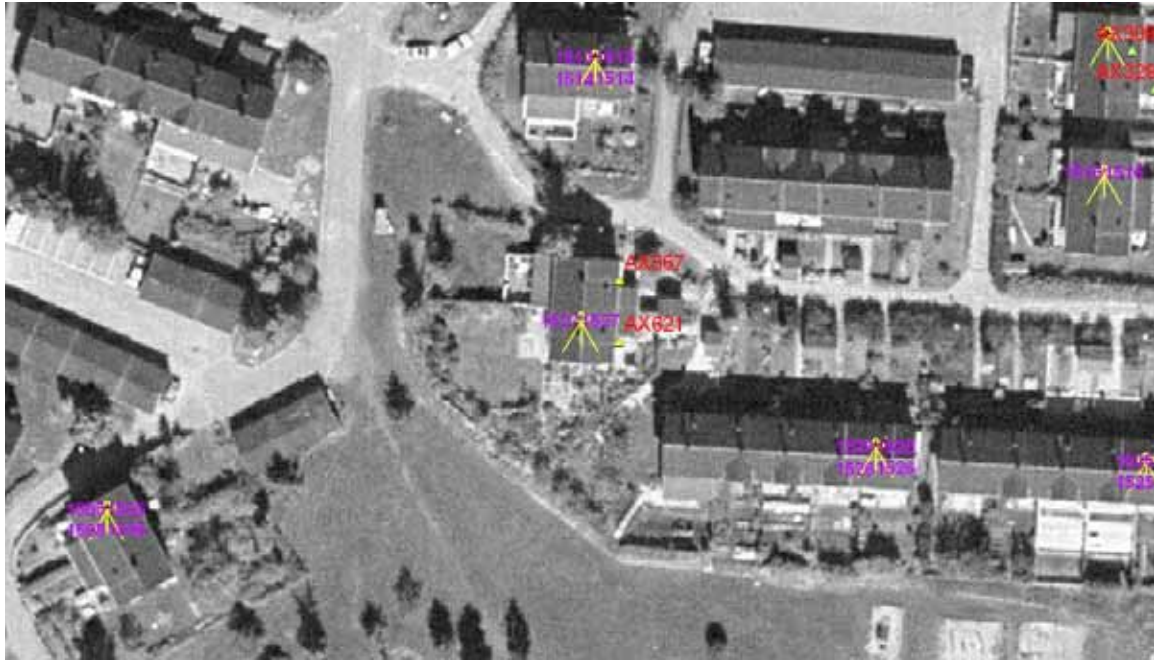
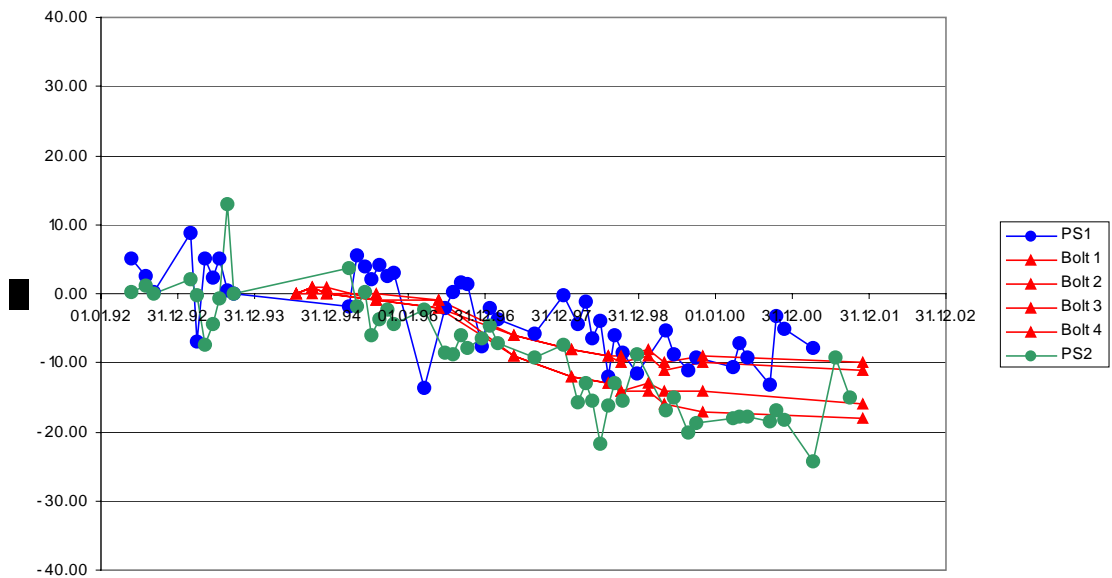
Munkebekken 110, 112

Figure 15. Both levelling and PS reveal between 1 and 2 cm subsidence at Munkebekken 110-112.

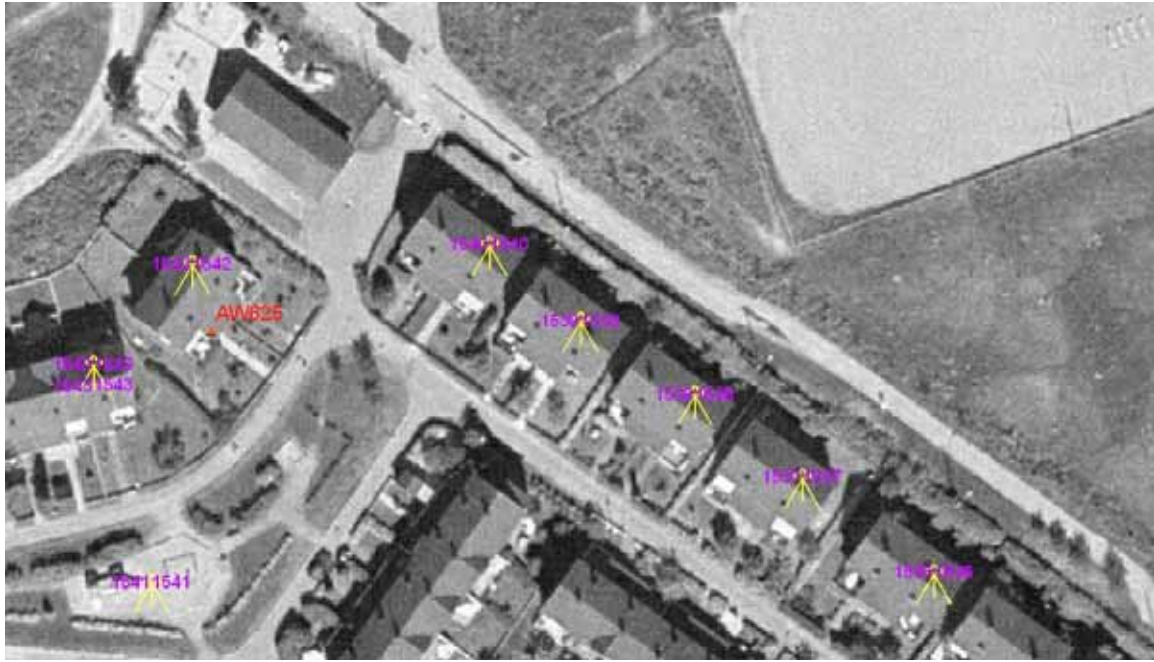
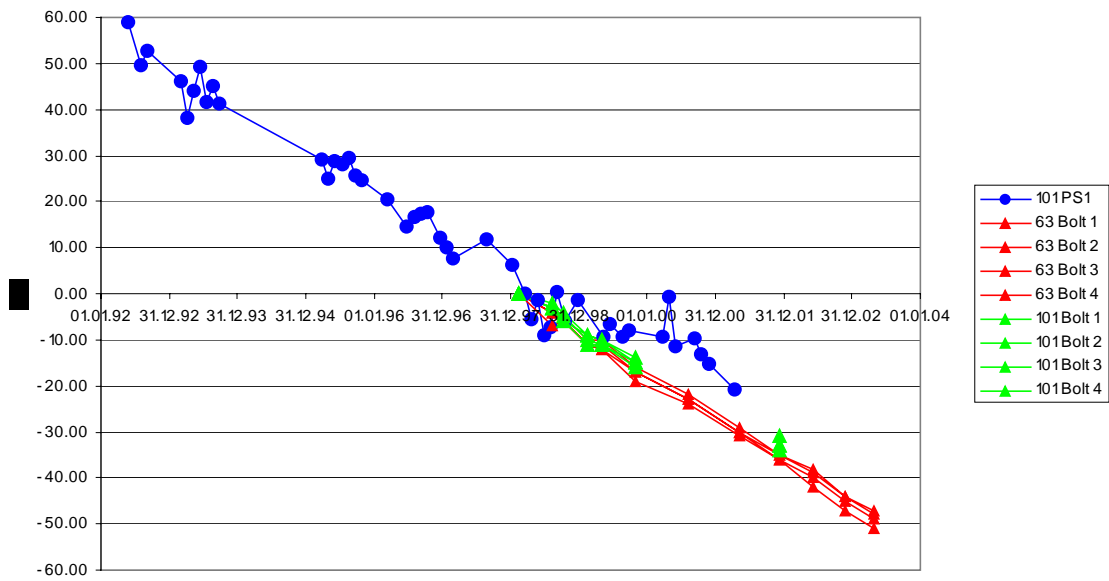
Munkebekken 63, 101

Figure 16. Levelling at both Munkebekken 63 and Munkebekken 101 shows a steady rate of subsidence from 1997. PS analysis from Munkebekken 101 (PS AW625) shows that this subsidence has had a nearly constant rate since 1992 and cannot be related to the tunnelling activity.

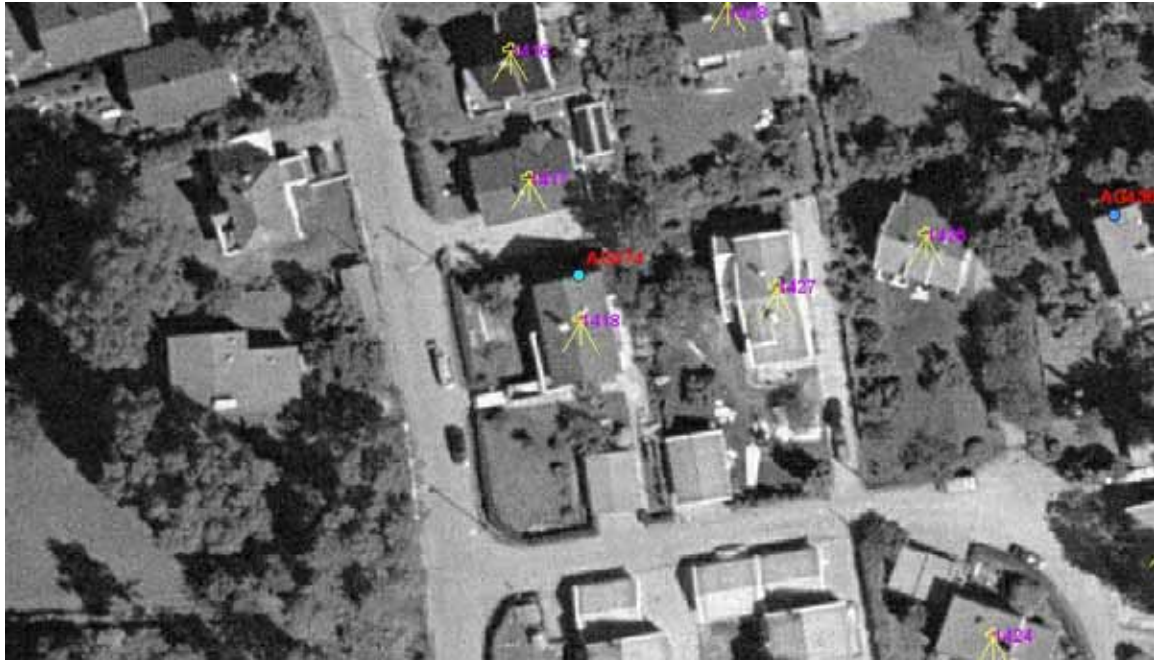
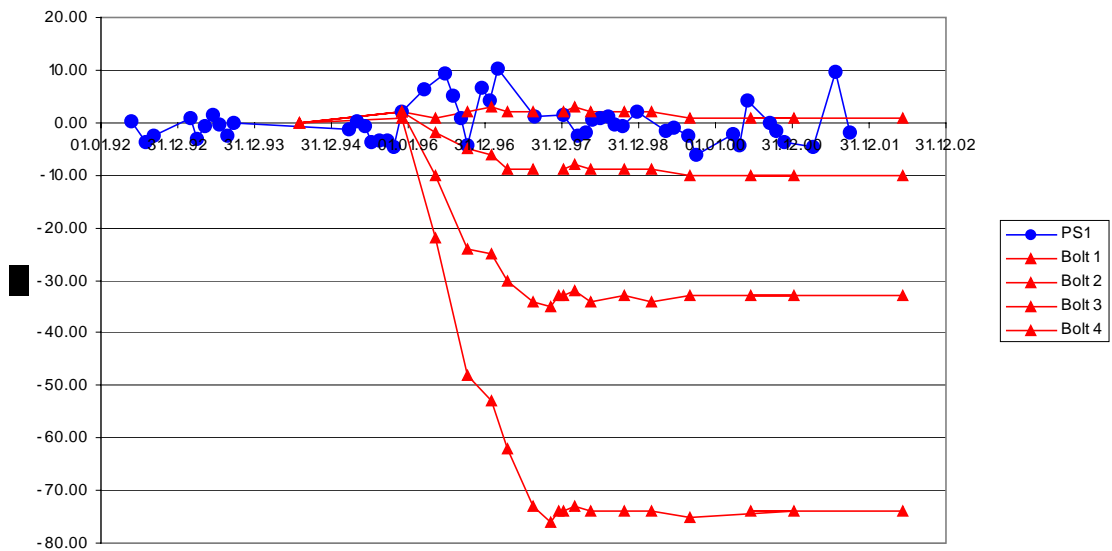
Hellerudveien 42A

Figure 17. One PS (PS AG474) at the north end of Hellerudveien 42A, between bolts 1 and 2, is insufficient to reveal almost 8 cm of tilting that occurred from 1996 to 1997.

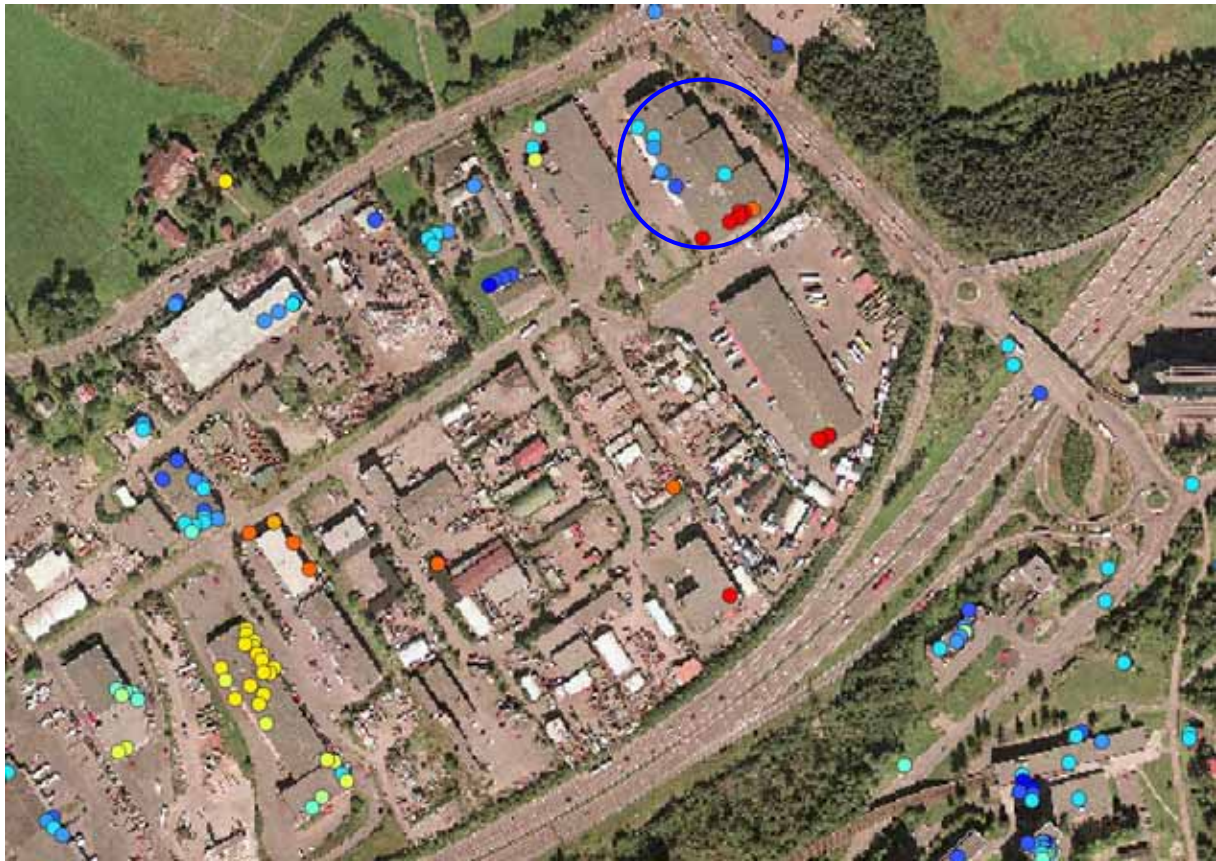
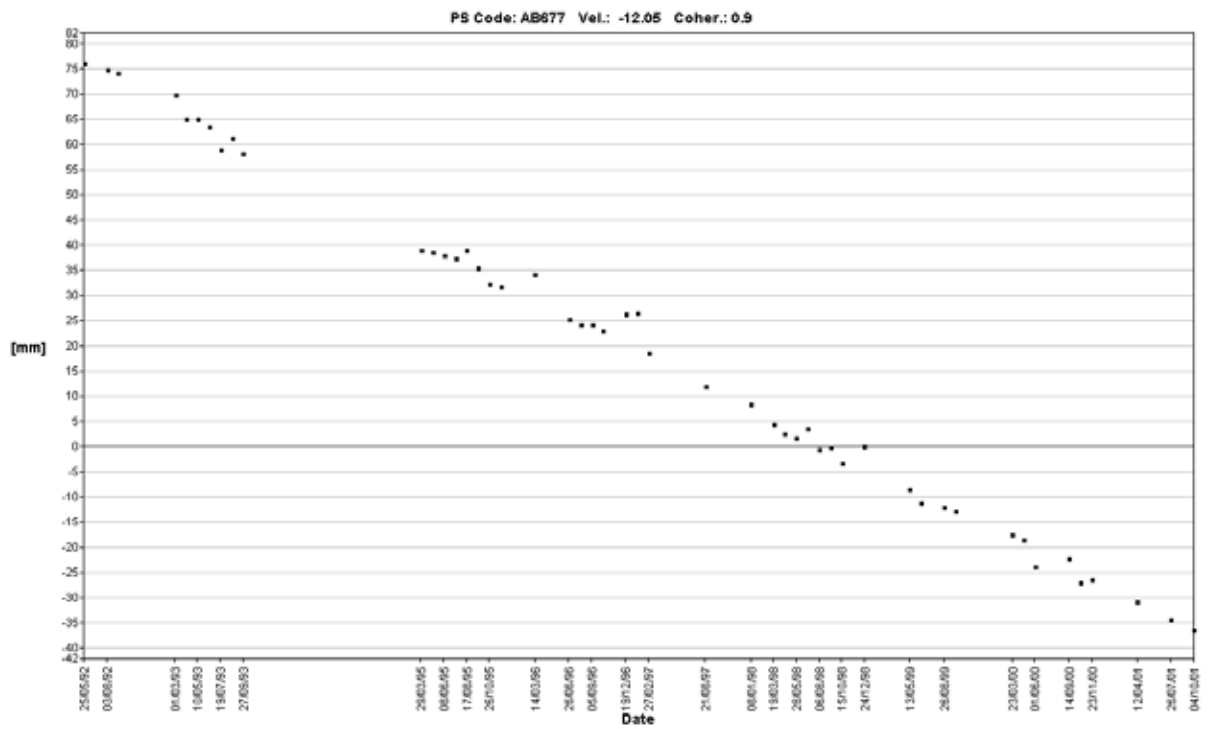
Figure 18. Displacement-time series from south end of Verkseier Furulunds vei 49 (outlined in blue).

In the northeastern end of Alnabru, north of the E6, is a former waste disposal site (Helge Sem, pers. comm.). In this area individual buildings show subsidence more than 20 mm/yr. One large building, built over the edge of the site, shows differential subsidence from one end to the other (Figure 18). Another building on Ole Deviks vei shows a similar subsidence pattern with associated structural damage (Figure 19).

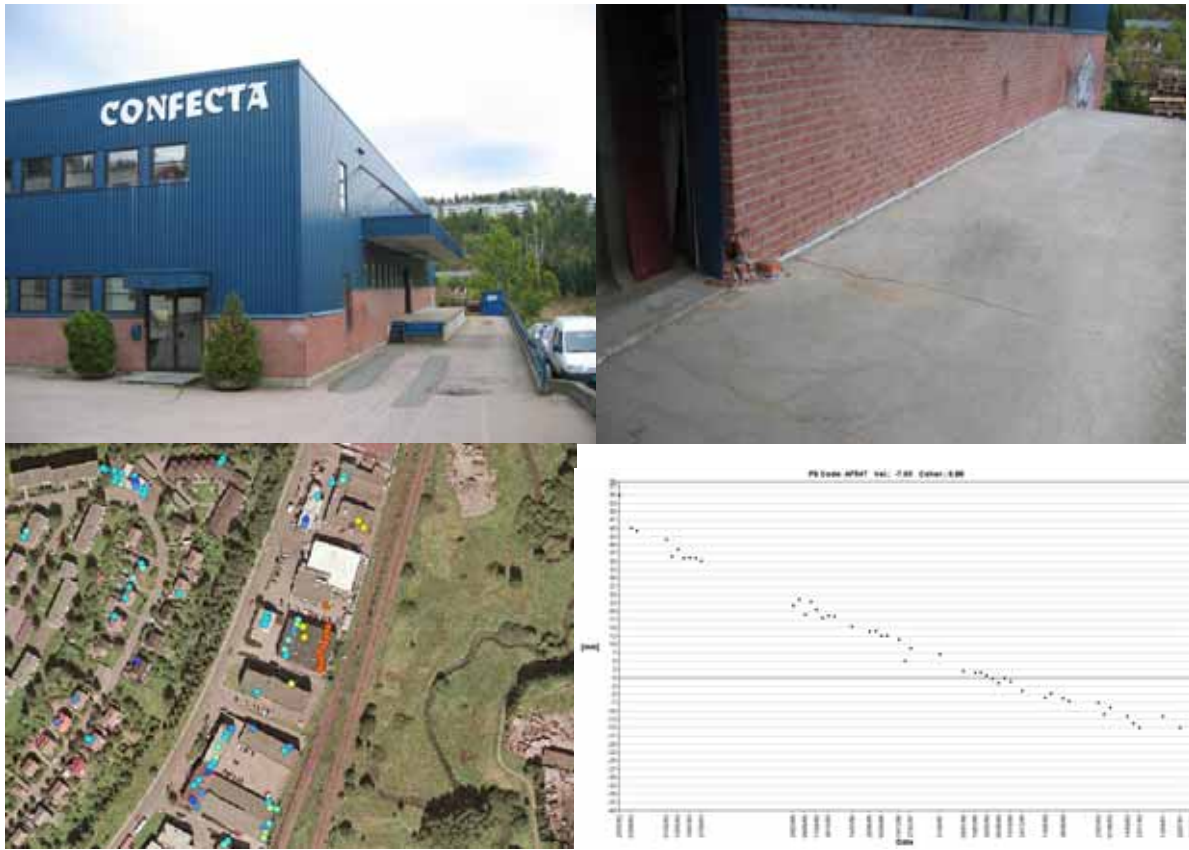
Figure 19. Displacement-time series from east end of Ole Deviks vei 32.
