Report no.: 2003.105		ISSN 0800-3416	Grading: Open	
Title: Evaluation of the use of PSInSAR for the monitoring of subsidence in Oslo region				
Authors: Dehls, J. F., Nordgulen, Ø.		Client: Oslo kommune (Friluftsetaten, Havnevesenet, Vann- og avløpsetaten, Plan- og bygningsetaten), Jernbaneverket (Region Øst)		
County: Oslo		Municipality: Oslo		
Map-sheet name (M=1:250.000) Oslo		Map-sheet no. and -name (M=1:50.000) 1814 I Asker, 1914 IV Oslo		
Deposit name and grid-reference:		Number of pages: 45	Price (NOK): 535	
		Map enclosures: 4		
Fieldwork carried out:	Date of report: 06.02.2004	Project no.: 3018.01	Person responsible:

Keywords:	subsidence		interferometry	
urban geology

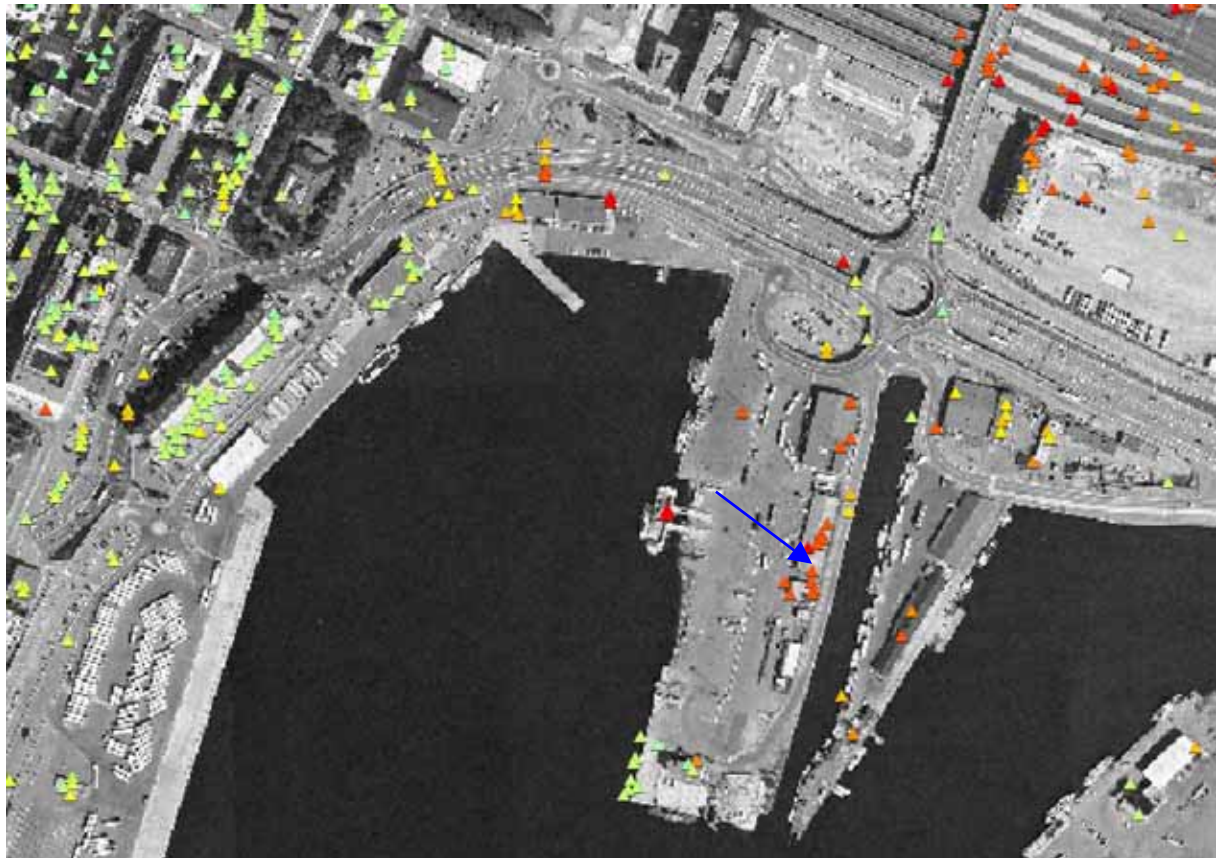
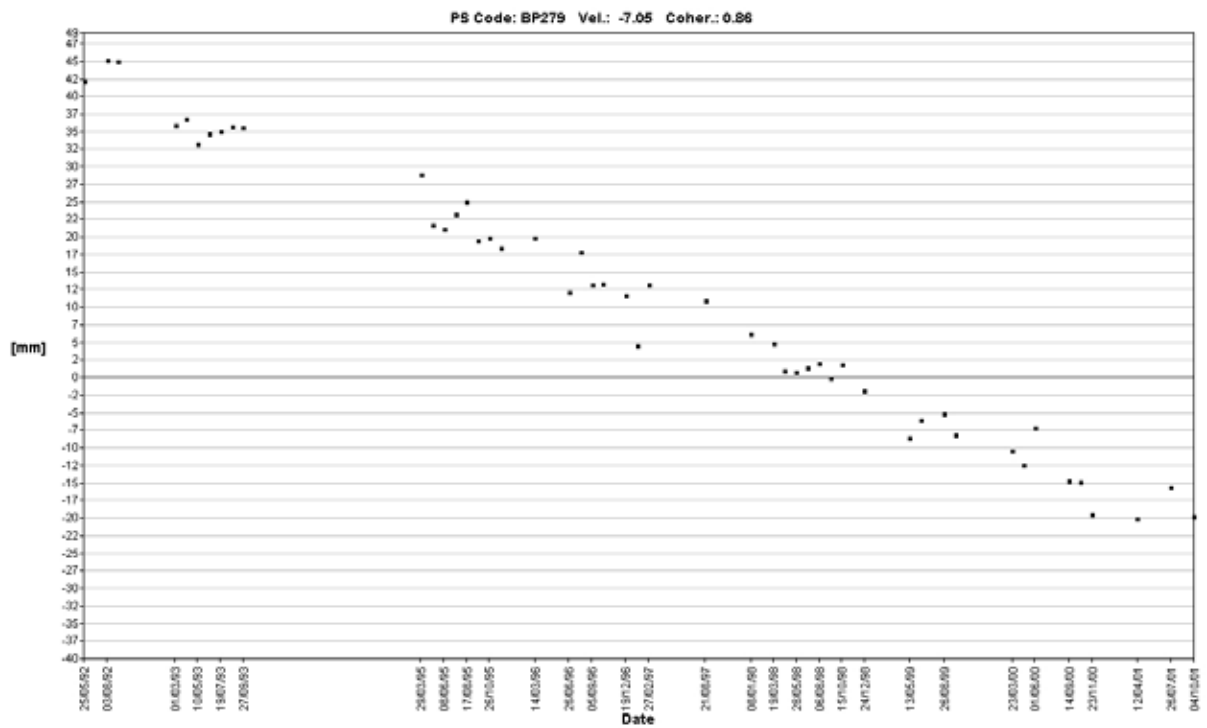
Figure 20. Almost all the data points with relative subsidence rates of 6 mm/yr or more lie within the Bjørvika/Grønland area. Within Bjørvika, subsidence rates are as high as 13 mm/yr. Displacement-time series shown is from Nylandsveien 28 (blue arrow).

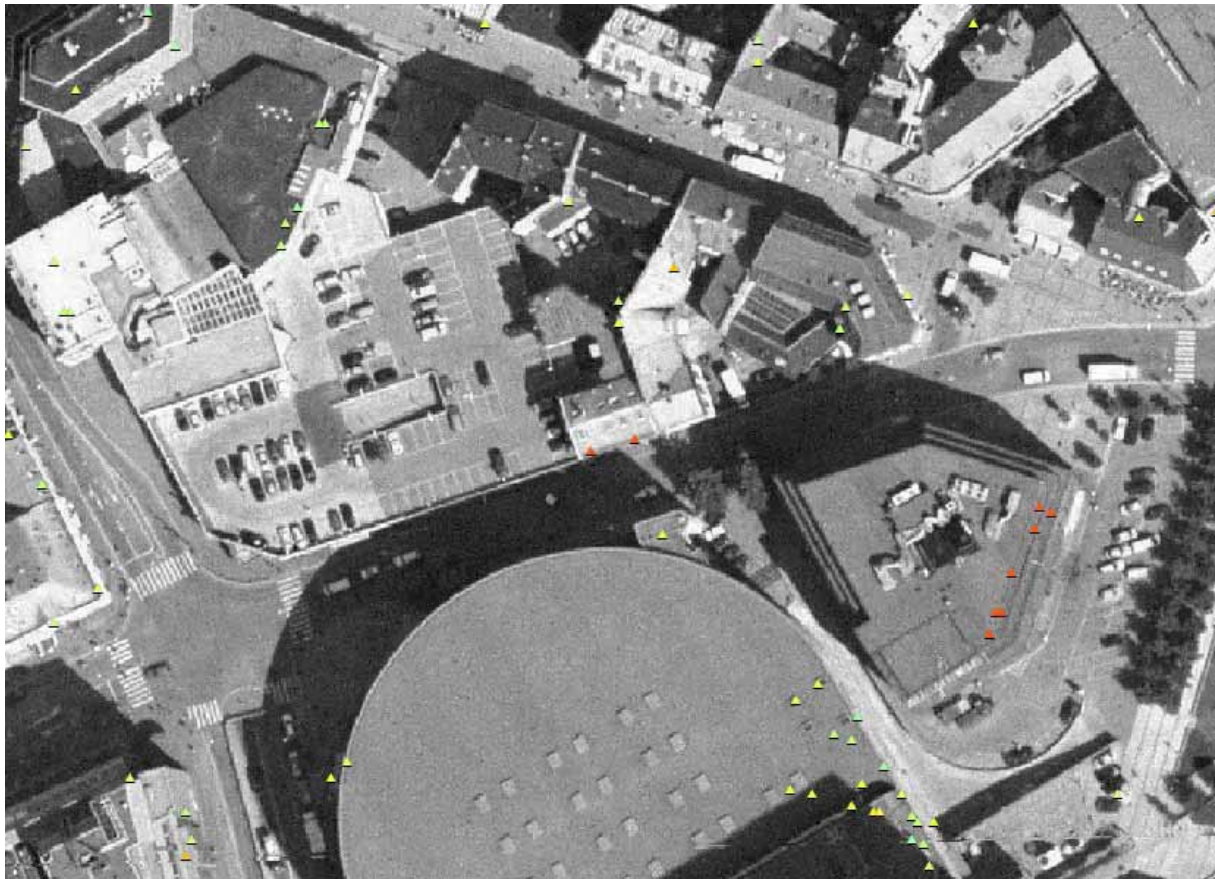
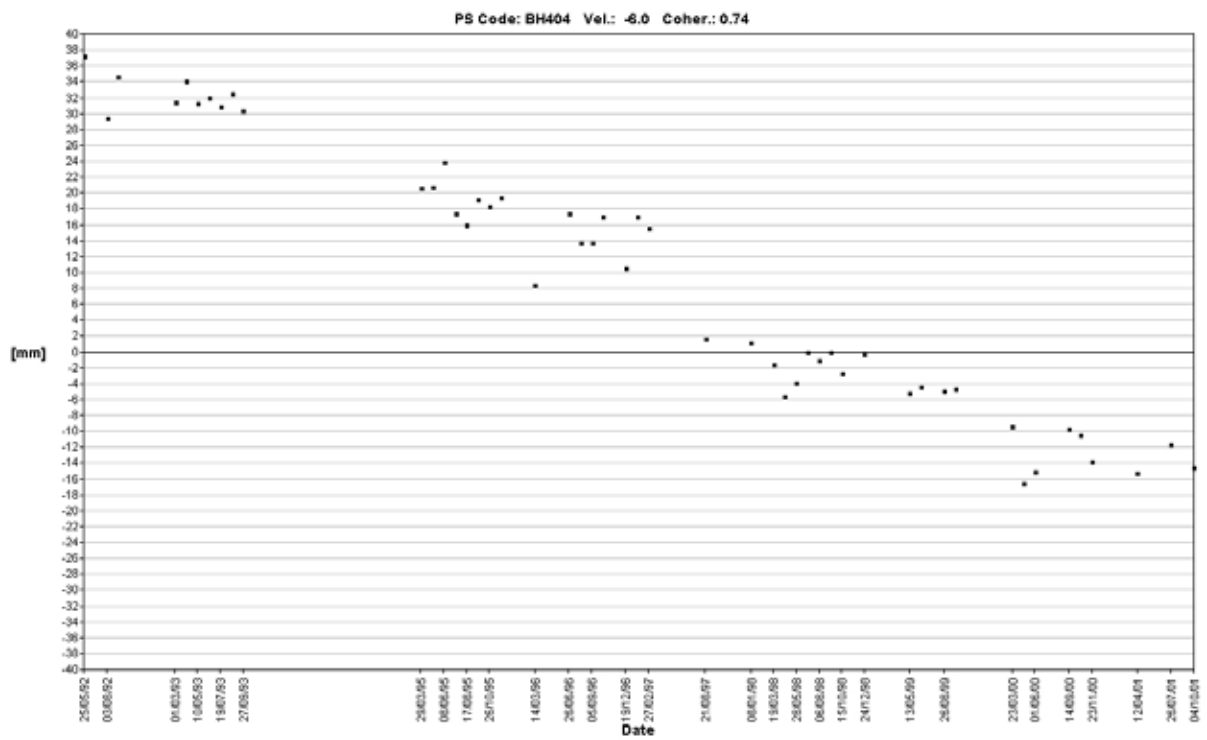
Figure 21. Displacement-time series from Stenersgata 22 (centre of photo).

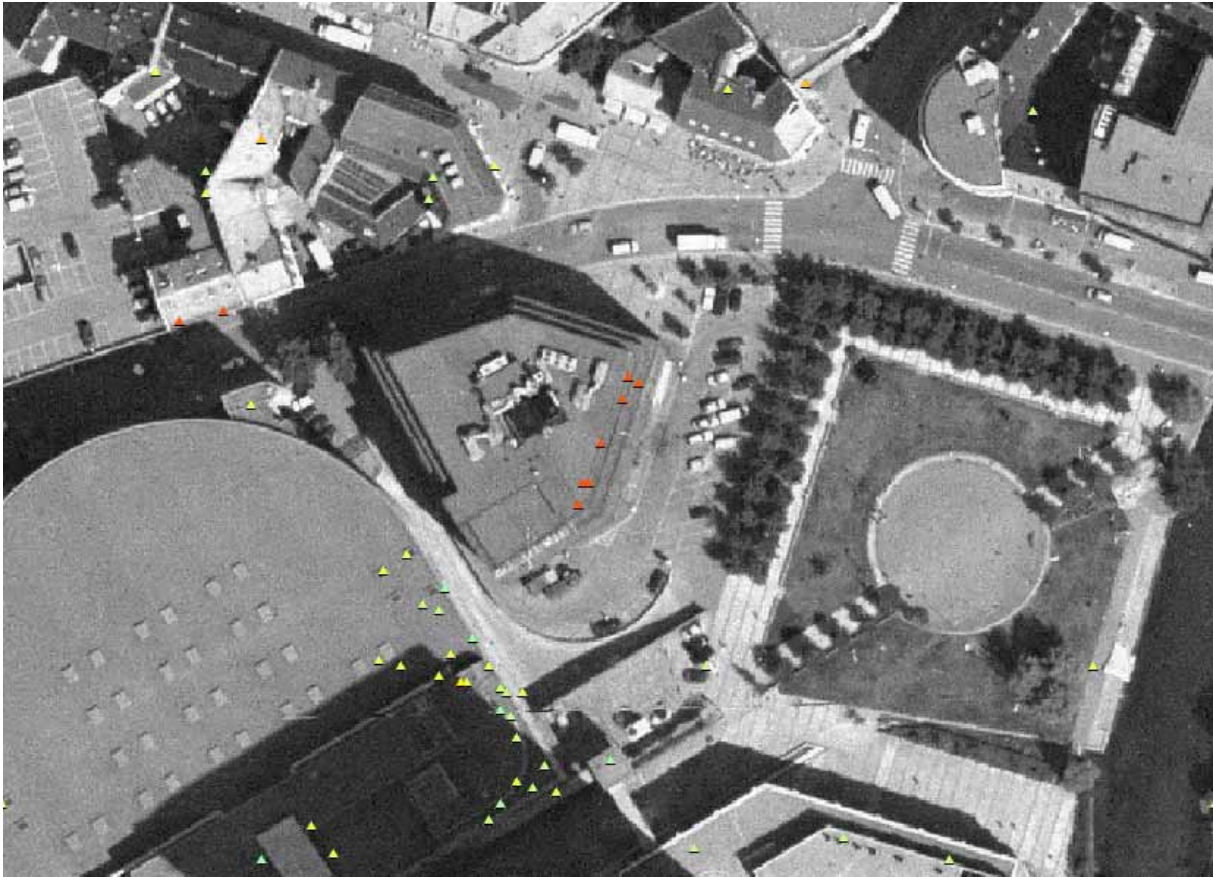
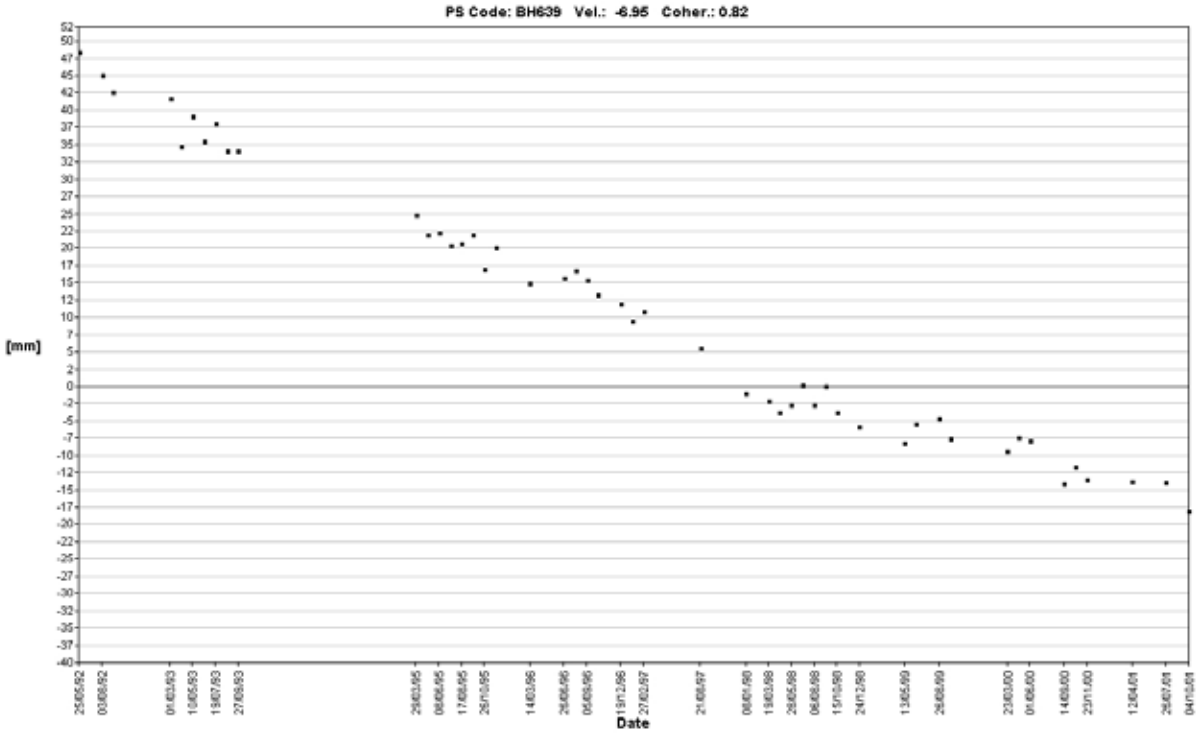
Figure 22. Displacement-time series from Lilletorget 1 (centre of photo).

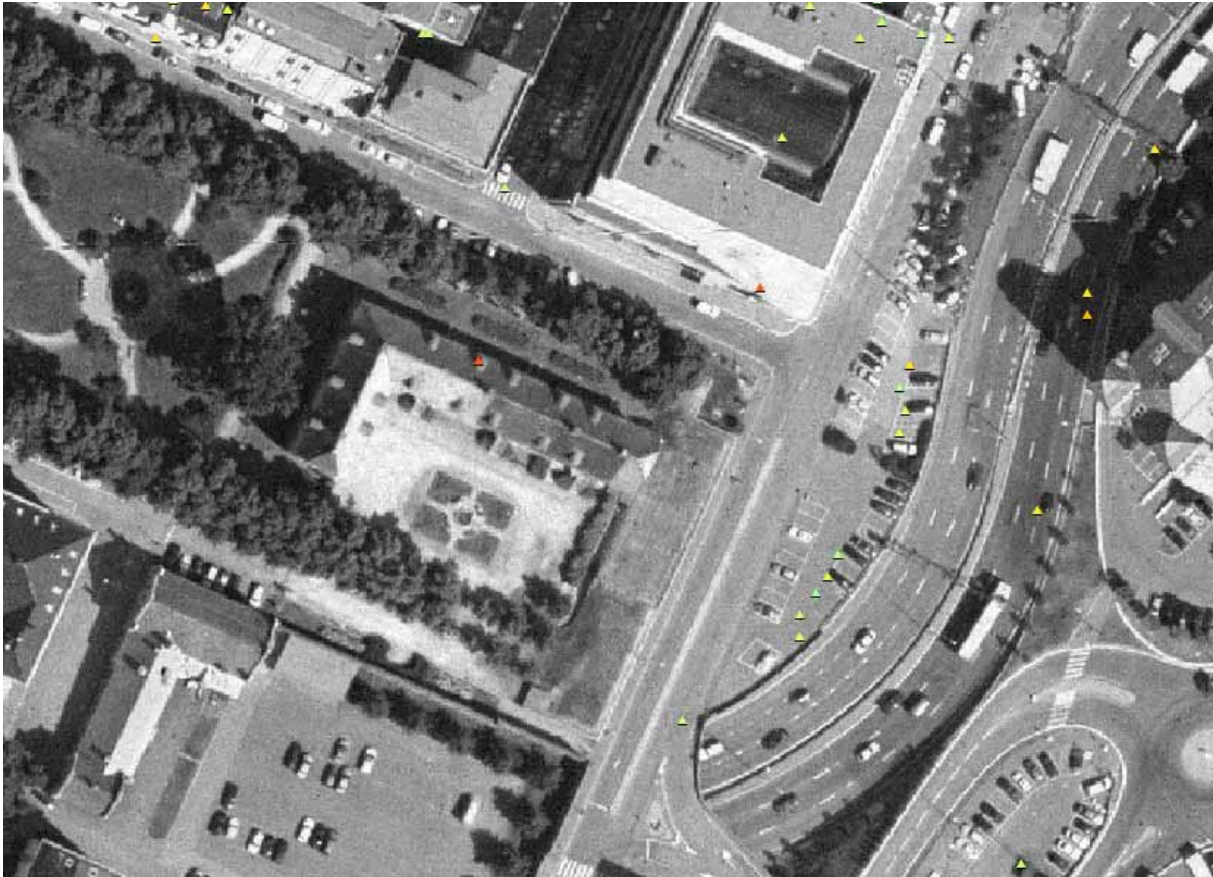
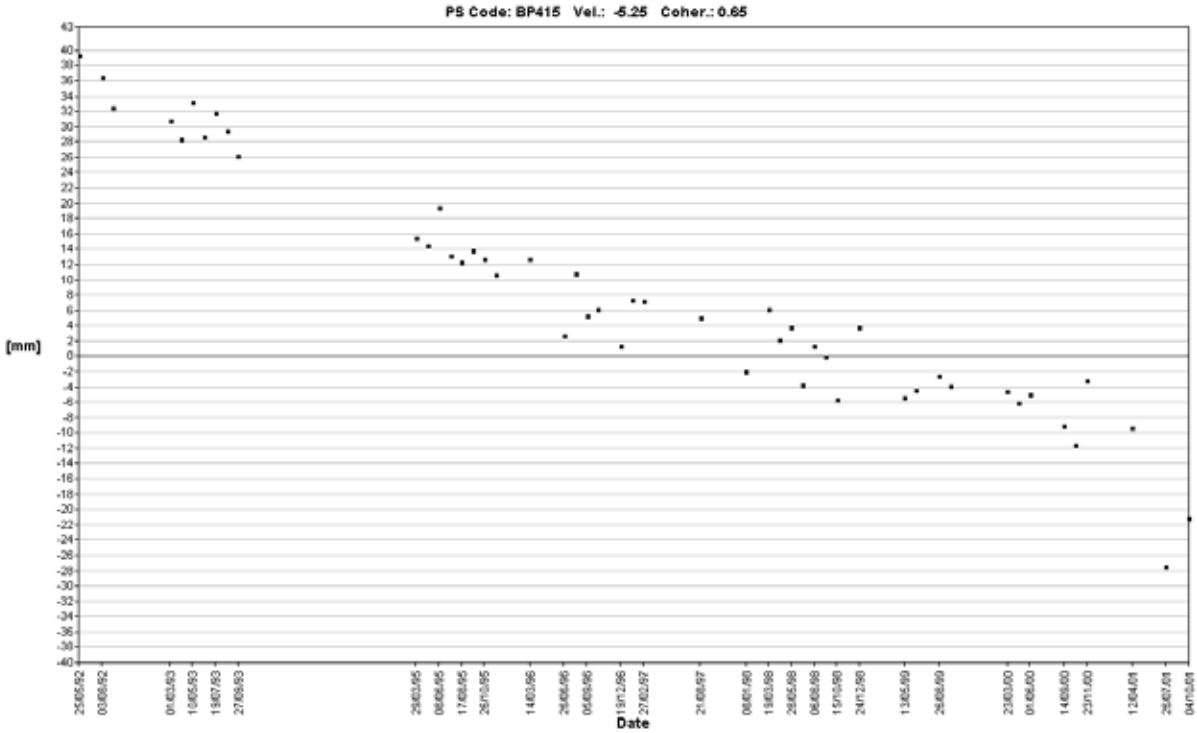
Figure 23. Displacement-time series from Grev Wedels plass 1 (centre of photo).

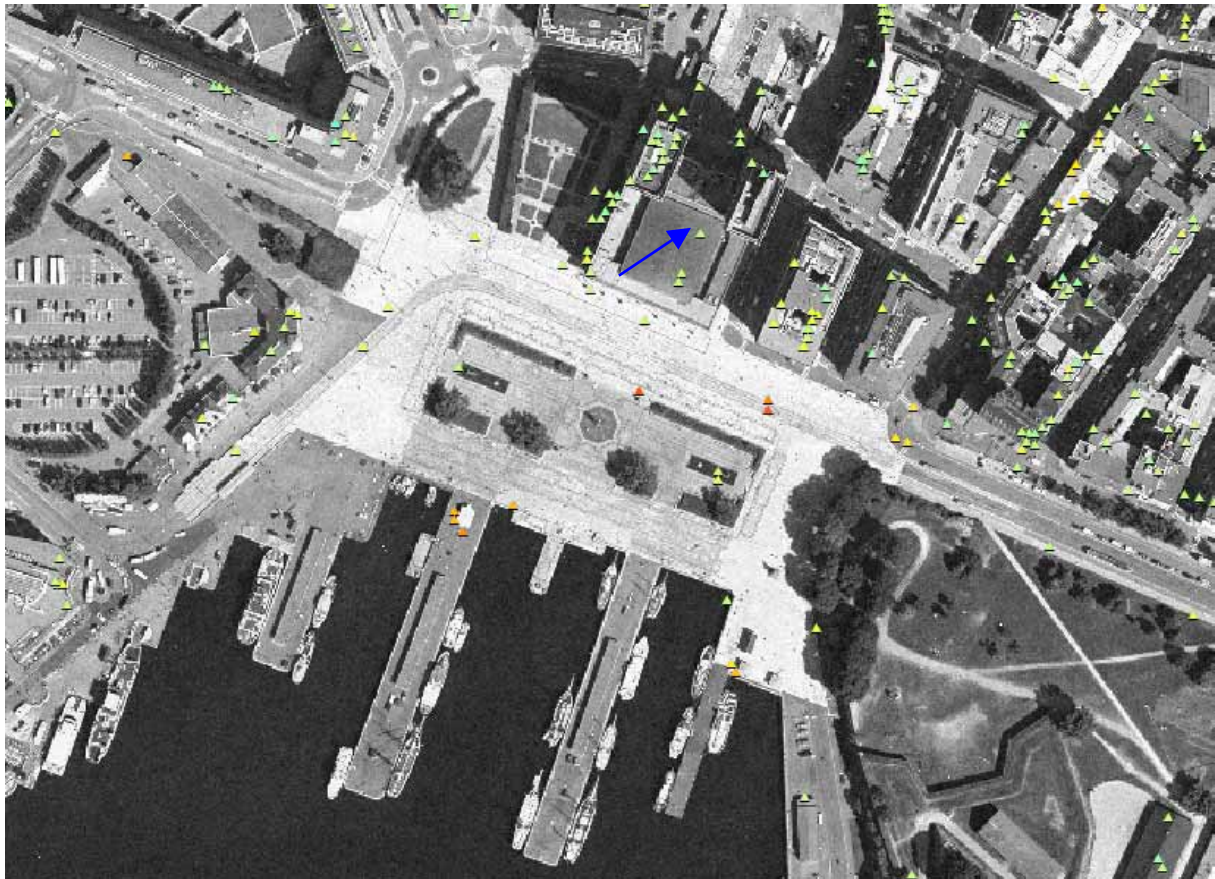
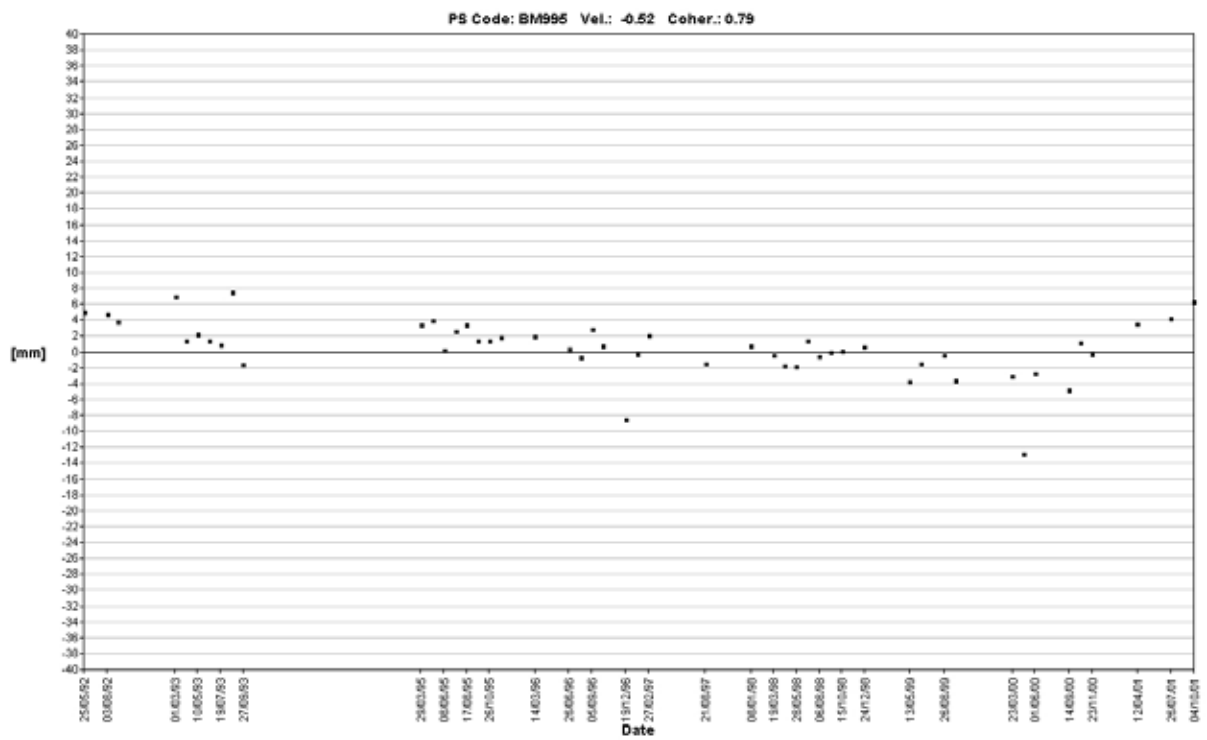
Figure 24. Displacement-time series from Rådhusplassen 1 (blue arrow).

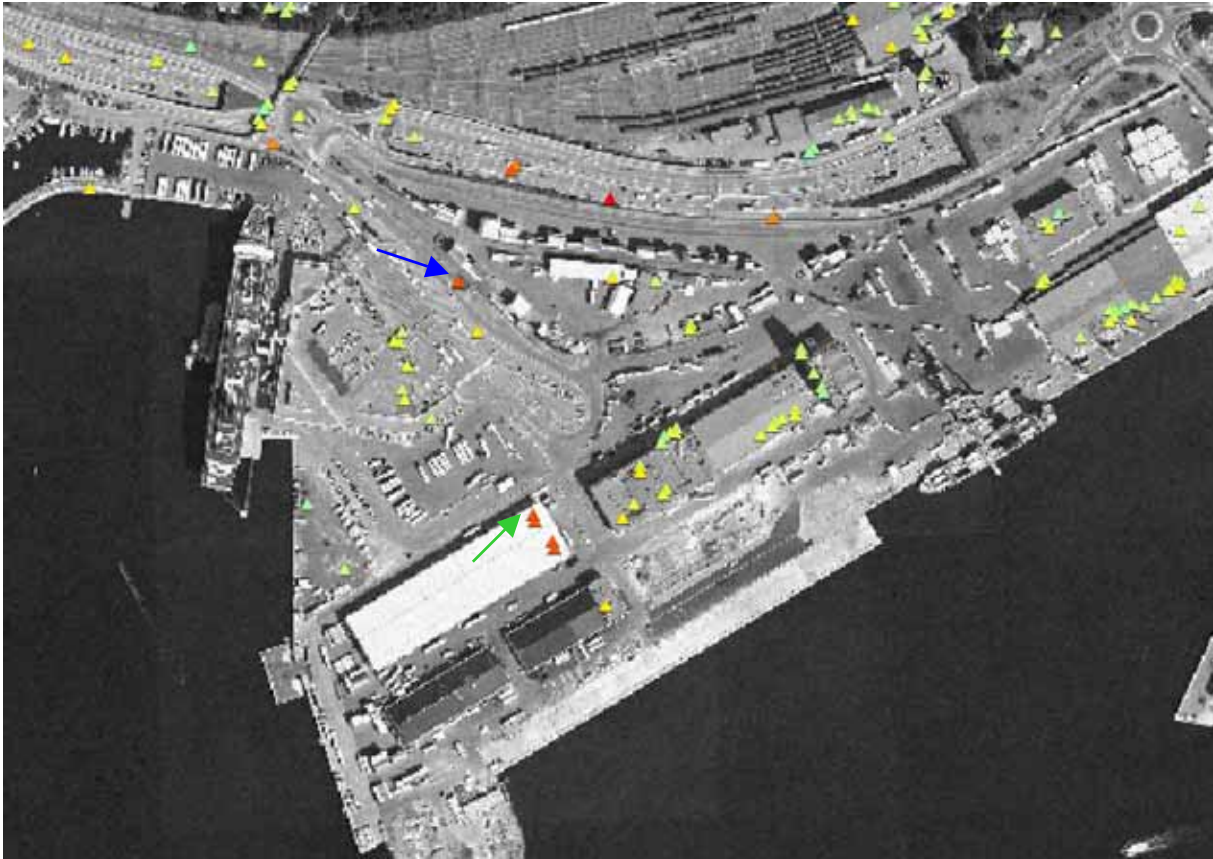
Figure 25. Subsidence pattern in Filipstad. Displacement-time series are shown in Figures 26 (blue arrow) and 27 (green arrow).

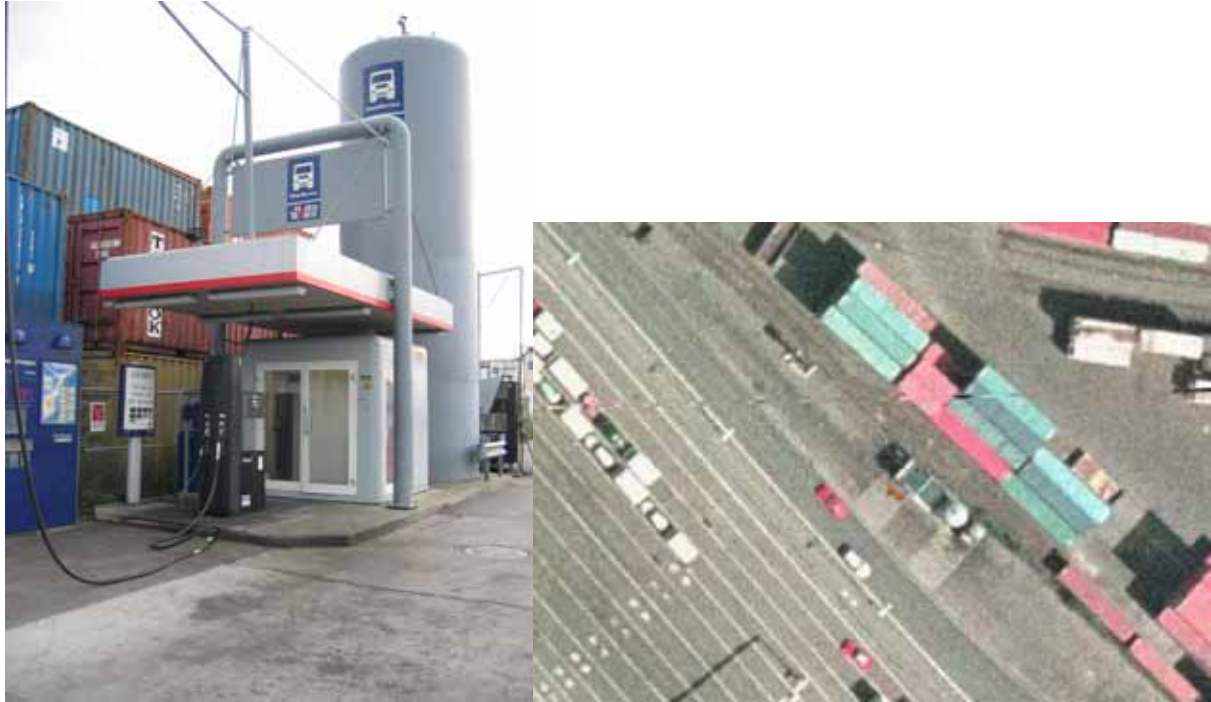
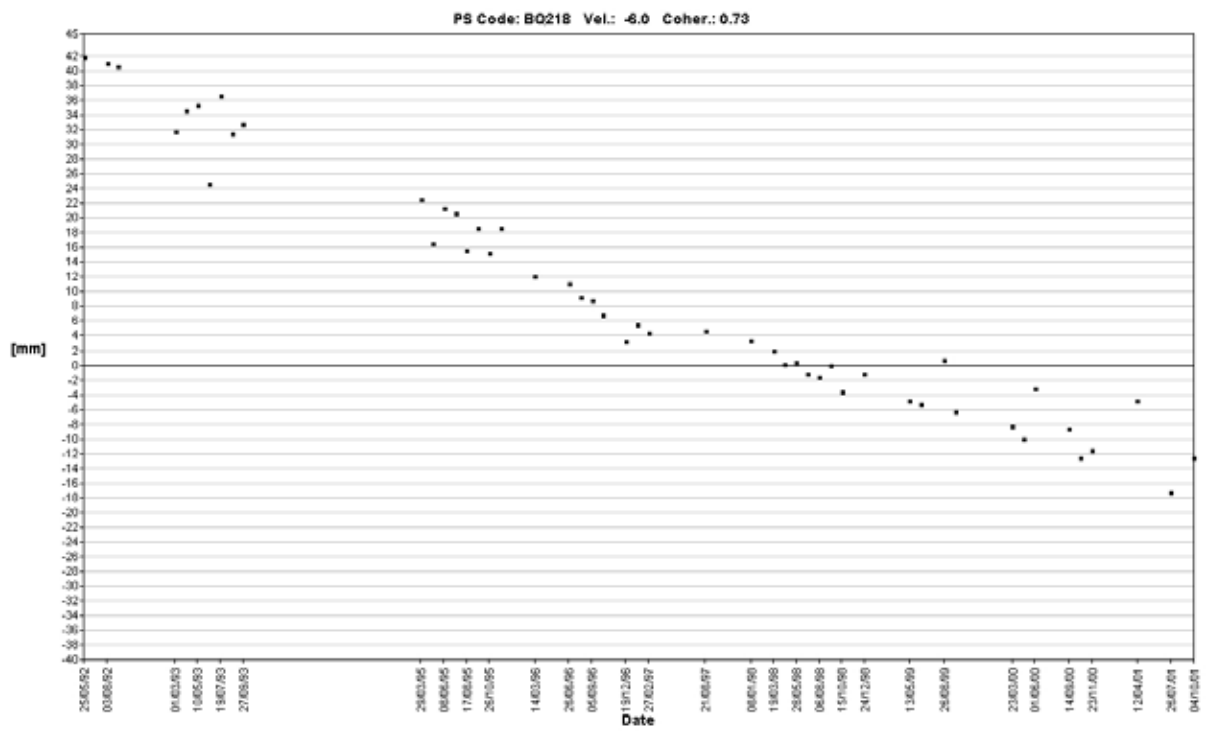
Figure 26. Displacement-time series from the gas station in Filipstad (see Figure 25 for location).

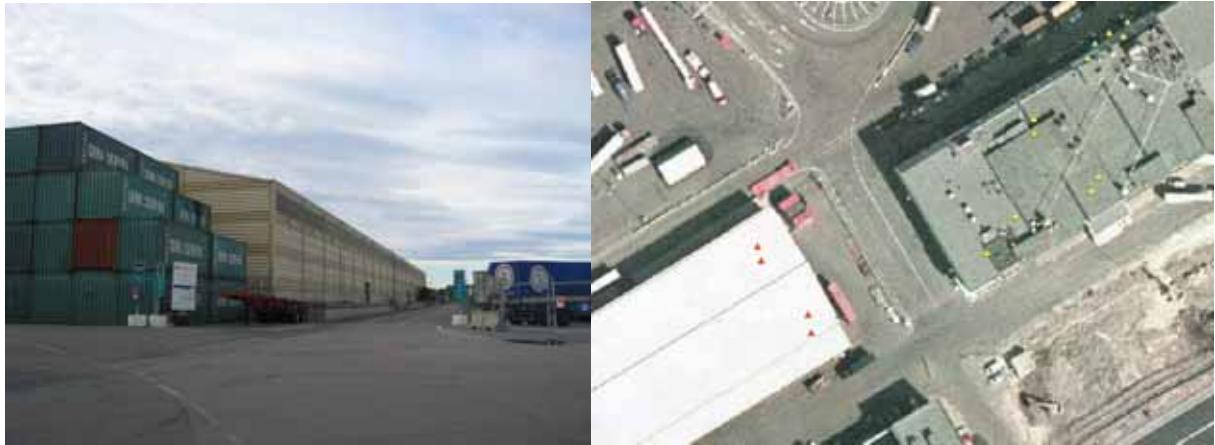
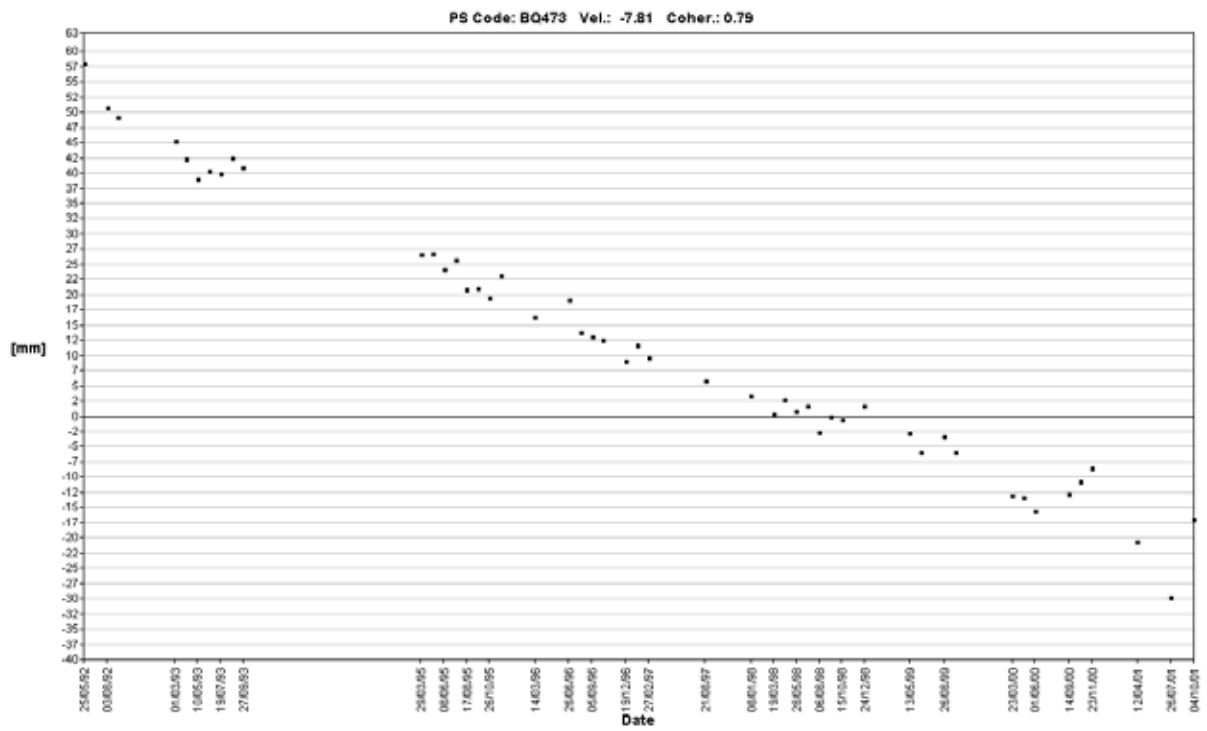
Figure 27. Displacement-time series from one of the warehouses in Filipstad (see Figure 25 for location).

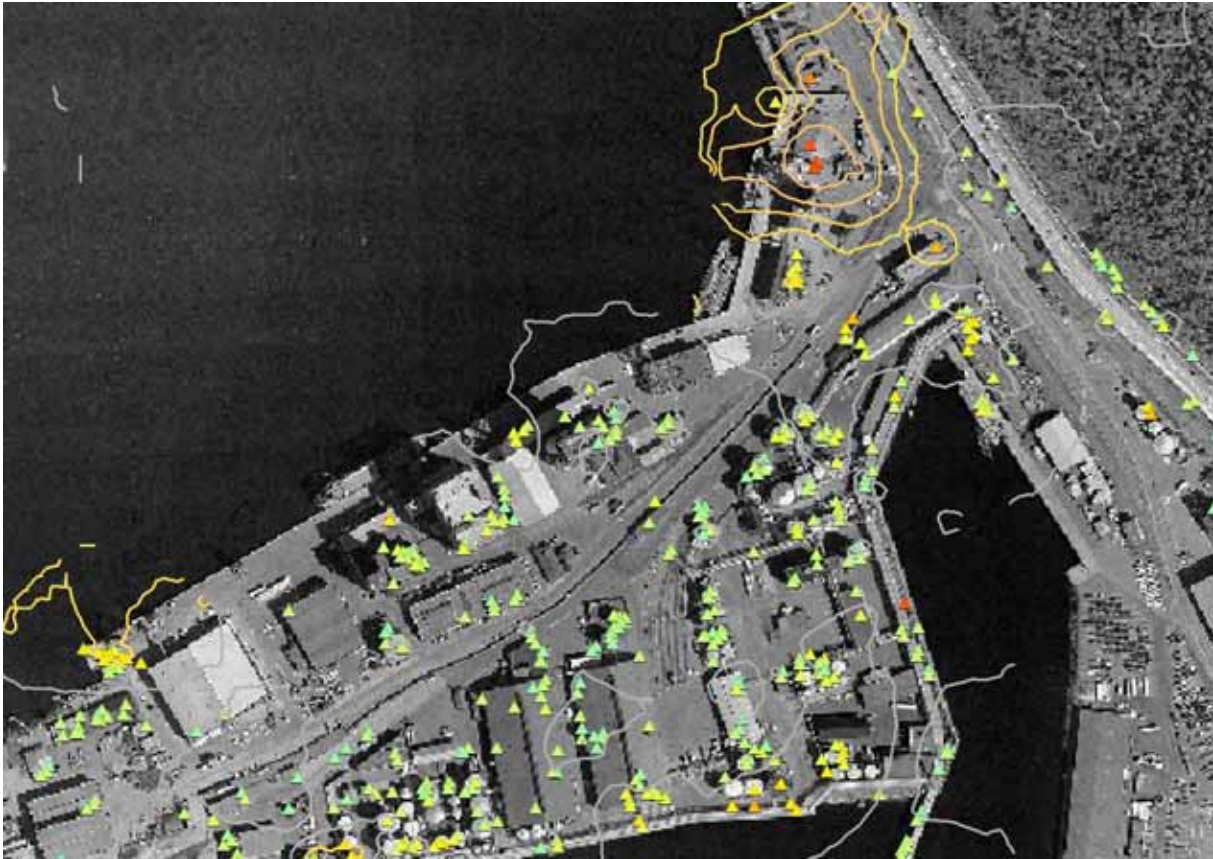
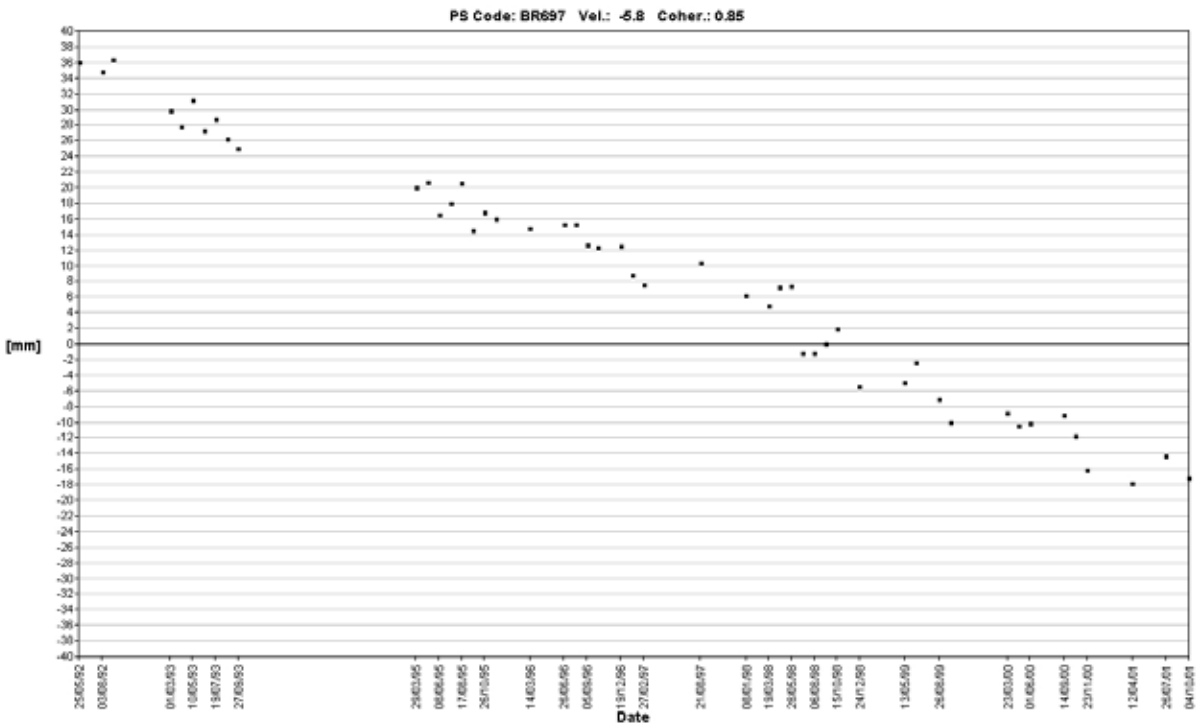
Figure 28. Displacement-time series from the northernmost building in Sjursøya.

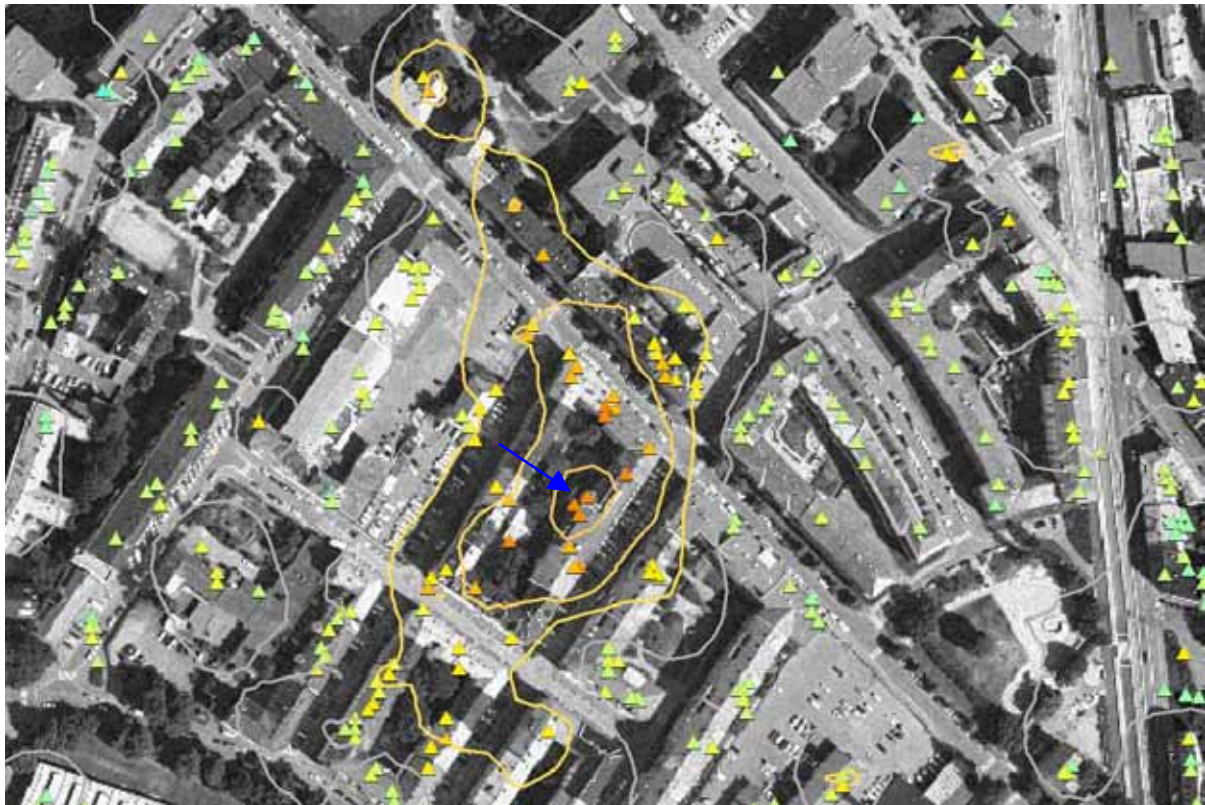
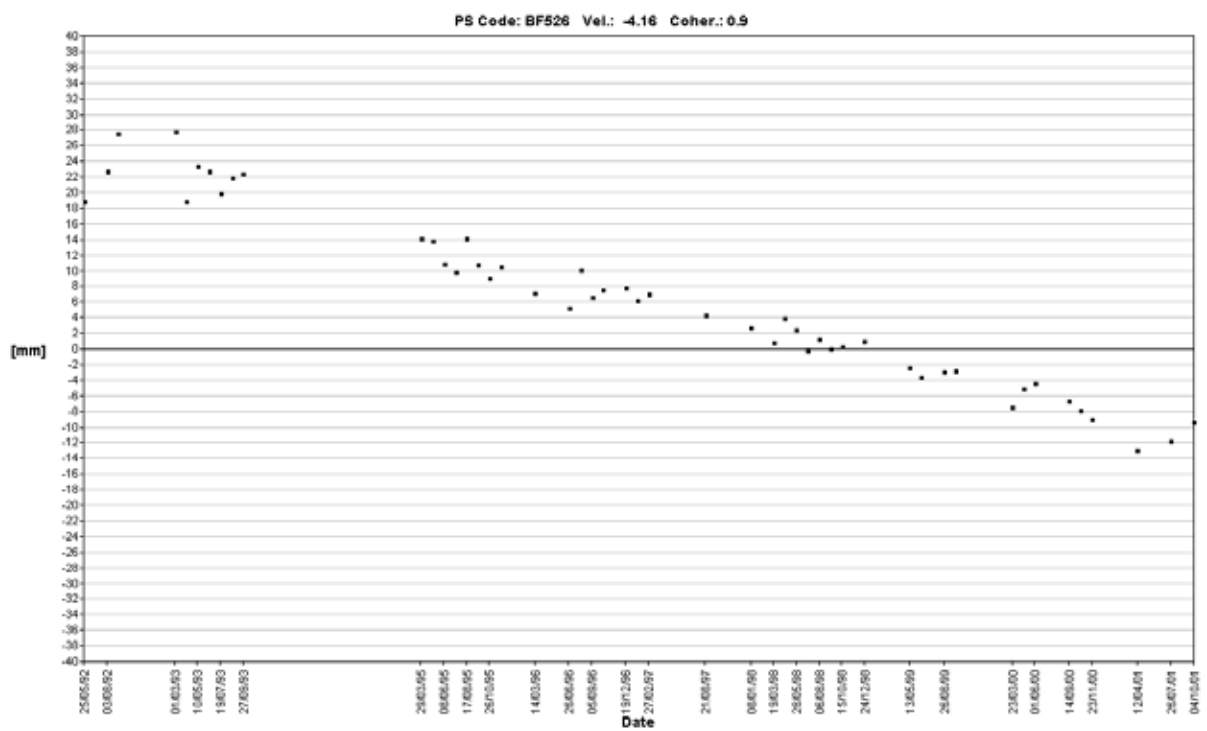
Figure 29. Displacement-time series from Eiriksgata 17 (blue arrow).

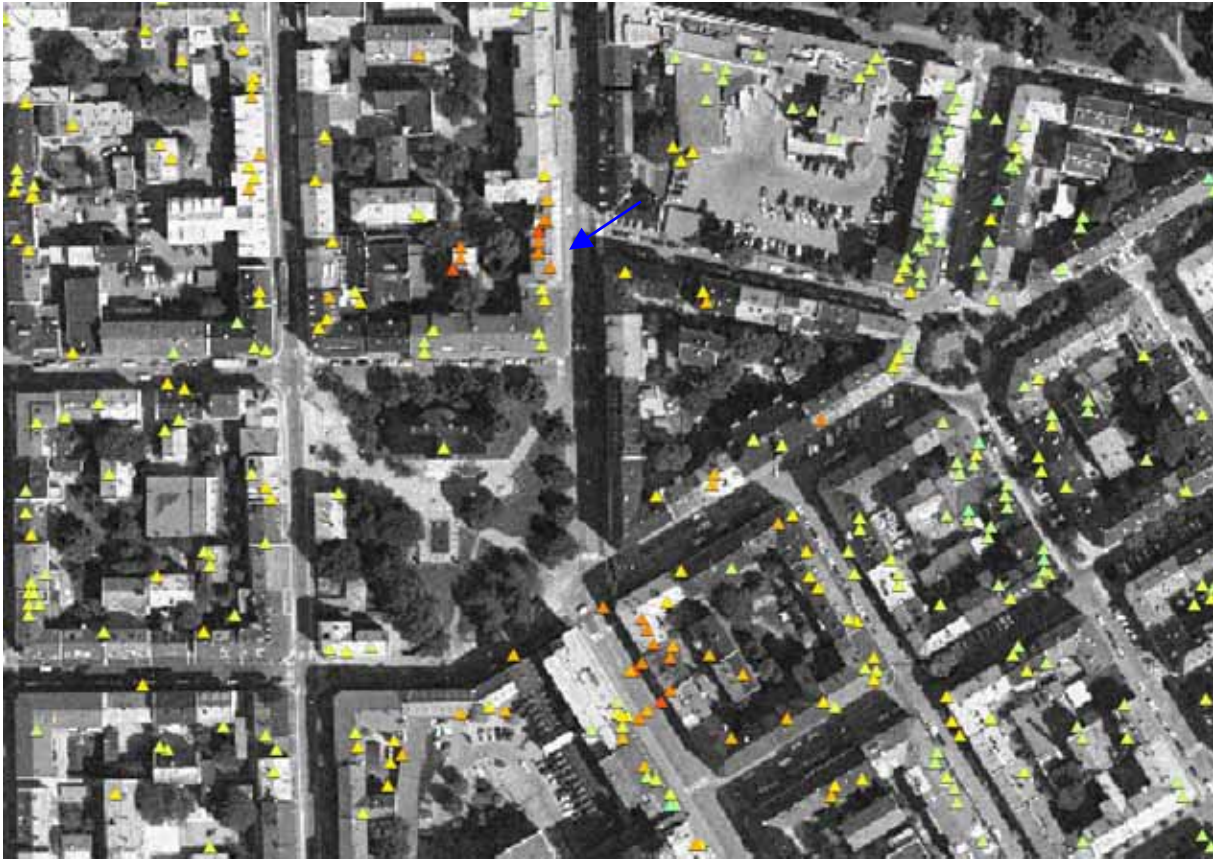
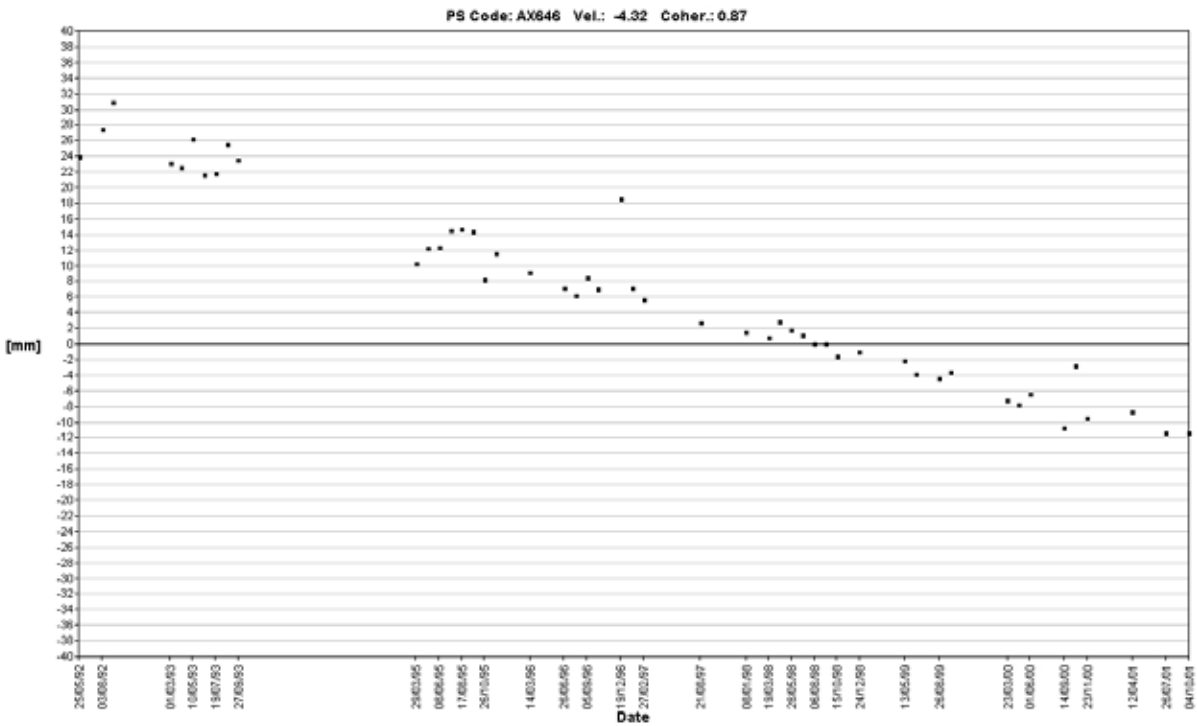
Figure 30. Displacement-time series from Toftes Gate 69 (blue arrow).

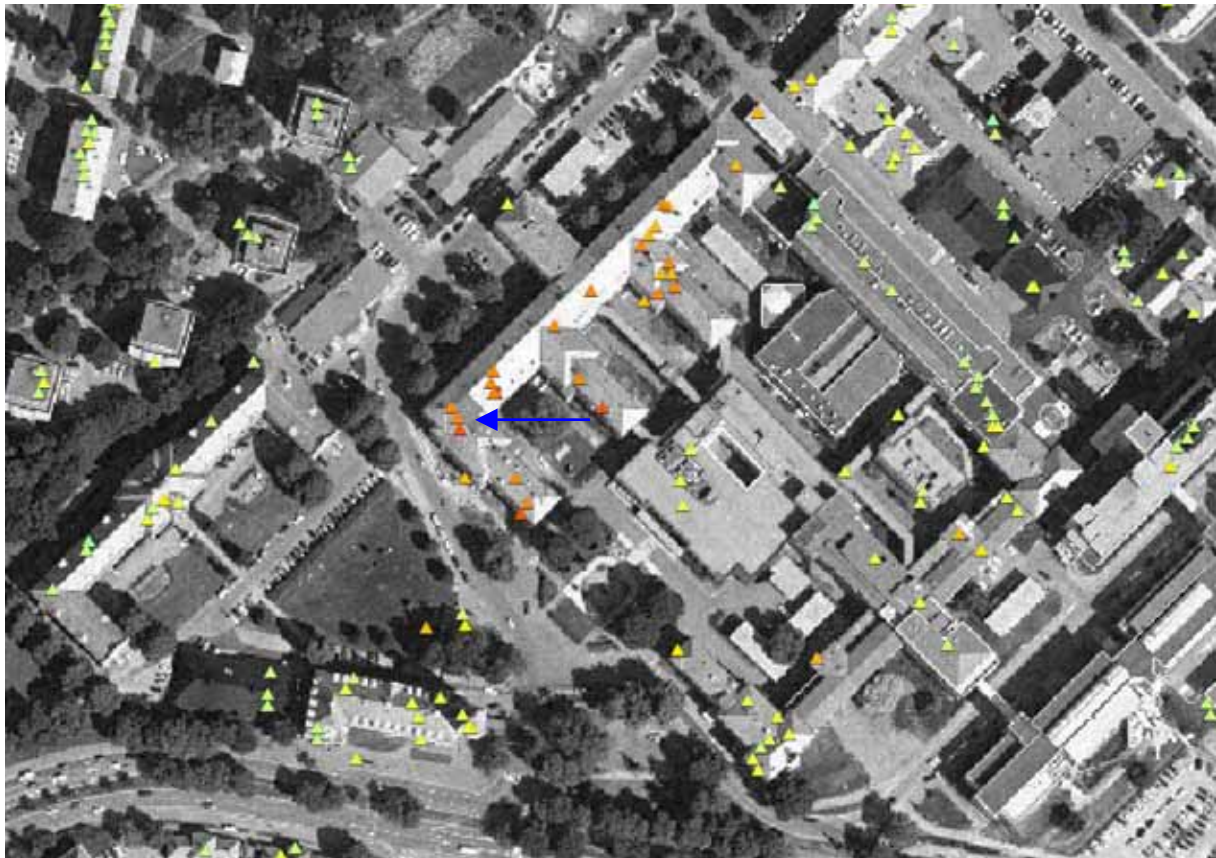
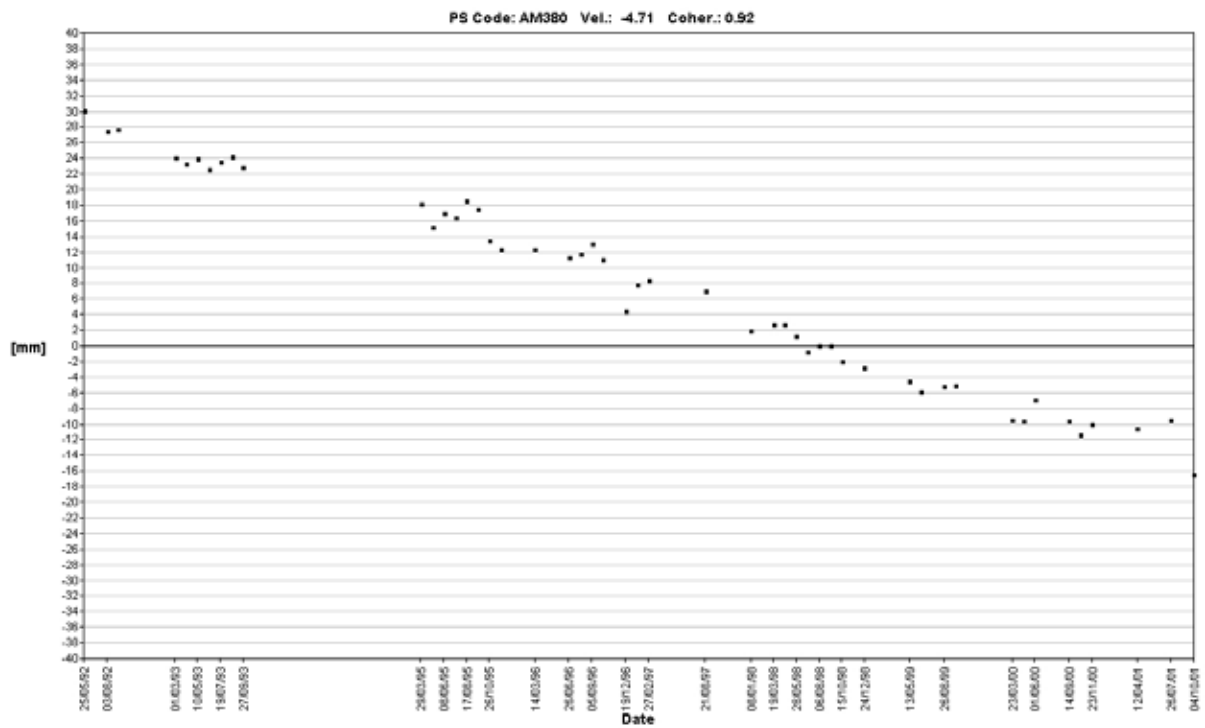
Figure 31. Displacement-time series from western corner of Ullevål hospital (blue arrow).
