Report no.: 2003.105		ISSN 0800-3416	Grading: Open	
Title: Evaluation of the use of PSInSAR for the monitoring of subsidence in Oslo region				
Authors: Dehls, J. F., Nordgulen, Ø.		Client: Oslo kommune (Friluftsetaten, Havnevesenet, Vann- og avløpsetaten, Plan- og bygningsetaten), Jernbaneverket (Region Øst)		
County: Oslo		Municipality: Oslo		
Map-sheet name (M=1:250.000) Oslo		Map-sheet no. and -name (M=1:50.000) 1814 I Asker, 1914 IV Oslo		
Deposit name and grid-reference:		Number of pages: 45	Price (NOK): 535	
		Map enclosures: 4		
Fieldwork carried out:	Date of report: 06.02.2004	Project no.: 3018.01	Person responsible:

Keywords:	subsidence		interferometry	
urban geology

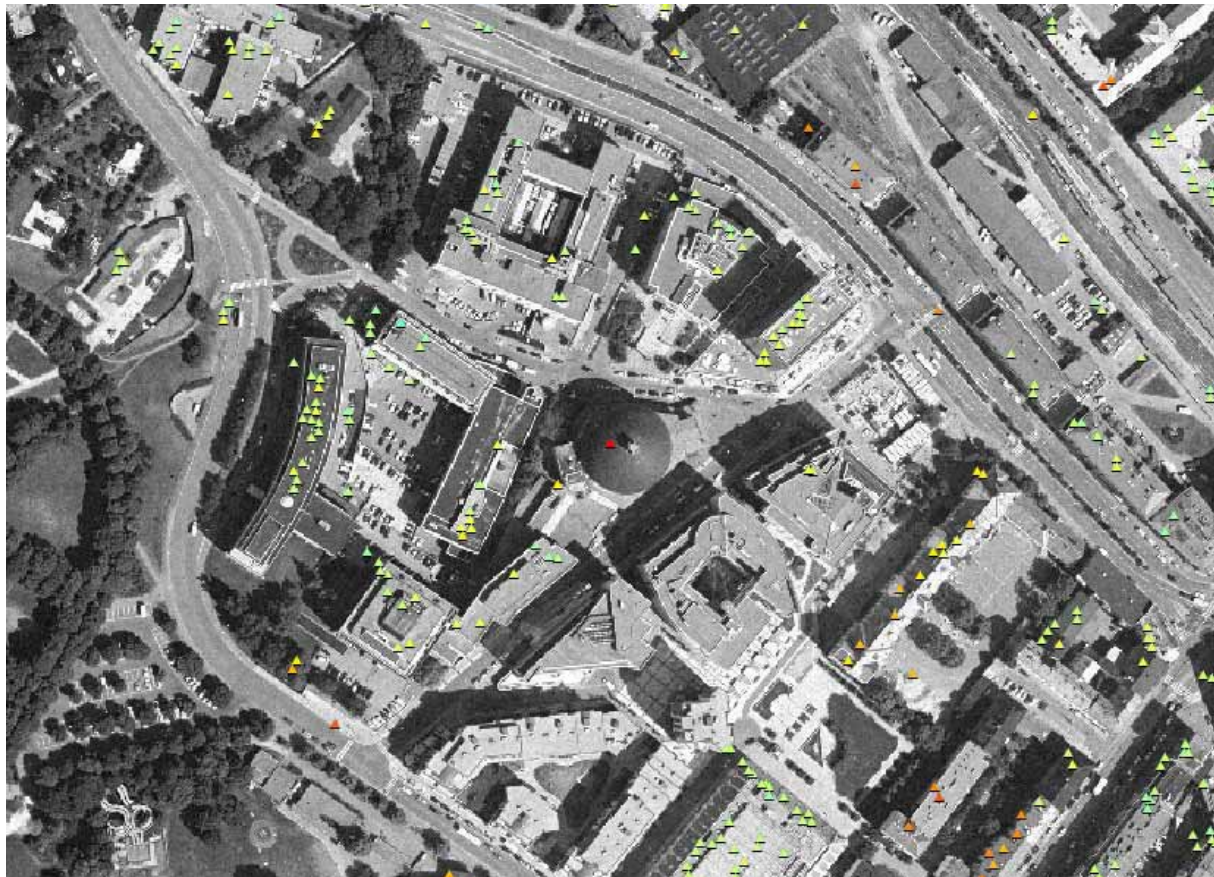
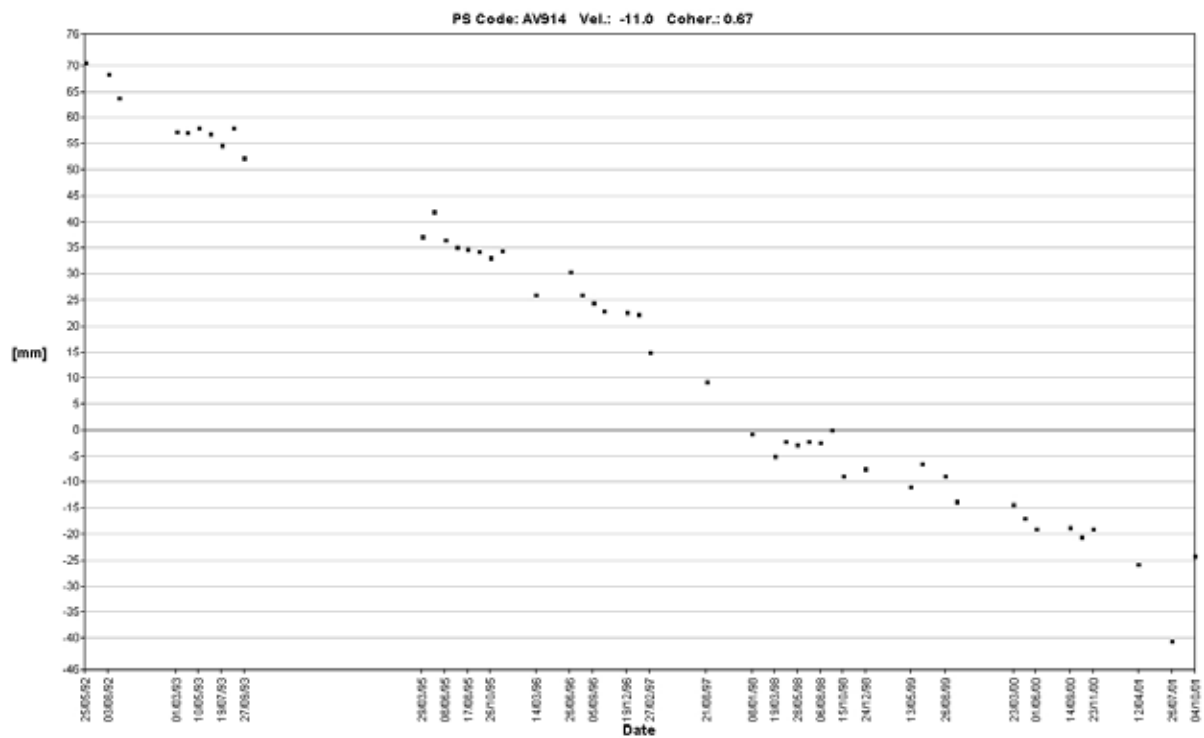
Figure 33. Displacement-time series from Fridtjof Nansensvei 8 (centre of photo).

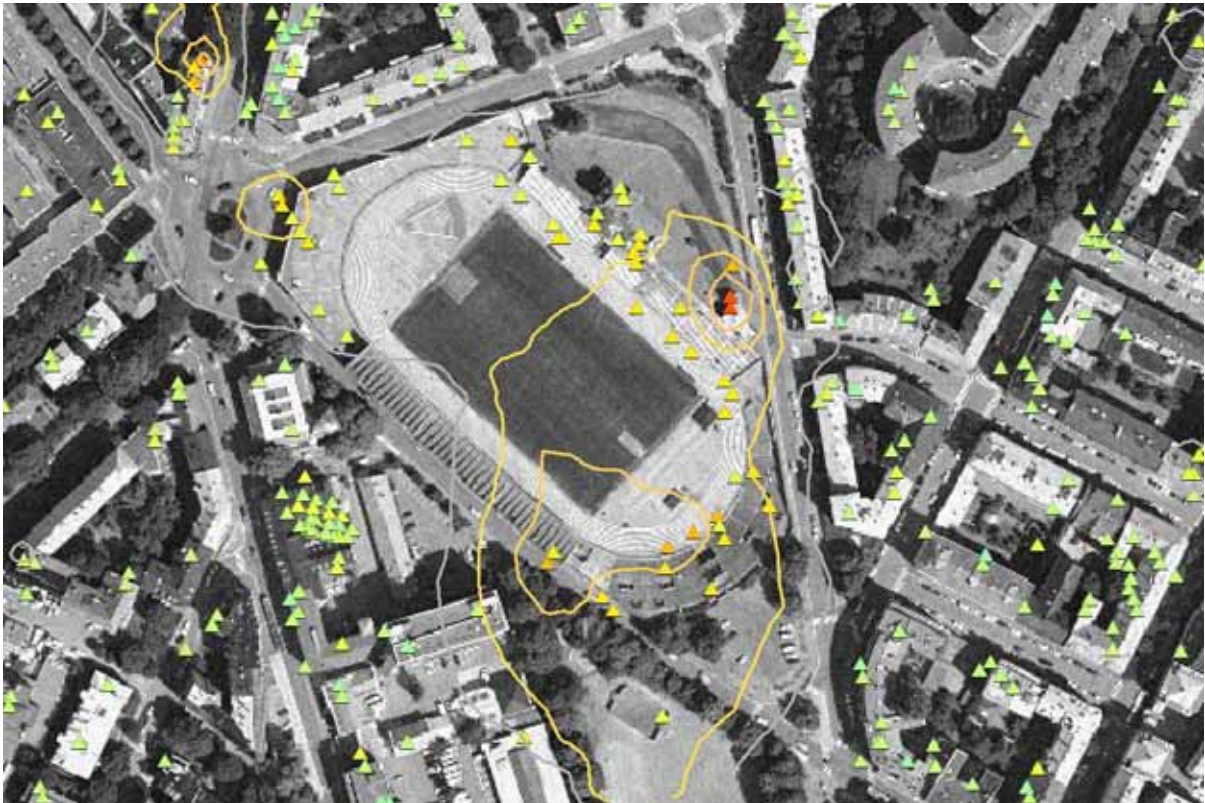
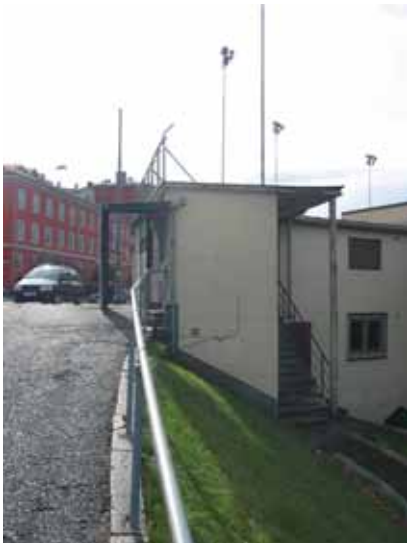
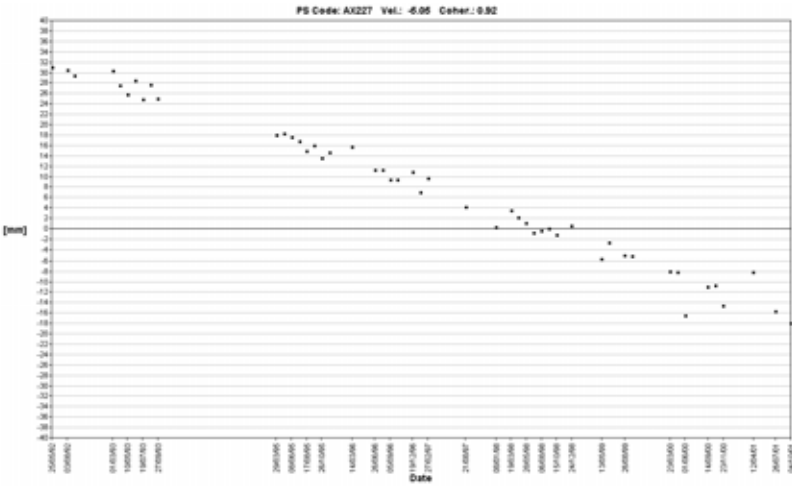
Figure 34. The area around Bislett stadium is subsiding between 1.5 and 2.0 mm/yr. Two PS have subsidence rate of 5 mm/yr, however these are located on the corner of a structure supported by a wooden post. It is most likely that this post is slowly deteriorating, leading to a slow collapse of the roof.

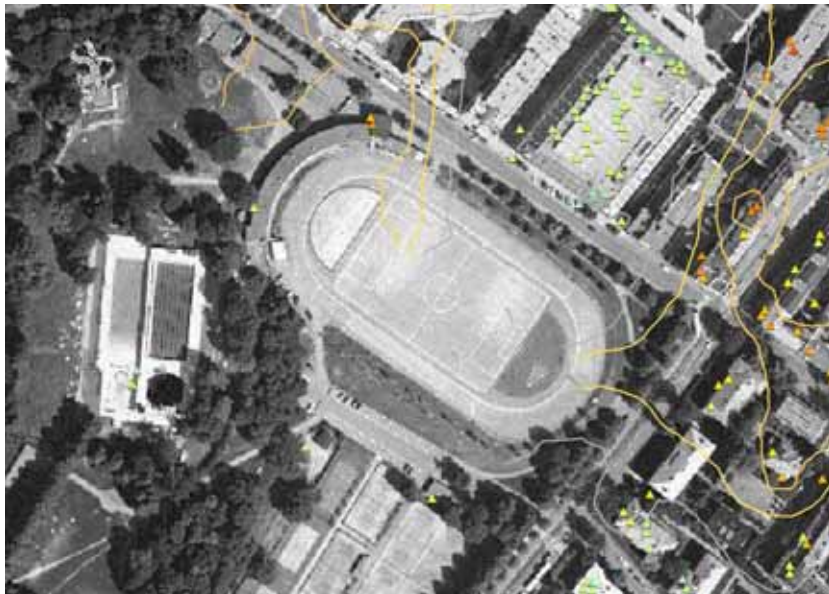
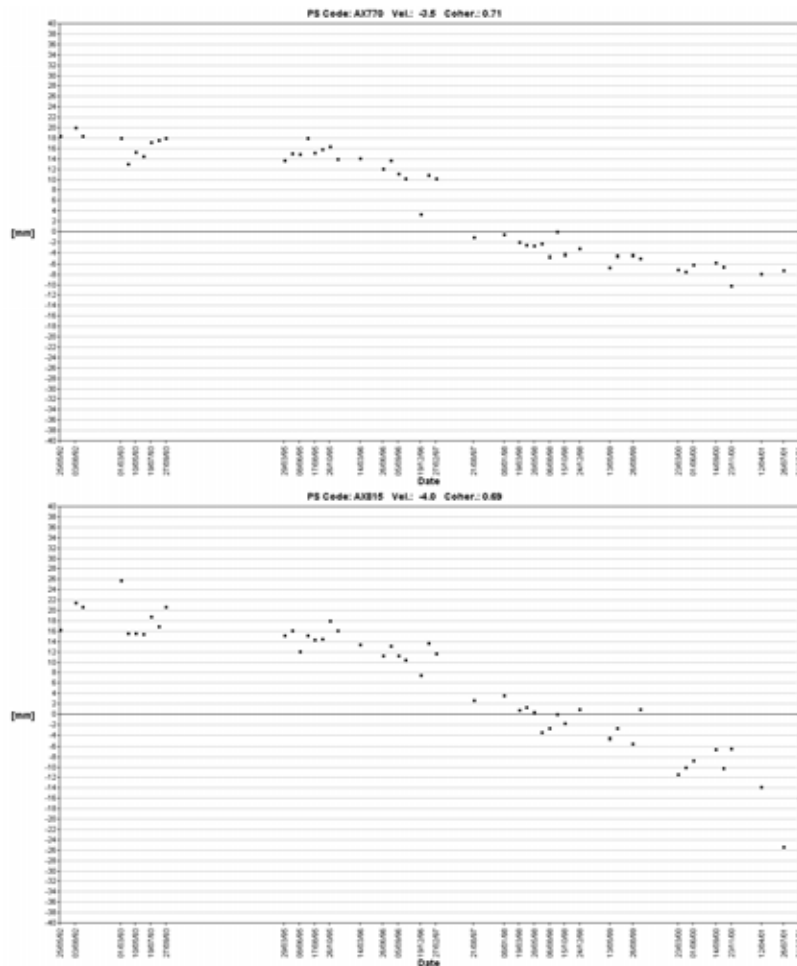
Figure 35. Only three PS were identified on Frogner stadion. According to the depth to bedrock map supplied by Oslo municipality, the stadium appears to be located on shallow sediments, with the exception of the northwestern and eastern corners. One of the PS identified is shows no subsidence on a structure on the northwestern corner of the stadium, and show subsidence rates of 3.5 to 4 mm/yr. No field checking has been carried out to determine if this represents true subsidence or slow collapse of the structure in question.

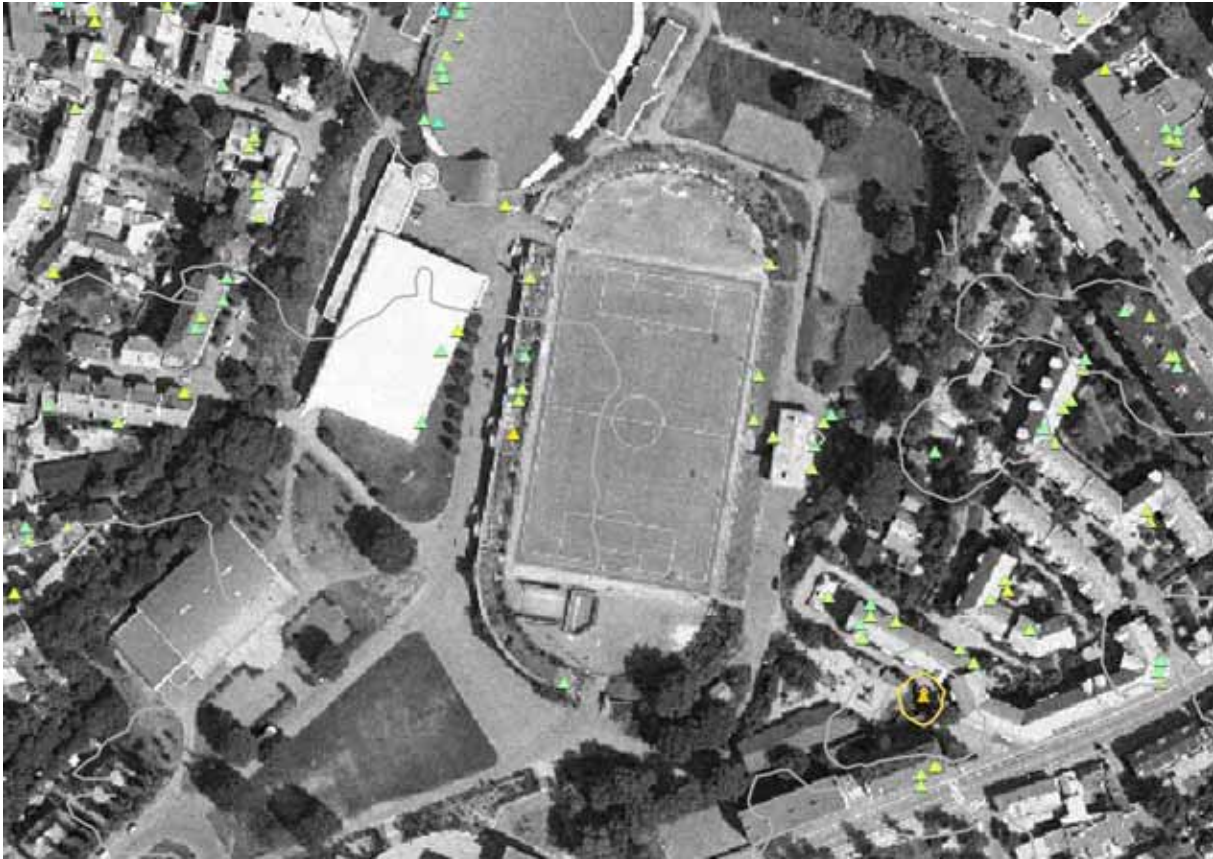
Figure 36. There is no evidence of subsidence in the area around Jordal Amfi.

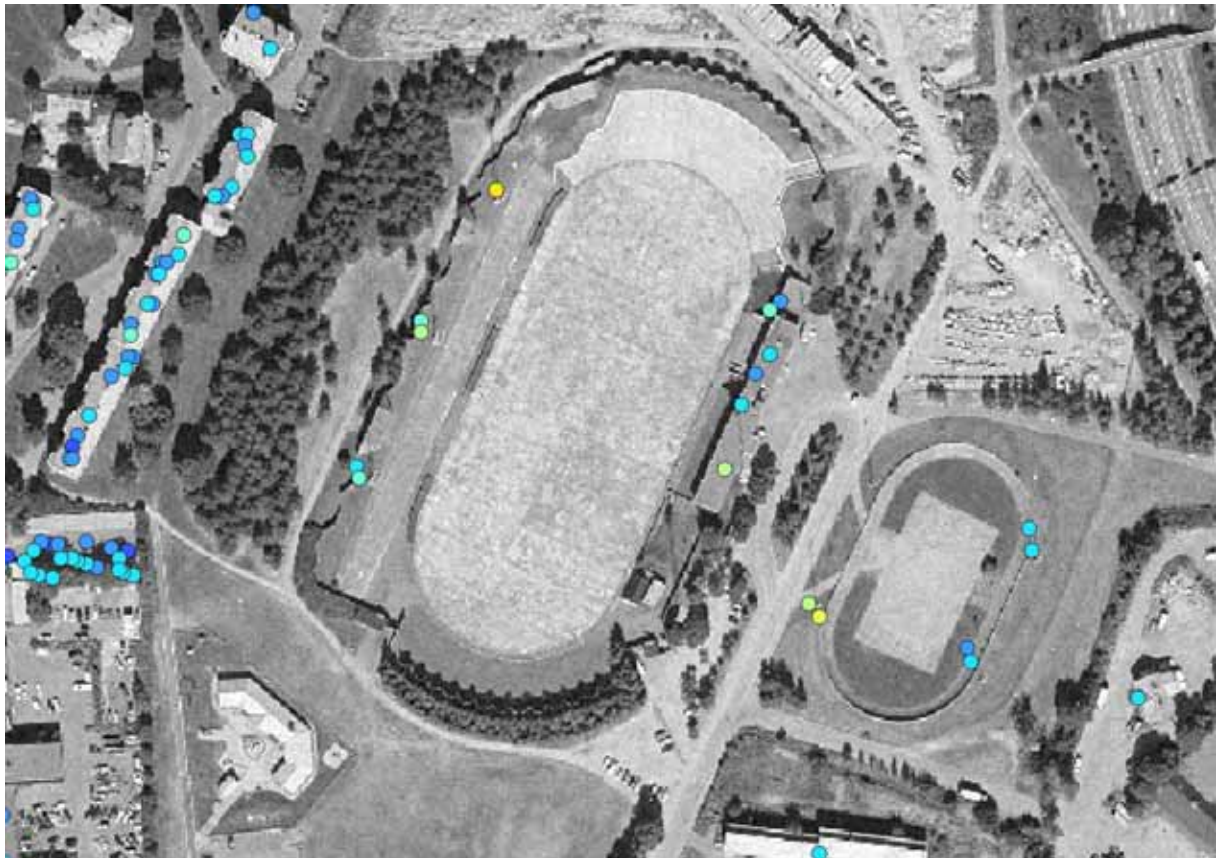
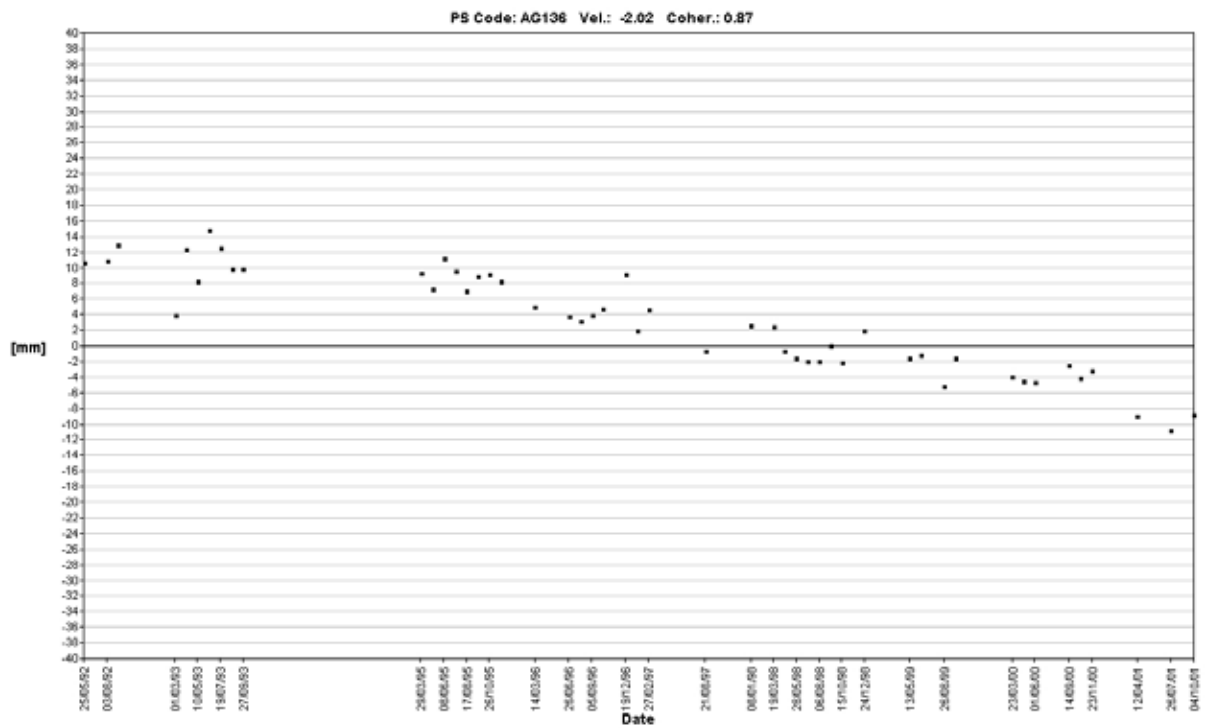
Figure 37. Only one point on Valle Hovin stadium shows any signs of subsidence (2 mm/yr). No visual inspection has been done.

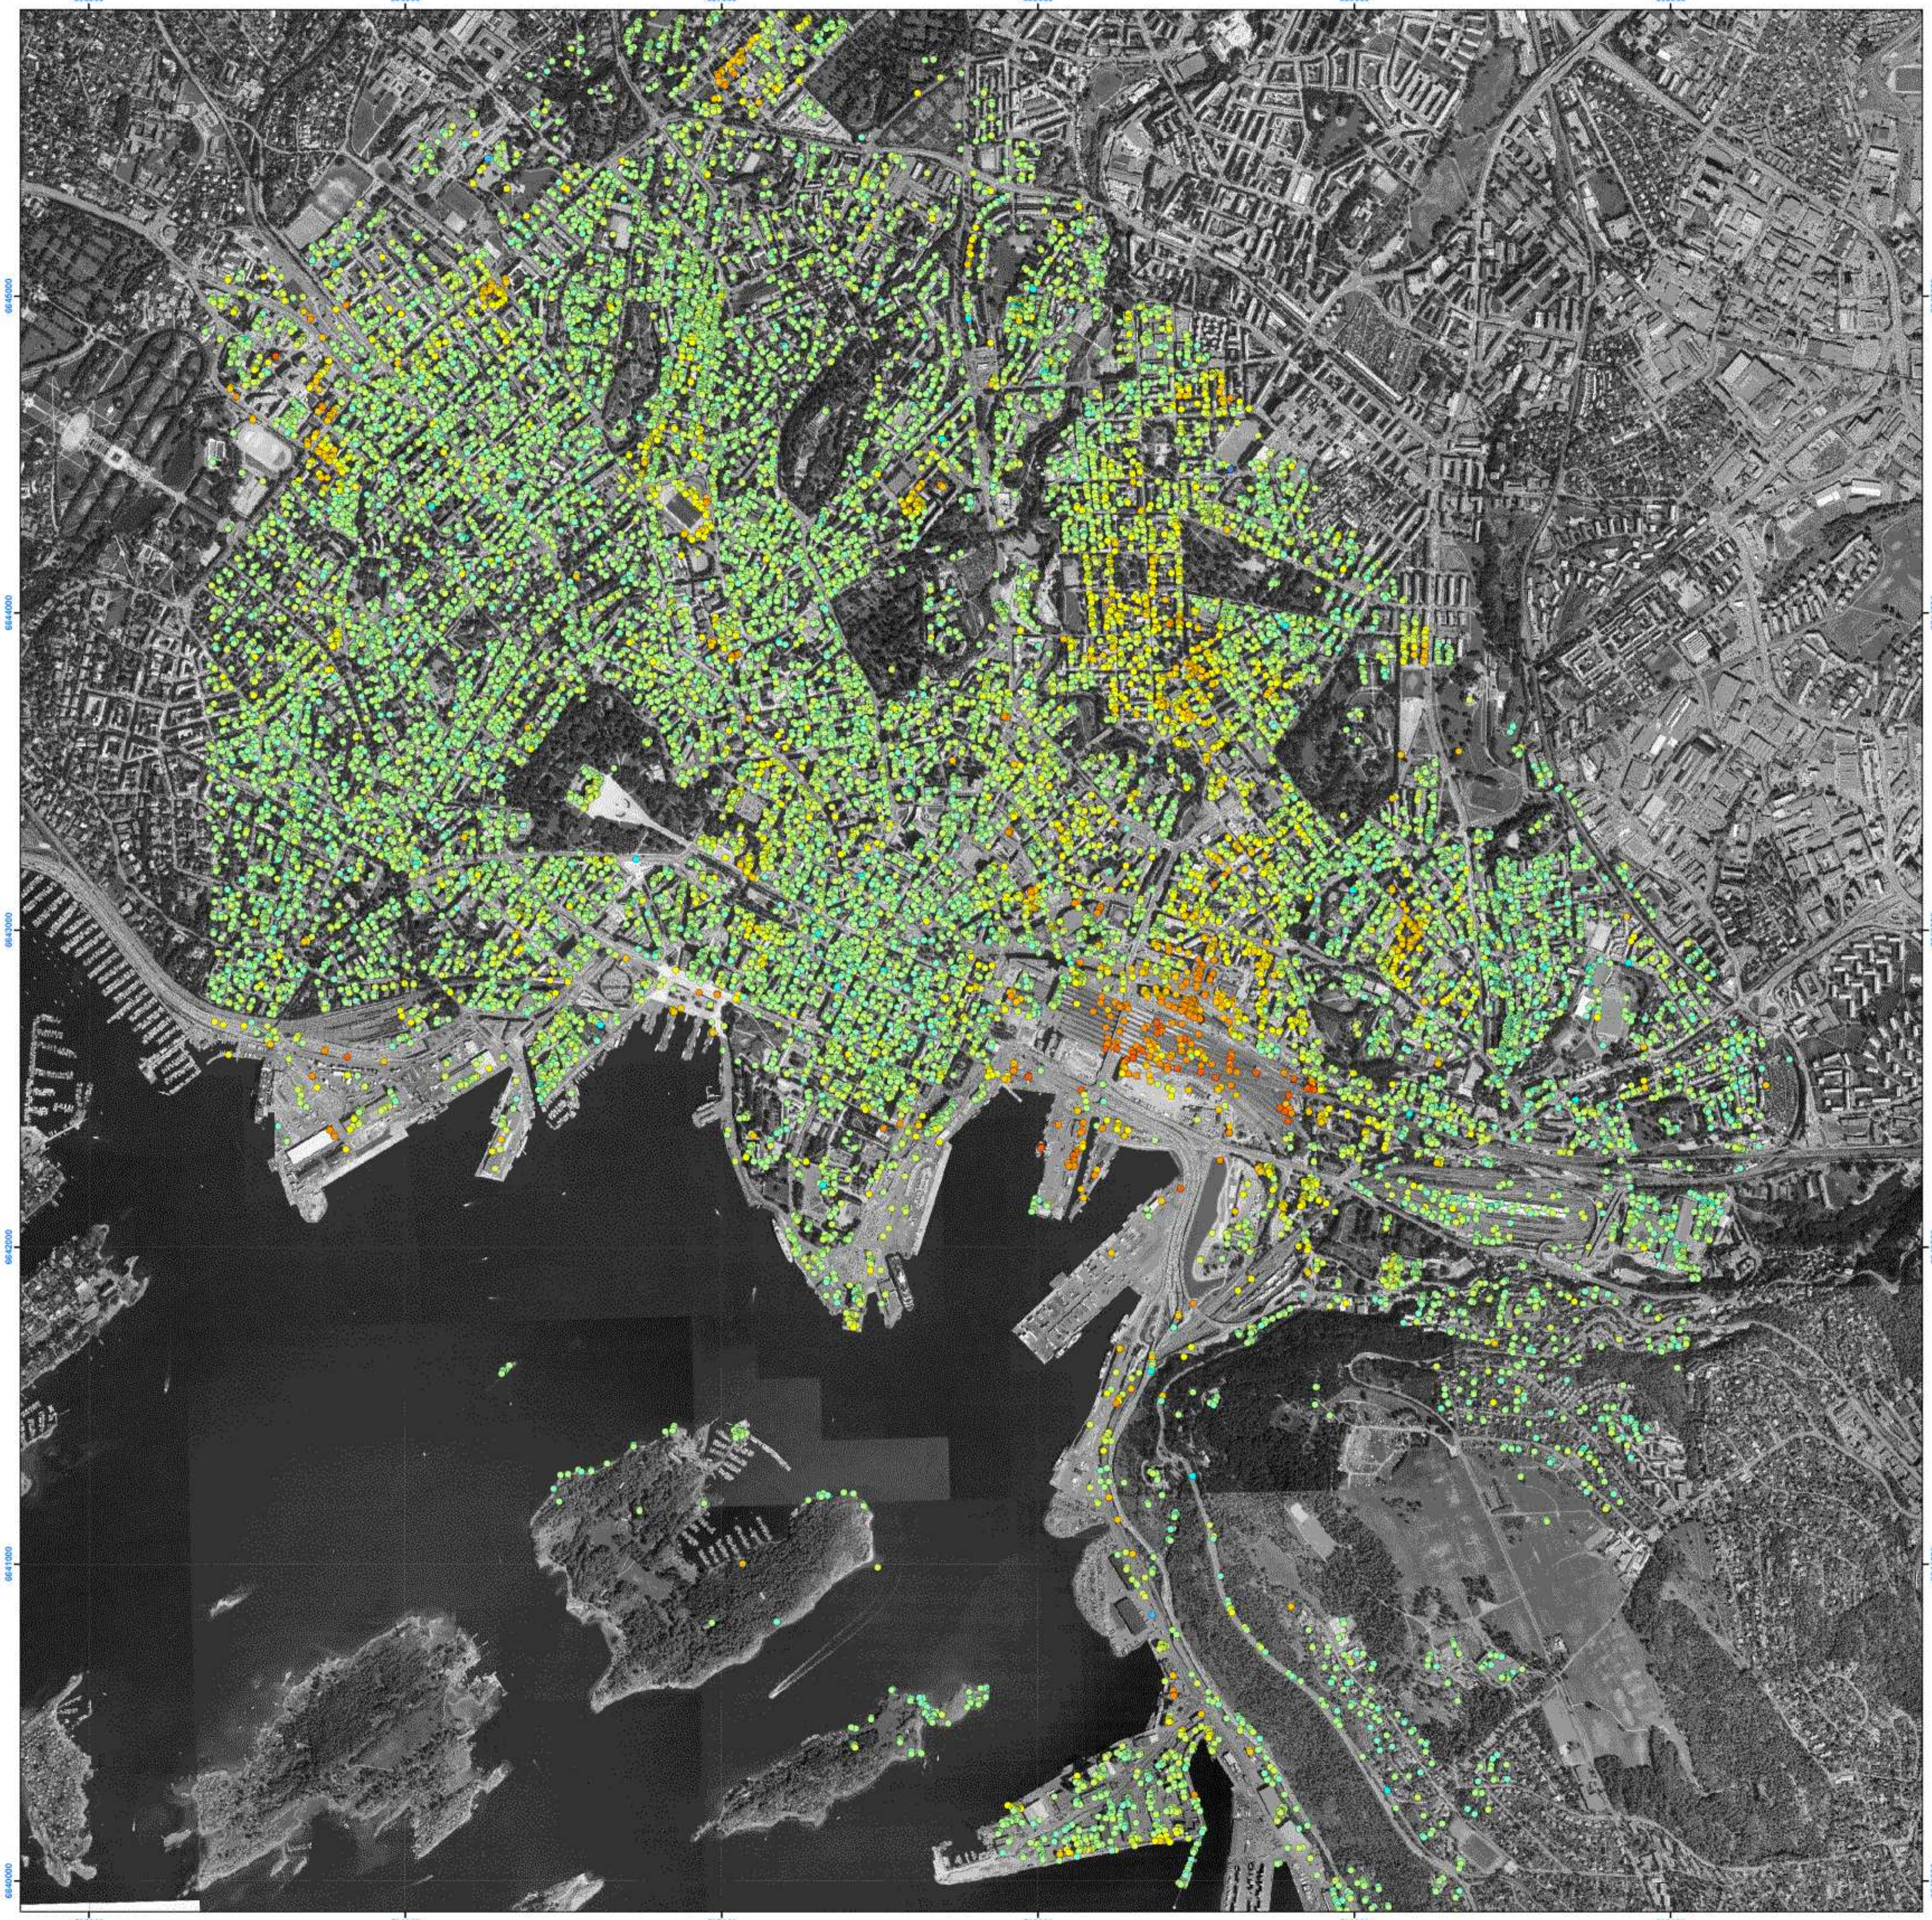
AVERAGE RELATIVE VELOCITY, 1992-2001, FROM DIFFERENTIAL RADAR INTERFEROMETRY ERS Track 337, Frame 2396 Oslo (Centre, Majorstua, Ullevål, Sjørseya)		
Drawing: Dehls, J. F.	Date: DEC 2003	Mapsheet (1:50 000): 1814 I Asker 1914 IV Oslo
Scale 1:10 000

Advanced processing was carried out over two areas. The first area covers central Oslo, from Sjursøya in the south to Ullevål in the north. The results from this area are shown in Map 3. The PS density in the city center is 2200 PS/km² in the new dataset. This represents an increase of over 80% from the standard processing.

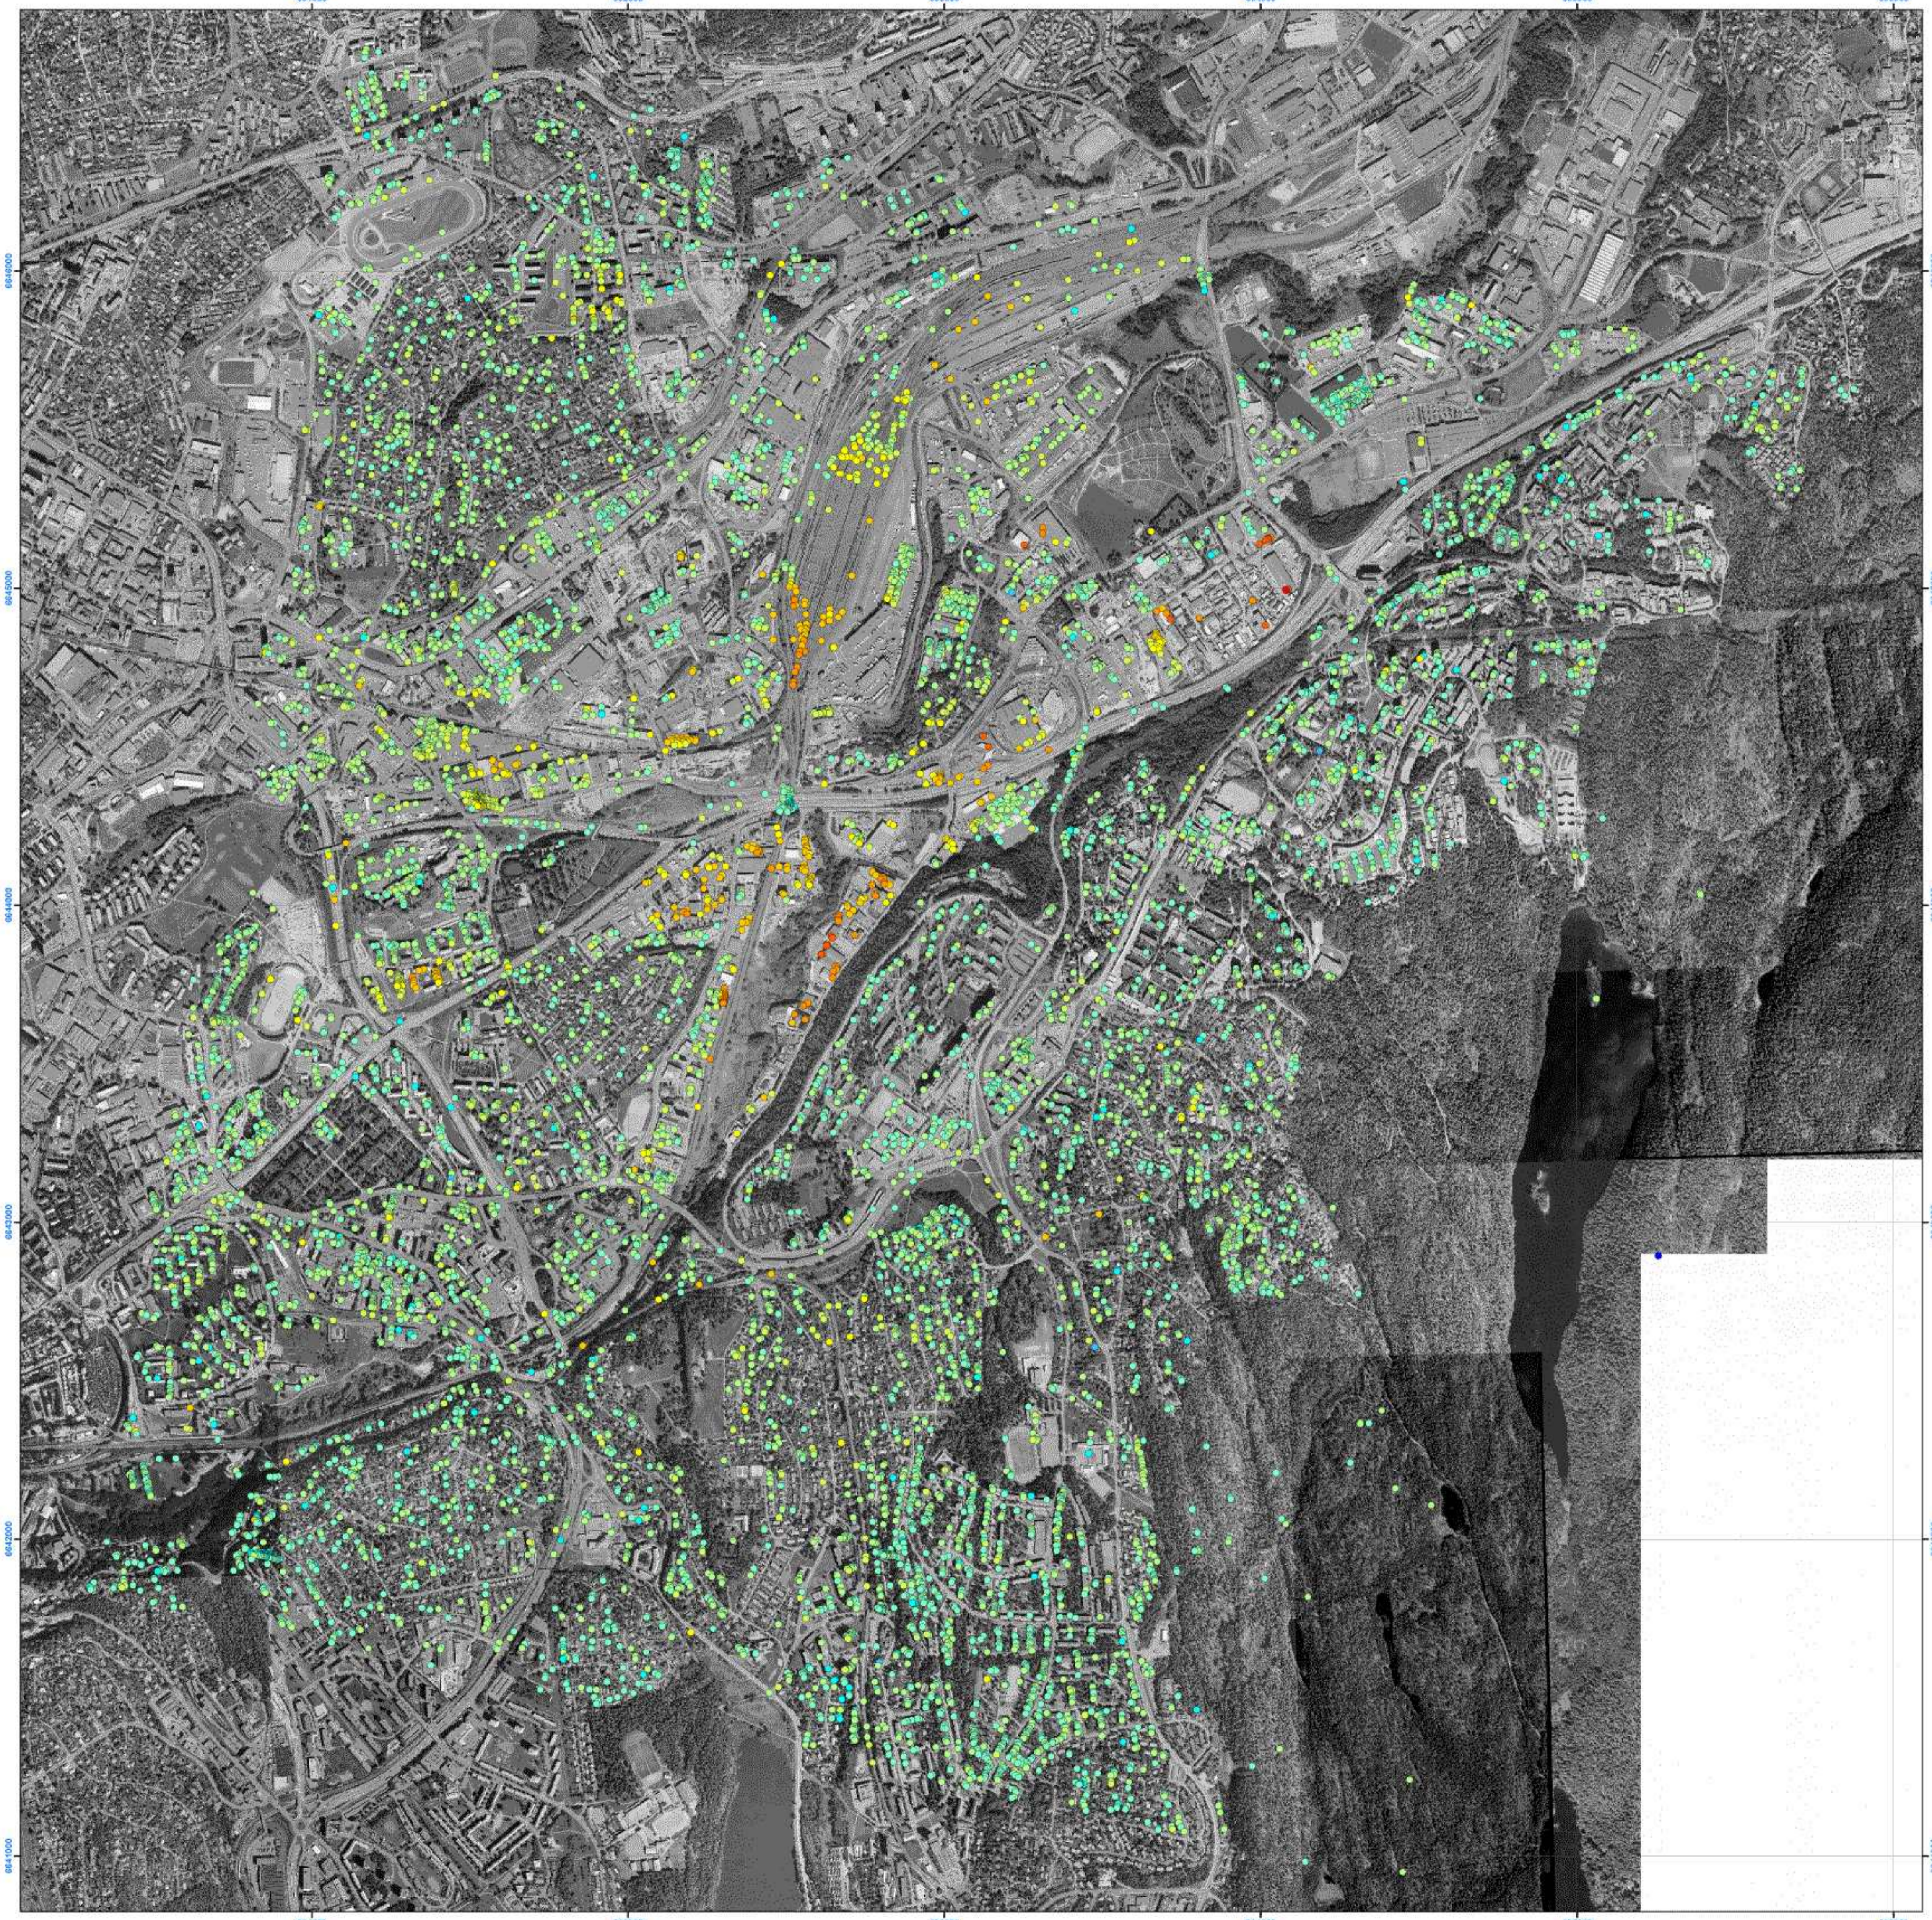
AVERAGE RELATIVE VELOCITY, 1992-2001, FROM DIFFERENTIAL RADAR INTERFEROMETRY		
ERS Track 337, Frame 2396 Oslo (Helsfyr, Alna, Lutvann)		
Drawing: Dehls, J. F.	Date: DEC 2003	
Scale 1:10 000		Mapsheet (1:50 000): 1914 IV Oslo

The second area covers the western part of Romeriksporten tunnel, as well as the Alnabru area to the north. The area processed includes the areas most affected by the groundwater withdrawal associated with tunnel construction. The results from this area are presented in Map 4. The most striking feature is the subsidence in the Alnabru area, probably due to compaction of surficial deposits. Within the Godlia and Hellerud areas, there is no obvious pattern of subsidence revealed by the average displacement rate.
