**ASSESSMENT METHODOLOGIES FOR SOIL/GROUNDWATER CONTAMINATION AT
FORMER MILITARY BASES IN LITHUANIA,
PART ONE: CHEMICAL INVESTIGATION**

FINAL REPORT

**NORTH ATLANTIC TREATY ORGANIZATION
SCIENTIFIC AFFAIRS DIVISION**

NGU Report 96.146

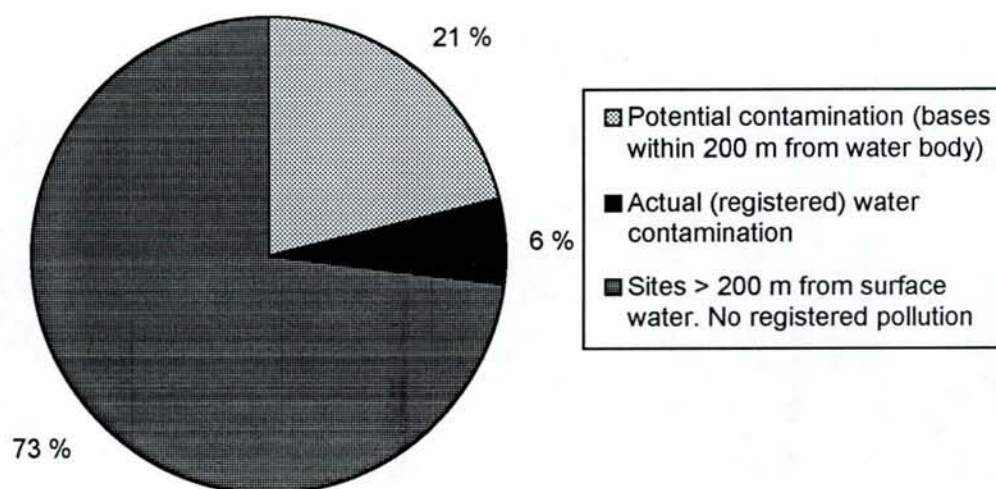
Figure 9. The relationship of oil contaminated sites to surface water bodies.

In 119 cases the oil-contamination source is located within 200 m of a surface water body (river or lake). In 35 of these cases direct influence of oil contamination on surface streams was observed. The relationship of oil contaminated bases to surface water bodies is shown in Figure 9.

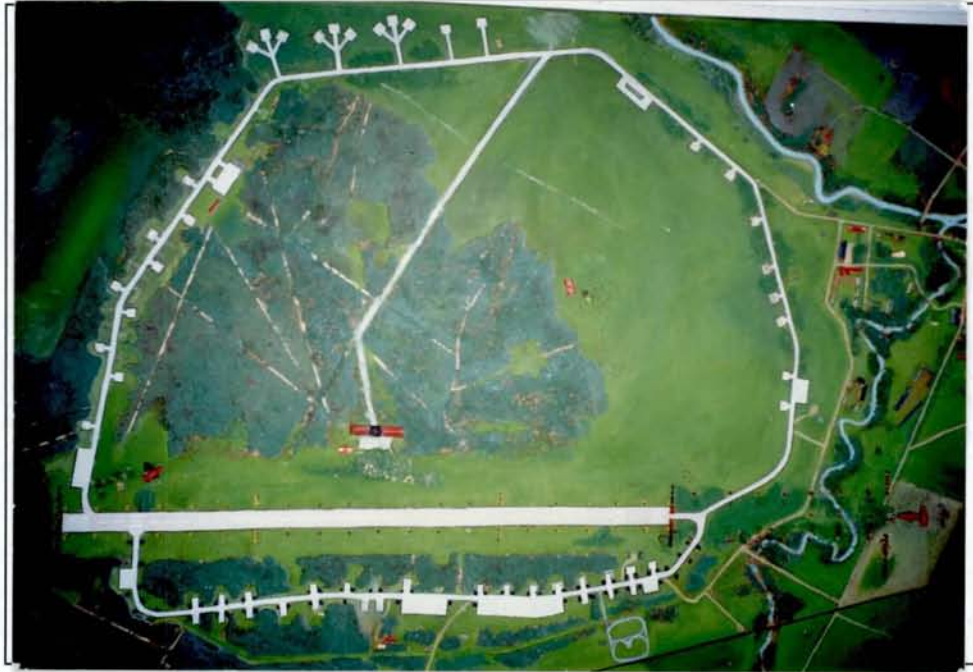
Photograph 1: Aerial photograph of the Pajuoste airfield showing the main features of the site, the wooded and grassed areas and drainage ditches.

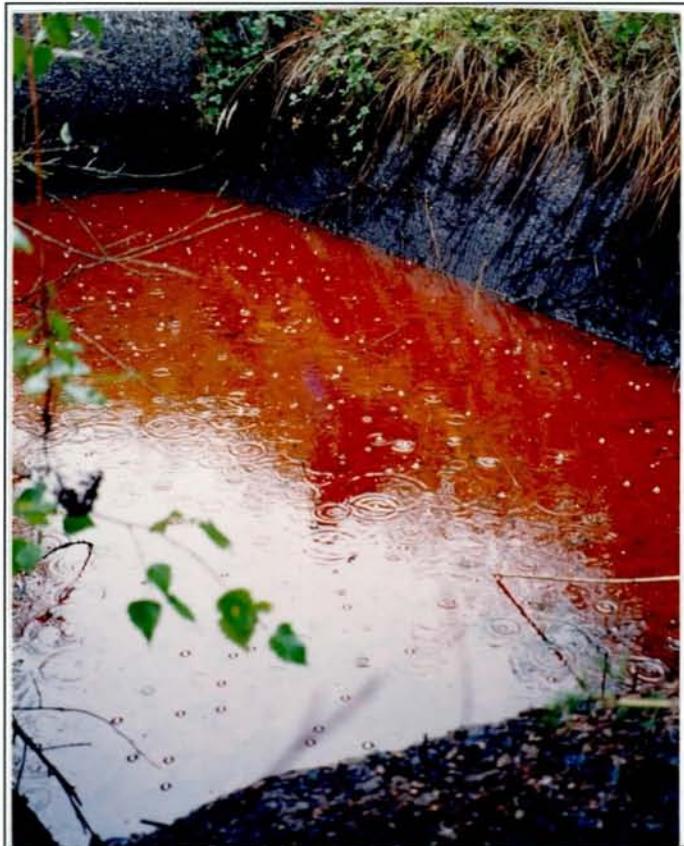
Photograph 2: Tank containing brown liquid near the fuel storage tank area.

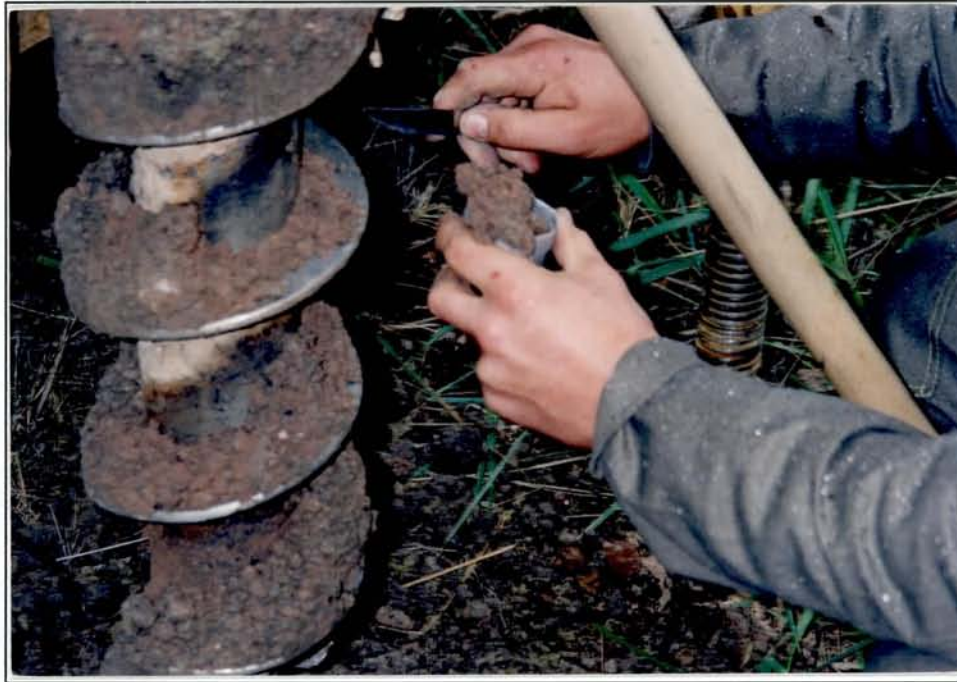
Photograph 3: Collecting a soil sample from the drilling rig auger during the establishment of Well 2 near the fuel storage site.

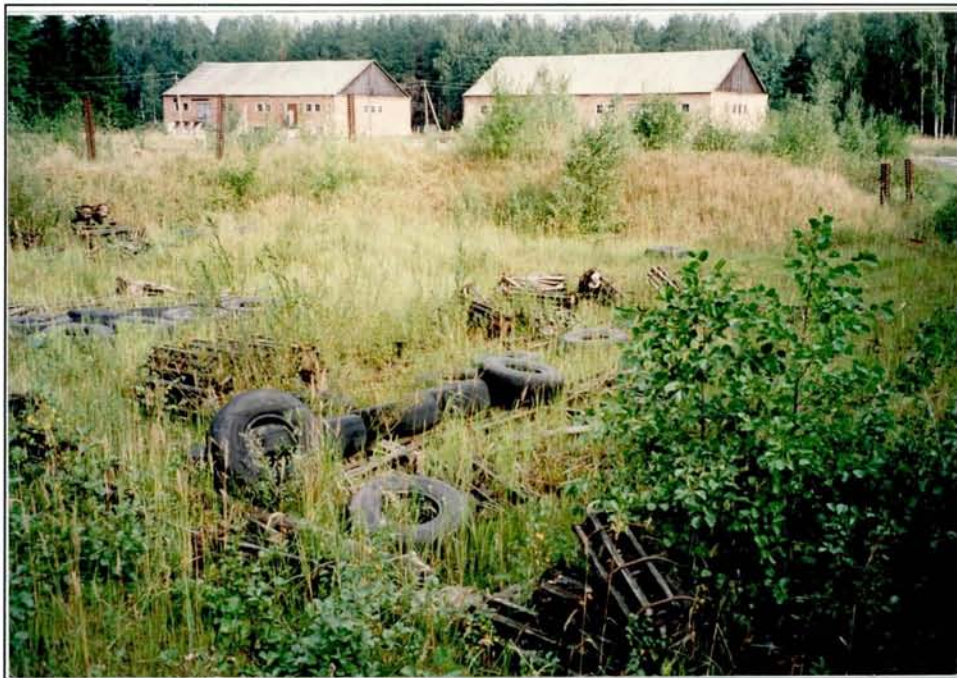
Photograph 4: Debris scattered in an area containing building foundations. The two buildings were former warehouses behind which run the railway lines.

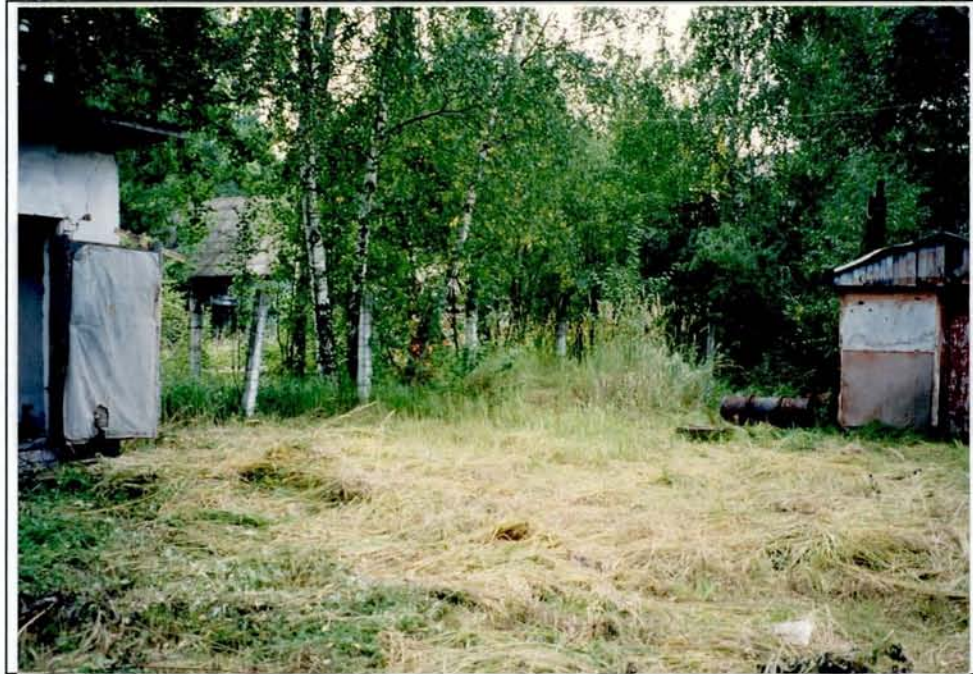
Photograph 5: Drums visible outside one of the buildings forming part of the chemical storage area. Sample Lit II-1 containing 1,2 dichloroethane was taken from one of these drums.

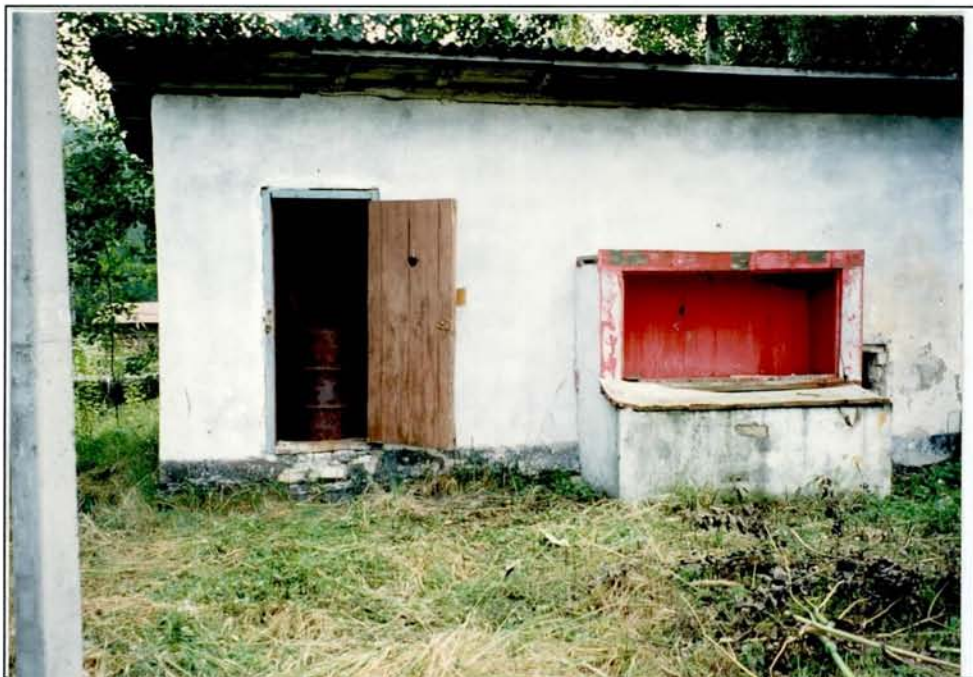
Photograph 6: One of the buildings in the chemical storage area. Several barrels inside the building were sealed and not sampled. Lit II-2 was taken from an open drum inside this building.

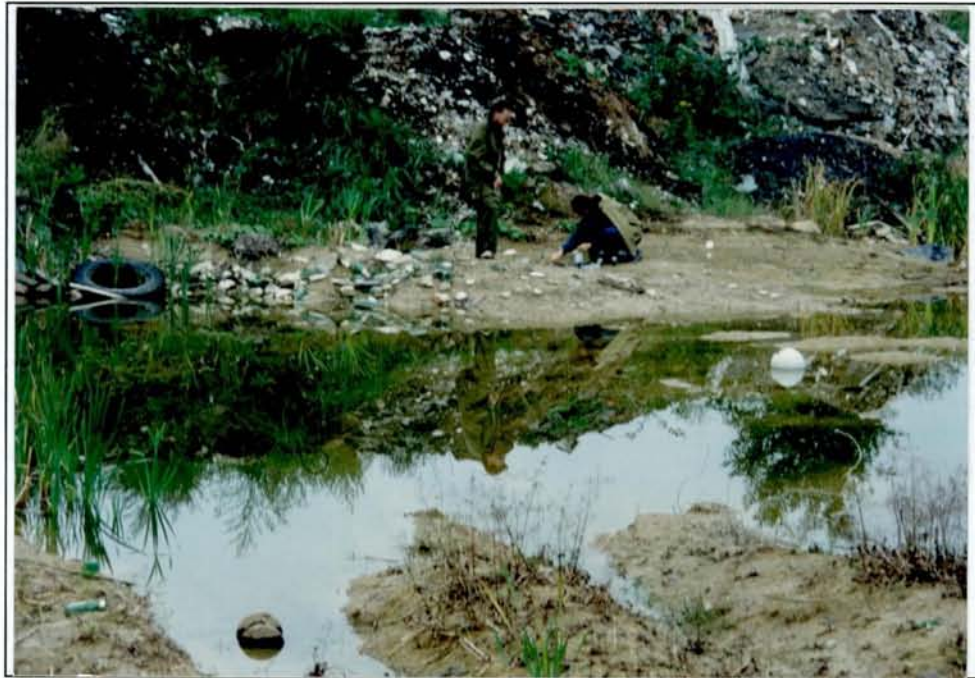
Photograph 7: Sampling soil at the toe of the landfill. This sample, LT54S, containing very high levels of petroleum products.

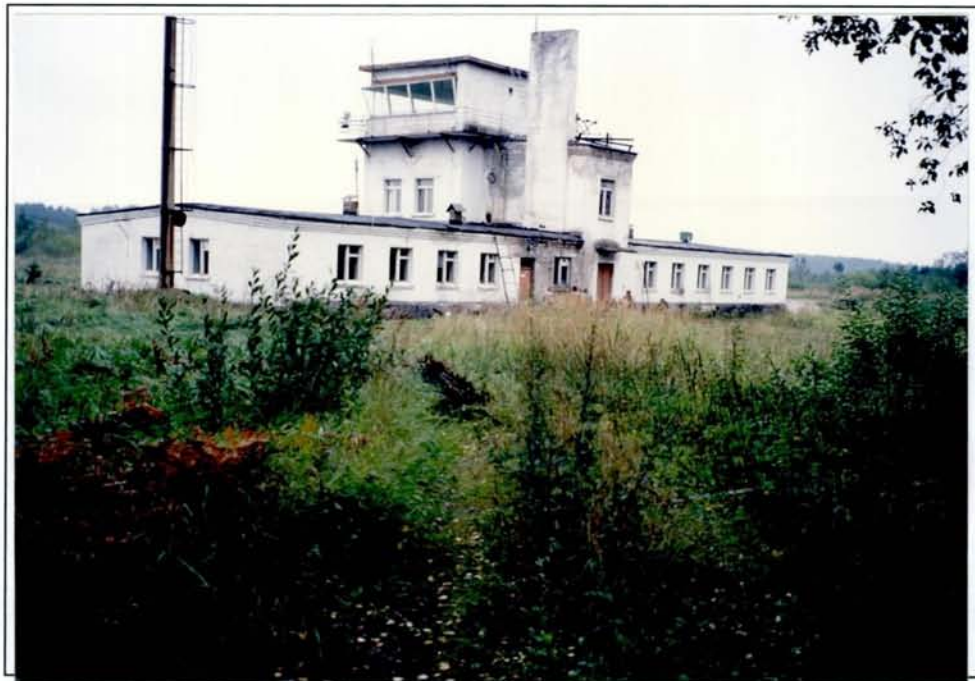
Photograph 8: The main building at the radar facility in the centre of the airfield.

The radar facilities of the base were situated near the centre and southwest of the main runway. They were reached by a road from the west side of the airfield parking areas. The radar facilities area contained several buildings which were bounded on the west side by a wooded area and a grassy area to the east. Two soil samples were taken from this location. One sample (LT35S) was taken adjacent to the west side of the main building (Photograph-8) outside of the back door. The second sample (LT36S) was taken beside a pile of discarded electronic components at the edge of the woods to the northwest of the radar facilities.
