THIRD SLOPE TECTONICS CONFERENCE

3rd Slope Tectonics conference –
Field excursion guide

Report no.: 2014.031		ISSN: 0800–3416		Grading: Open	
Title: 3rd Slope Tectonics conference – Field excursion guide					
Authors: T. Oppikofer, R.L. Hermanns, G. Sandøy			Client: -		
County: Møre og Romsdal			Commune: -		
Map-sheet name (M=1:250.000) Ålesund, Røros & Sveg			Map-sheet no. and -name (M=1:50.000) -		
Deposit name and grid-reference: -			Number of pages: 167		Price (NOK): 315
			Map enclosures: 0		
Fieldwork carried out: -	Date of report: 05.09.2014		Project no.: 355400		Quality control:

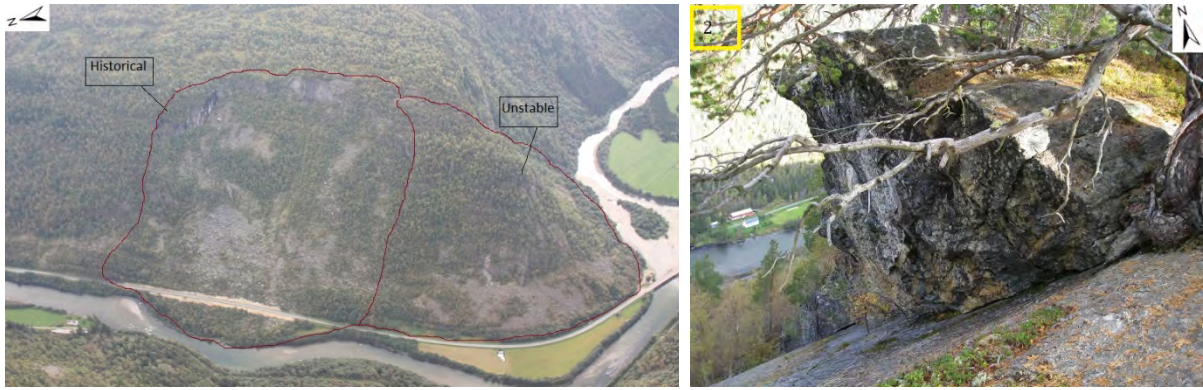
Figure 5: Photographs of the Ivasnasen rockslide scar: left) overview photograph of the scar and the unstable rock slope; right) along the moderately NW-dipping sliding surface and the northeastern flank (photographs: T. Oppikofer / G.M. Dreiaås) (Dreiaås 2012).

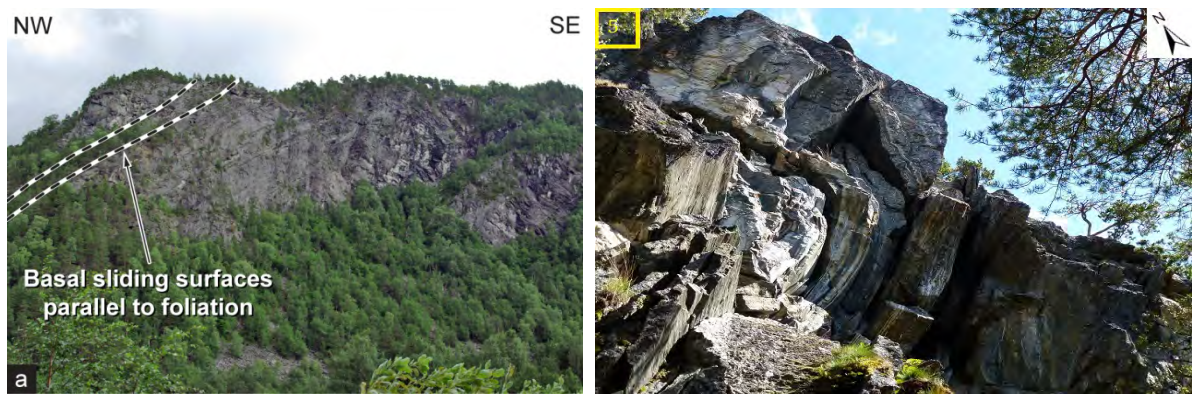
Figure 8: Photograph of the Ivasnasen unstable rock slope: left) lateral view of the SW-facing cliff with the location of foliation-parallel basal sliding surfaces (photograph: A. Saintot); right) fractured rock mass at the foot of the unstable rock slope (photograph: G.M. Dreiß)

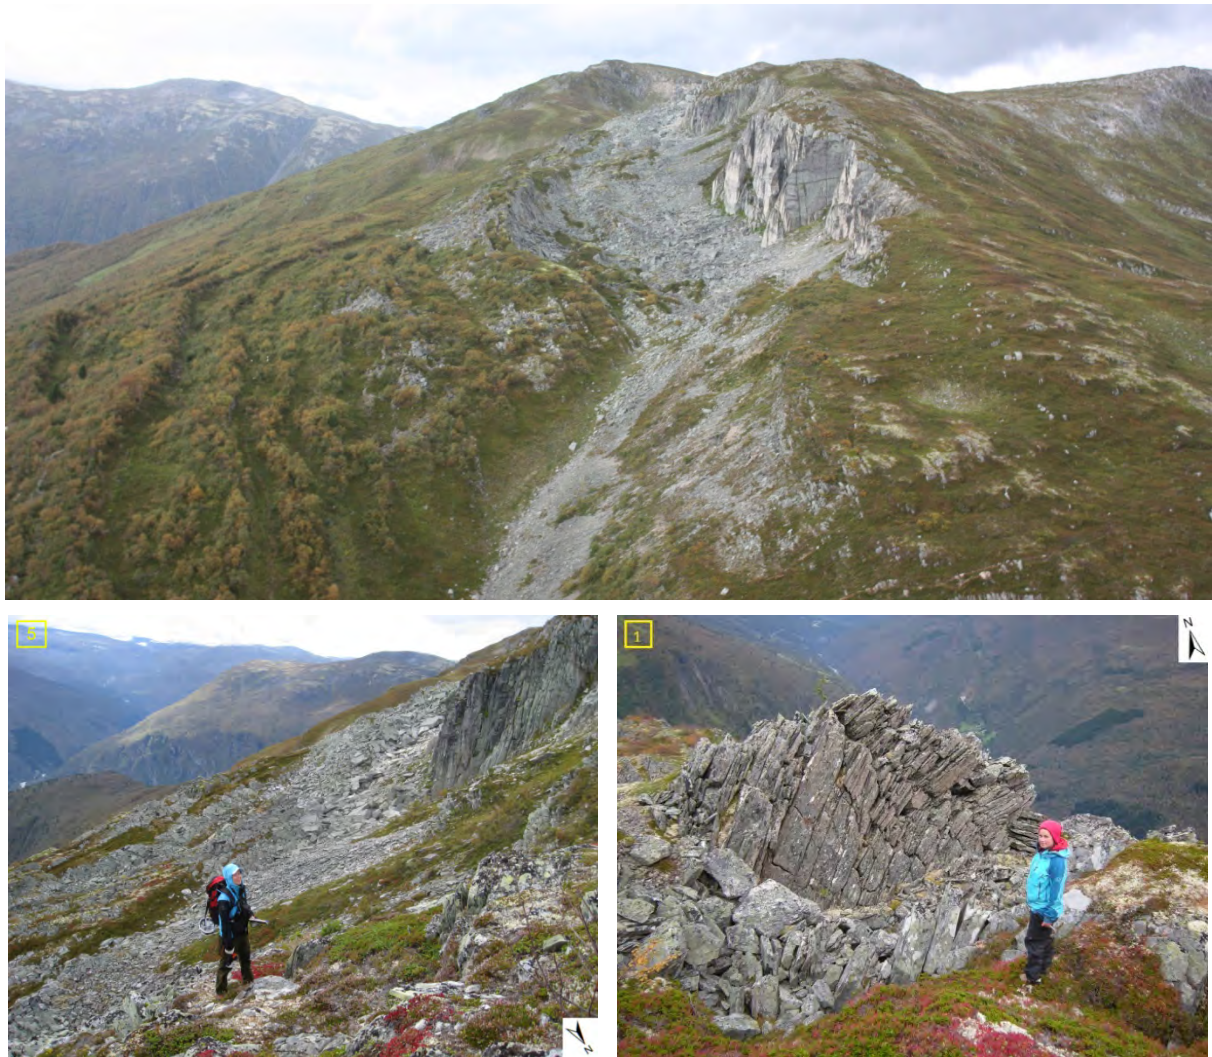
Figure 9: Photographs of the Vollan unstable rock slope: a) overview of the back-scarp in quartzites and the more plastic deformation of the phyllites (photograph: T. Oppikofer); b) back-scarp formed by the vertical foliation (photographs: G.M. Dreiaås); c) outcrop-scale representation of a possible flexural toppling mechanism for the unstable rock slope (photographs: G.M. Dreiaås).

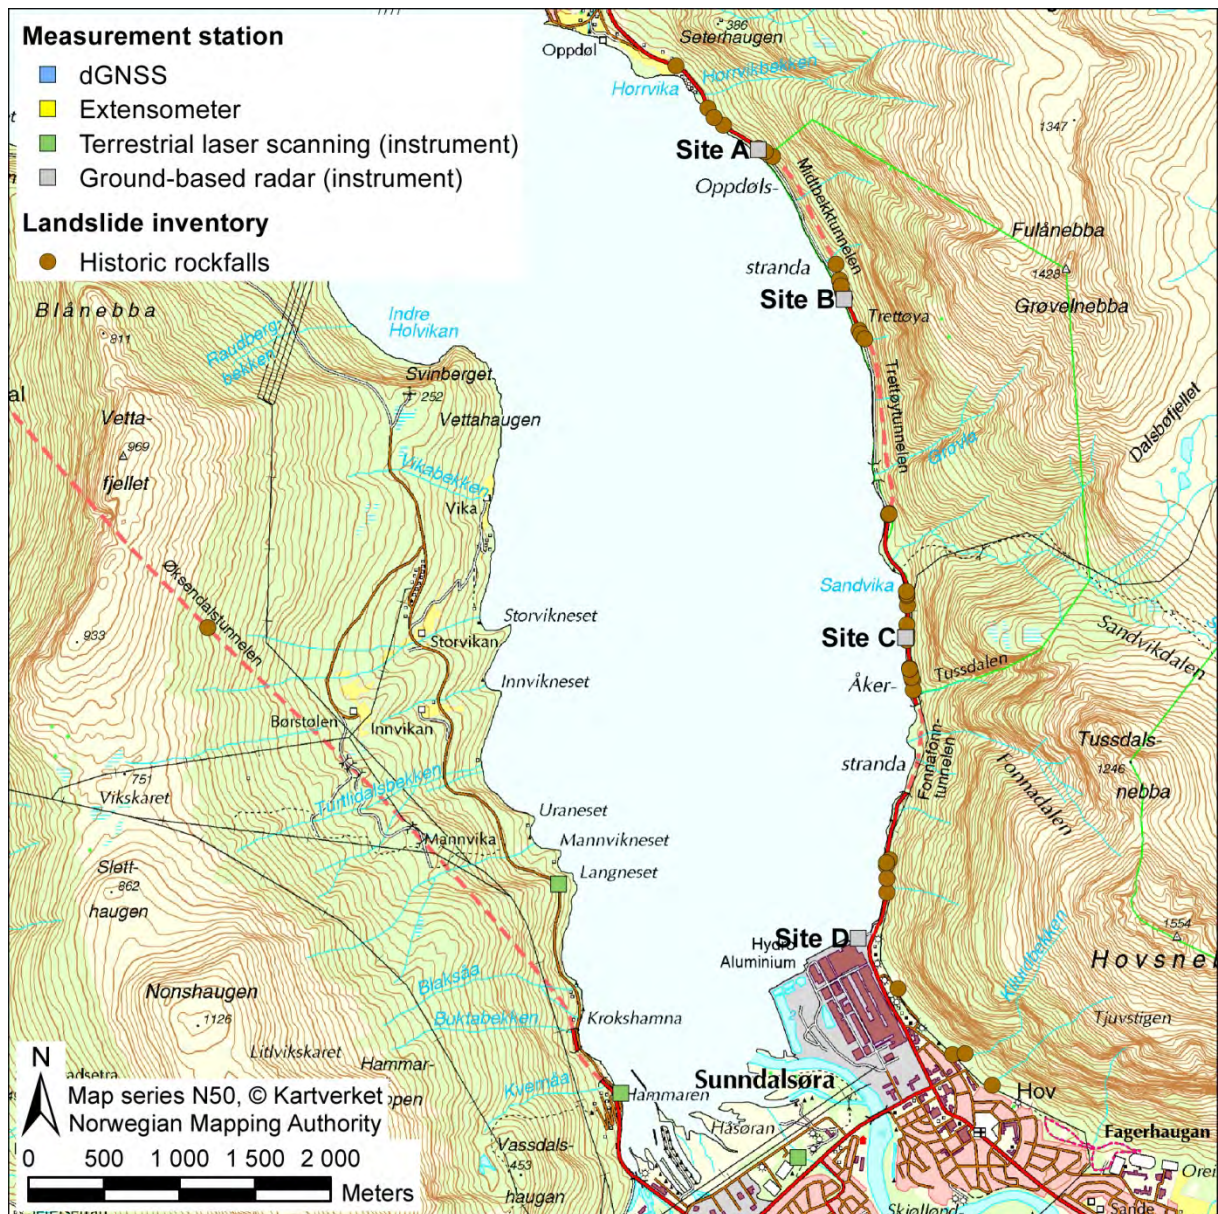
Figure 11: Situation map of stop 2: the rockfall-prone section of the National road Rv70 at Oppdølstranda between Sunndalsøra and Oppdøl. A newly opened tunnel now bypasses this hazardous road section.

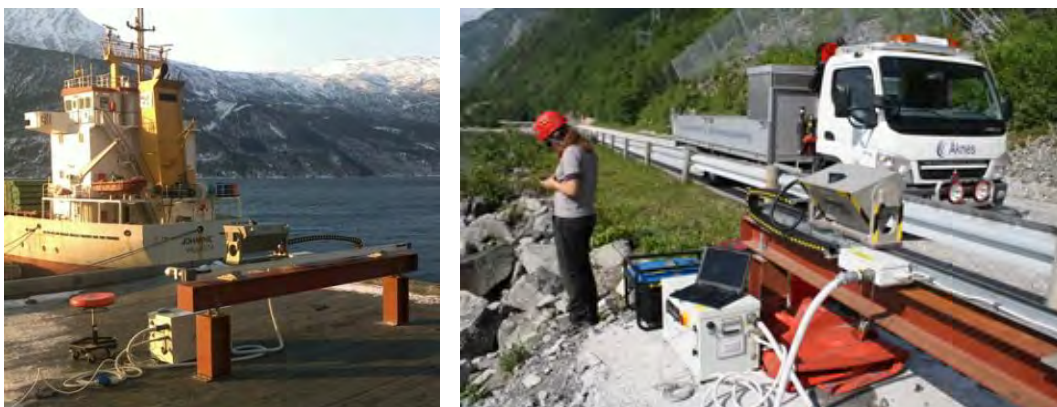
Figure 12: Photographs of the ground-based radar installation on 2.5 m-long steel rails (Kristensen 2013).

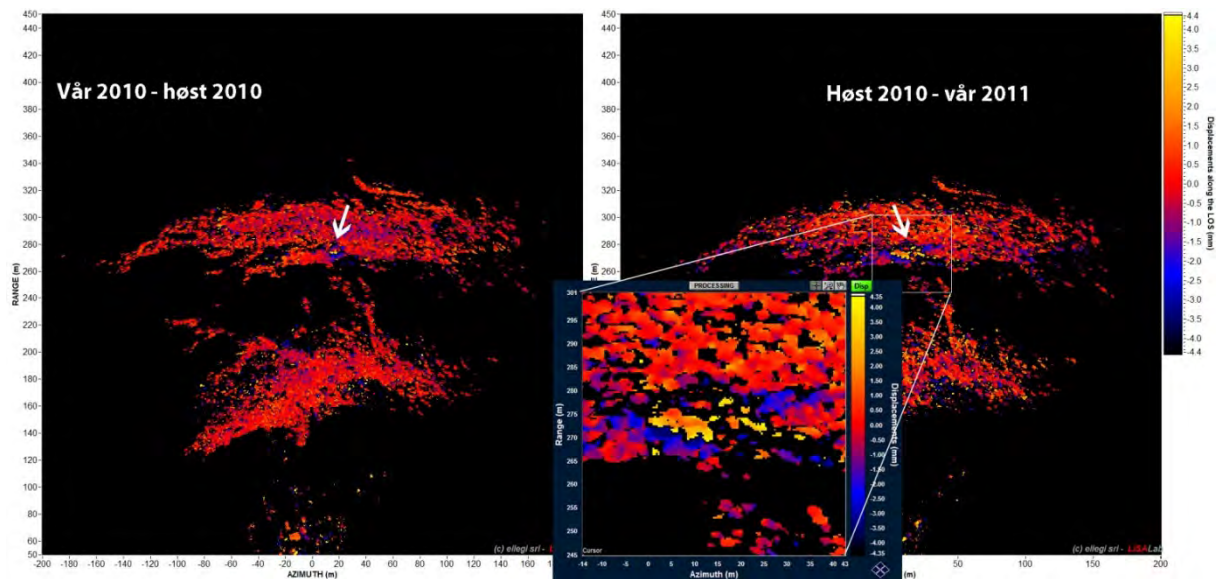
Figure 13: Ground-based radar measurements prior to the 8 June 2011 rockfall: left) between spring and autumn 2010; right) between autumn 2010 and spring 2011. Red color equal no movements and blue about -4 mm, yellow and orange about 6-8 mm. The pre-failure deformation in the rockfall release area is clearly visible (Kristensen 2013).

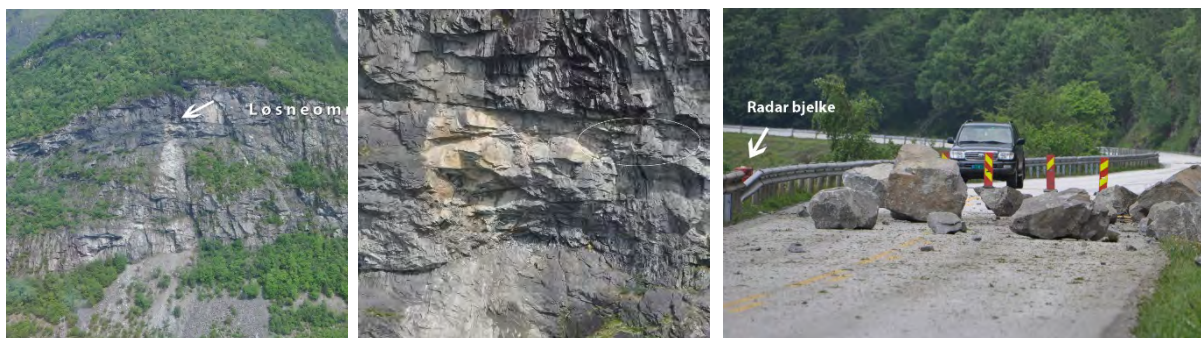
Figure 14: Pictures of the 8 June 2011 rockfall scar and rockfall blocks on the road. The blocks destroyed and crossed the rockfall protection fence above the road (photographs: T. Humstad, Norwegian Public Roads Administration) (Kristensen 2013).

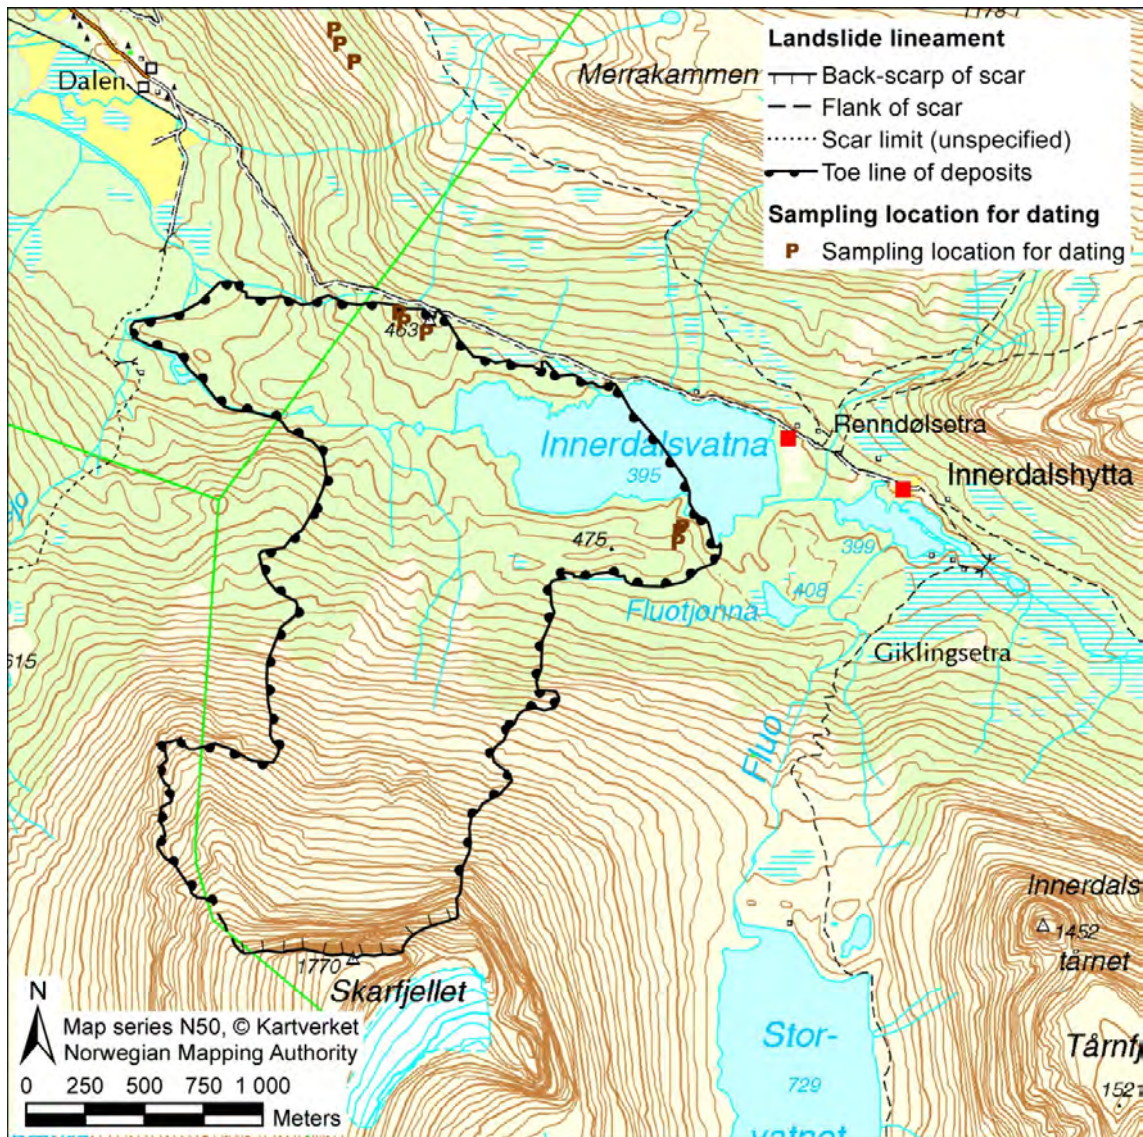
Figure 16: Situation map of stop 3: the rock avalanche deposits from Skarfjellet dammed the Innerdalsvatna Lake; remnants of multiple other rock avalanches can be found further up and down the valley.

Multiple rock avalanche deposits composed of rock boulders several meters in diameter occur in Innerdalen Valley. The blocky deposits are divided into six units (A to F in Figure 17). The main rock avalanche deposits (A) have an estimated volume of 39 million m³ and typical lateral levees and frontal rims. The rock avalanche crossed the valley, ran-up on the opposite valley side by up to 65 m and dammed the river to form Innerdalvatnet Lake. Boulders are several meters to tens of meters in diameter and cover the entire surface of the deposits.

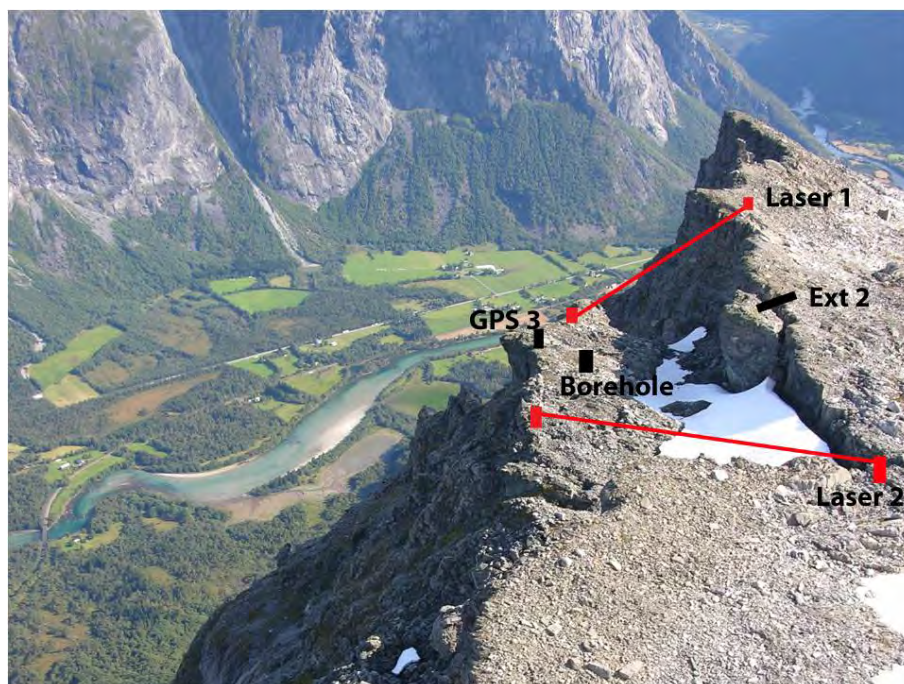
Figure 38: Photo of the upper part of Mannen, showing the block that has been lowered from the plateau. Some instruments from the upper part of the rock slope instability are shown (Blikra and Kristensen 2012).

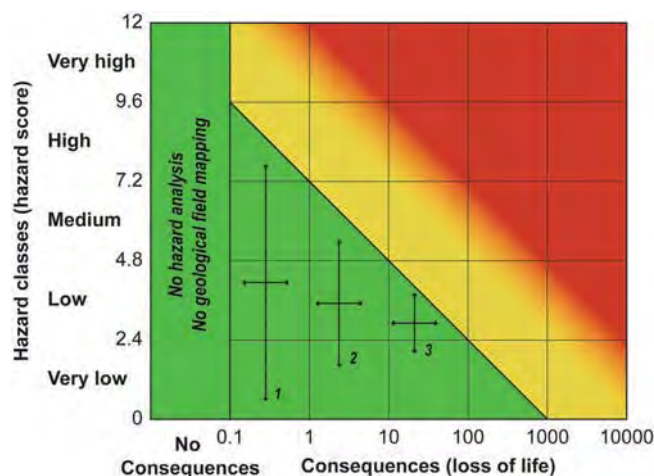
Fig. 2 Risk matrix, showing the risk classes (green is low, yellow is moderate and red is high). The diagram also shows under which conditions no geological field mapping will be carried out (no consequences) and 3 examples with increasing consequences (1–3) that require decreasing uncertainty levels and hence increasing certainty of geological observations

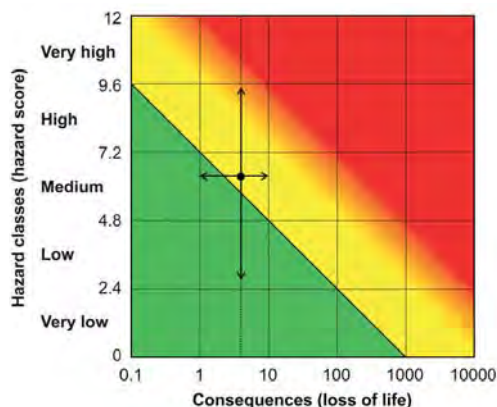
Fig. 3 - Risk classification matrix for follow-up with monitoring and further investigations of unstable rock slopes in Norway: green = low risk; yellow = moderate risk; red = high risk. The risk of an unstable rock slope is represented by its mean value, the minimum and maximum consequences (horizontal arrows), the 5% and 95% percentiles of the hazard score (vertical arrows) and the minimum and maximum scores of the hazard analysis (dotted line)

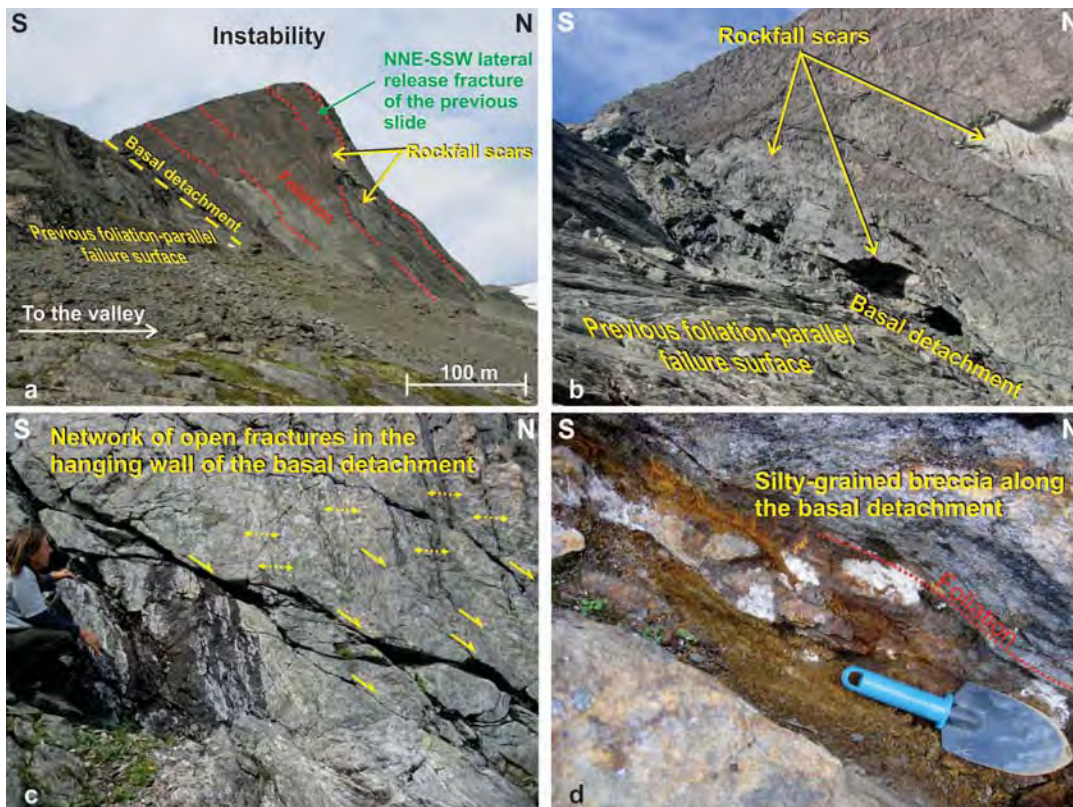
Figure 5. Svarttinden: photographs of the eastern side of the current unstable block. a) View of the remaining instability over the basal detachment of the previous rock slope failure. b) Roughness of the basal detachment (undulation and steps) and rockfall activity from the remaining instability. c) Deformation in the hanging wall of the basal detachment interpreted to accommodate the gravity-driven displacement of the remaining instability. d) Unconsolidated breccia along the basal detachment interpreted to be the product of past displacements.

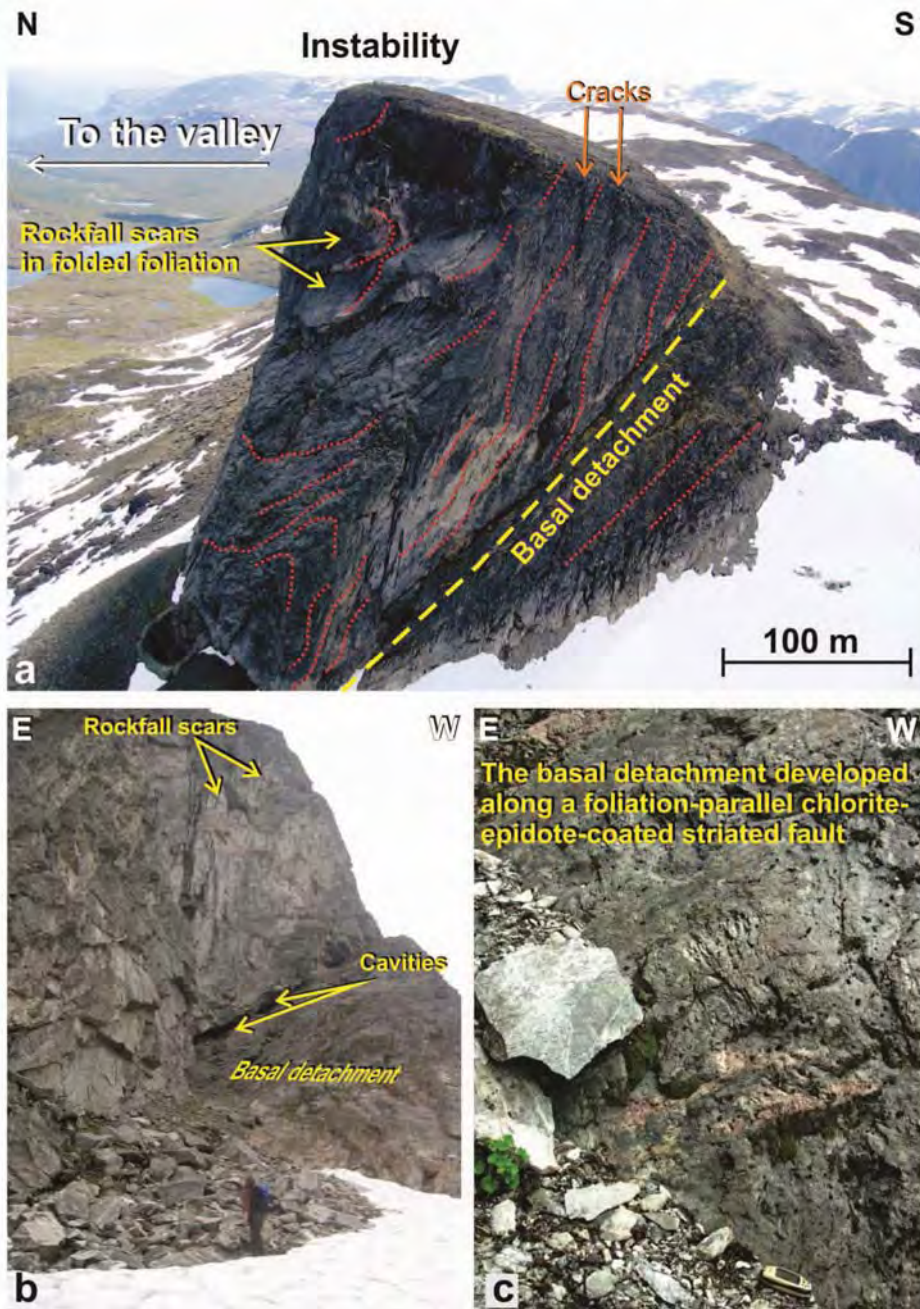
Figure 6. Svarttinden: photographs of the western side of the remaining instability. a) View from helicopter showing (1) the sources of rockfalls at the hinges of recumbent folds and (2) the ductile deformation of the metamorphic foliation and the pre-existing ductile shear along the present-day basal detachment. b) Rockfall activity from the remaining instability and elongated cavities along the detachment (seen also on (a)). c) The basal detachment of the rockslide is a pre-existing foliation-parallel chlorite- and epidote-coated cataclastic fault.

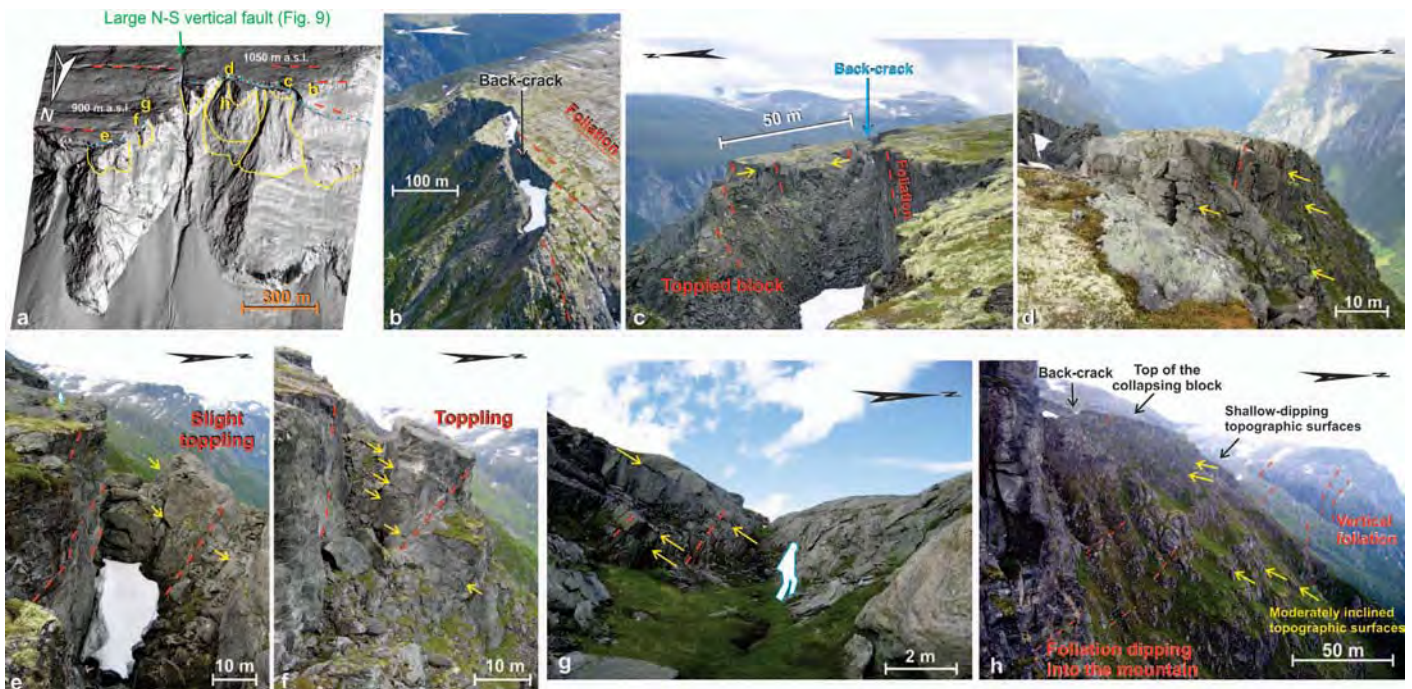
Figure 8. a) Flatmark: 3D view of the hillshaded ALS-DEM showing rock slope instabilities of various sizes (back-cracks at the edge of the plateau as blue dashed lines, limits of instabilities on the slope as yellow lines, traces of the steep metamorphic foliation as red dashed lines; locations of photos in (b) (h) are shown). b)h) photographs of the rock slope instabilities at Flatmark with the trace of the metamorphic foliation (red dashed lines) and shallow to moderately valley-dipping joints that developed perpendicular to the foliation dip line (yellow arrows). b) View from helicopter of the largest instability with a back-crack opening partly guided by a pre-existing quasi-vertical metamorphic foliation. c) close view to the east of the 20 m wide back-crack largely filled by debris; the instability is affected by toppling. d) Close view to the west of the largest instability. e) And f) toppling displacements observed at the top of two instabilities in the eastern part of the Flatmark plateau. g) Shallow to moderately valley-dipping topographic surfaces on the largest rock slope instability corresponding to joints that systematically developed perpendicular to the foliation dip line; these are favorably orientated toward the valley where the foliation steeply dips into the mountain and where the basal sliding surfaces of the instabilities are expected to daylight.

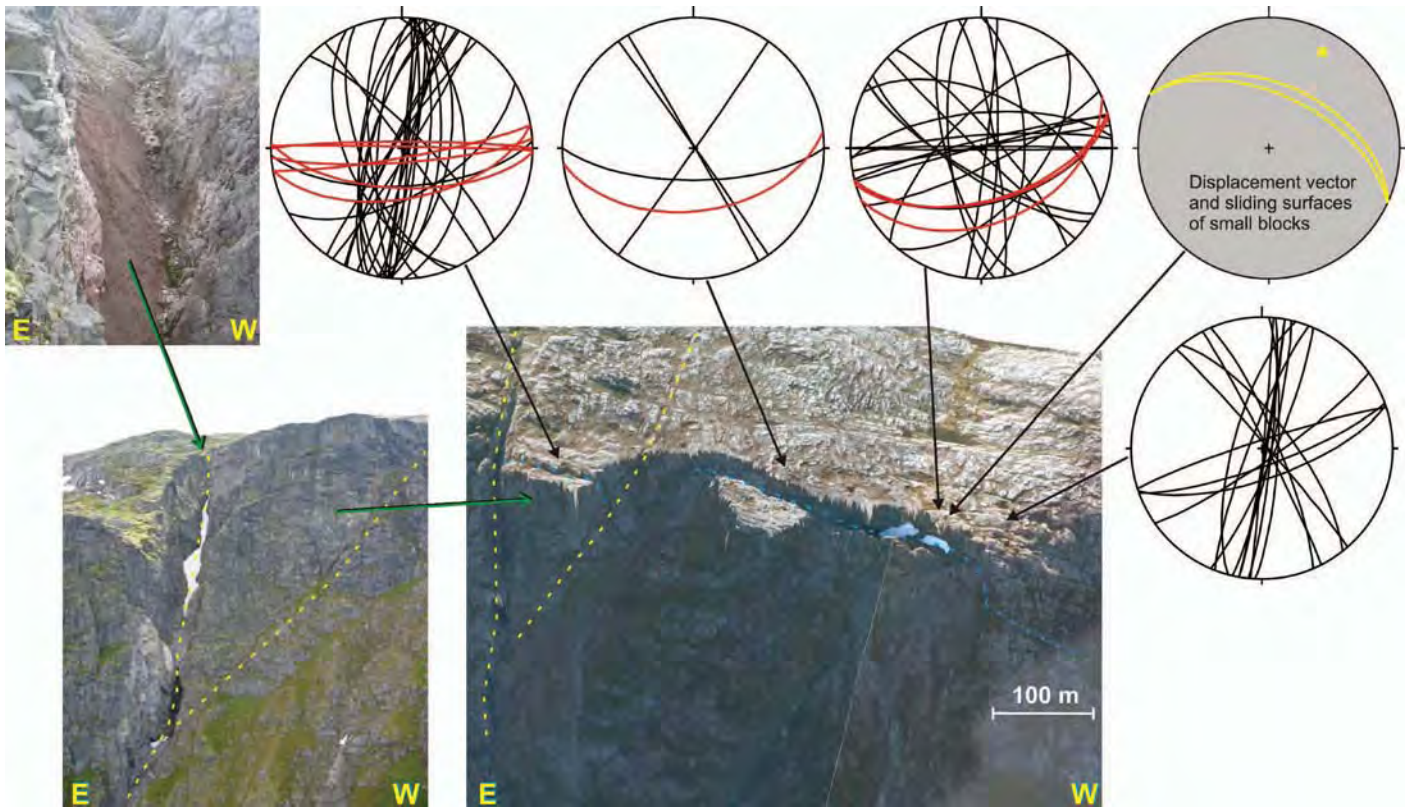
Figure 9. Stereoplots of field measurements at the edge of the Flatmark plateau where the largest instability developed: metamorphic foliation in red and joints in black, two planes at the base of small detached blocks have an orientation favorable for sliding. Locations of field measurements on a 3D view of the top of the largest instability (aerial photograph draped on DEM). Photographs taken from helicopter of one of the instabilities, delimited by a foliation-parallel back-crack (blue line) and two preexisting tectonic faults (yellow lines), one being largely hematite-rich cataclastic (located on Fig. 8a).

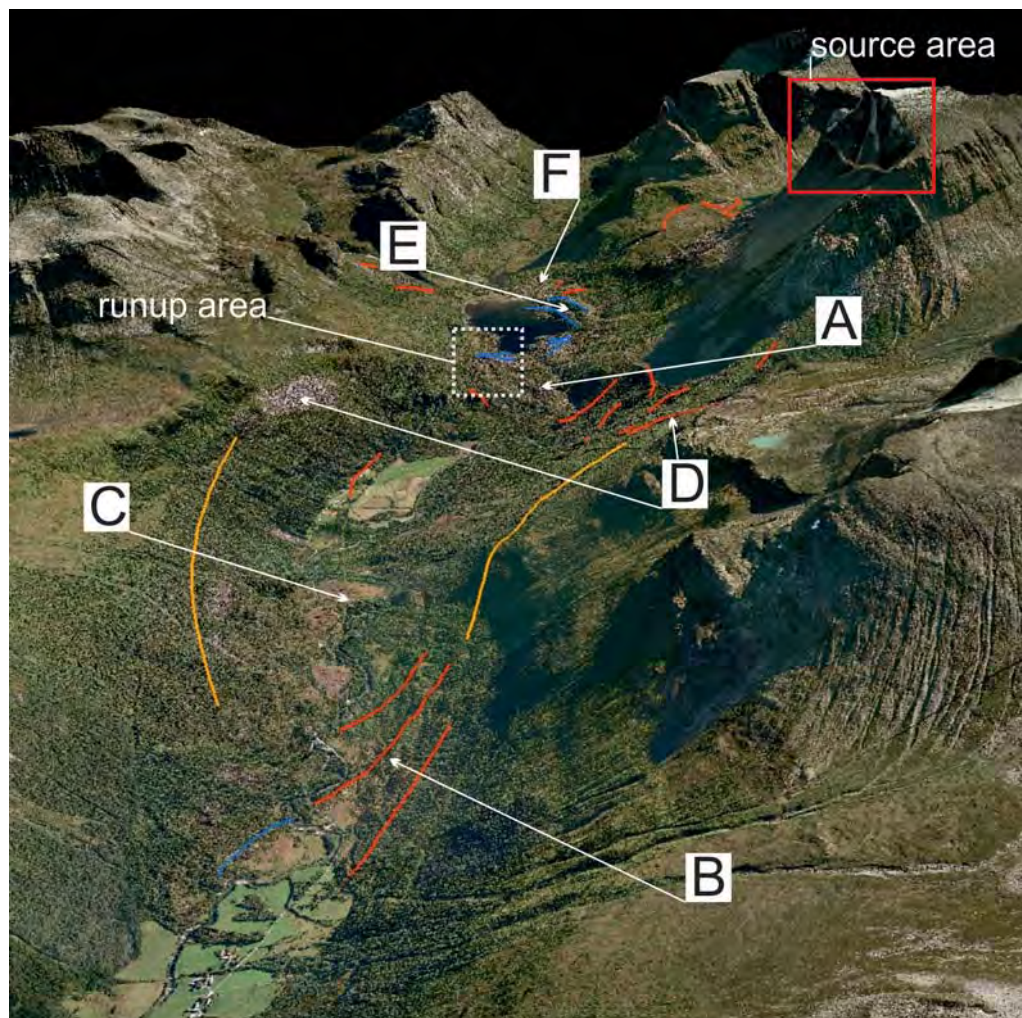
Fig. 3 - Oblique view of Innerdalen valley showing the main part of the multiple landslide deposits. View direction to WSW. A - F mark the main deposits described in text. The rock face of the source area is marked with red rectangle, the runup with dotted rectangle. Orange lines mark lateral moraines, red lines mark the frontal moraines

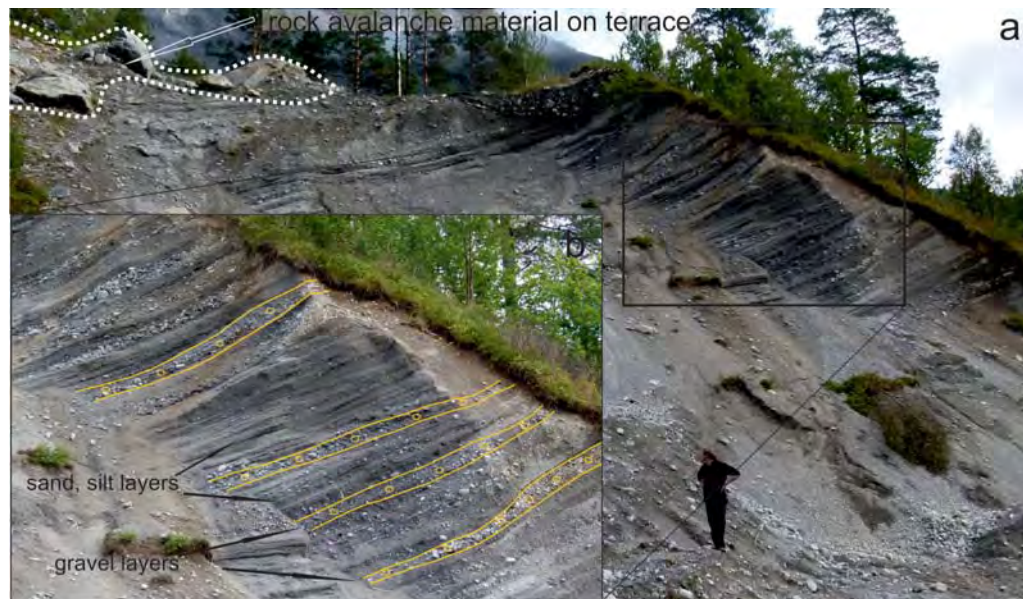
Fig. 6 - Marine terrace deposit in Innfjorddalen valley. Rock avalanche material is deposited on top of the terrace at 120 m a.s.l. (upper left corner) (a). Typical bedding structures of a propagating delta are visible in (b). View towards SSE. For scale consider Geologist in lower right of (a)

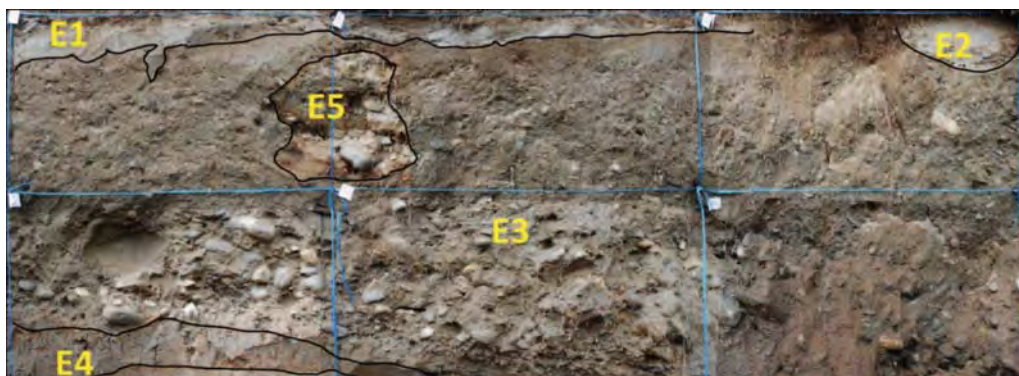
Fig. 7 - Exemplary excavation of the deformed valley fill deposits at the border between deformed and undeformed valley sediments. The blue raster shows 6 cells (1 m length, 0.5 m width). (E1, E2: layered silt and sand; E3, E5: islands of gravelly deposits without layering; E4: layered sand and silt)

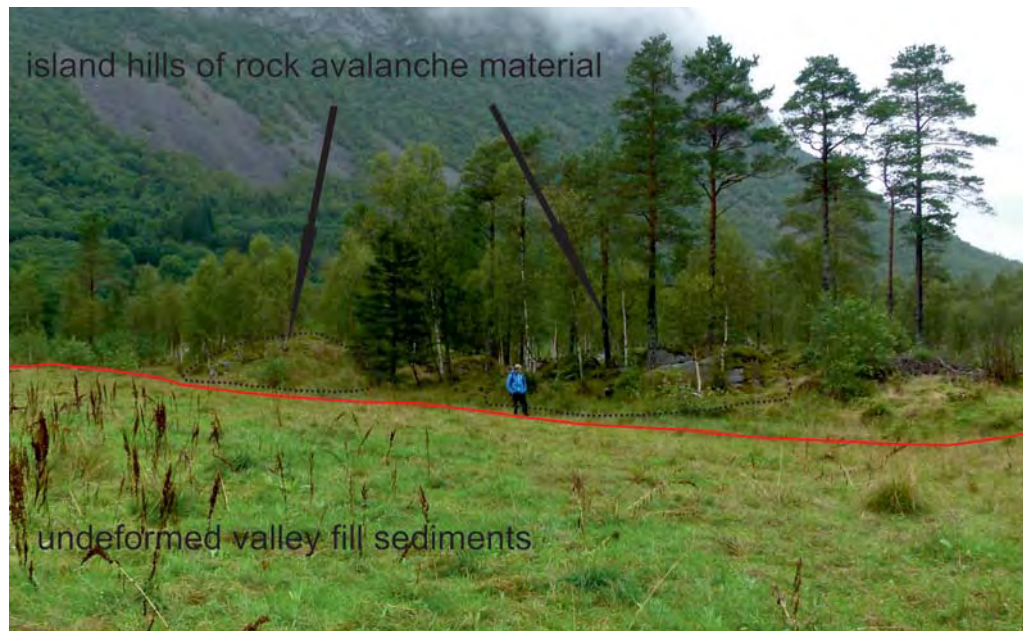
Fig. 8 - Isolated island hill deposits of rock avalanche material in Innfjorddalen at the border to the undeformed valley fill deposits (view towards NNE). For scale consider Geologist in the center

distal part occurs in form of separated island hills of rock avalanche material. Following this interpretation the Fahrböschung angle of the whole event is 19.6°. Such island hills have been also described in the distal part of the Flims rock avalanche deposits in the Swiss Alps and called there “Toma-hills” (VON POSCHINGER, 2002). The Flims rock-avalanche is interpreted to have dropped into a lake (VON POSCHINGER *et alii*, 2006) and also at that site the frontal hills (Toma-hills) are separated from the main body of the rock avalanche by valley fill deposits that have no sedimentary structure and are strongly homogenized (Bonaduz gravel). Similarly to Flims the deformed valley fill deposits in Innfjorddalen are strongly homogenized and lack sedimentary structure. Therefore, we interpret that similar to the Flims rock avalanche also the oldest rock avalanche in the Innfjorddalen dropped in its distal part into a water body. As no morphological landforms as moraine dams or rockslide dams exist in the lower Innfjorddalen valley the only water body could have been the fjord itself. The lower limit of deformation structures in the valley fill lie at 20 m a.s.l. This line is interpreted to represent the sea level at the time of the oldest rock avalanche. Following this interpretation, this rock avalanche would have dropped into

the valley and made a 90 degree turn after a run-up of 110 m at the opposite valley site. The remaining mass would have run down the valley strongly liquefying and deforming the valley fill deposits in those areas where they have strongly been water saturated close to the former shore line of the fjord. Here the rock avalanche may have split into two bodies, one coming to rest onshore and another running out into the shallow fjord. An alternative interpretation is that both bodies are connected below the surface and that the undeformed valley fill deposits have been deposited later under water level covering the connection of both parts.

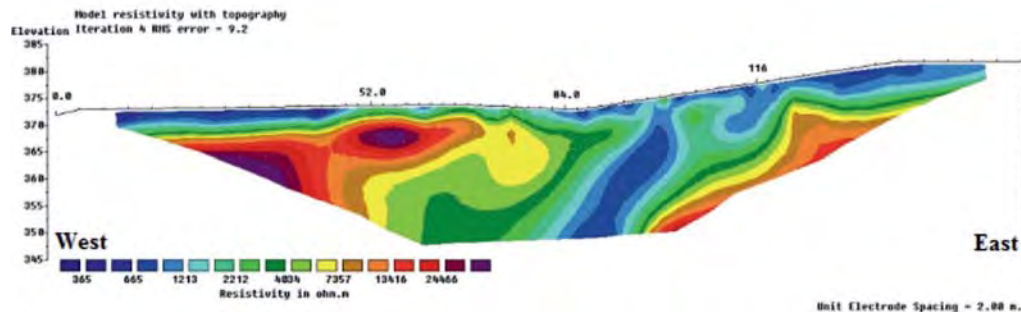
Fig. 4 - Resistivity results along profile P1; low resistivity (blue colours) represent peat material at the surface and a 10 meter wide fractured zone in the bedrock dipping towards the west

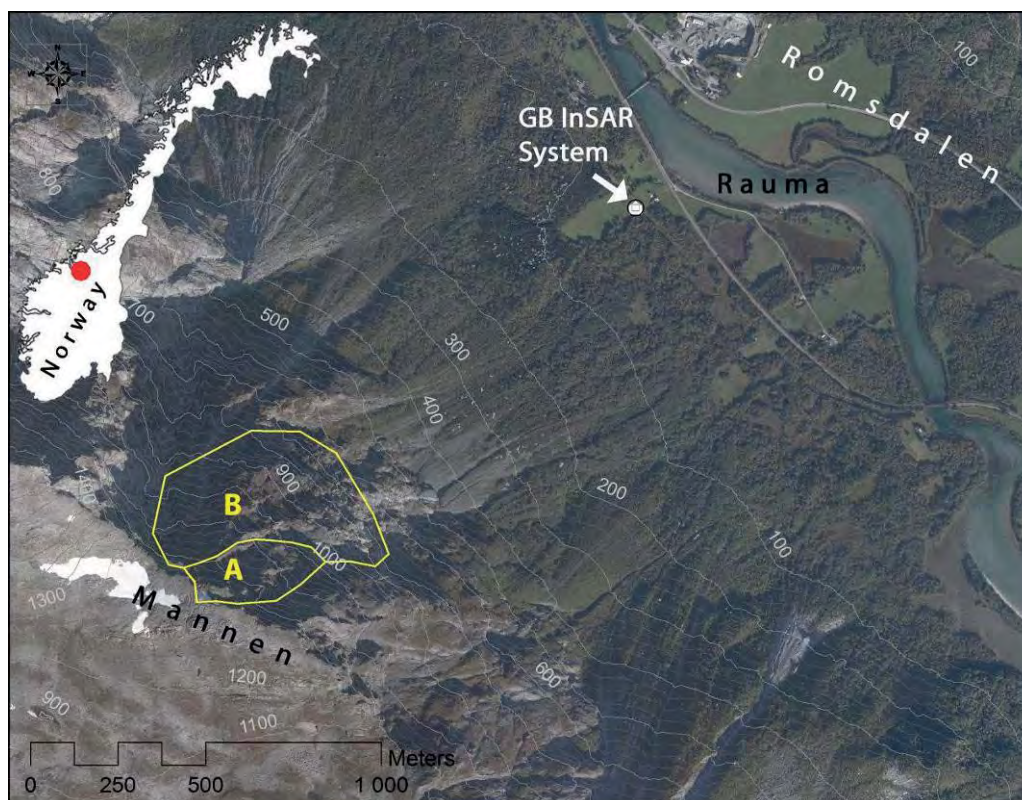
Figure 4.9-1. The location of Mannen and the mapped scenarios, with estimated annual likelihood of A: 1/100 and B: 1/1000.

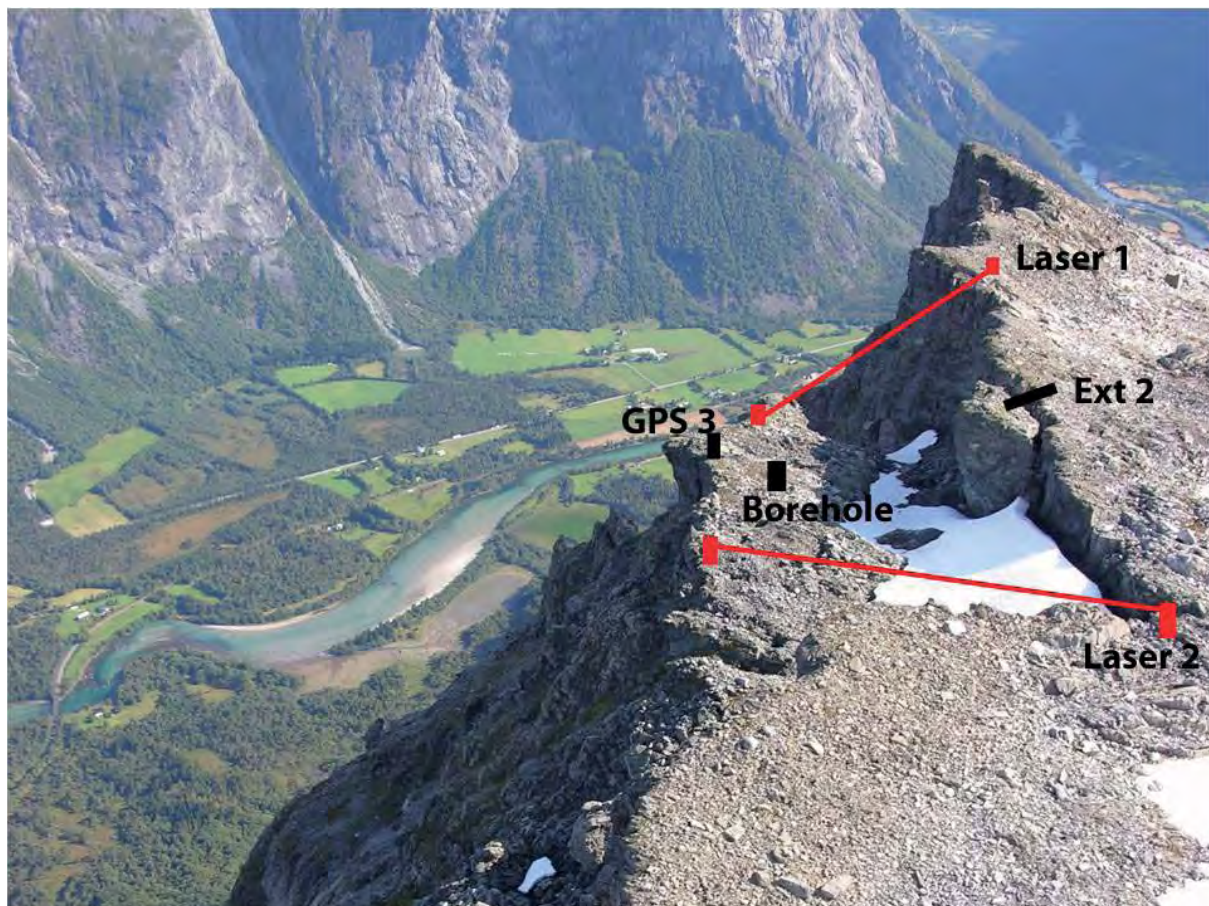
Figure 4.9-3. Photo of the upper part of Mannen, showing the block that has been lowered from the plateau. Some instruments from the upper part of the rock slope instability are shown.

A part of the plateau towards the valley (100 million m³) is bounded by deep clefts indicating past movement, but most of this appears inactive today (Figure 4.9-2). A block of possibly 15-20 million m³ has been lowered 15-20 m from the plateau (Figure 4.9-2 and Figure 4.9-3), and a block in its upper part (of 2-3 million m³) has been measured periodically with DGPS, showing a yearly movement of 4-5 cm dipping 45-50° against ENE. These two blocks are the basis of scenarios (A & B) drawn in Figure 4.9-1 and Figure 4.9-2. The Norwegian Geological Survey and the county governor have estimated that the annual probability of a rock avalanche of scenario A is about 1/100. Following structural and geological analysis of the surrounding areas, Henderson and Saintot (2007) deduced a translational sliding as a mechanism of deformation of the rock slope instability.

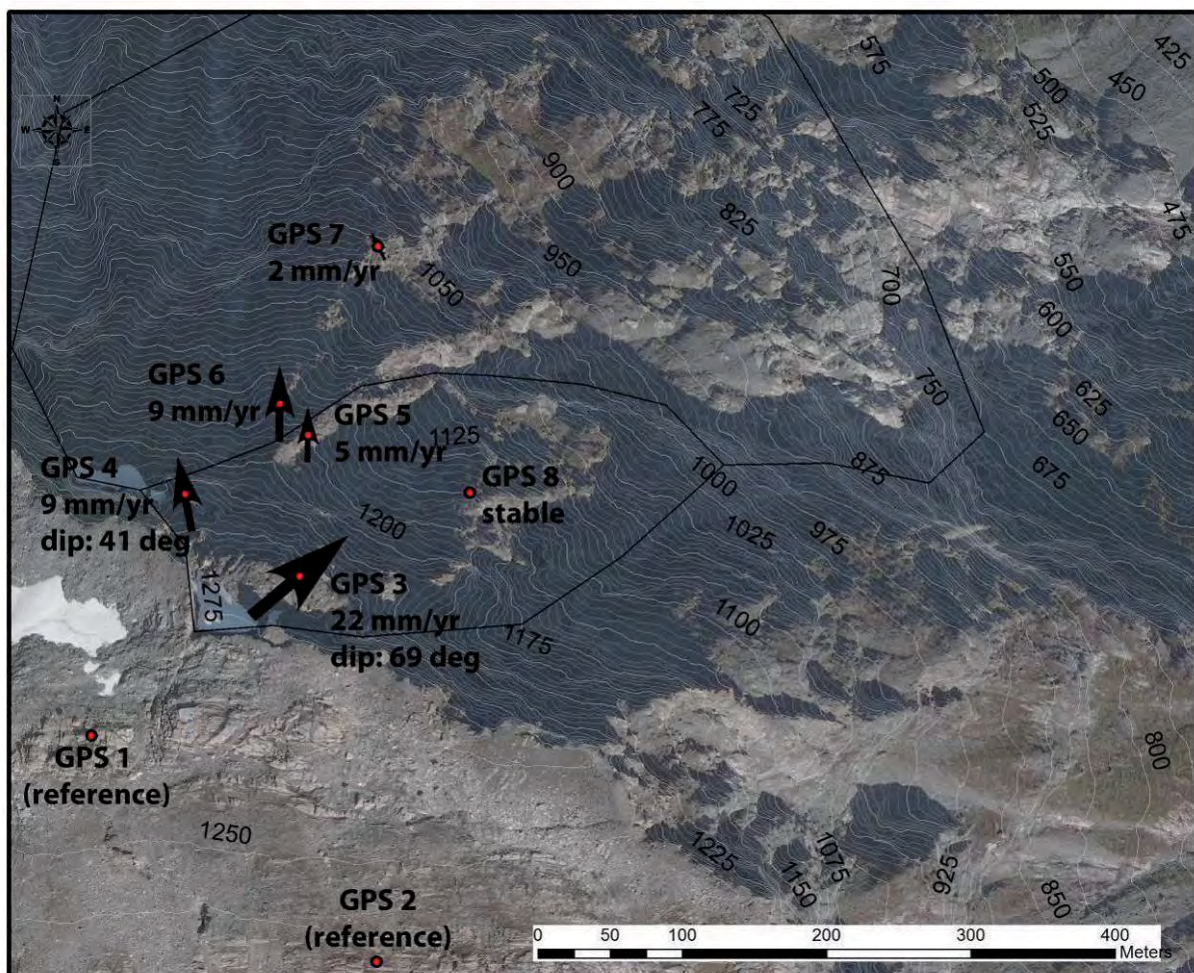
Figure 4.9-4. The location of the GPS antennas and an overview of their velocities and directions.

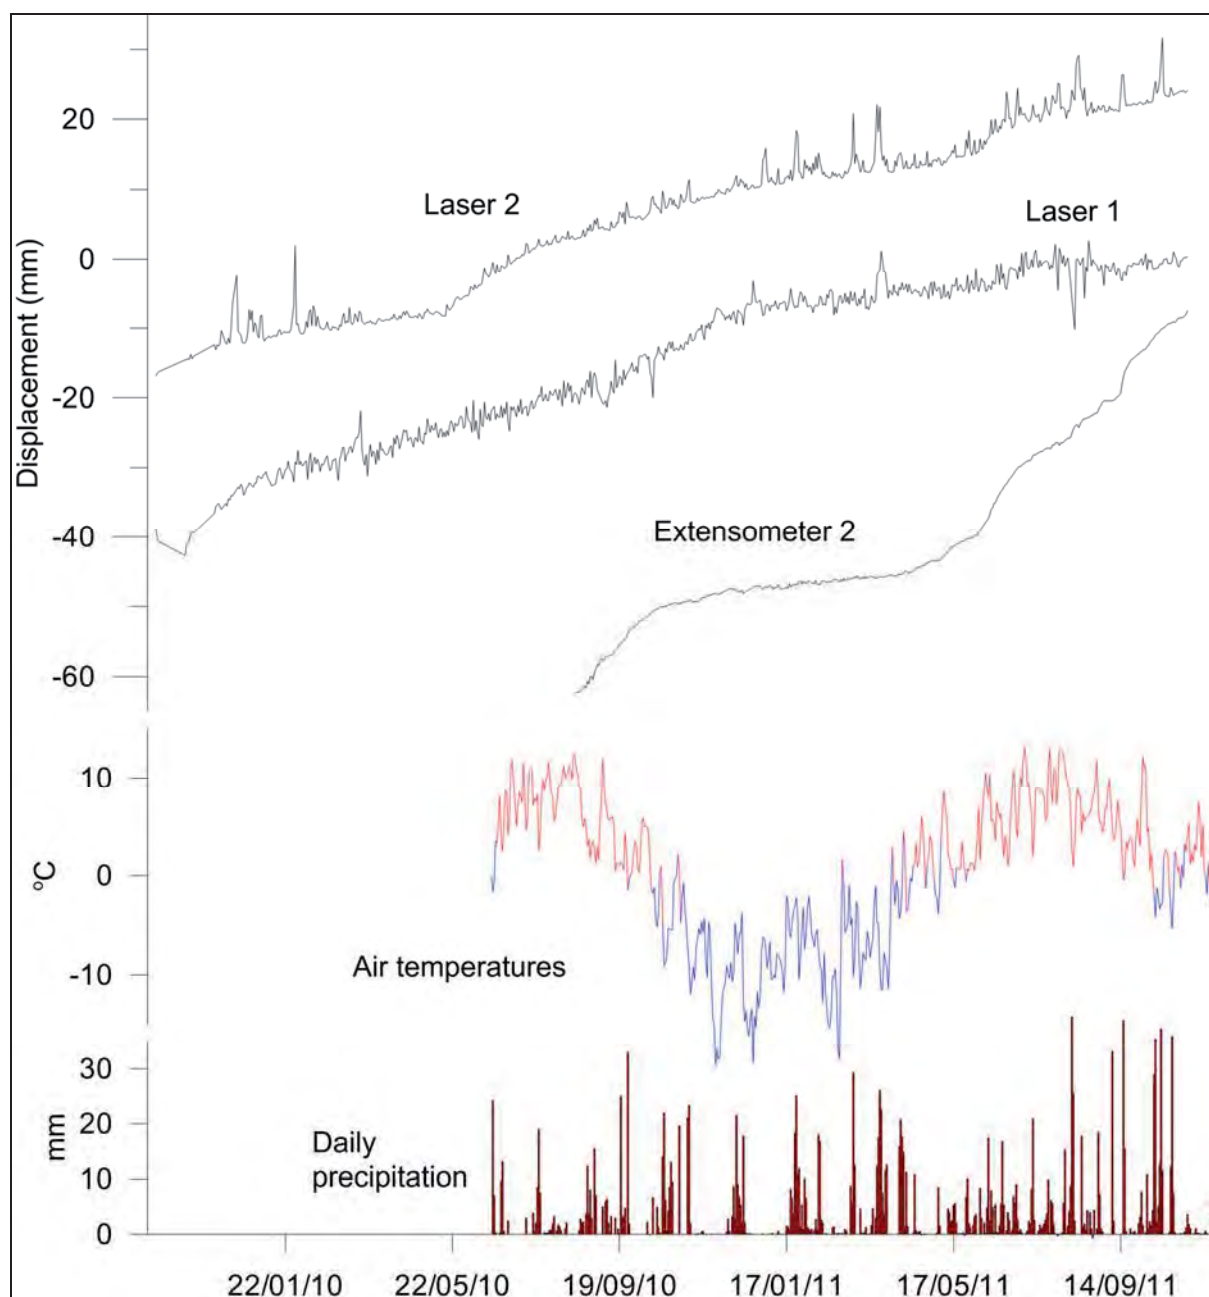
Figure 4.9-6. Displacement of lasers and extensometer 2. Air temperature and daily precipitation is also shown.
