THIRD SLOPE TECTONICS CONFERENCE

3rd Slope Tectonics conference –
Field excursion guide

Report no.: 2014.031		ISSN: 0800–3416		Grading: Open	
Title: 3rd Slope Tectonics conference – Field excursion guide					
Authors: T. Oppikofer, R.L. Hermanns, G. Sandøy			Client: -		
County: Møre og Romsdal			Commune: -		
Map-sheet name (M=1:250.000) Ålesund, Røros & Sveg			Map-sheet no. and -name (M=1:50.000) -		
Deposit name and grid-reference: -			Number of pages: 167		Price (NOK): 315
			Map enclosures: 0		
Fieldwork carried out: -	Date of report: 05.09.2014		Project no.: 355400		Quality control:

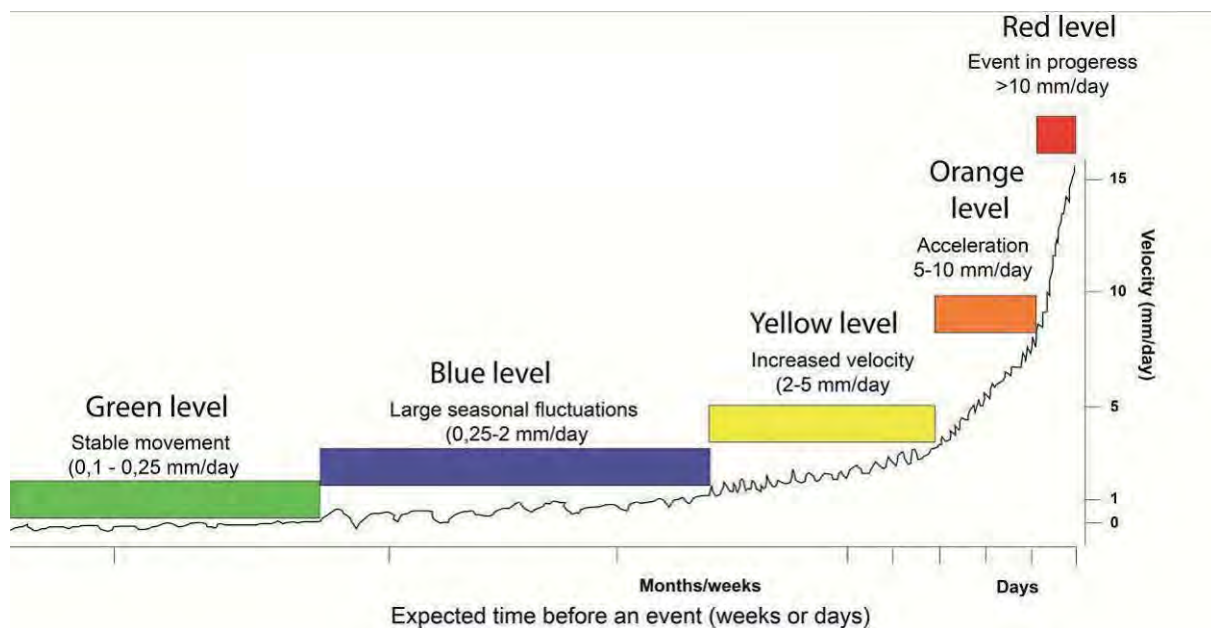
Figure 4.9-9. Early-warning levels for the Mannen rockslide

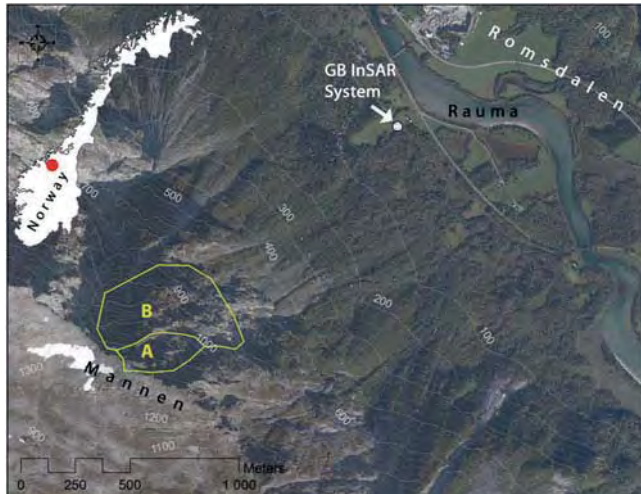
Fig. 1 The mountain of Mannen and the valley Romsdalen. The two scenarios, A and B are indicated in yellow as well as the position of the GB InSAR system in the valley

Mannen is a 1,295 m high mountain which is a part of a plateau above the steep, glacial eroded valley Romsdalen. A part of the plateau (100 mill. m³) towards the valley is bounded by deep clefts indicating past movement, but most of this appear inactive today. A block of possibly 15–20 mill. m³ has been lowered 15–20 m from the plateau, and a block in the upper part of this (2–3 mill. m³) has been measured periodically with DGPS, showing an yearly movement of 5–6 cm dipping 45–50 against ENE. These blocks are the basis of the scenarios (A and B) drawn in Fig. 1. NGU and the County Governor have estimated that the yearly probability of A; a 2–3 mill. m³ rock slide is about 1/100.

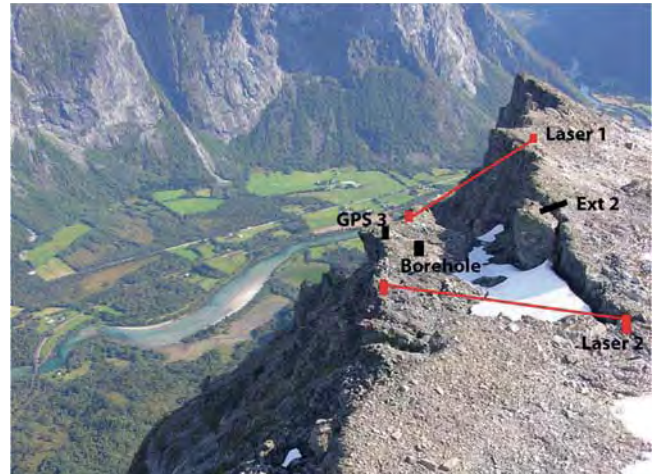
Fig. 2 Photo of the upper back-crack area and the plateau which has sunk 15–20 m. The position of some instruments is drawn

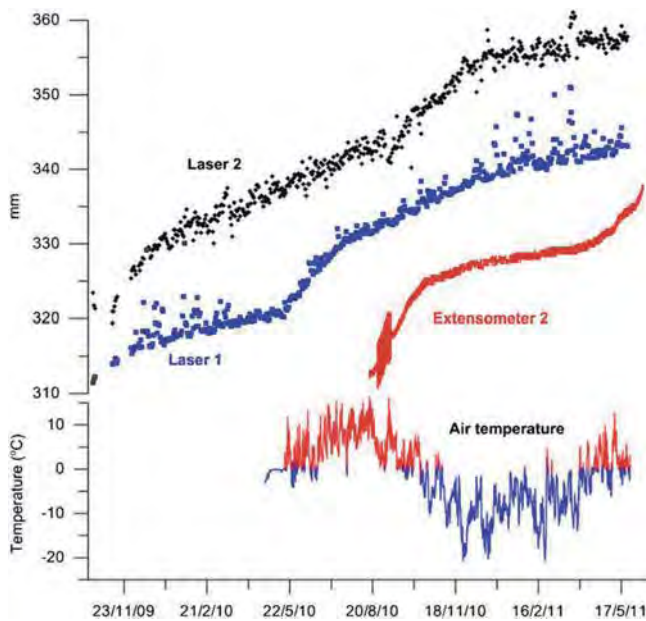
Fig. 3 Measurement of displacement of the two lasers and extensometer 2. Also shown is the air temperature, red are positive and blue are negative temperatures

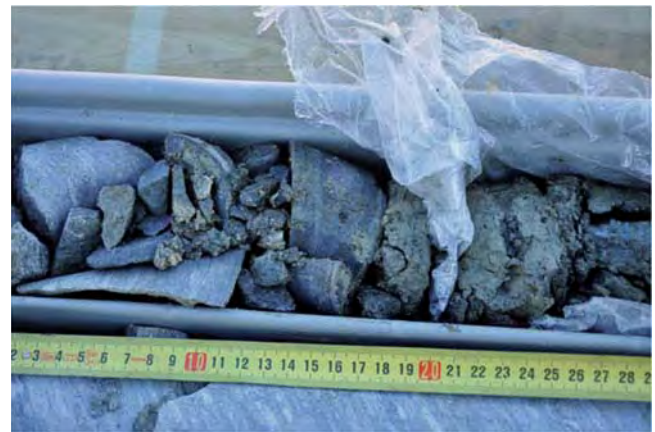
Fig. 8 Crushed bedrock at 28 m depth

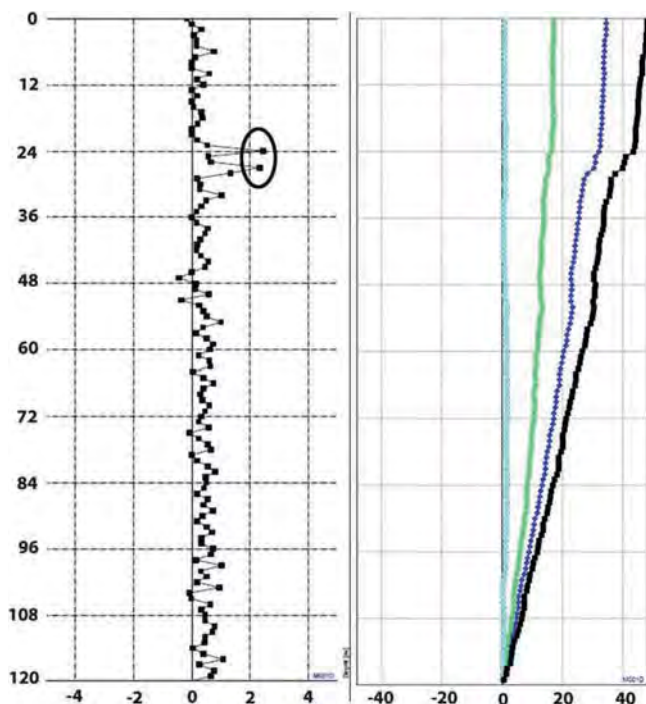
Fig. 9 Displacement of the DMS column in the period 24 February 2011 to 2 June 2011. The x-axis is in millimeters and positive is movement towards north. *Left*: Differential plot showing displacement in each module *Right*: Cumulative displacement at four time intervals

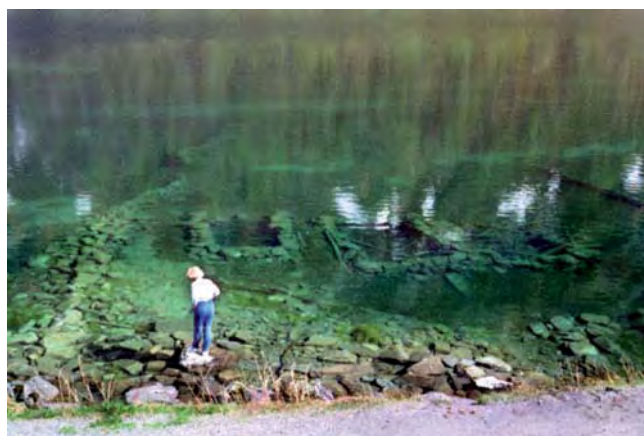
Fig. 5 Old farm houses visible in rockslide dammed Lyngstøylvatnet (Photo by Astor Fuseth)

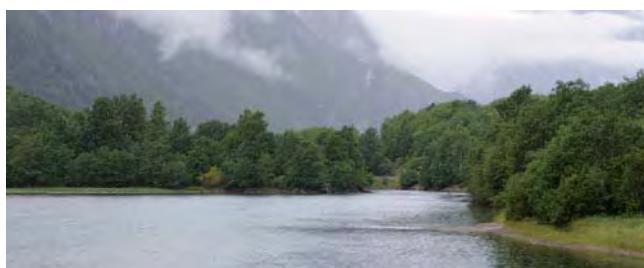
**Fig. 10** Remnant lake in Rauma valley behind prehistoric dam impounded by a rock avalanche

but a remnant lake would prevail. This is suggested by rest of prehistoric rockslides dam in Rauma valley where also remnant lakes exist (Fig. 10).

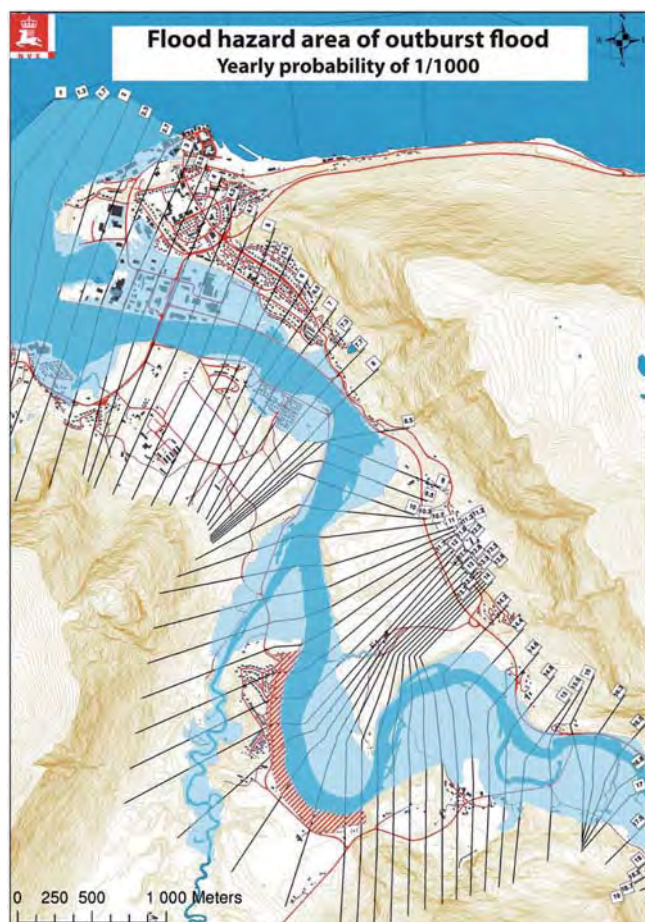
Fig. 14 Map showing simulated flooding area of the lower river section related to an outburst flood with a 1 in 1,000 years probability. Area marked in red is estimated to be eroded in this scenario

given for the one in 1,000 hundred years scenario (Fig. 14). As Rauma river enters the fjord at a delta on which the city of Åndalsnes is partly constructed, various flood scenarios

indicate that several hundred houses and touristic facilities would be flooded. This information is a necessary input for regional planning in the area.
