NGU Report 2011.026

Mannen unstable rock slope (Møre & Romsdal):
Logging of borehole and drill core KH-01-10,
geomorphologic digital elevation model
interpretation & displacement analysis by
terrestrial laser scanning

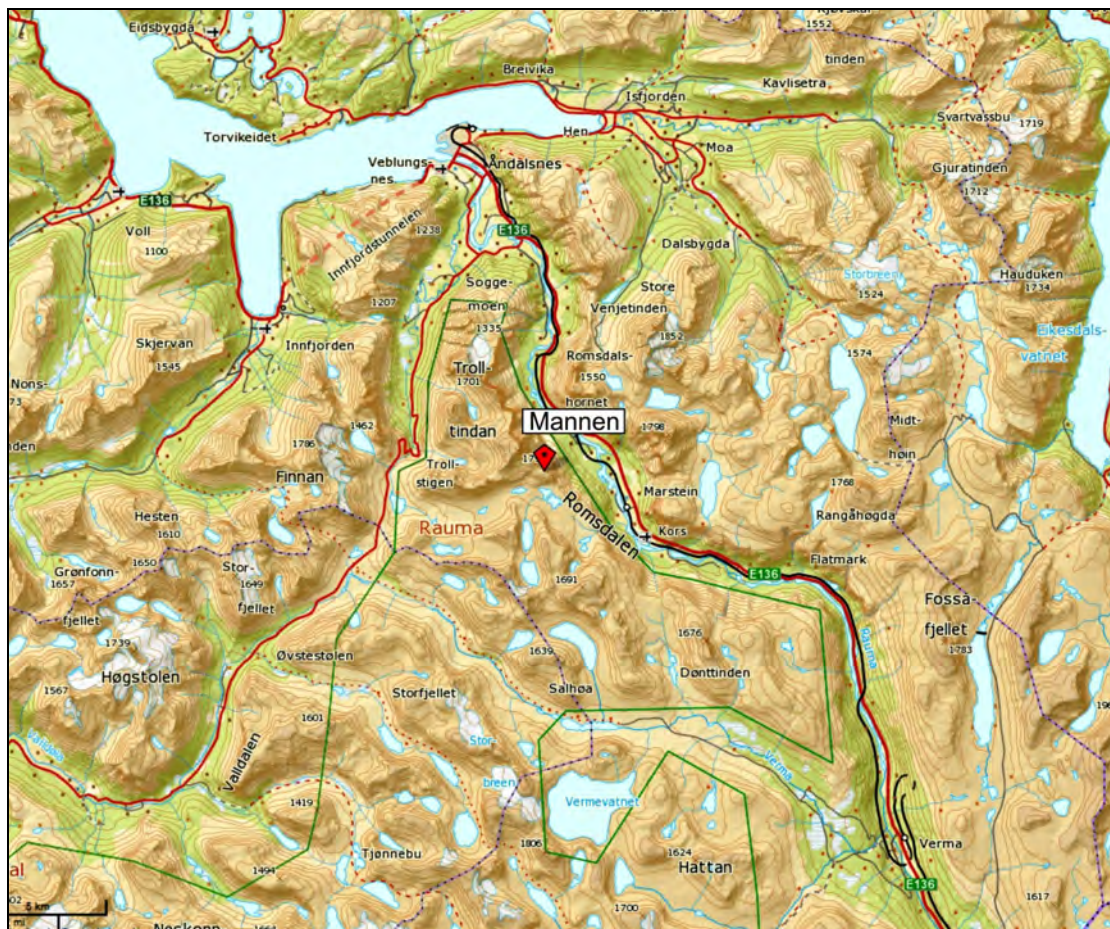
Figure 1. Mannen unstable rock slope on the southern side of Romsdalen (Western Norway).

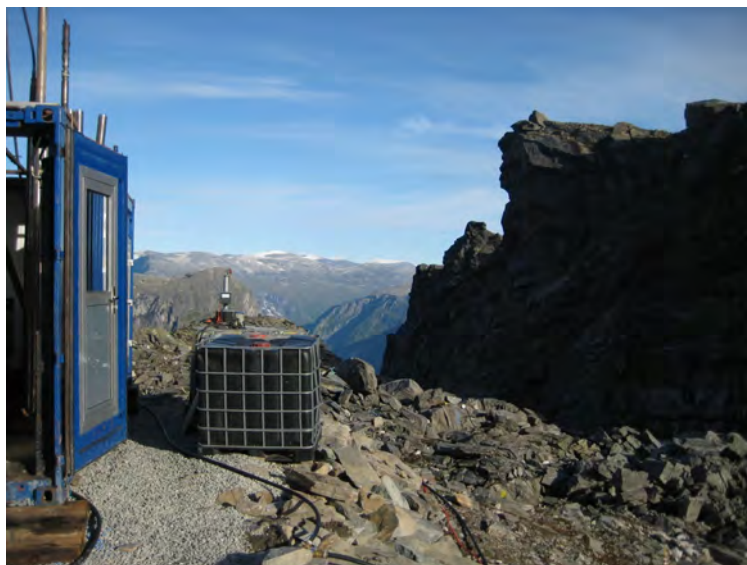
Figure 3. Photograph of the drilling site on the top of the moving block. The main back-crack (black wall) is on the right side.

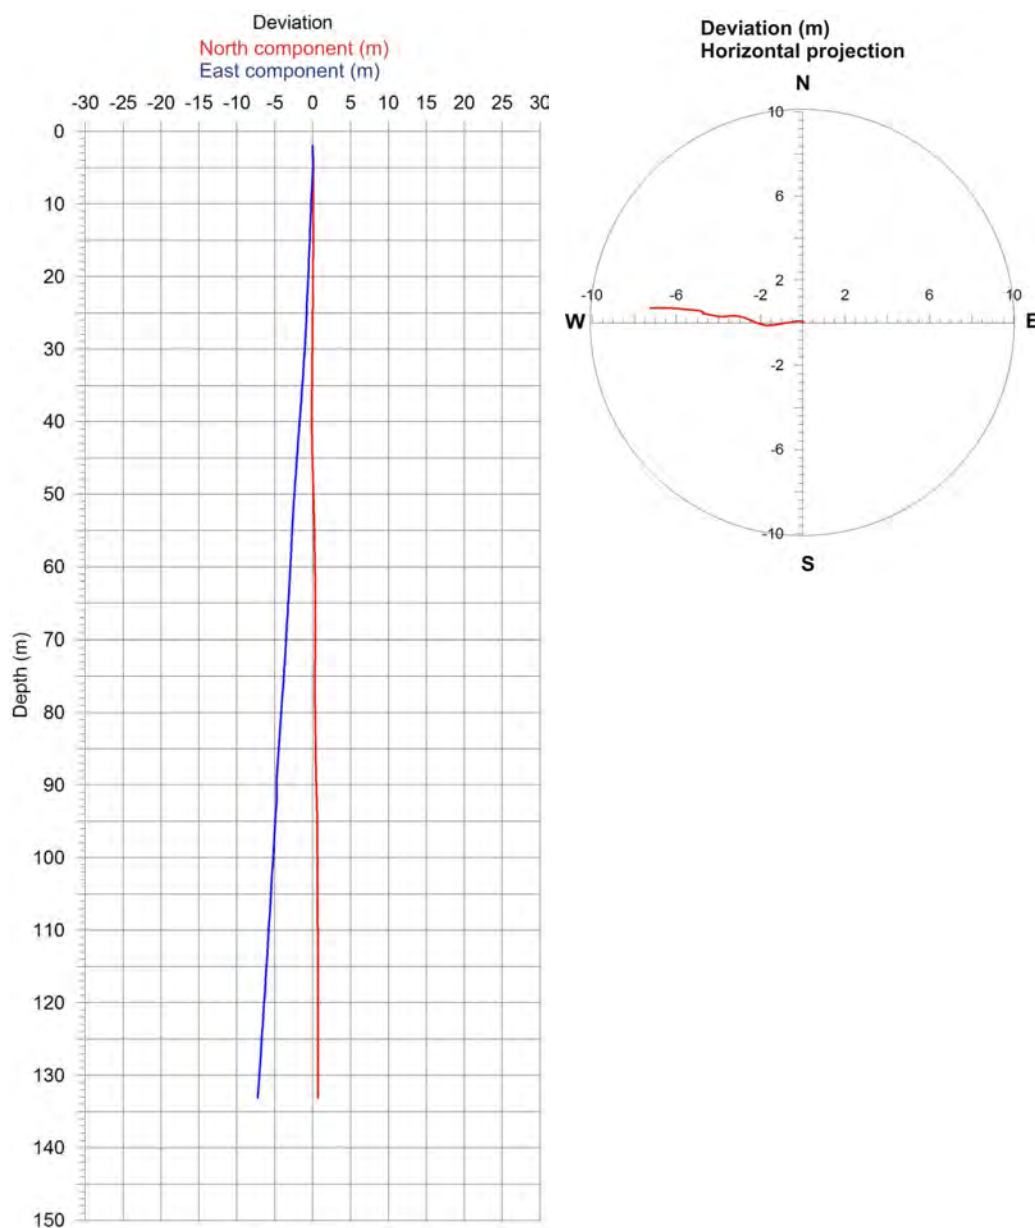
Figure 27. Mannen borehole deviation: north and east components (left) on the vertical section and direction viewed from the top (right).

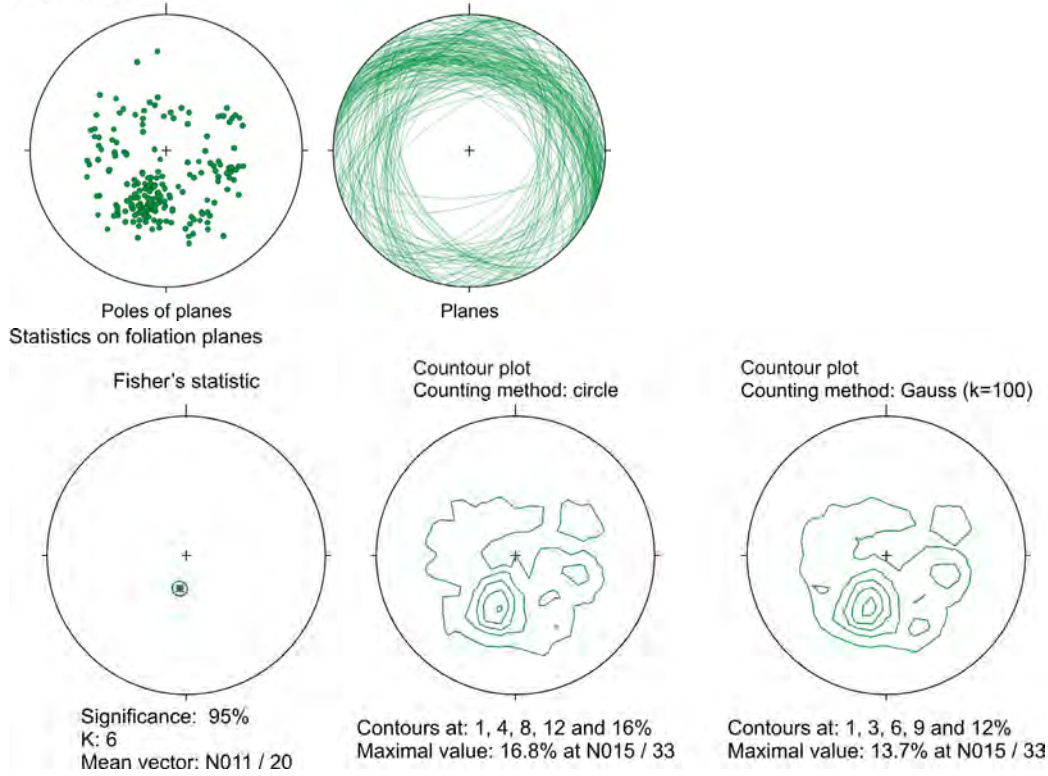
Figure 28. Stereoplots (lower hemisphere, Schmidt's projection) of the foliation planes measured along the borehole by televiwer imaging.

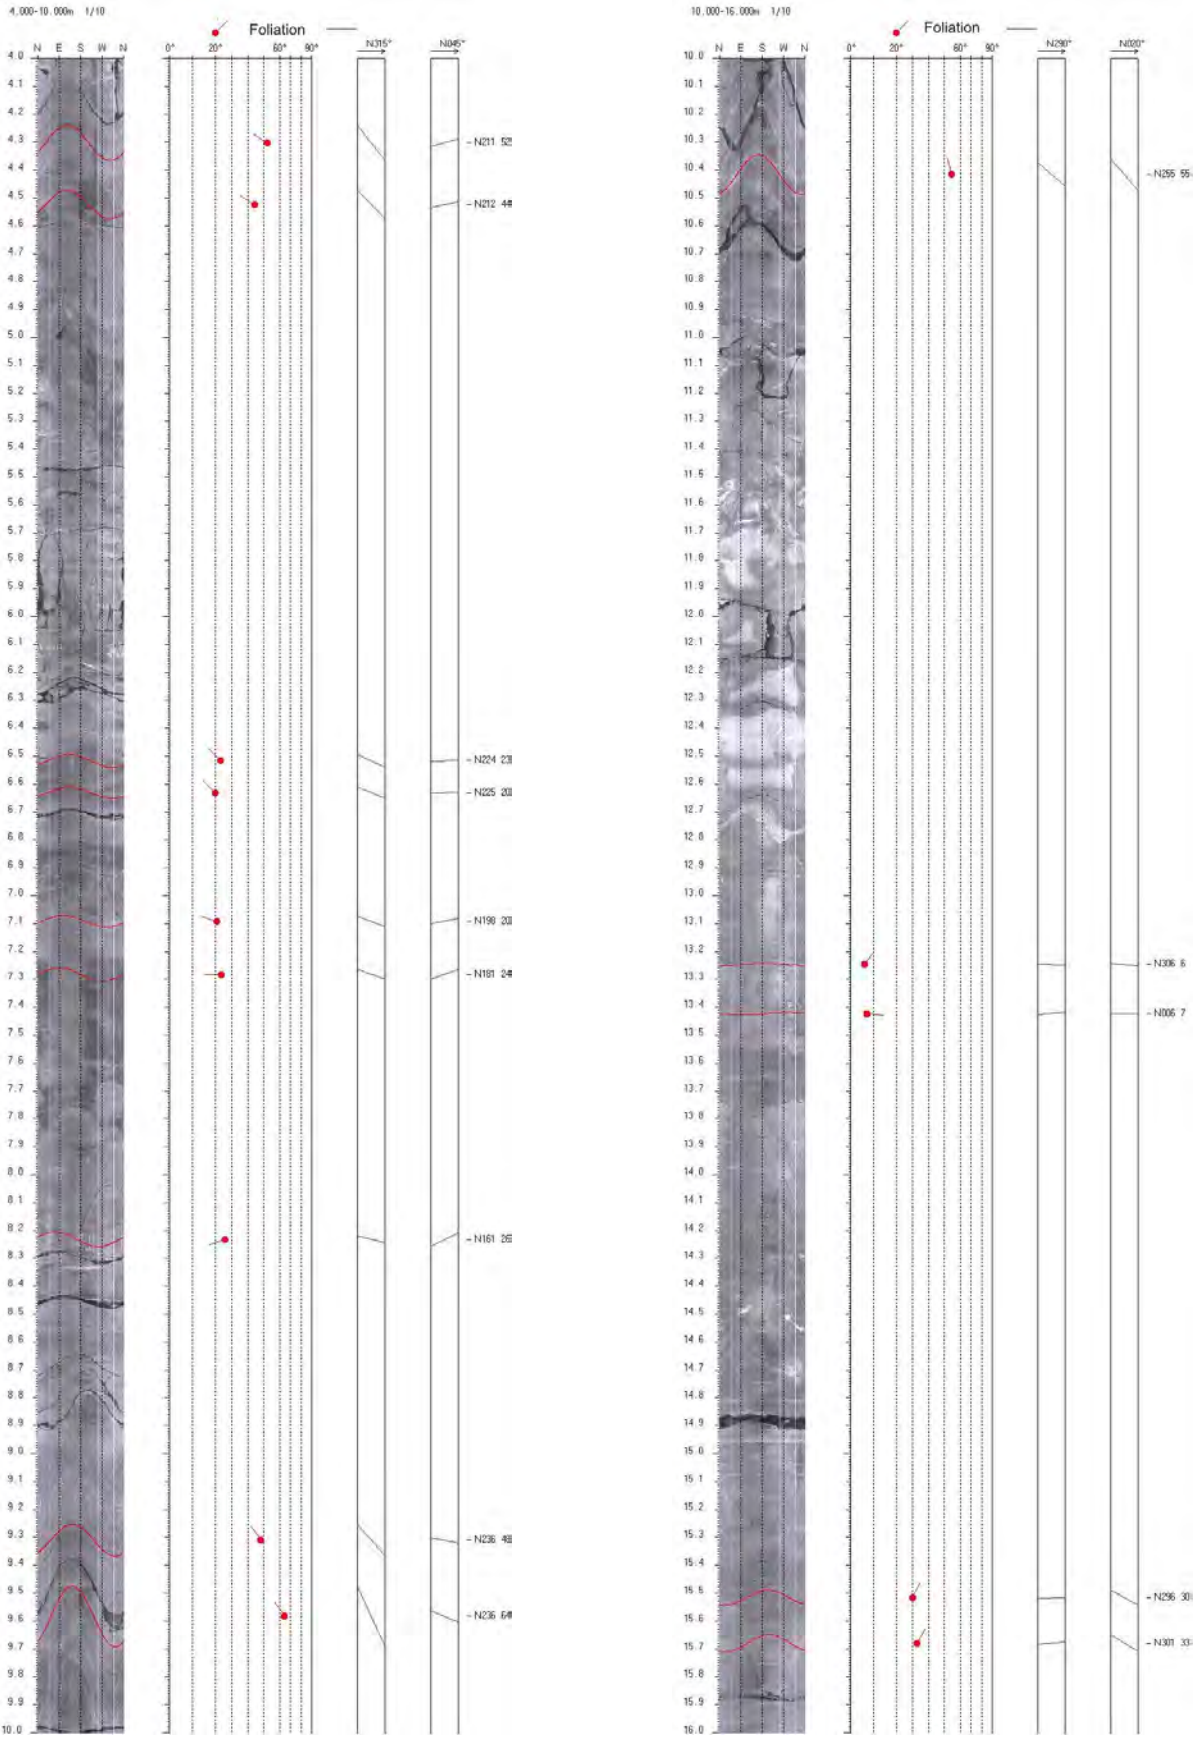
Figure 30. Unwrapped optical images of the wall of Mannen borehole with digitised foliation planes in the 4–16 m depth interval (left). Dip angle and dip direction of each plane are displayed on the arrow plot (N up; centre). Attitude of foliation plane is seen from two different angles (to N315 and N045 or to N290 and N020) with strike (right hand rule) and dip angle of the plane (right).

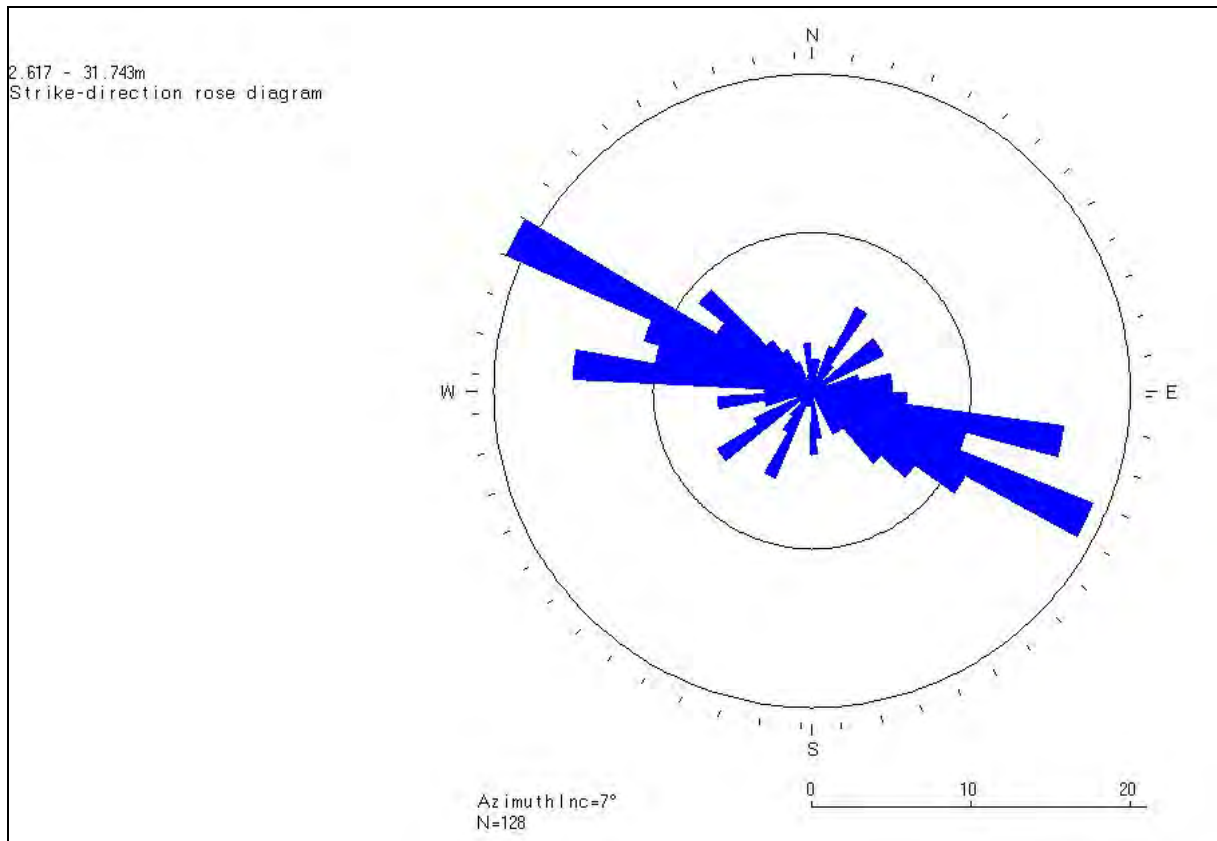
Figure 34. Rose diagram of the fractures in the 3–32 m depth interval.

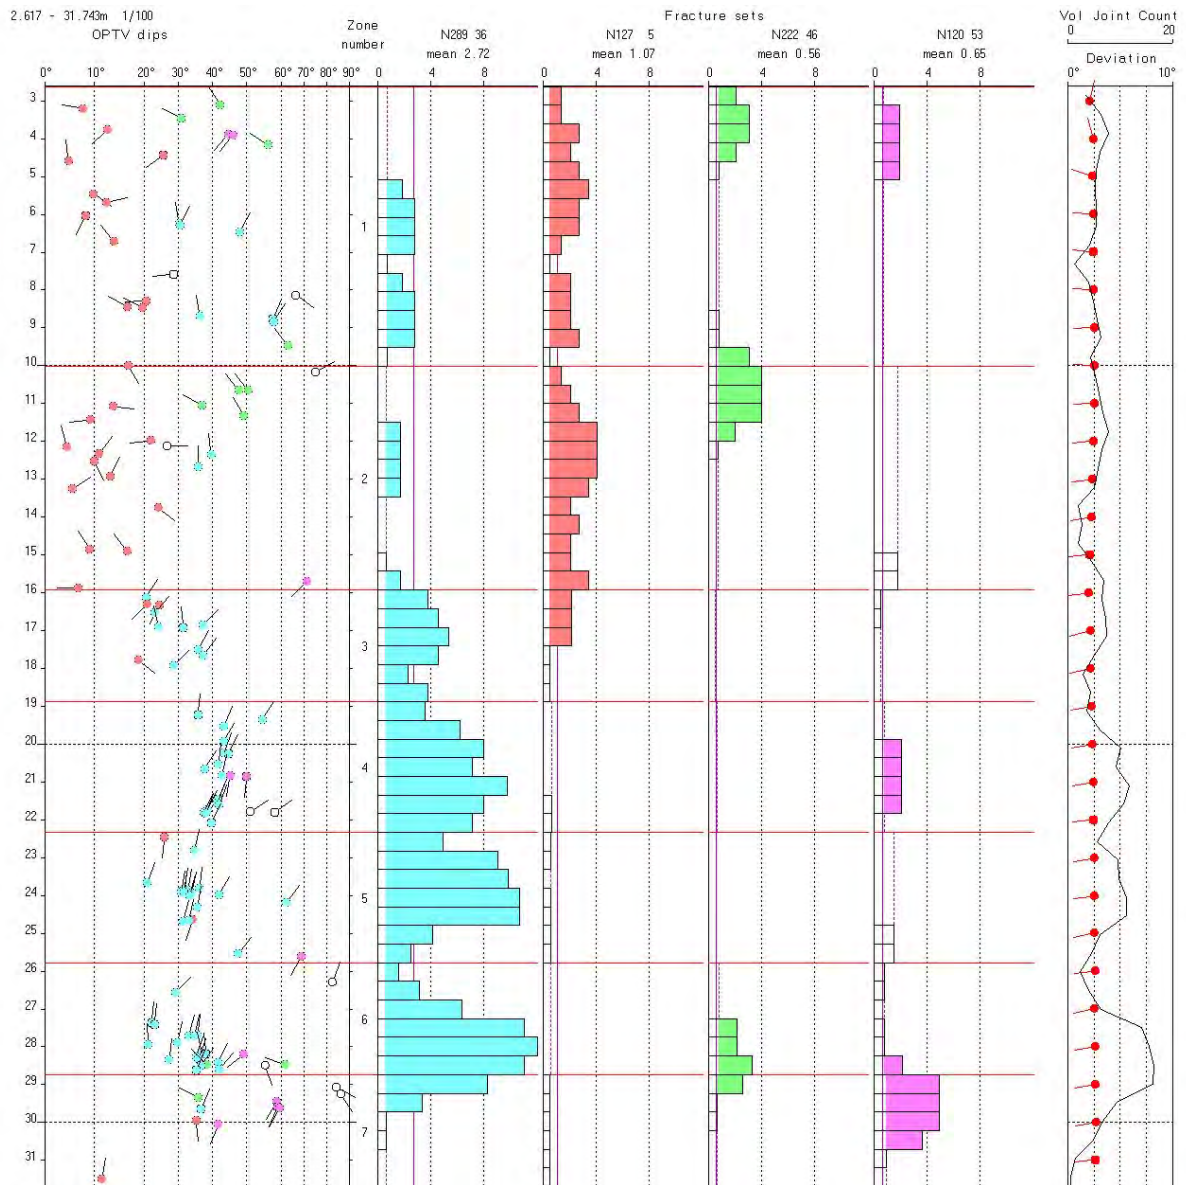
Figure 35. Arrow plots (N up) of the 128 fractures in the c. 3–32 m depth interval, frequency histograms of the four fractures sets as defined by the statistical analysis (see Figure 33; with identical colours representing the fracture sets). The deviation of the borehole (arrow plot; N up) is shown in the right.

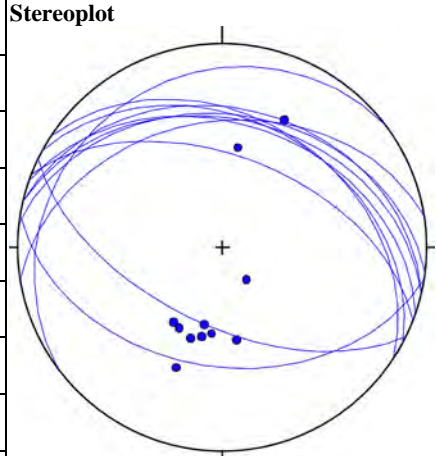
Depth [m]	Dip direction [°]	Dip angle [°]	Thickness [m]	Comments	Stereoplot
14.9	323	13 (mean) 16 (bottom)	0.03	Open fracture (see Figure 38)	
17.6	033	36	0.12	Open fracture, crushed zone (see Figure 39)	
19.3	021	44 (mean) 53 (bottom)	0.09	Open fracture, crushed zone (see Figure 39)	
20.6	019	39	0.09	Open fracture, fractured zone (see Figure 40)	
23.7	013	28 (mean) 37 (bottom)	0.13	Open fracture, fractured zone (see Figure 40, Figure 43)	
27.5	007	29 (mean) 35 (bottom)	0.23	Crushed zone with clays (see Figure 41, Figure 43)	
27.8	013	32	0.15	Crushed zone (see Figure 41, Figure 43)	
28.0	351	29 (mean) 38 (bottom)	0.20	Crushed zone with clays (see Figure 41, Figure 43)	
28.2–28.7	028 (mean)	37 (mean)	0.50	Severely crushed zone (see Figure 42, Figure 43)	
29.5	206	59	0.02	Open fracture (see Figure 42)	
30.0	189	38 (mean) 41 (bottom)	0.07	Open fracture, crushed zone (see Figure 42)

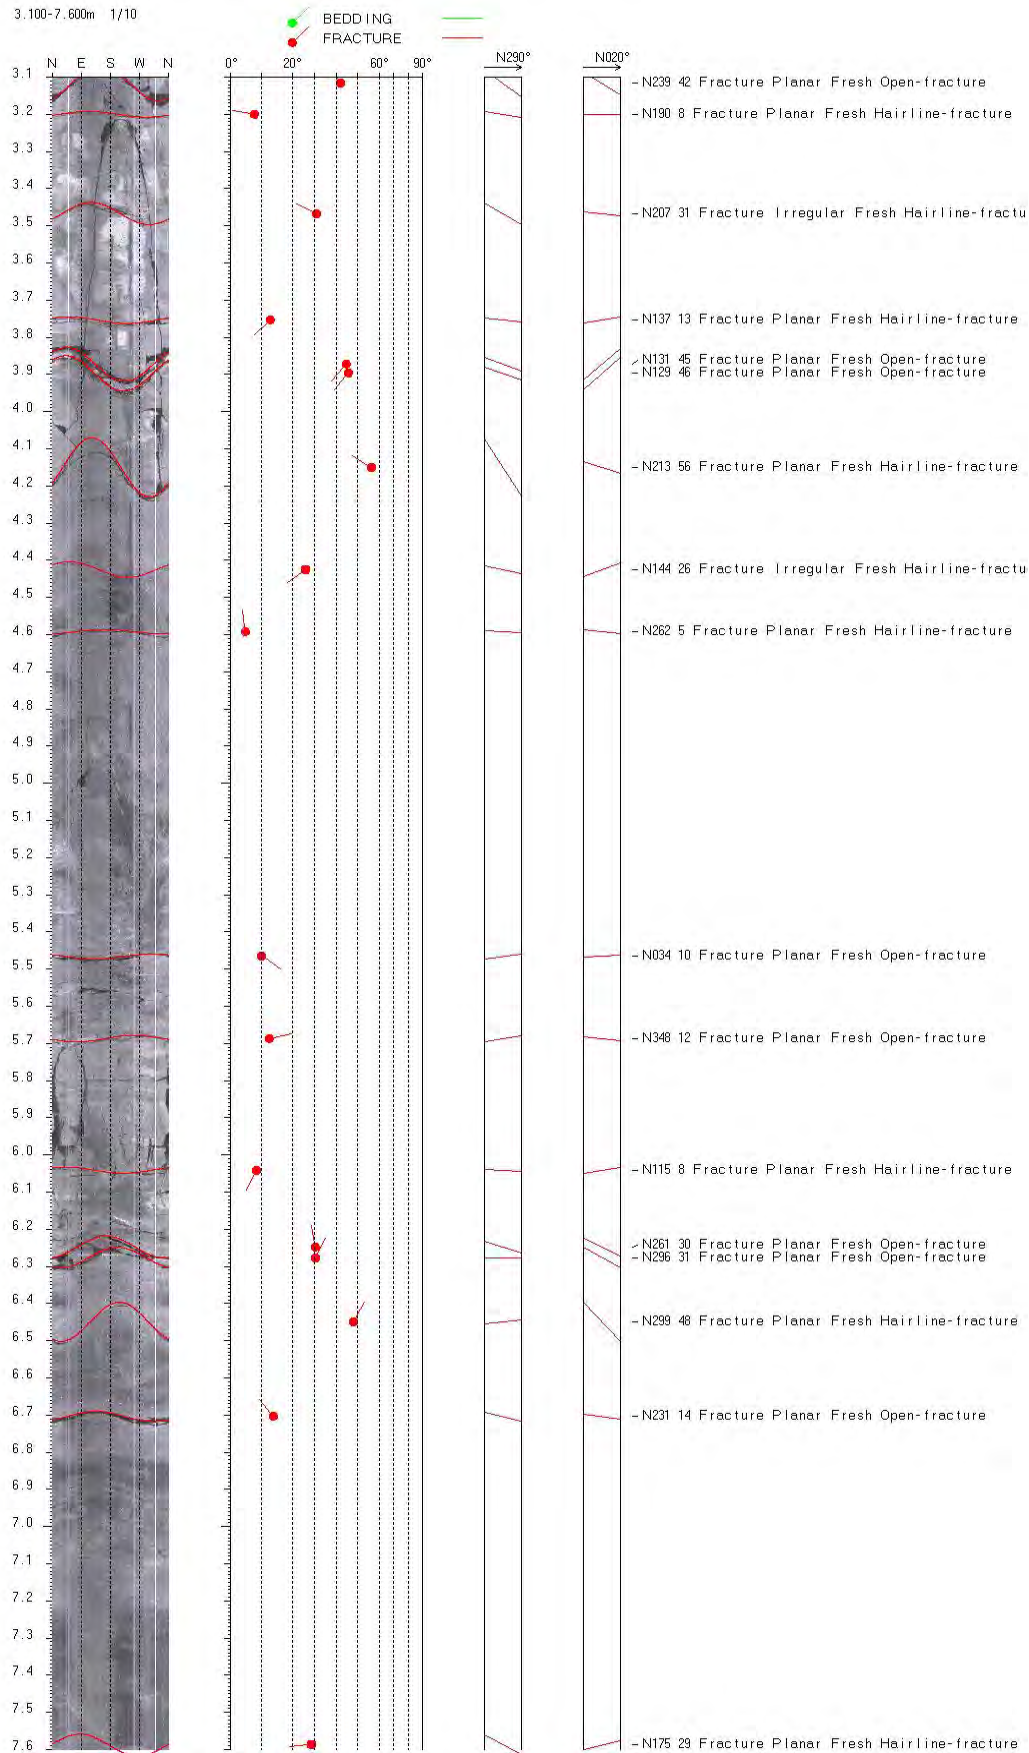
Figure 36. Optical televiwer synthetic images with digitised planar fractures in the 3.1–7.6 m depth interval (left); arrow plots of the fracture orientation (N up; centre); attitude of the fracture from two different view angles (to N290 and N020 herein) and strike/dip angle of the fracture with main characteristics (right).

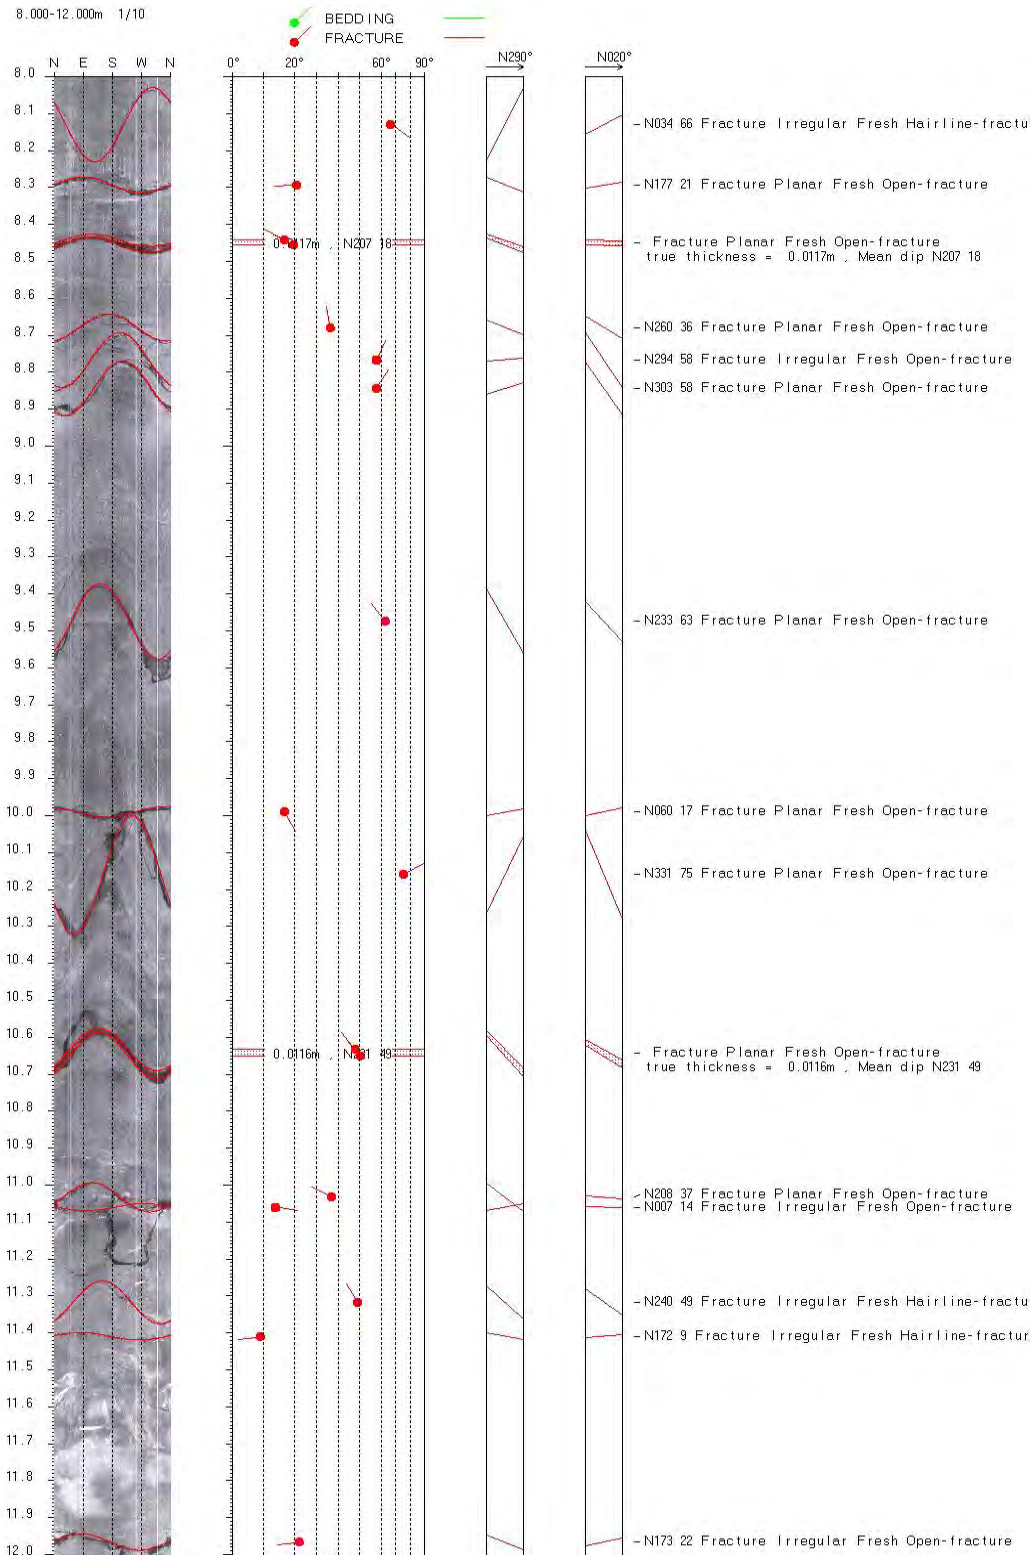
Figure 37. Optical televiewer synthetic images with digitised planar fractures in the 8–12 m depth interval (caption as on Figure 36).

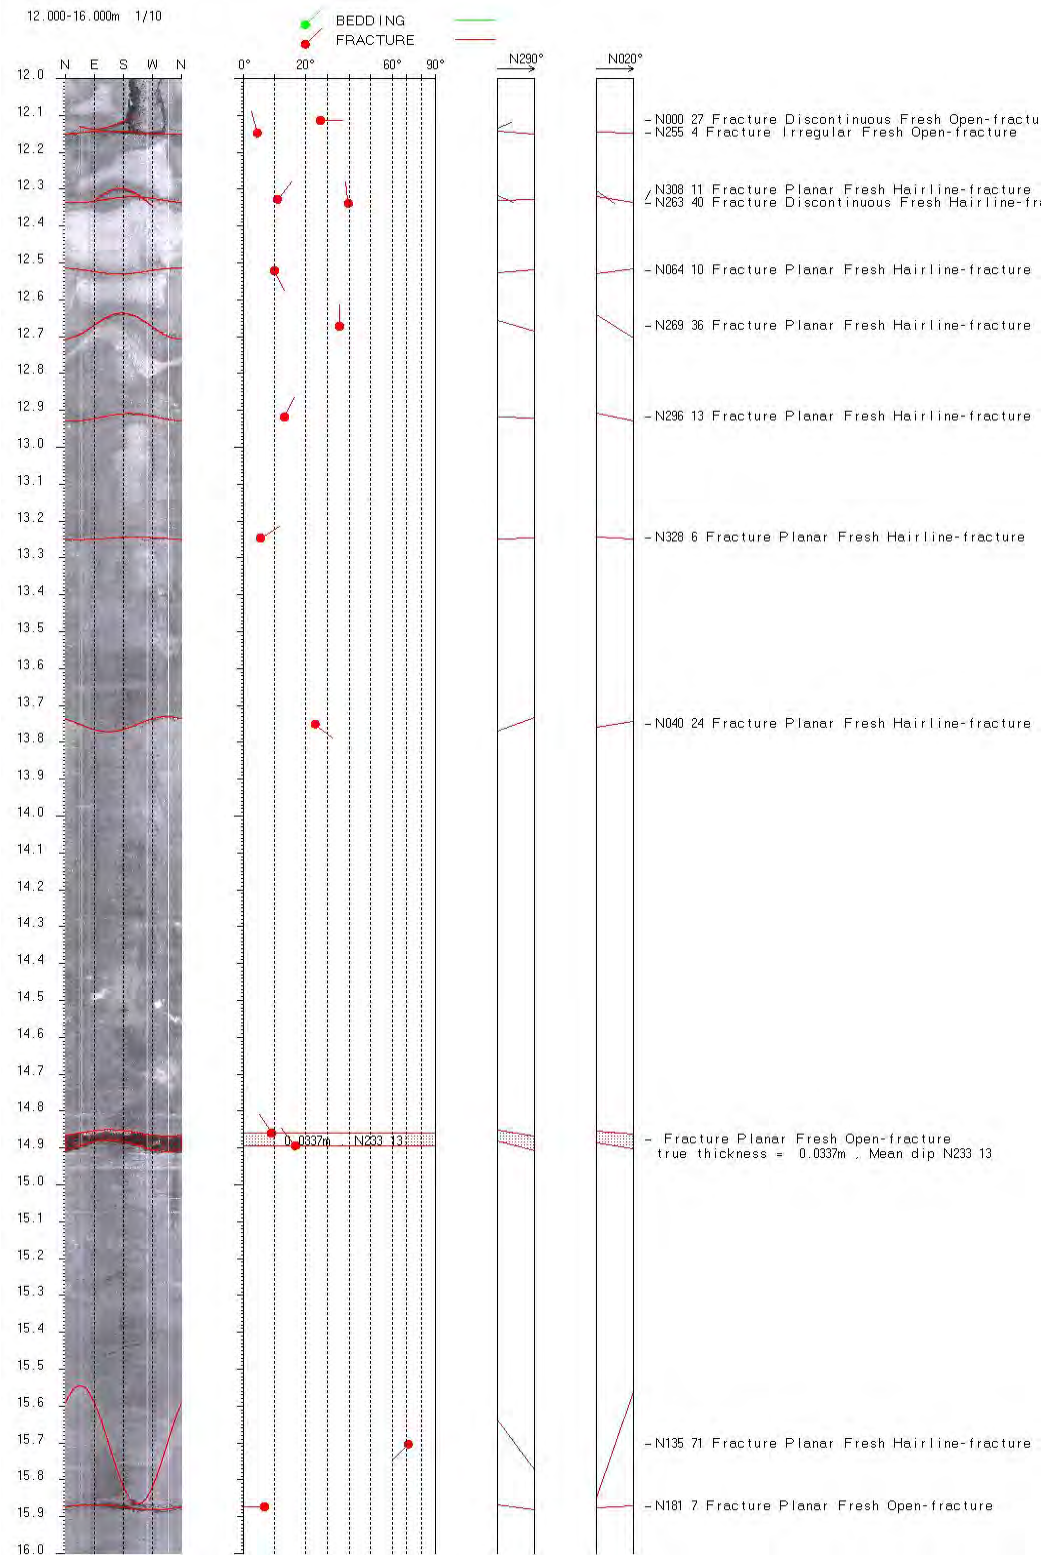
Figure 38. Optical televiewer synthetic images with digitised planar fractures in the 12–16 m depth interval (caption as on Figure 36).

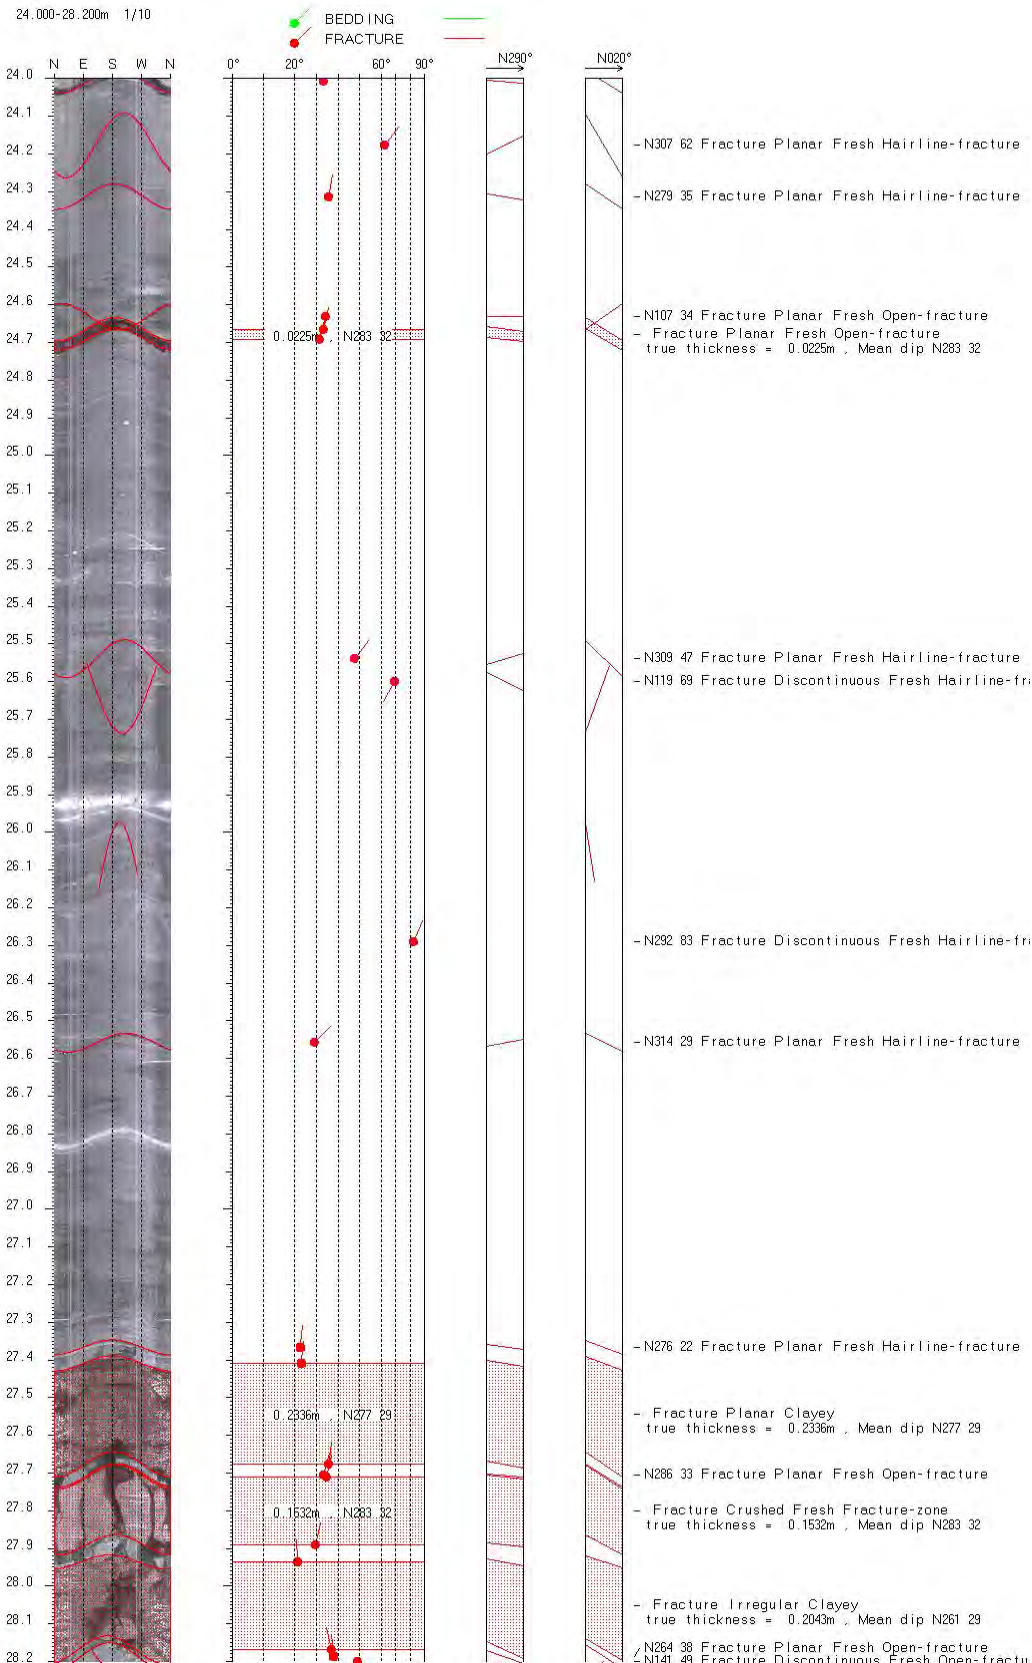
Figure 41. Optical televiewer synthetic images with digitised planar fractures in the 24–28.2 m depth interval (caption as on Figure 36).

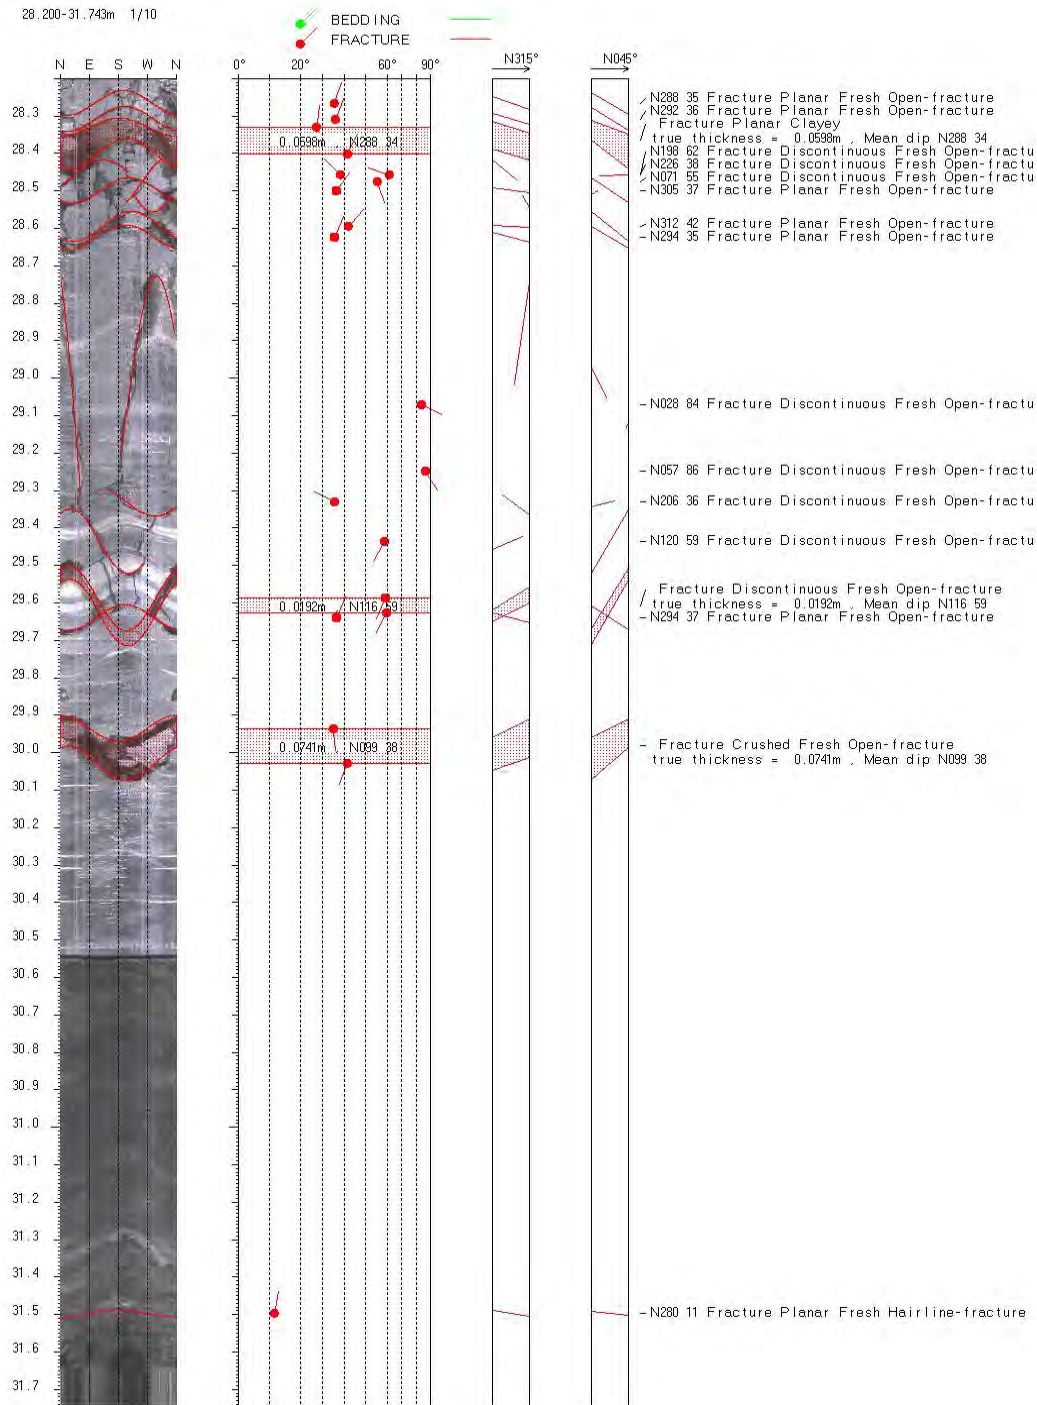
Figure 42. Optical televiwer synthetic images with digitised planar fractures in the 28.2–31.7 m depth interval (caption as on Figure 36).

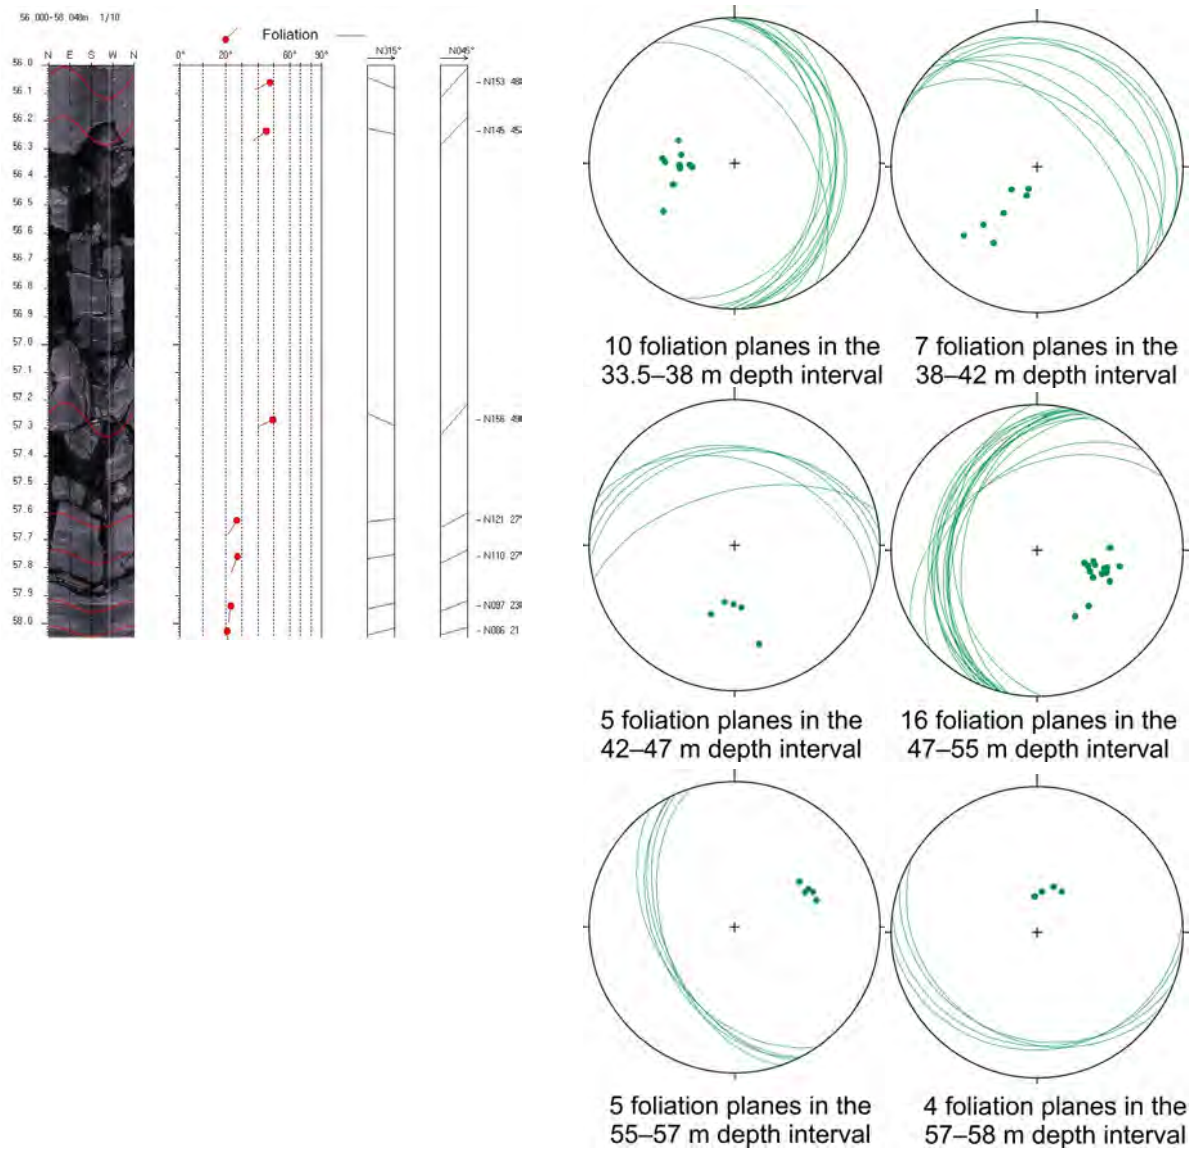
Figure 46. Unwrapped optical images of the wall of Mannen borehole with digitised foliation planes in the 56–58 m depth interval (caption as in Figure 30) and stereoplot of the metamorphic foliation (planes and poles) in the 33.5–38, 38–42, 42–47, 47–55, 55–57 and 57–58 m depth intervals (data listed in Appendix 1).

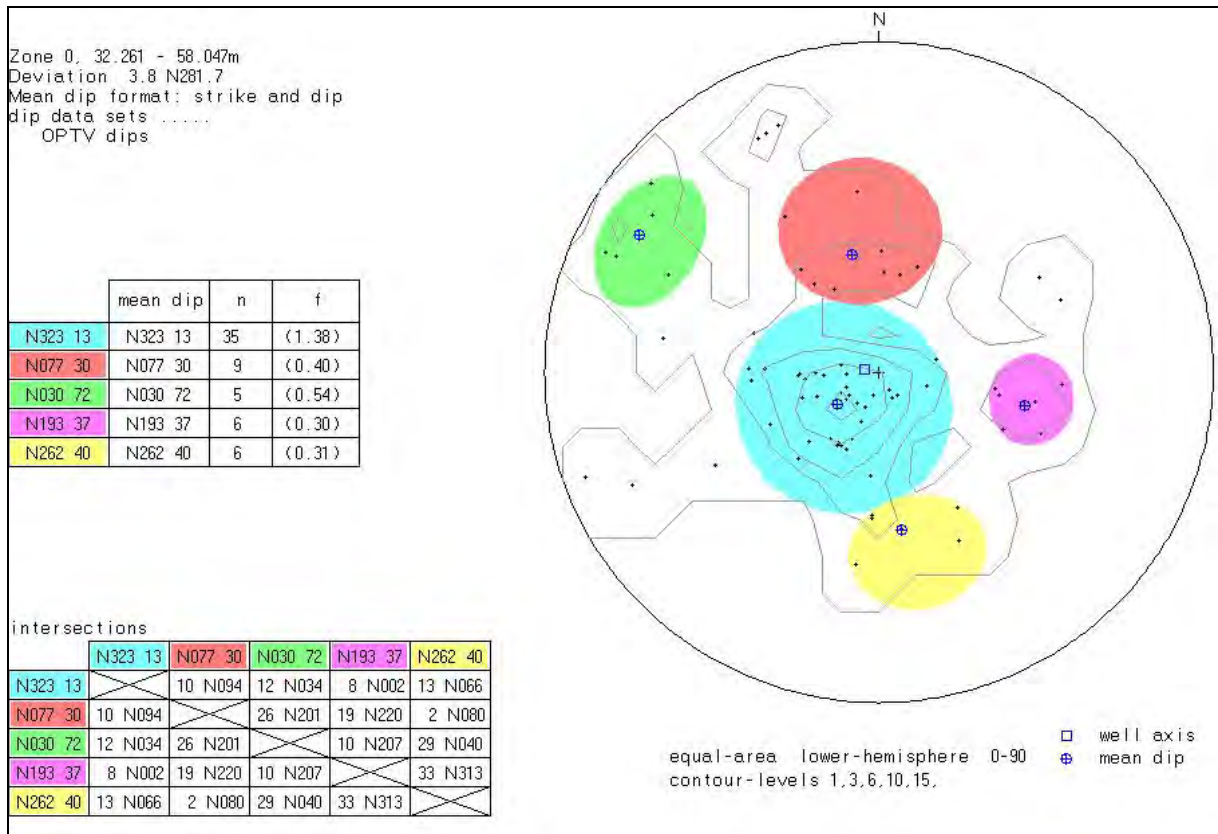
Figure 47. Contour plots, with poles of fractures, providing four main fracture sets in the c. 32–58 m depth interval.

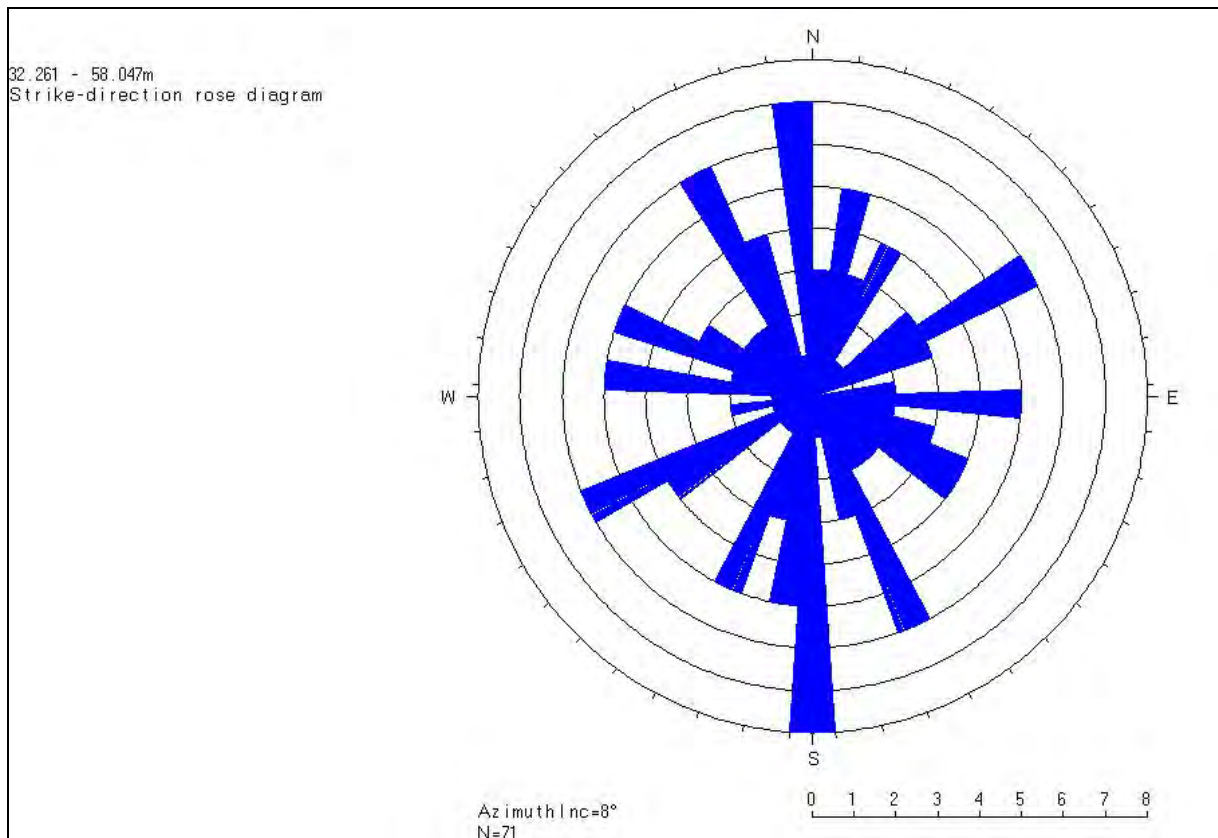
Figure 48. Rose diagram of the fractures in the 32–58 m depth interval.

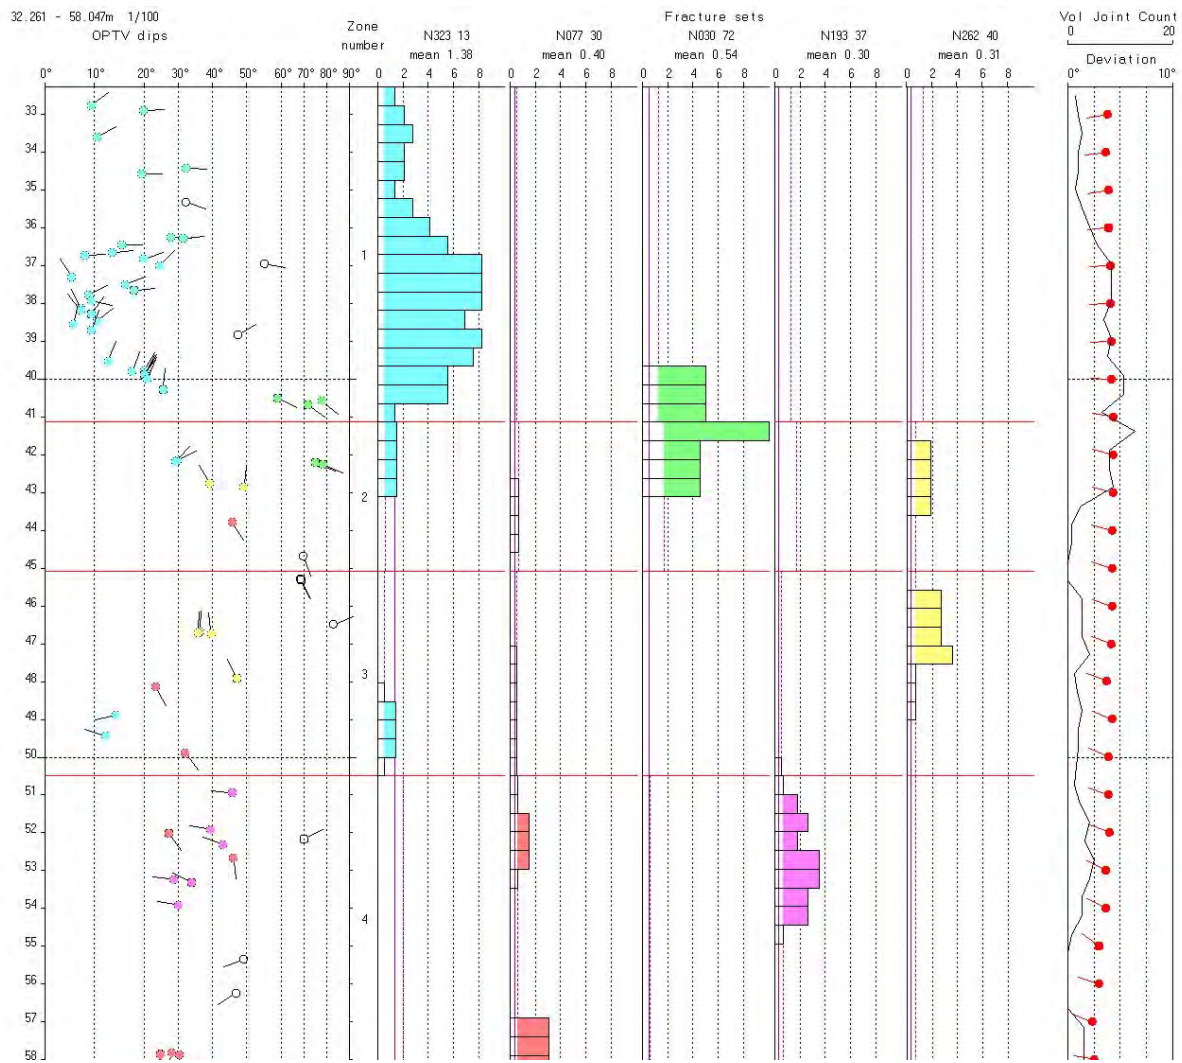
Figure 49. Arrow plots (N up) of the 71 fractures in the c. 32–58 m depth interval, frequency histograms of the five fractures sets as defined by the statistical analysis (see Figure 47). The deviation of the borehole (arrow plot; N up) is shown in the right.
