NGU Report 2011.026

Mannen unstable rock slope (Møre & Romsdal):
Logging of borehole and drill core KH-01-10,
geomorphologic digital elevation model
interpretation & displacement analysis by
terrestrial laser scanning

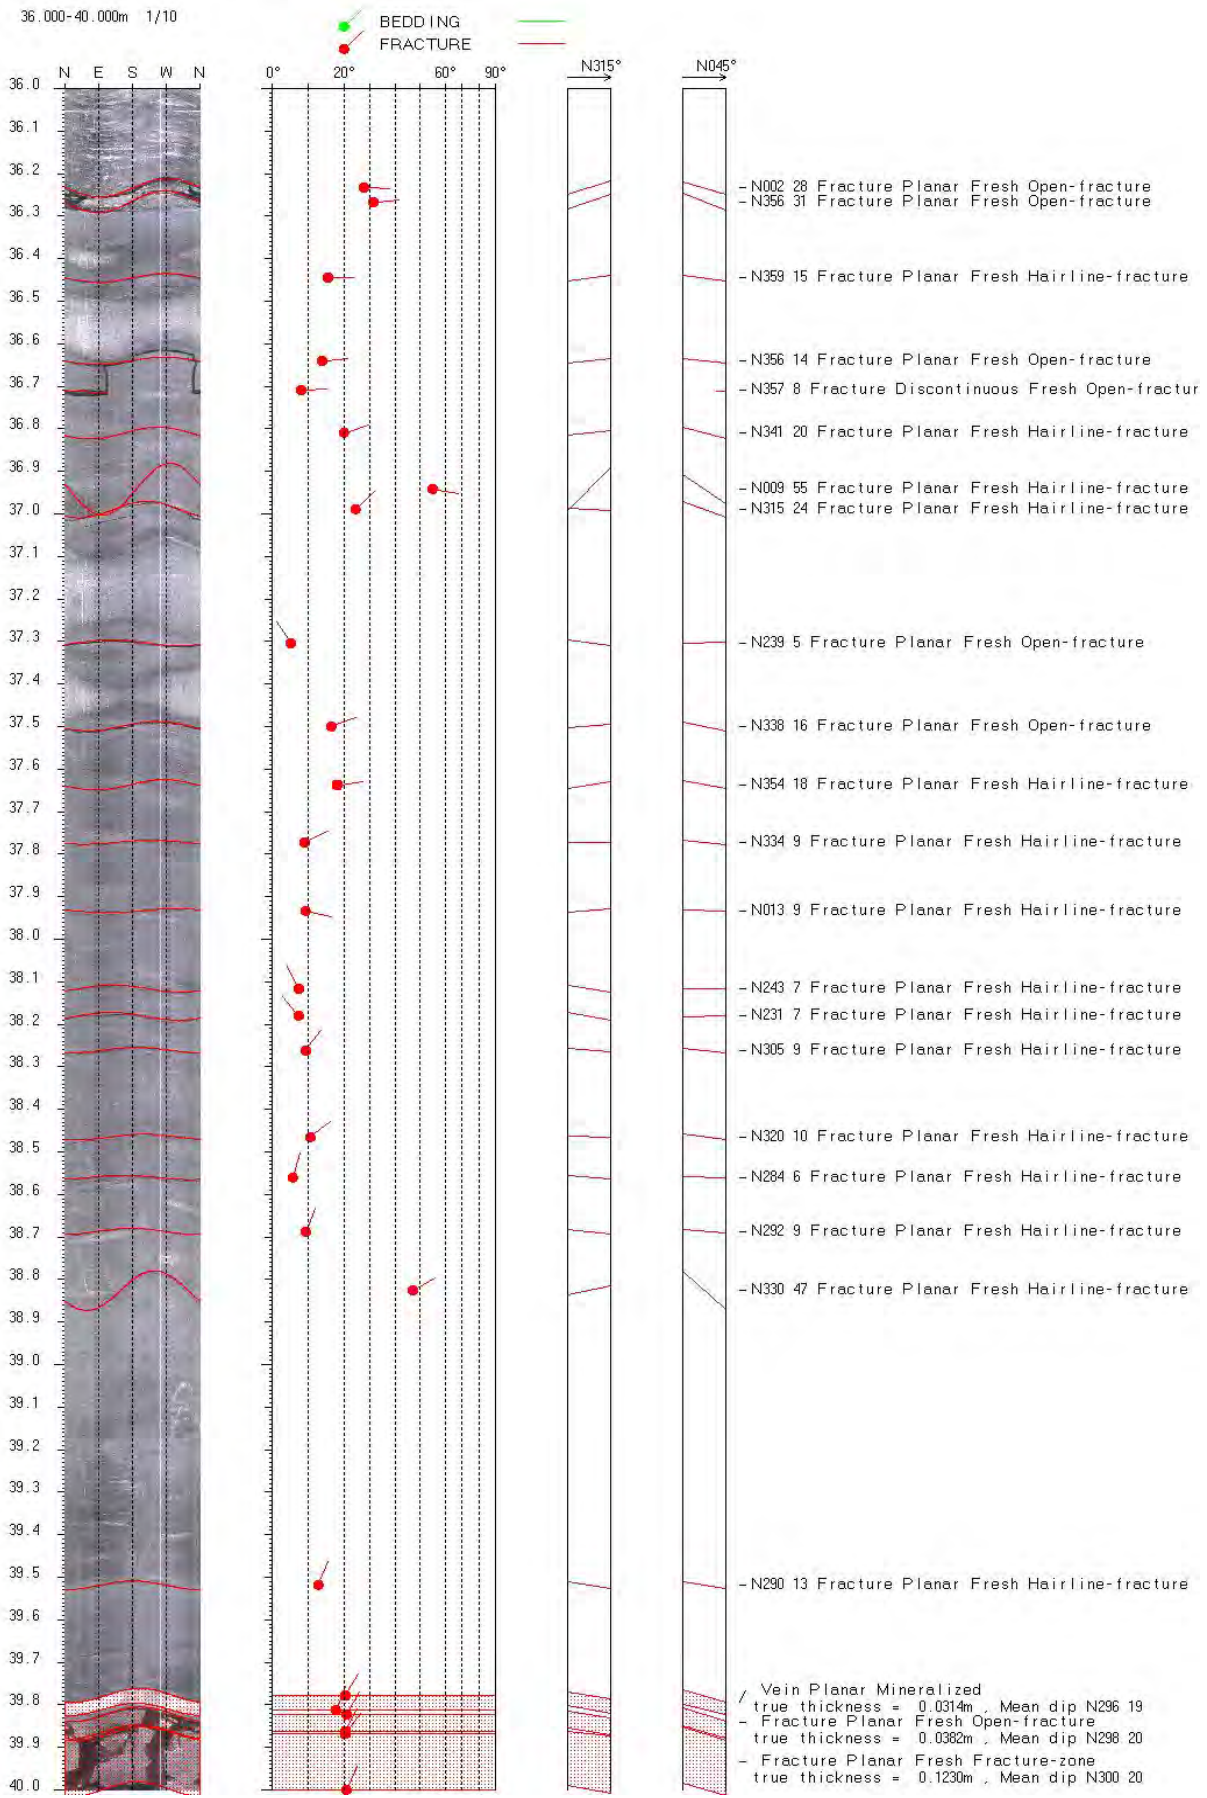
Figure 51. Optical televiewer synthetic images with digitised planar fractures in the 36–40 m depth interval (caption as on Figure 36).

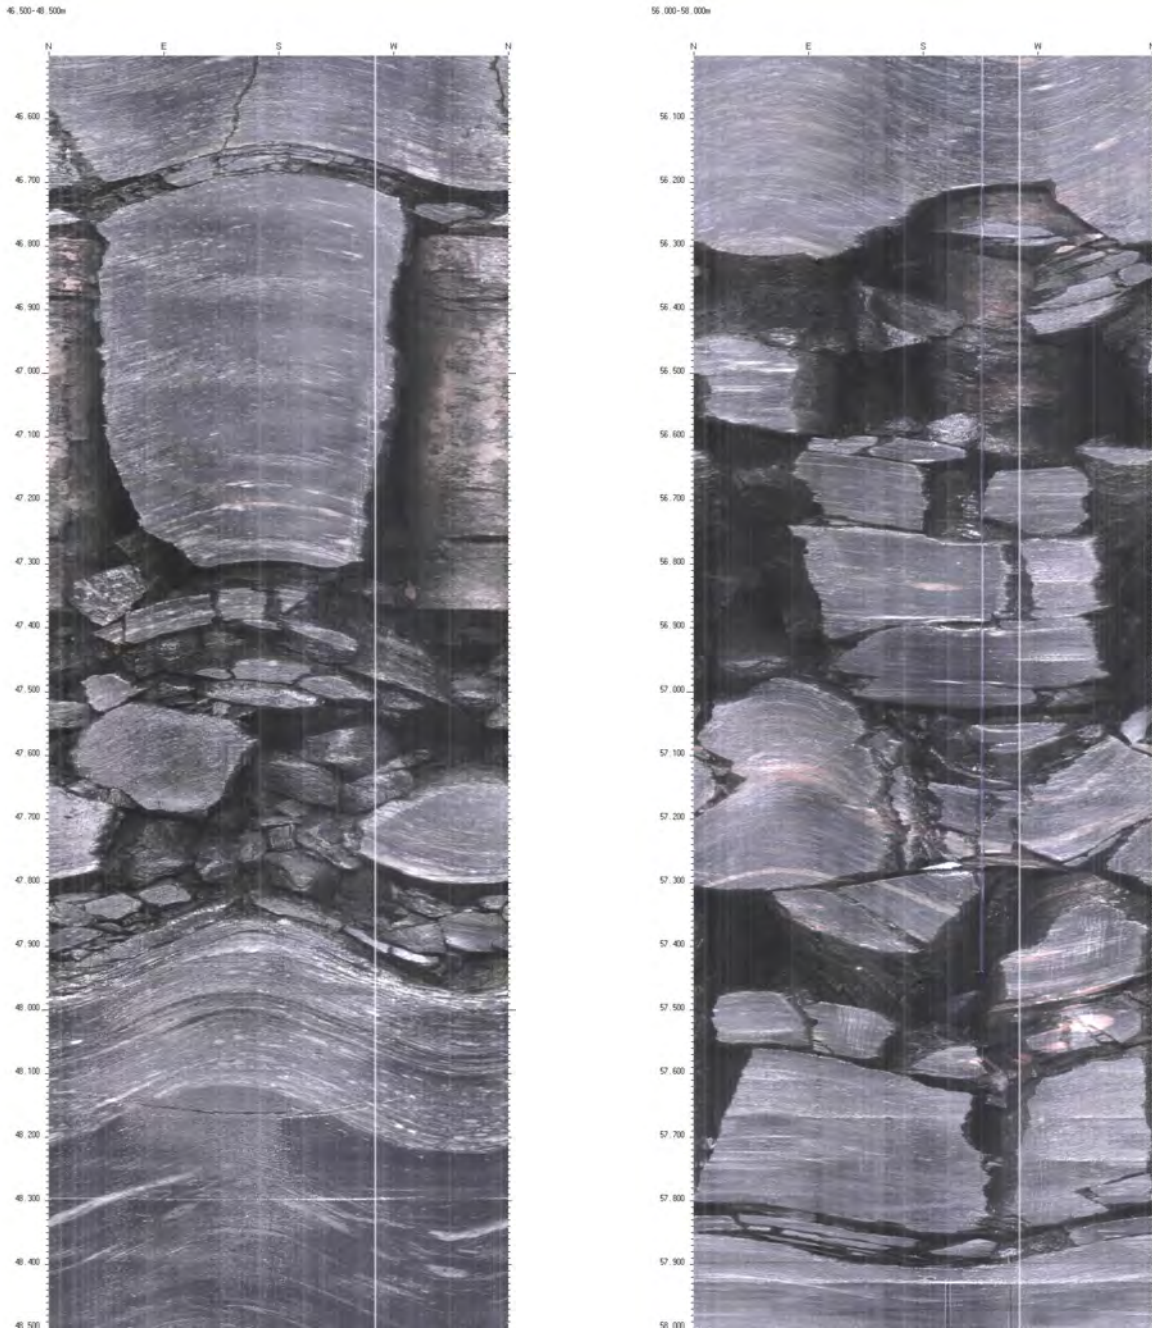
Figure 57. Optical televiewer images showing crushed zones at 46.7 m (left) and 56.3 m (right) depths.

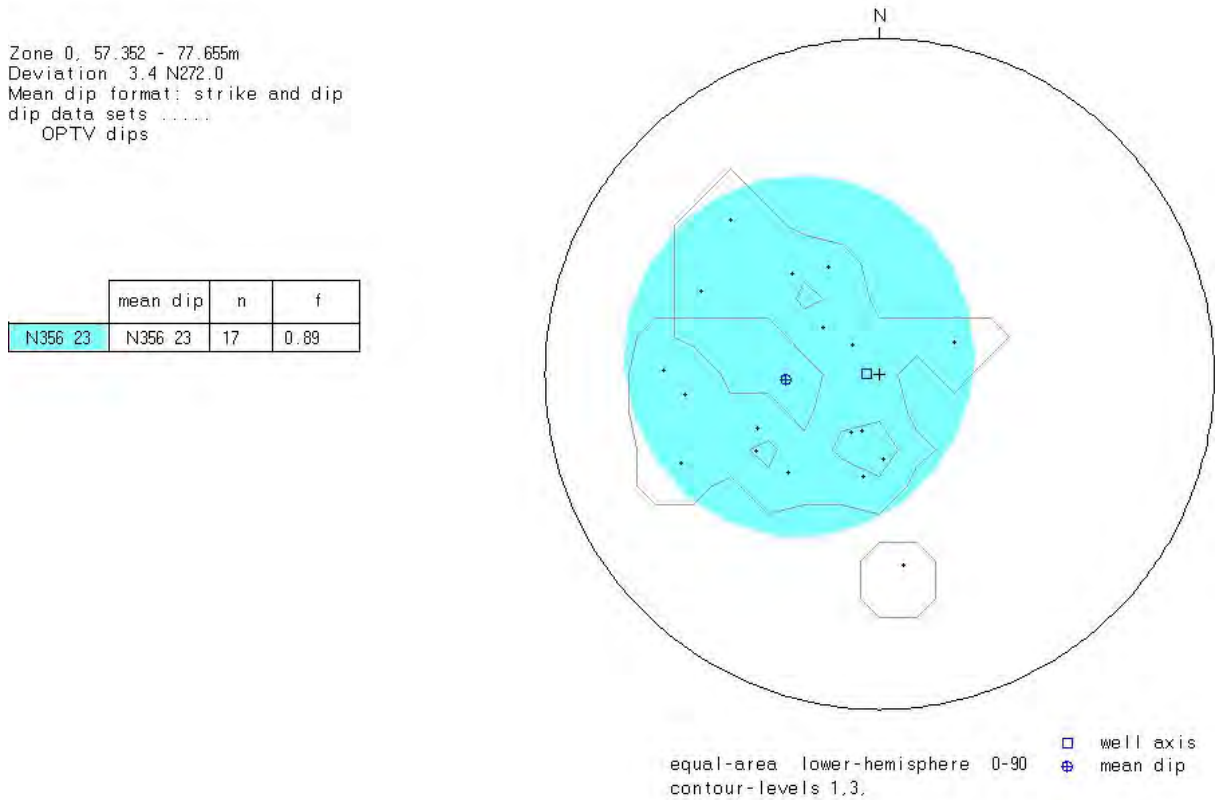
Figure 60. Contour plots, with poles of fractures, providing one main fracture set in the c. 57–77 m depth interval. Note that the strong dispersion of the 18 fractures provides a statistic analysis of low significance.

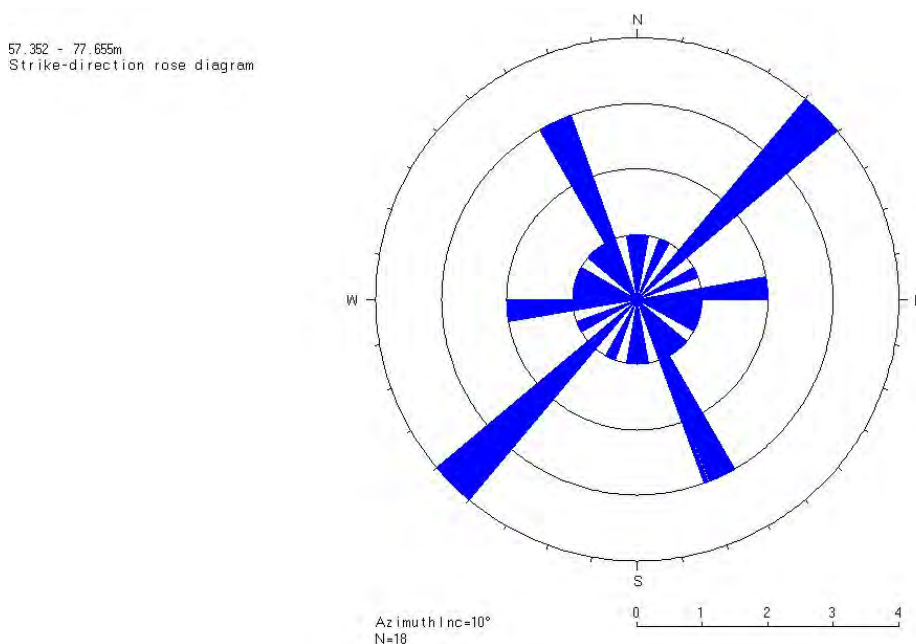
Figure 61. Rose diagram of the fractures in the 57–77 m depth interval.

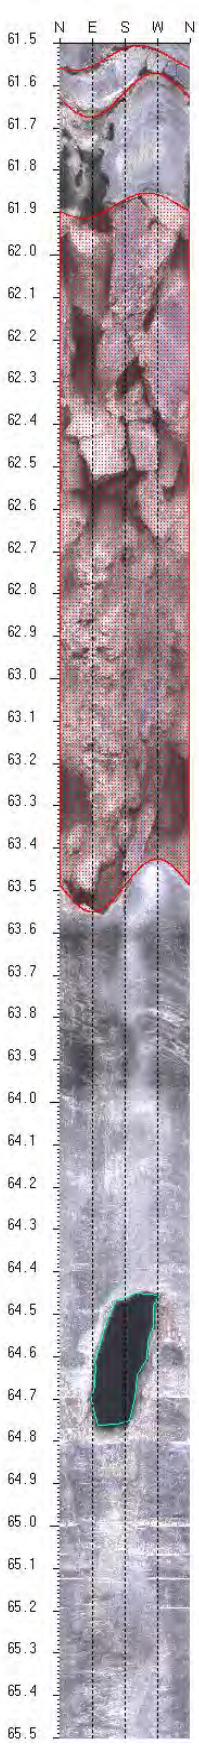
Figure 64. Optical televiewer synthetic images with digitised planar fractures in the 61.5–65.5 m depth interval (caption as on Figure 36).

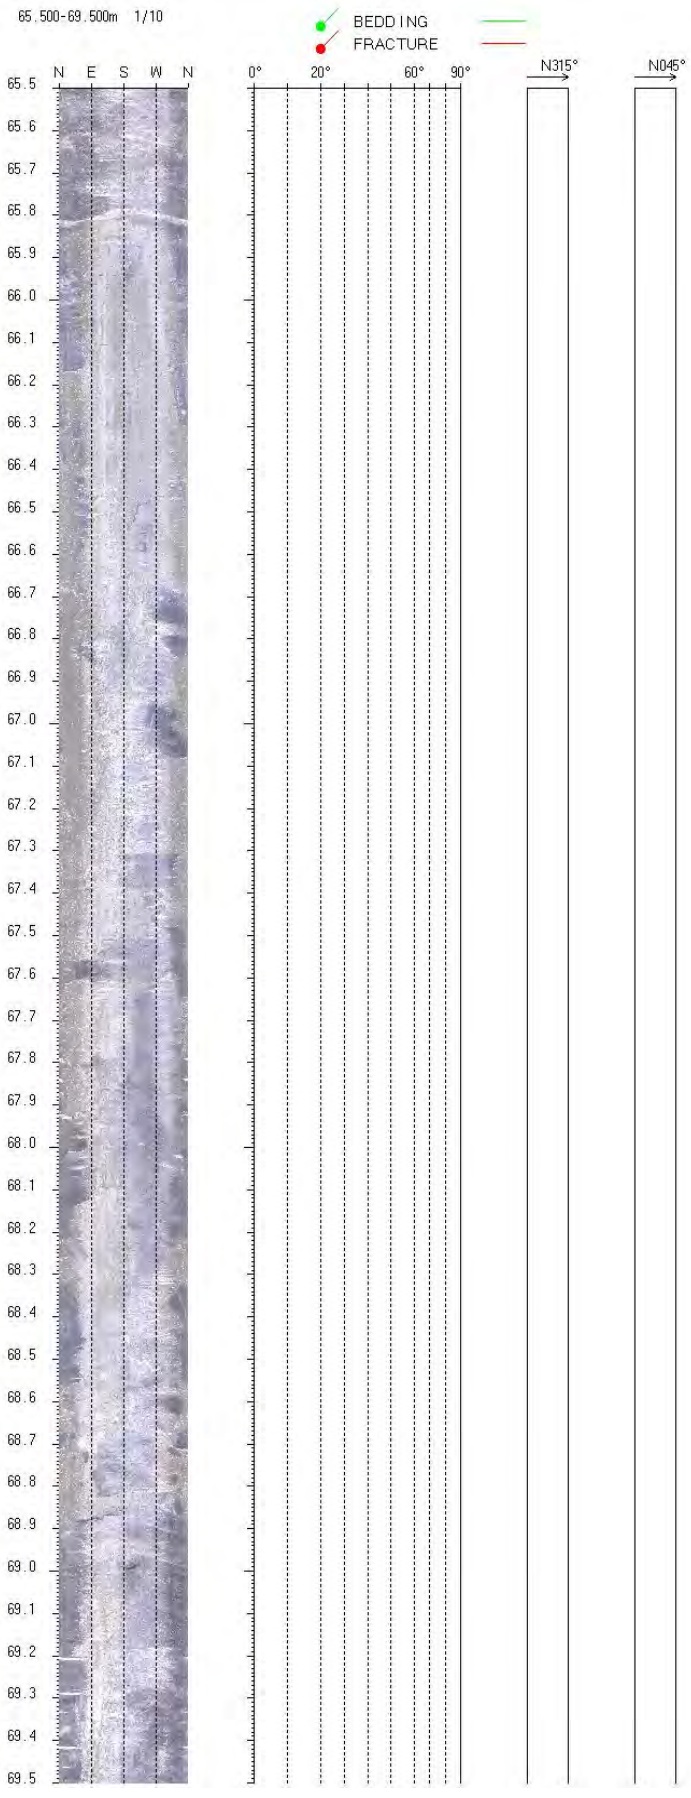
Figure 65. Optical televiewer synthetic images with digitised planar fractures in the 65.5–69.5 m depth interval (caption as on Figure 36).

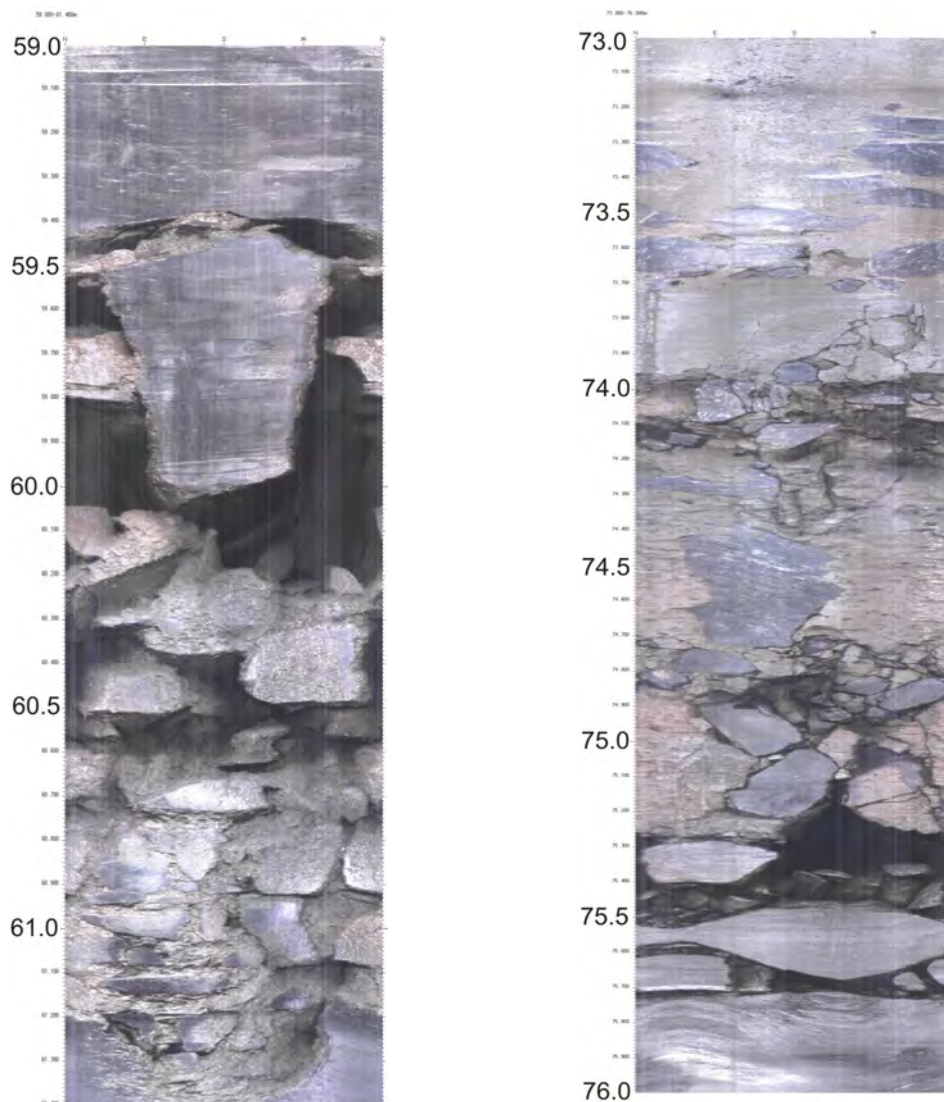
Figure 68. Optical televiewer images showing crushed zones at 59.4 m (left) and 73.2 m (right) depths. The filling of the fractures is partly cement, which was injected to stabilise the borehole. The cement is especially visible in the picture to the right as a grey mass.

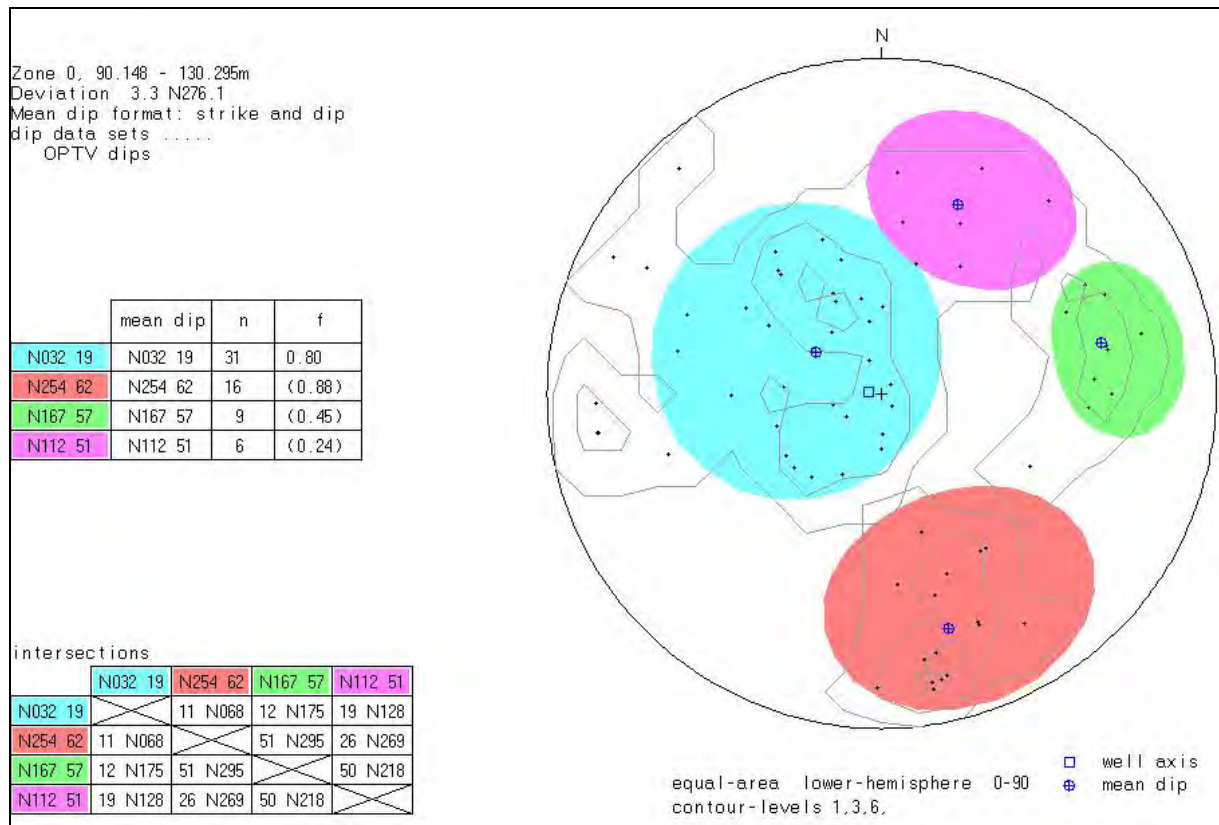
Figure 73. Contour plots, with poles of fractures, providing four main fracture sets in the c. 89–133 m depth interval.

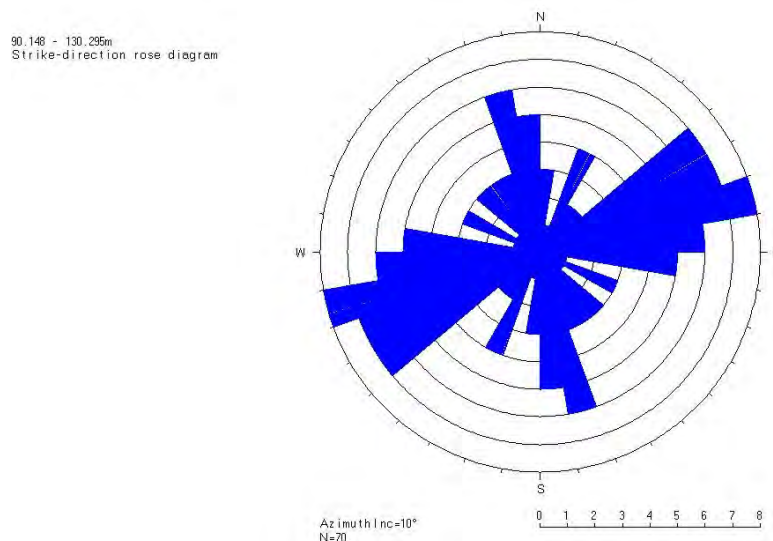
Figure 74. Rose diagram of the fractures in the 90–131 m depth interval.

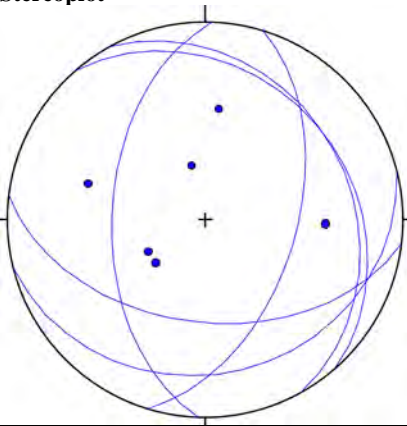
Depth [m]	Dip direction [°]	Dip angle [°]	Thickness [m]	Comments	Stereoplot
91.9	061	27	0.17	Crushed zone (see Figure 76)	
93.5	166	23	0.08	Crushed zone (see Figure 77)	
94.5	107	52	0.06	Open fracture (see Figure 77)	
111.7	049	27	0.07	Partially crushed zone (see Figure 80)	
112.1	284 (mean) 272 (bottom)	46 (mean) 51 (bottom)	1.12	Crushed zone (see Figure 80 and Figure 86)	
123.3	187 (mean)	39 (mean) 47 (bottom)	0.27	Partially crushed zone (see Figure 83)

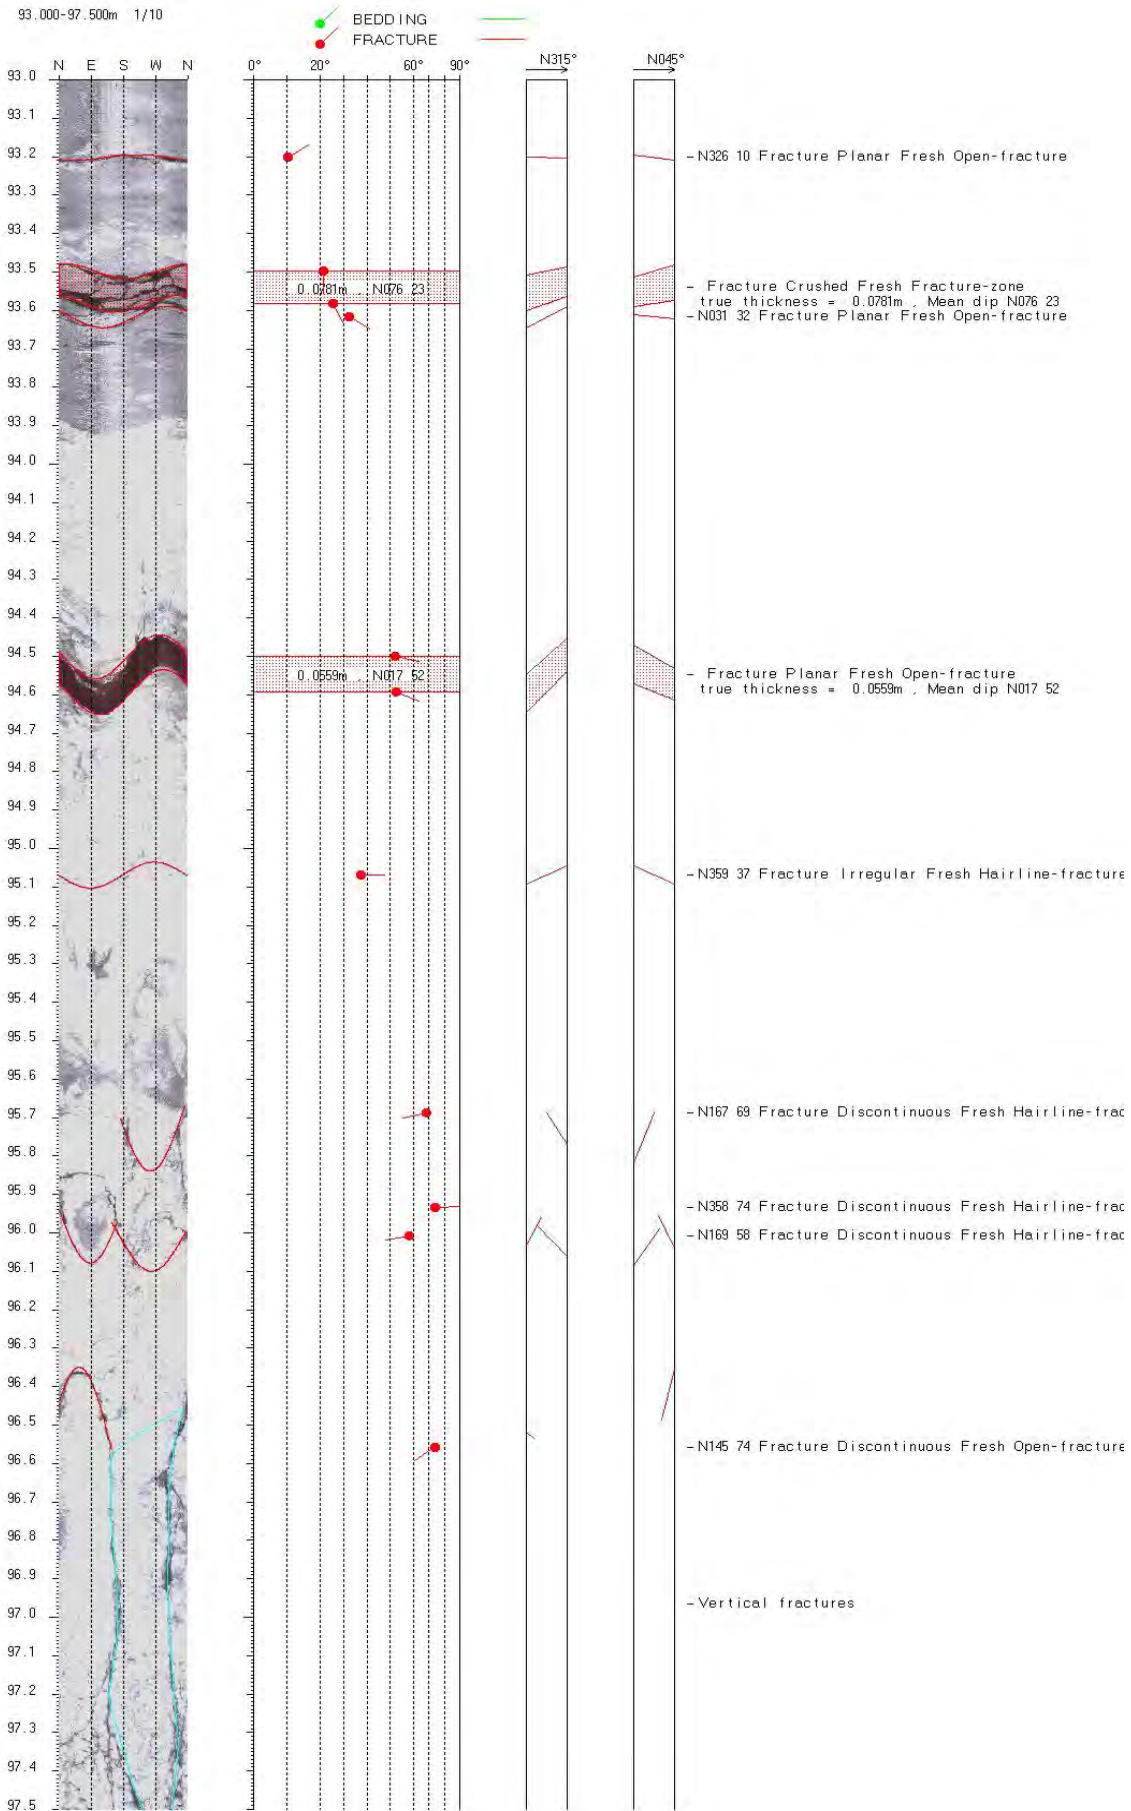
Figure 77. Optical televiwer synthetic images with digitised planar fractures in the 93–97 m depth interval (caption as on Figure 36).

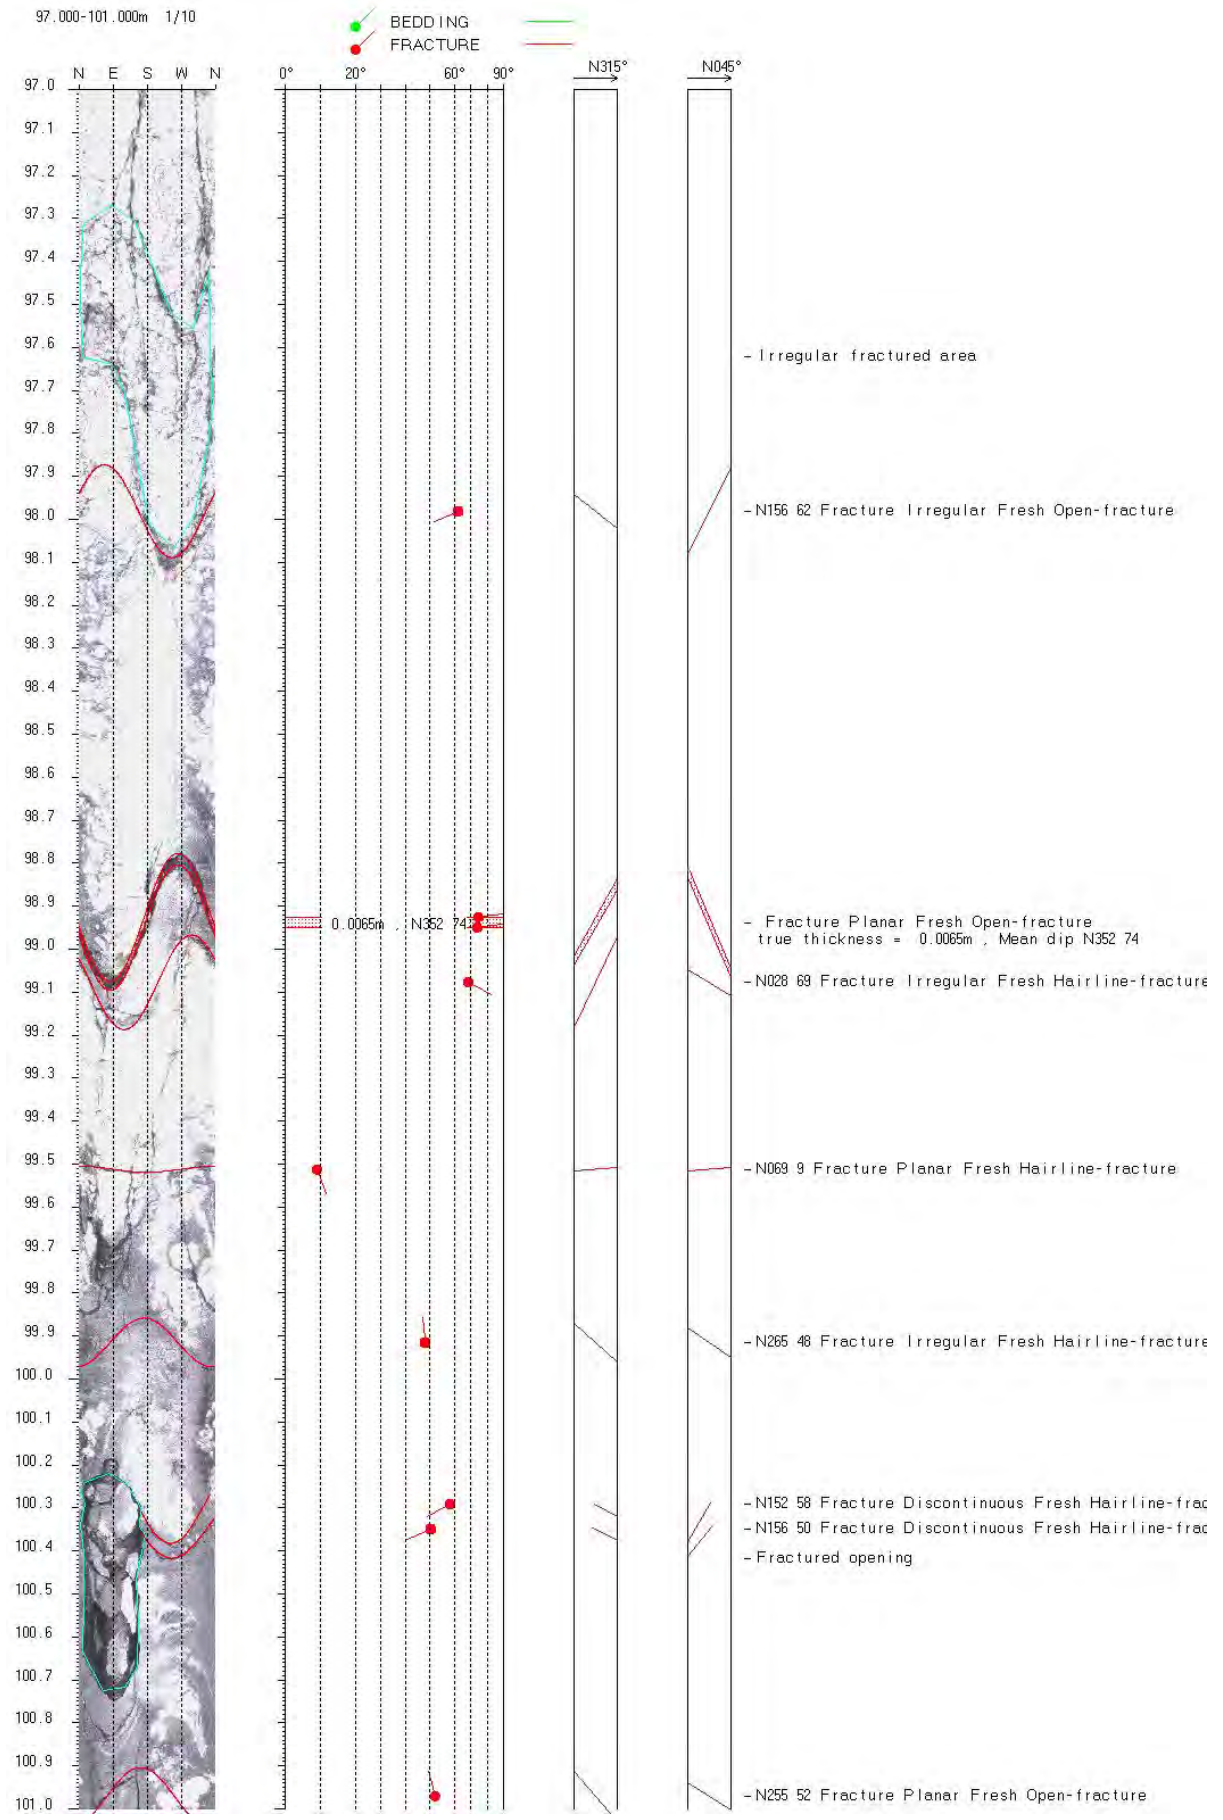
Figure 78. Optical televiwer synthetic images with digitised planar fractures in the 97–101 m depth interval (caption as on Figure 36).

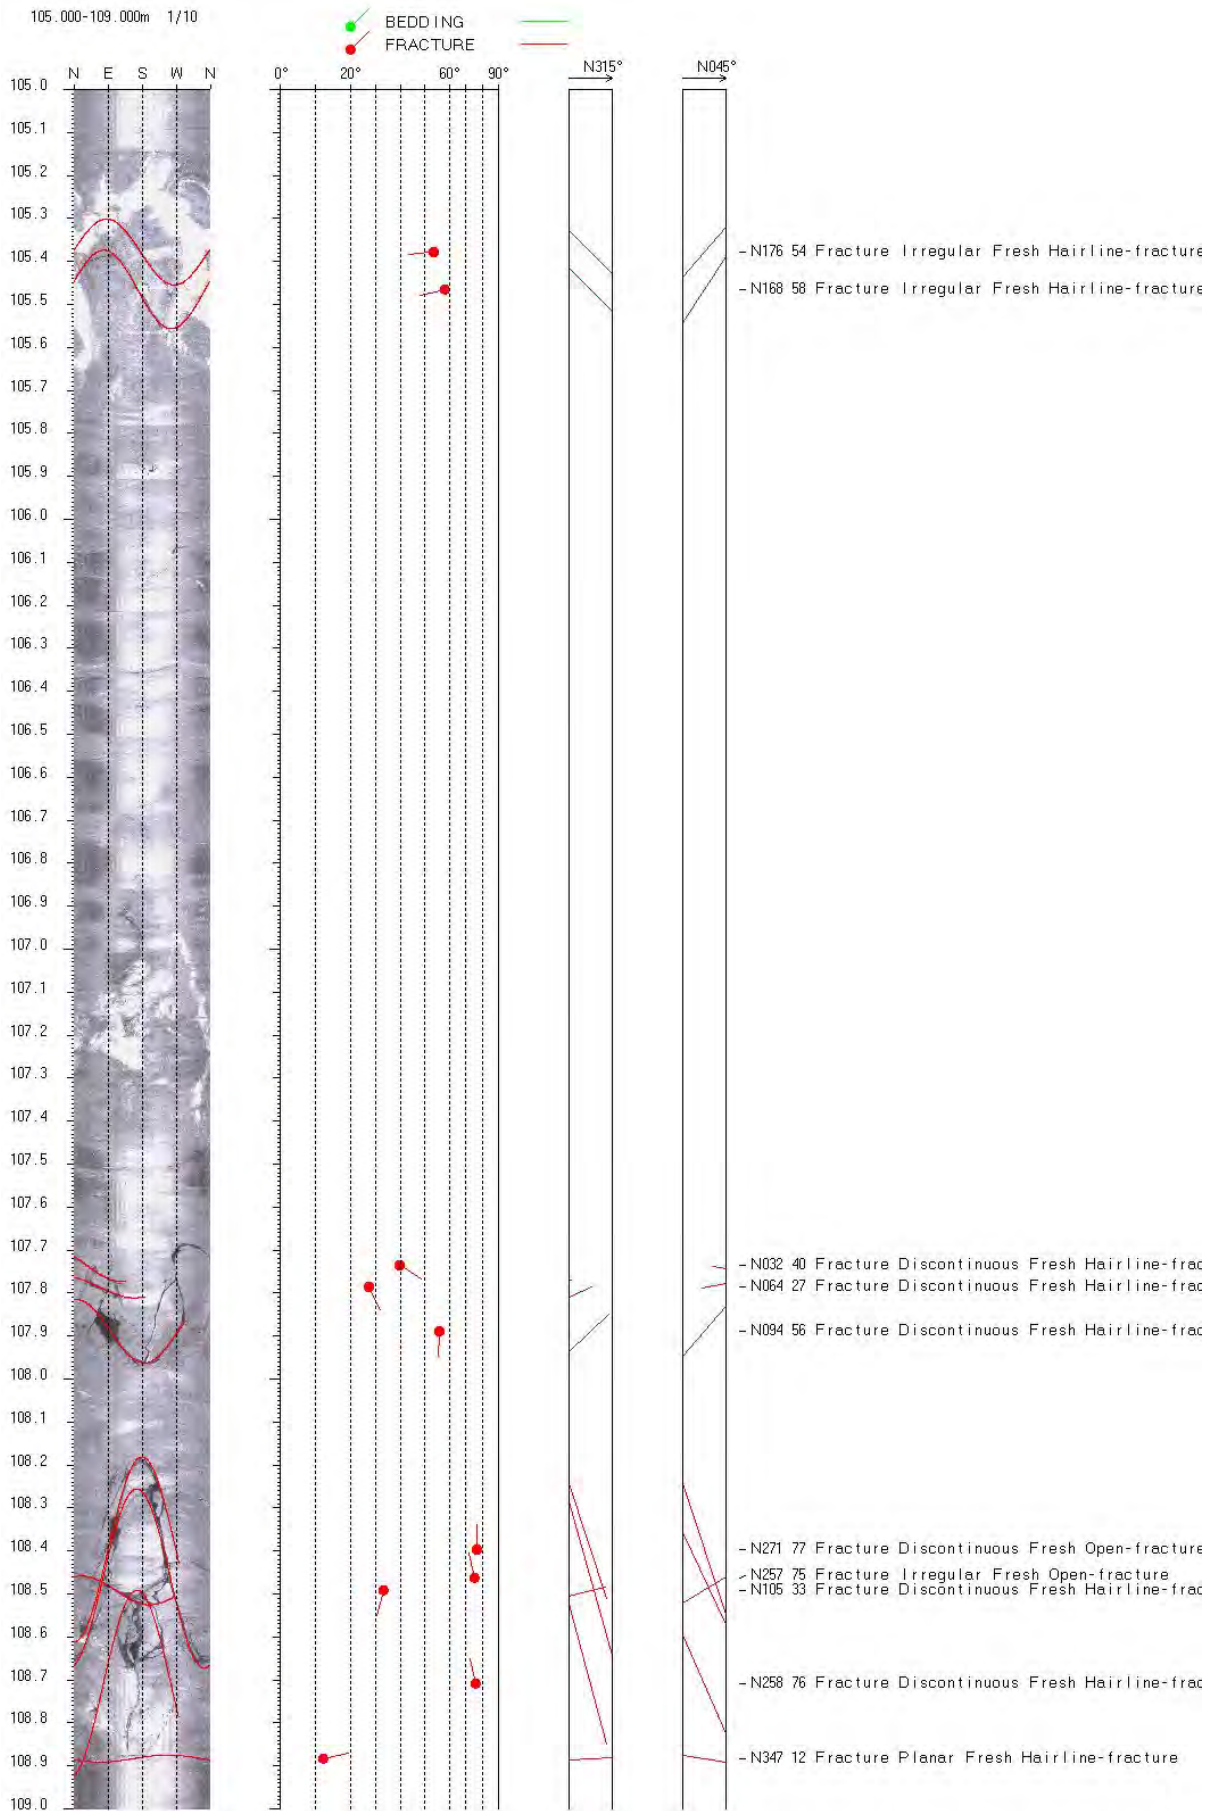
Figure 79. Optical televiewer synthetic images with digitised planar fractures in the 105–109 m depth interval (caption as on Figure 36).

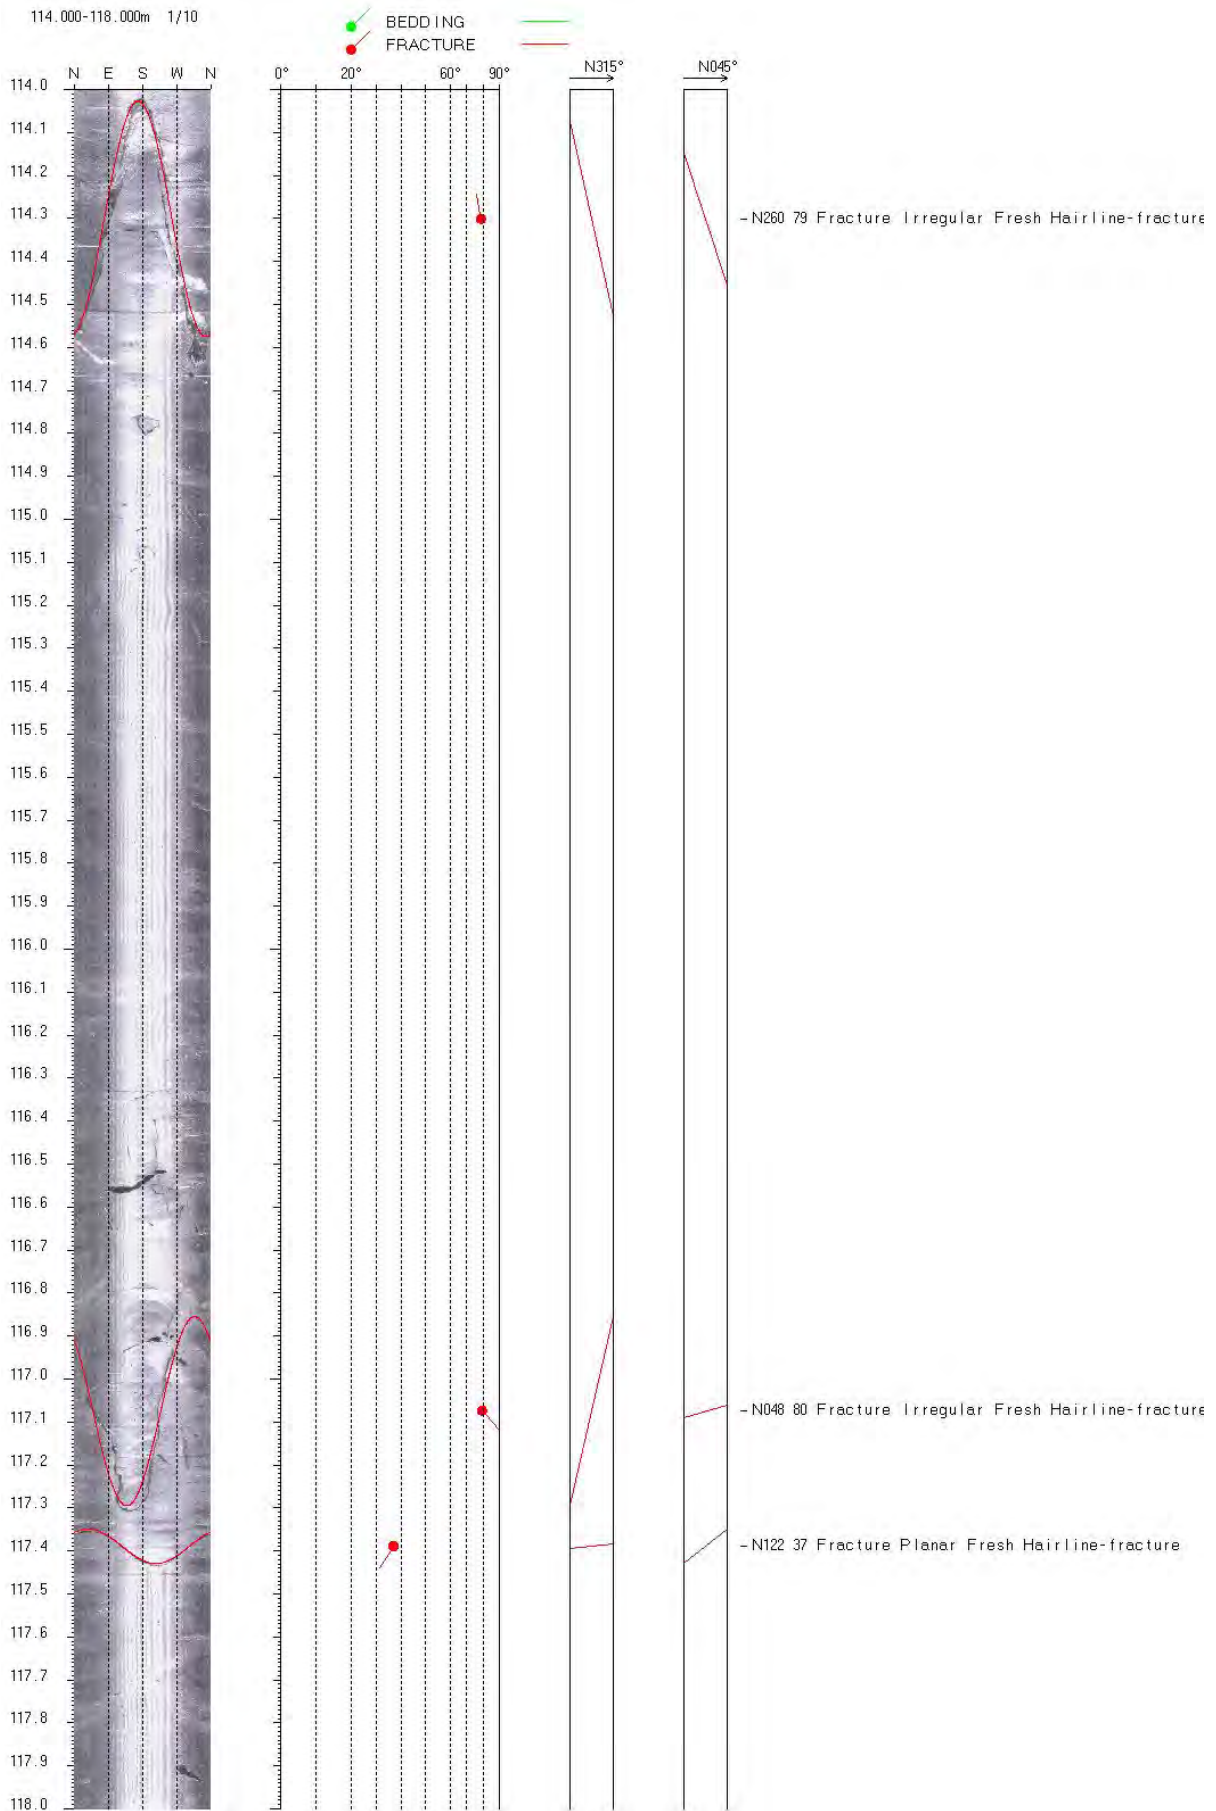
Figure 81. Optical televiewer synthetic images with digitised planar fractures in the 114–118 m depth interval (caption as on Figure 36).

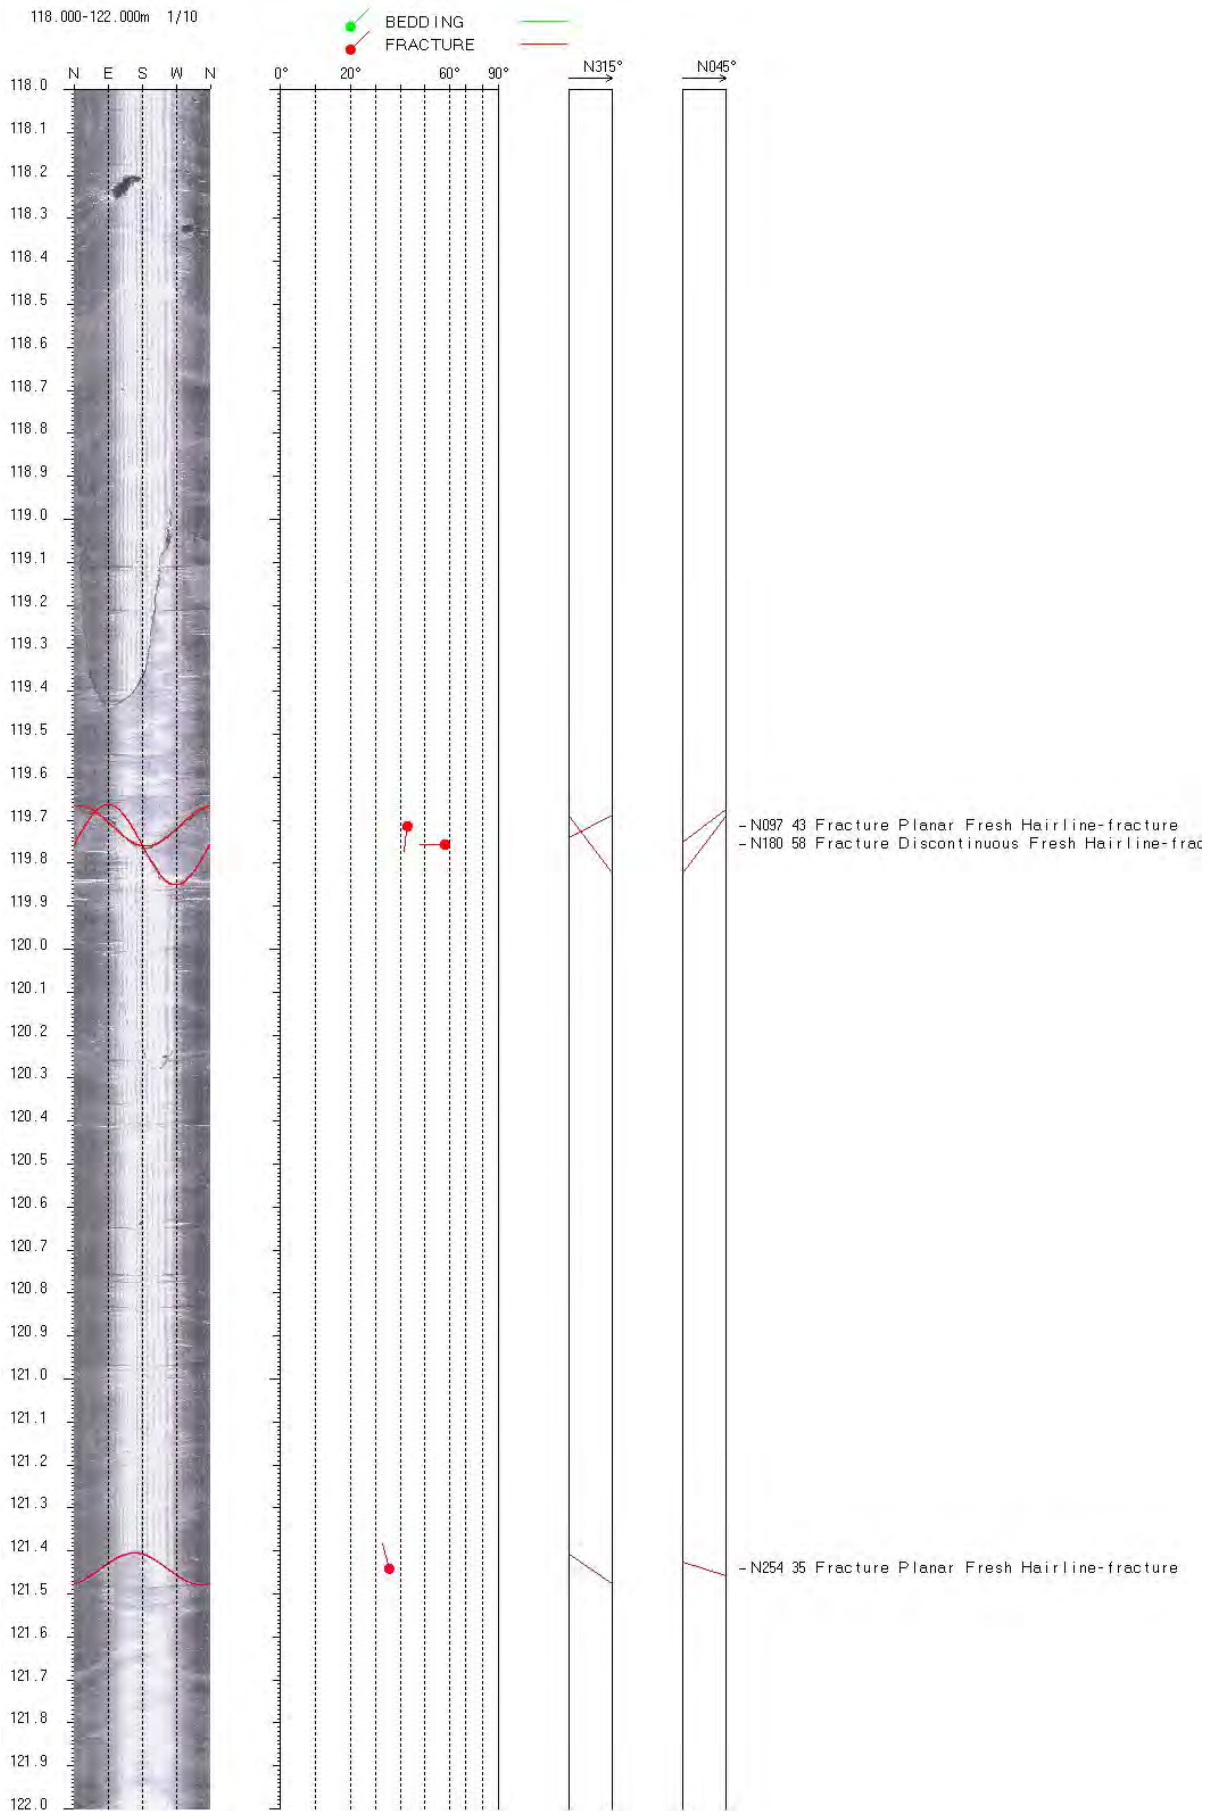
Figure 82. Optical televiewer synthetic images with digitised planar fractures in the 118–122 m depth interval (caption as on Figure 36).

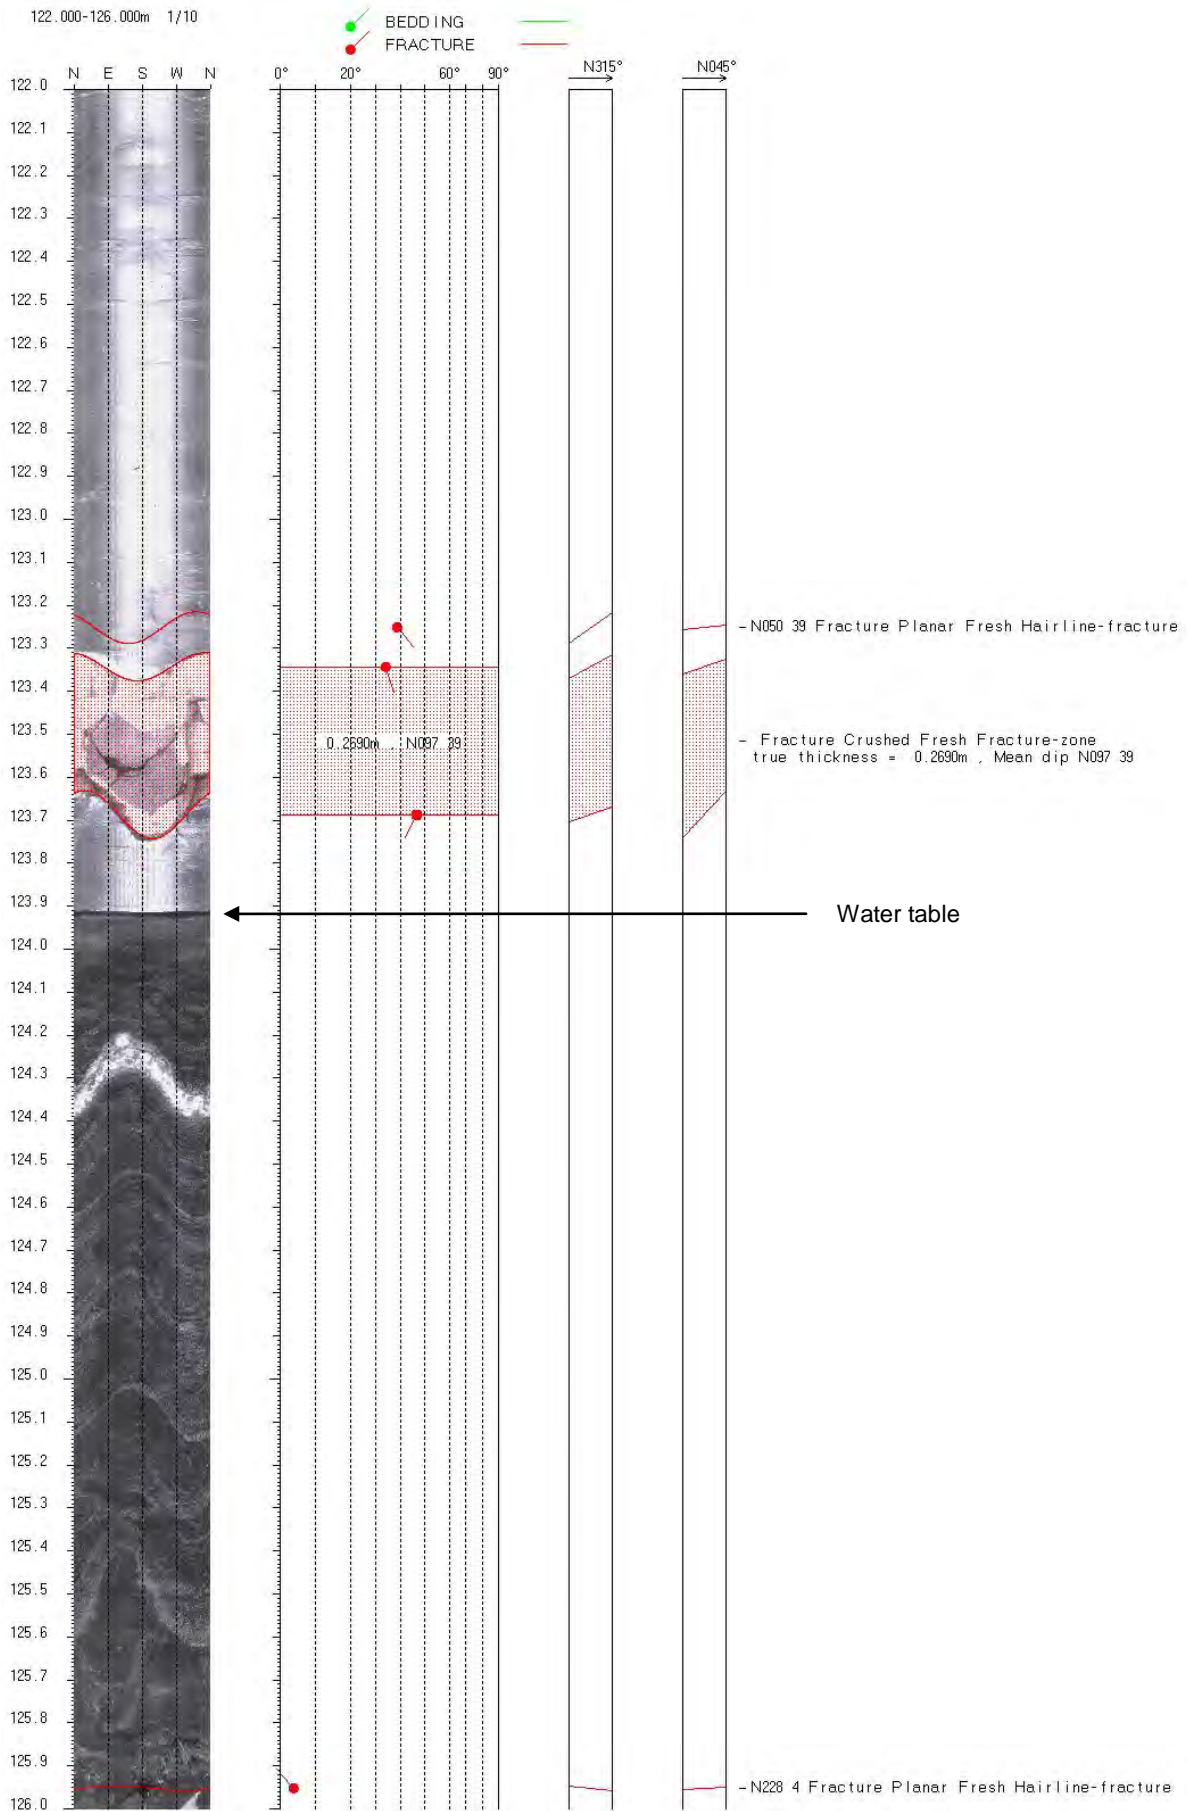
Figure 83. Optical televiewer synthetic images with digitised planar fractures in the 122–126 m depth interval (caption as on Figure 36).
