NGU Report 2011.026

Mannen unstable rock slope (Møre & Romsdal):
Logging of borehole and drill core KH-01-10,
geomorphologic digital elevation model
interpretation & displacement analysis by
terrestrial laser scanning

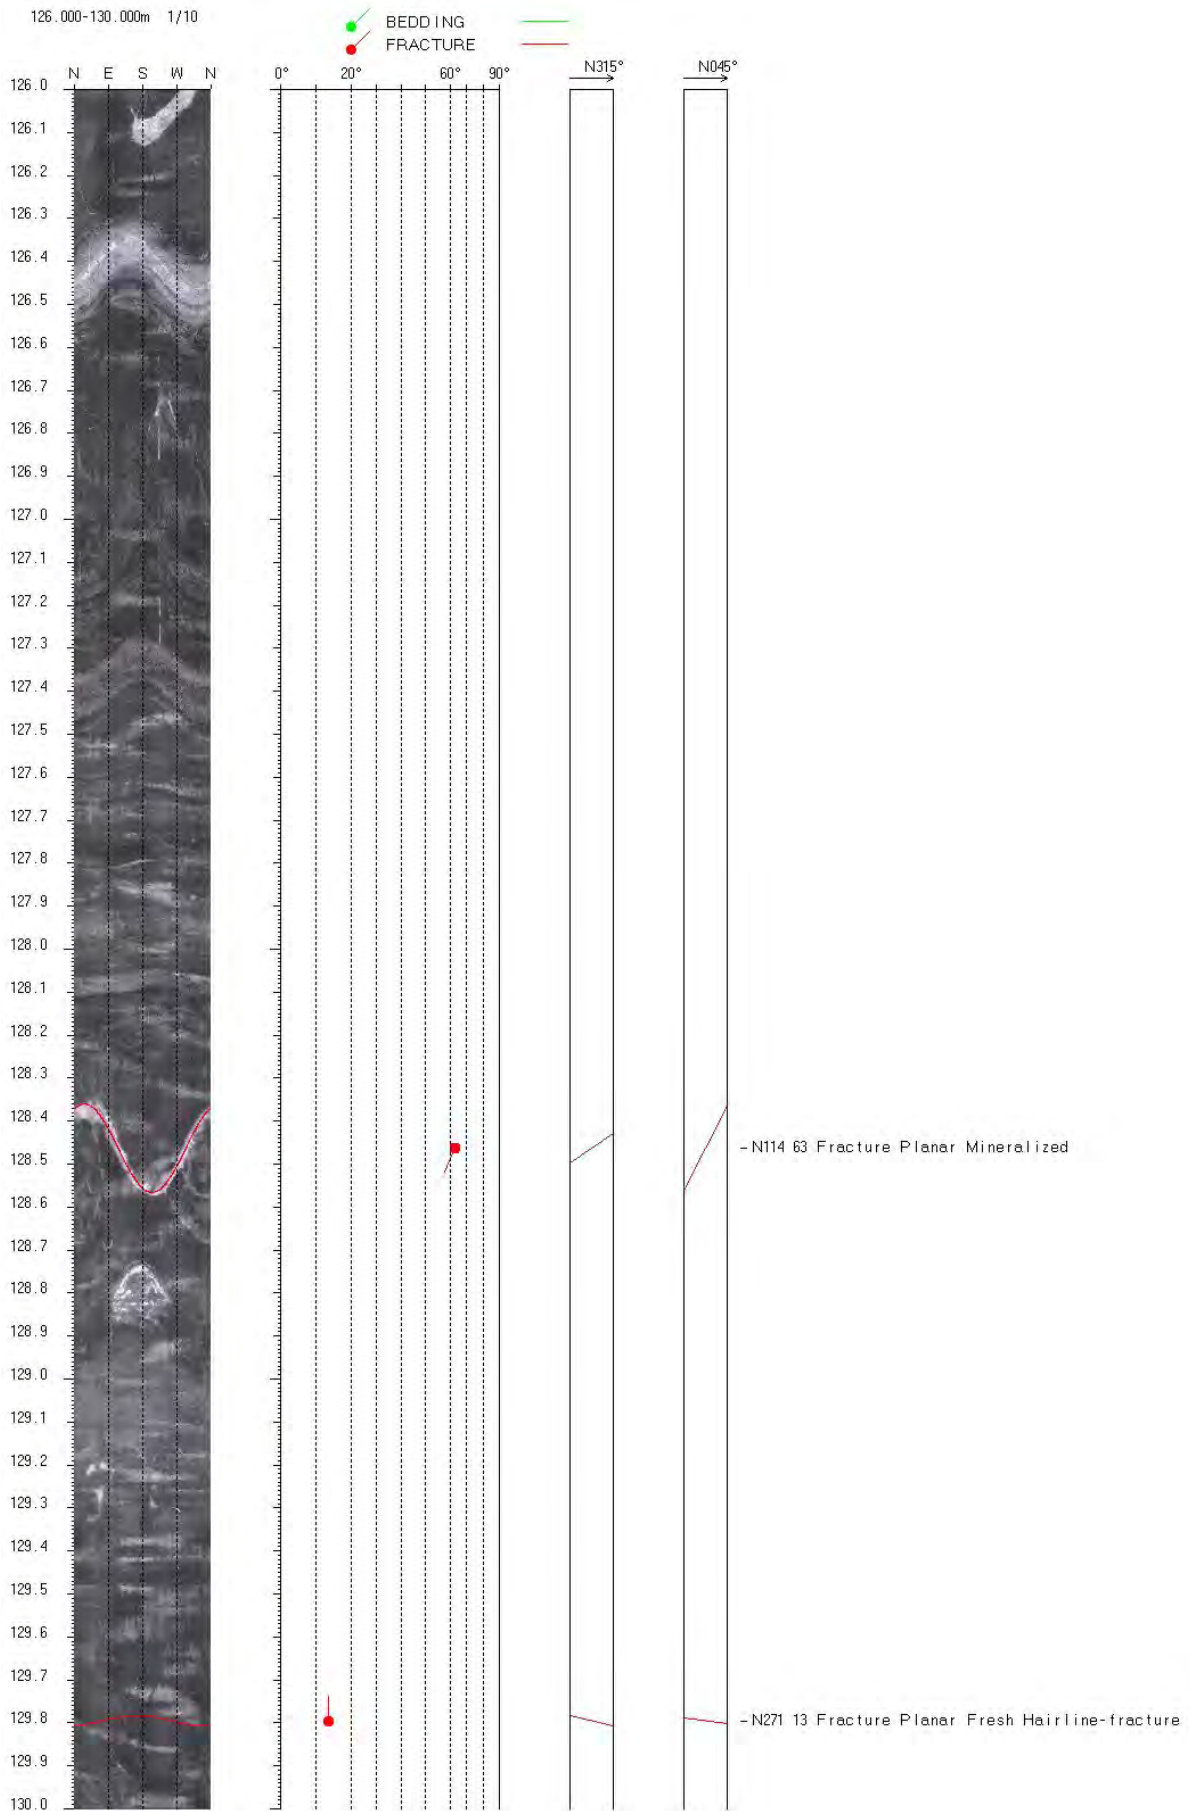
Figure 84. Optical televiewer synthetic images with digitised planar fractures in the 126–130 m depth interval (caption as on Figure 36).

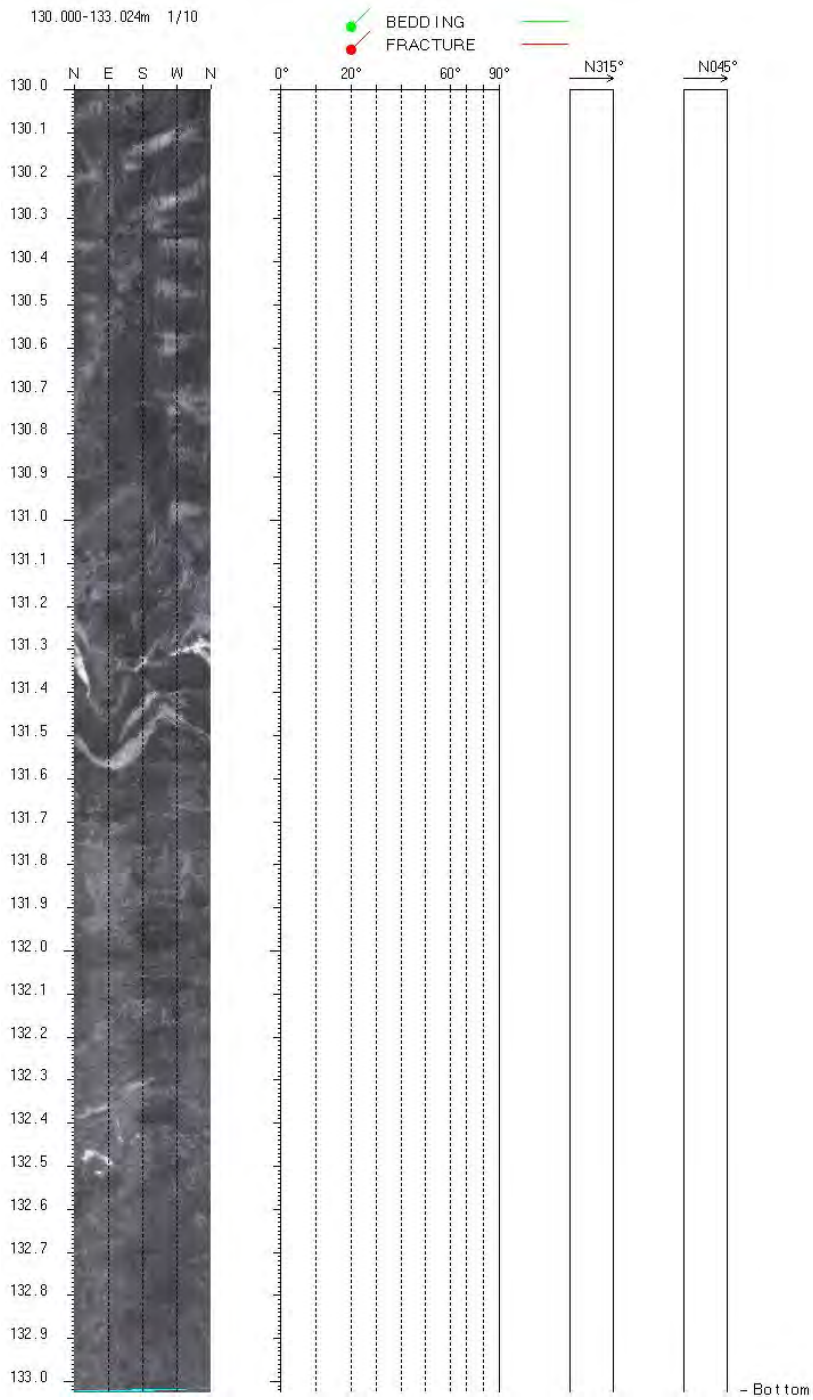
Figure 85. Optical televiewer synthetic images with digitised planar fractures in the 130–133 m depth interval (caption as on Figure 36).

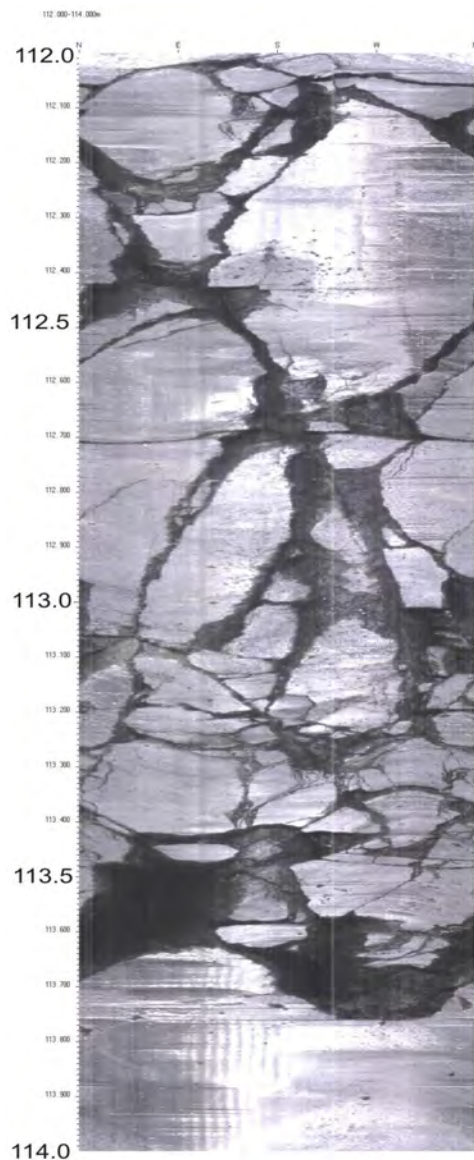
Figure 86. Optical televiewer images showing a crushed zone in the 112–114 m depth interval.

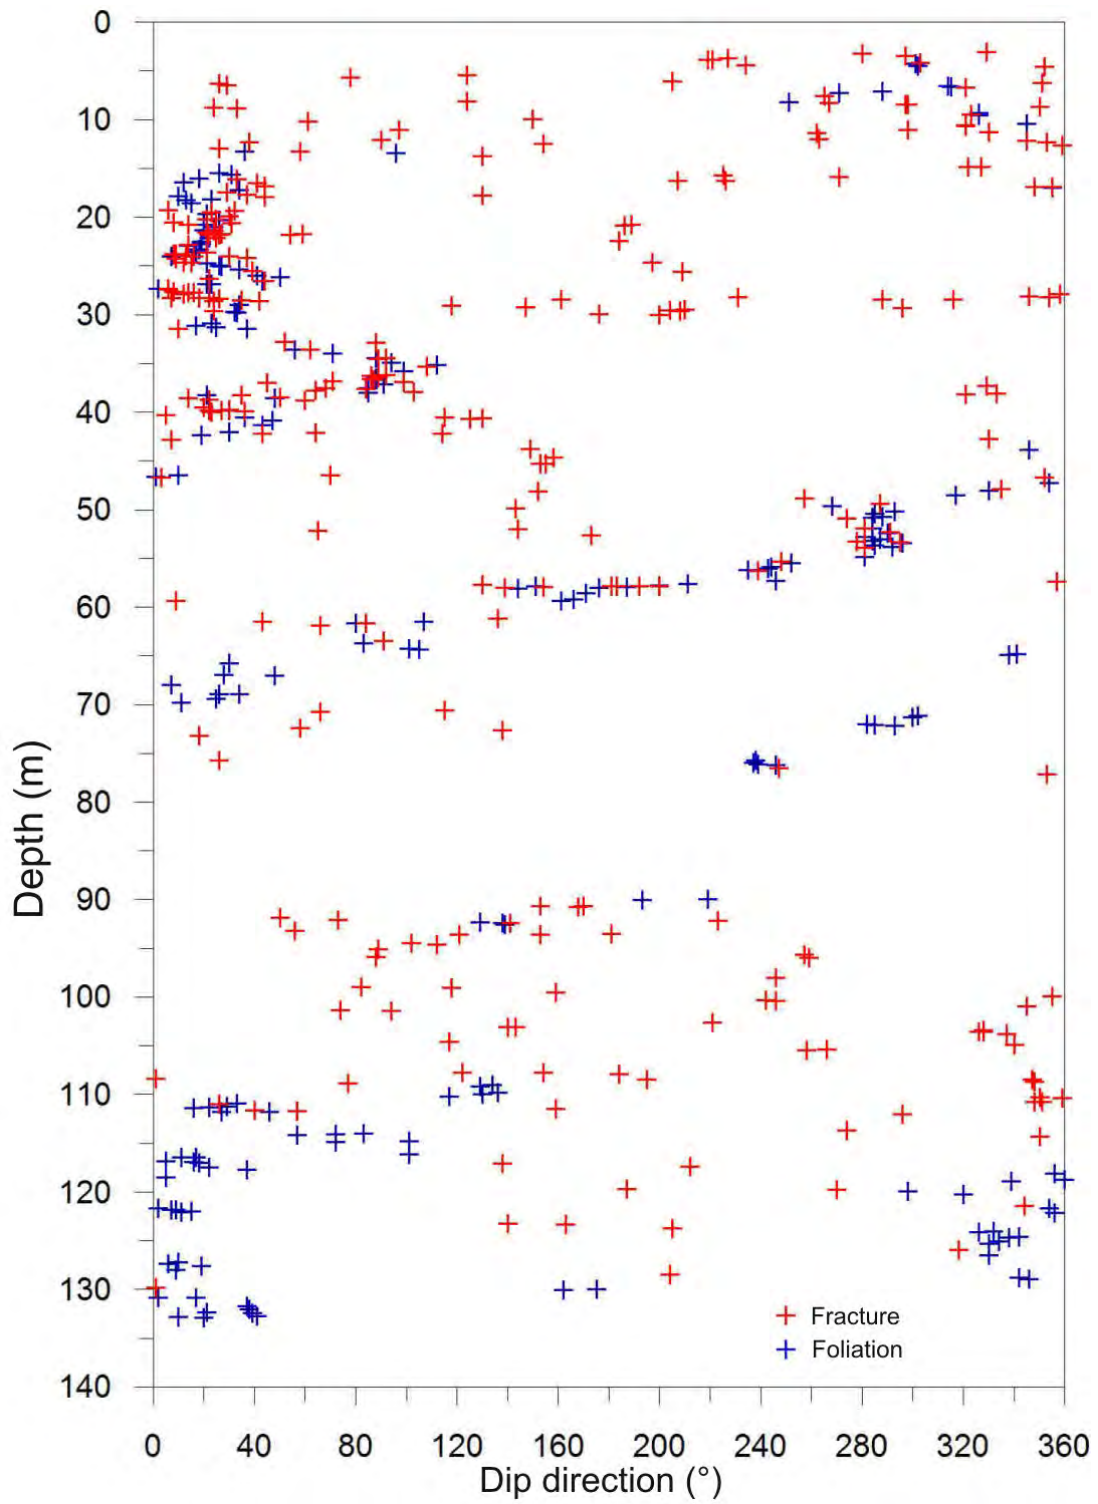
Figure 87. Dip direction of fractures and foliation in function to depth.

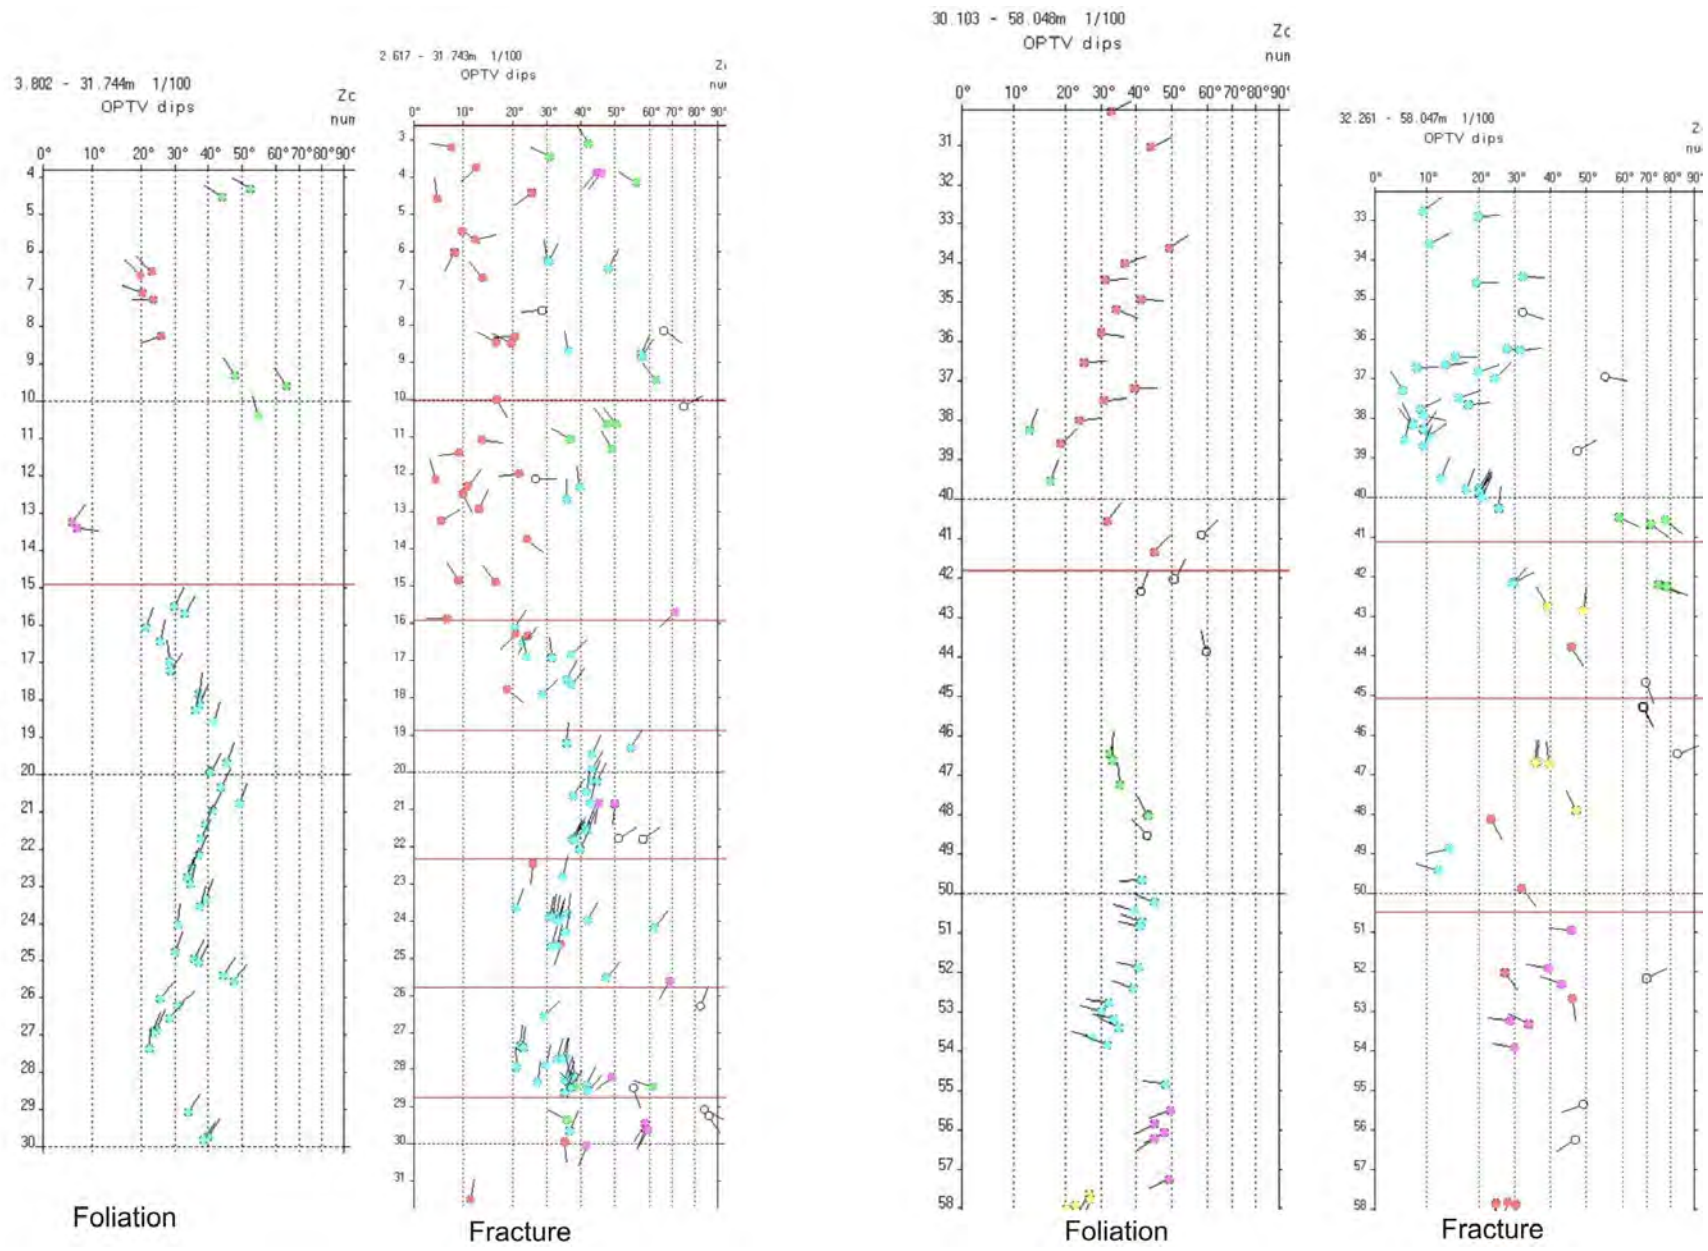
Figure 88. Arrow plots of the foliation and fractures planes in the 4–58 m depth interval.

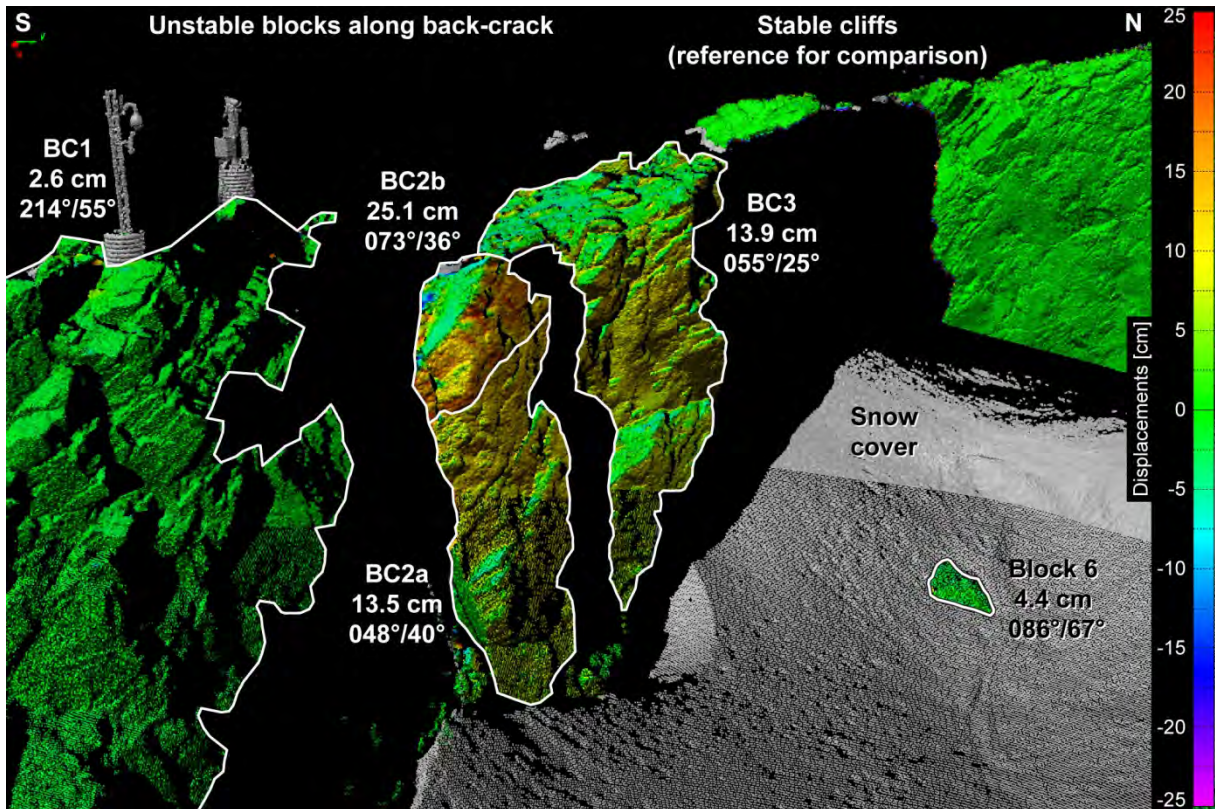
Figure 95: Shortest distance comparison for the 4 blocks along the back-crack (view to the W). The three columns are detached from the stable rock mass behind. The middle column can be divided into two parts BC2a and BC2b with high displacement rates (25 cm) for the latter.
