NGU Report 2001.108

Hazard evaluation of rock avalanches; the
Baraldsnes - Oterøya area

Report no.: 2001.108		ISSN 0800-3416	Grading: Open
Title: Hazard evaluation of rock avalanches; the Baraldsnes - Oterøya area			
Authors: Blikra, Lars H. ¹ , Braathen, Alvar ¹ & Skurtveit, Elin ² (¹ NGU ² NGI)		Client: Hydro Technology and Projects	
County: Møre og Romsdal		Commune:	
Map-sheet name (M=1:250.000) Ålesund		Map-sheet no. and -name (M=1:50.000) Brattvåg (1220 III); Vestnes (1220 II)	
Deposit name and grid-reference:		Number of pages: 33	Price (NOK): Kr. 260,-
Fieldwork carried out: September 2001		Date of report: 15.02 2002	Map enclosures:
Fieldwork carried out: September 2001		Date of report: 15.02 2002	Project no.: 2962.01
Fieldwork carried out: September 2001		Date of report: 15.02 2002	Person responsible:

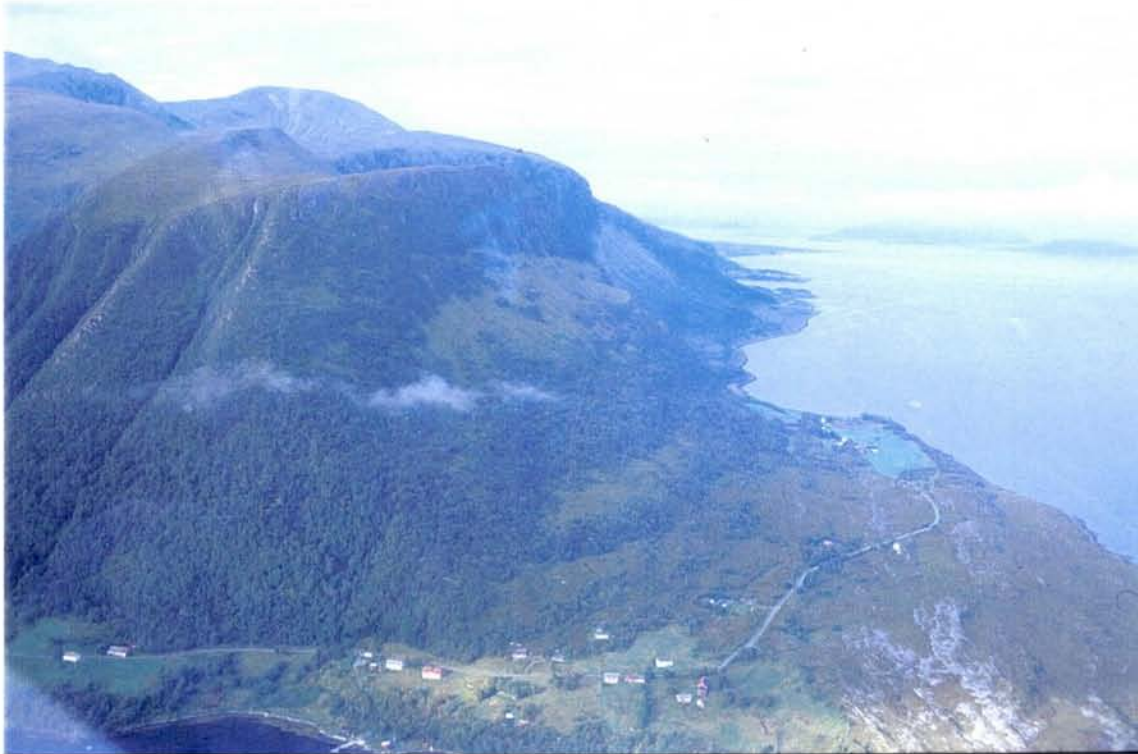
Figure 3. View from the NE towards the Baraldsneset peninsula and the mountain Skårahornet.

On the mountain above Baraldsneset, there are no signs of significant instability. At places, fractures reactivate the steep foliation, and some cross-fractures divide the rock into large blocks (Figs. 3, 4 and 5). Fracture frequencies¹ (ff) are low, generally in the range of 1-2 fractures/metre. One minor fracture zone, oriented nearly perpendicular to the slope, was identified. Here, ff reached 3-4. Importantly, on the mountain and especially marginal to the steep slope, no observed blocks appear to be unstable. The only observations of instability

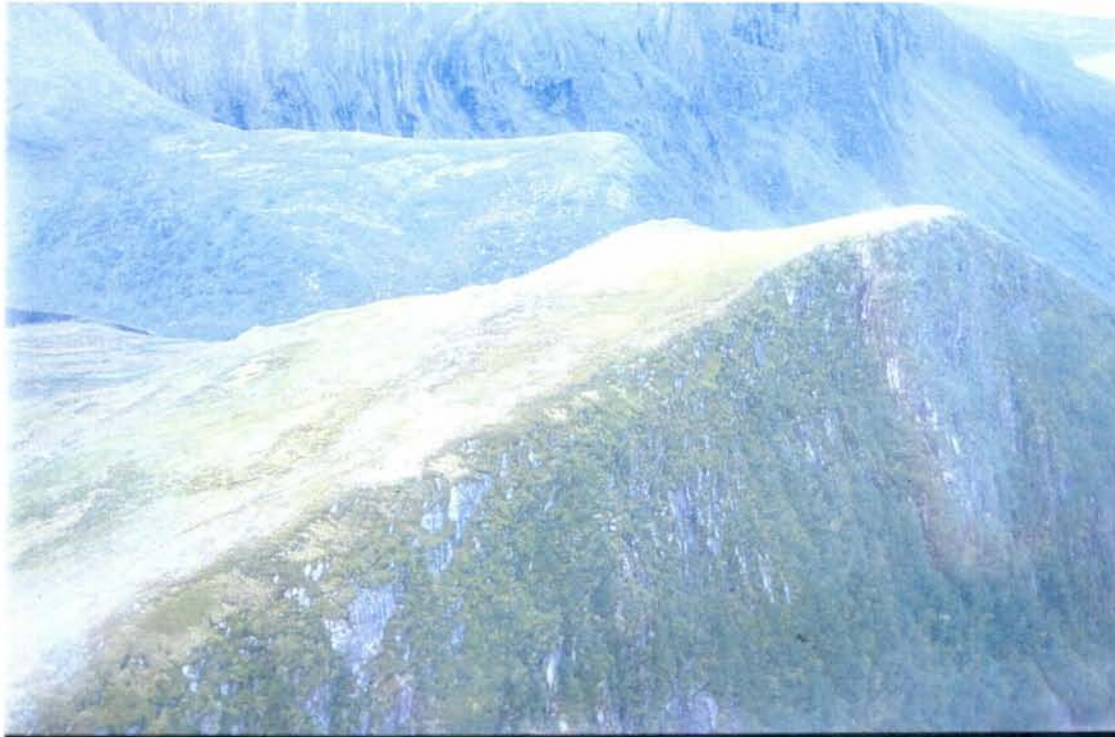
Figure 4. The Skårahornet mountain viewed from the ENE.

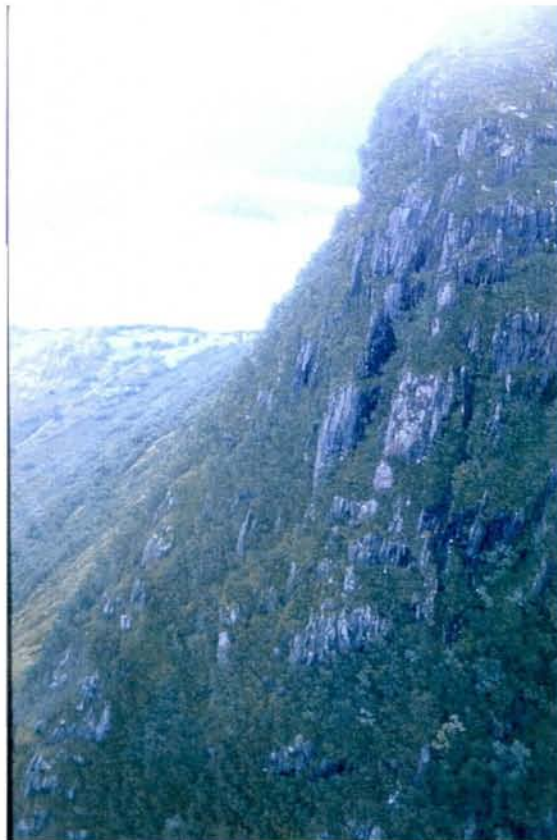
Figure 5. The Skårahornet mountainside viewed from the west. Note the step-like geometry caused by the foliation and block fall-out from the rock-face.

were found along the upper part of the slope. There, cm-wide, open crevasses along the upper and inner margin of blocks (Fig. 5) indicate movement by rotation. A fall-out or toppling process generally causes collapse of single blocks.

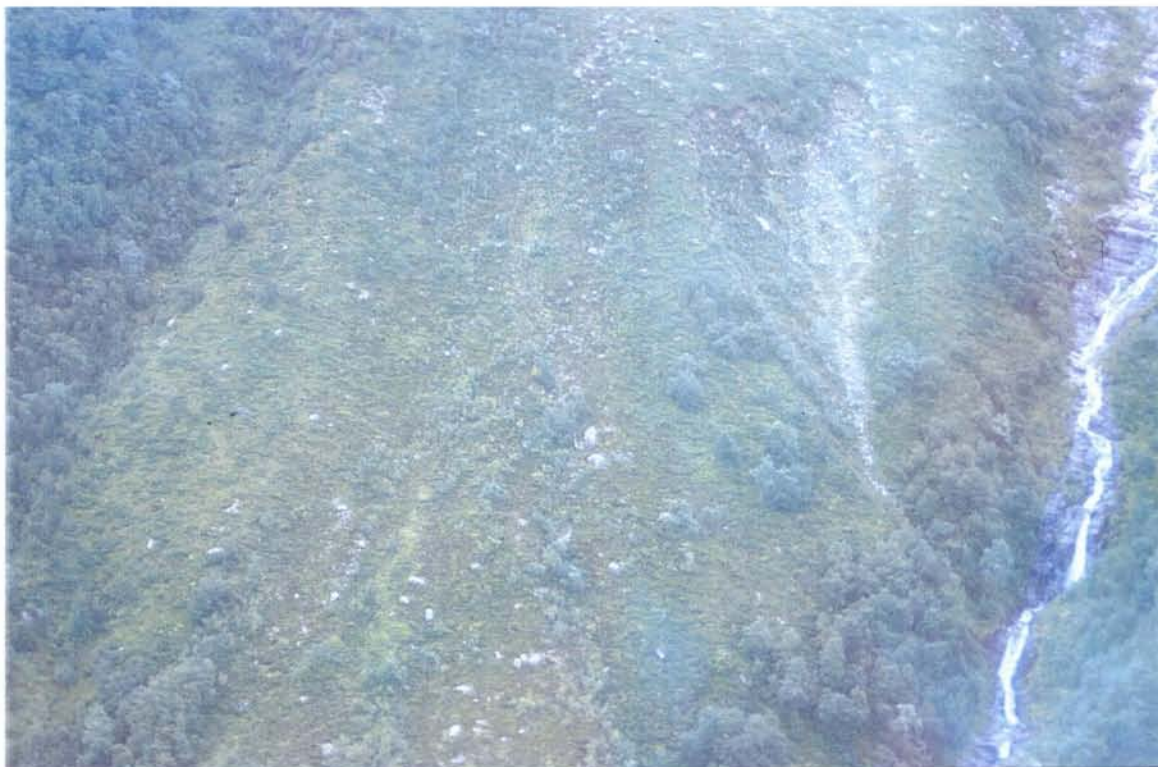
Figure 7. Photograph from Koppelva showing a slide scar from debris flow. The small valley is filled with a relatively thick glacial-till cover

The small valley along Kloppelva, south of Skår, are characterized by a relatively thick cover of glacial till. Kloppelva marks a deep incision (debrisflow channel) into this till cover, and debrisflow tracts also occur further east (see Fig. 6). Debrisflows along Kloppelva have developed a large fan extending from 100 m above sea level to the shoreline. Some of the debrisflow events that have occurred are relatively large with up to 2 m high lateral levees and individual boulders more than 2 m in diameter. There are also distinct slide scars in the glacial till further east (Fig. 7), and two well-defined debrisflow channels run down against Skår (Fig. 6). Blocks triggered from the western slope of Skårhornet may trigger debrisflows in the glacial-till and such events may reach the depression just south of Einargården.

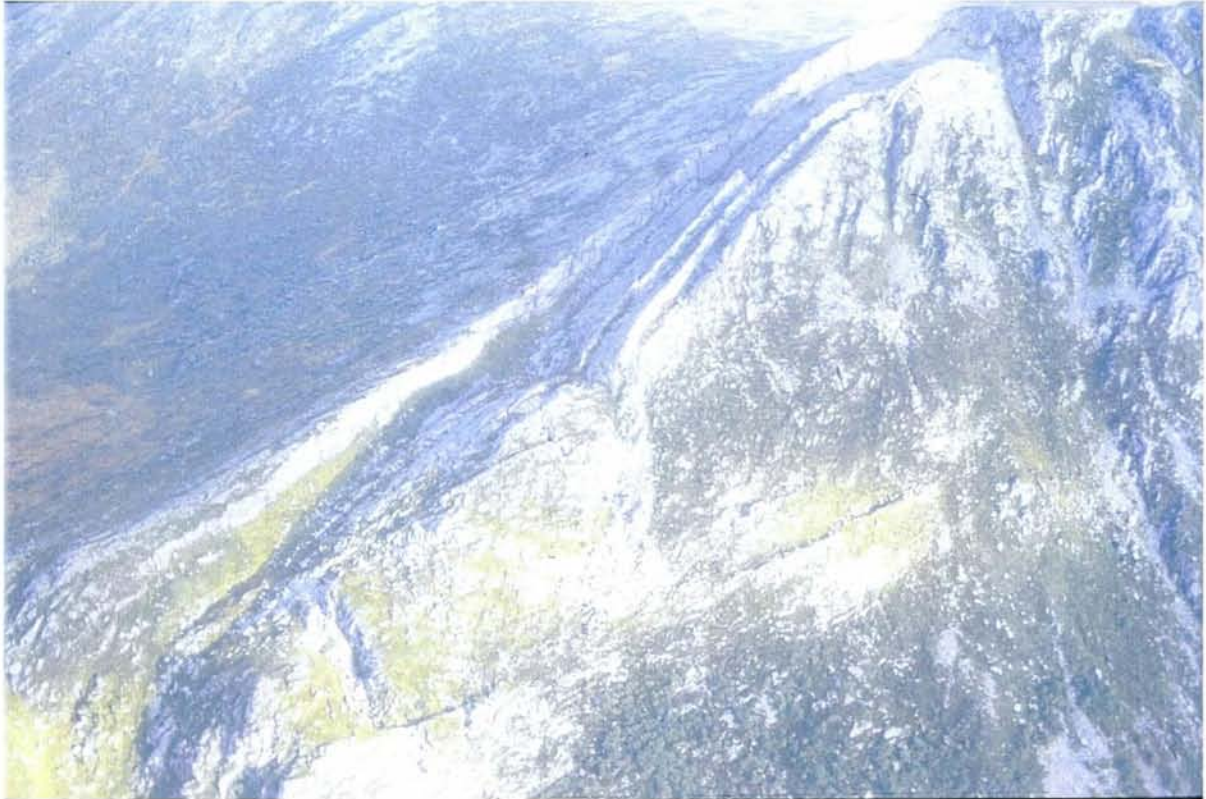
Figure 10. View from the south of the mountain-side below Oppstadhornet. Main features of the collapse field are displayed in the line drawing.

The slide-block field is approximately 600 m wide and 1 km long/high, and is characterised by significant internal faulting/sliding marginal to larger collapse structures (Figs. 10 and 11). The field is bound by three key structures. In the west, a NW-SE striking and steeply NE dipping fracture-zone, reactivating a Devonian (?) fault, is clearly visible. The fracture-zone forms a transfer structure that has seen highly down-oblique sliding, and that forms the western termination of the collapsed field. Above the field, the main, upward-bounding structure is clearly displayed as an escarpment (Figs. 12 and 13). This structure is

Four blocks with different deformation style have been identified within the slide-block field (see blocks of Figs. 9 and 10). A southwestern block (block 1) is moderately shattered. Internally, this block shows indications for minor down-SE sliding (< 1 m) on SW-NE striking fractures; however, the main structure is the bounding NW-SE cross-fracture zone to the NE, which reveals down-S movement. The next block to the NE, block 2, is deformed in a similar fashion, albeit deformation is more intense. There has been moderate (< 2 m) down-SE movement on SW-NE striking fractures, and some NE-SW striking cross-fractures reveal down-S and sinistral separation. Some also appear as open fissures, consistent with sub-

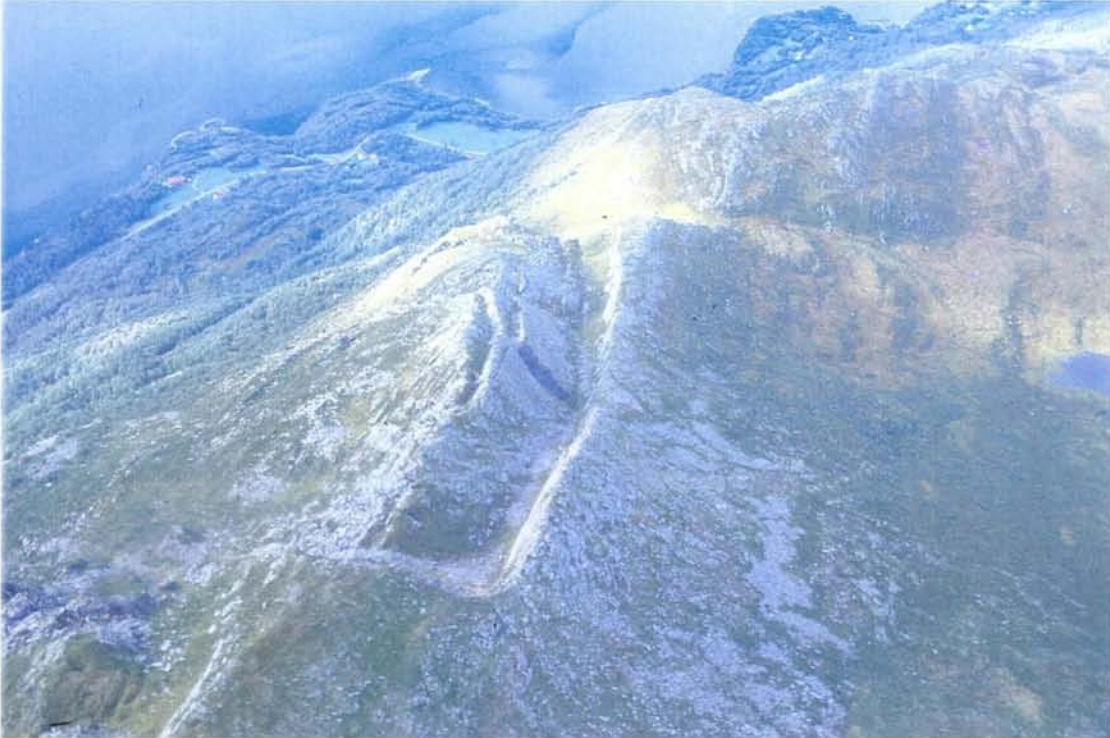
Figure 11. View from the north, showing the master fault in the back of the collapse field, and a major, wide-open cross-crevasse.

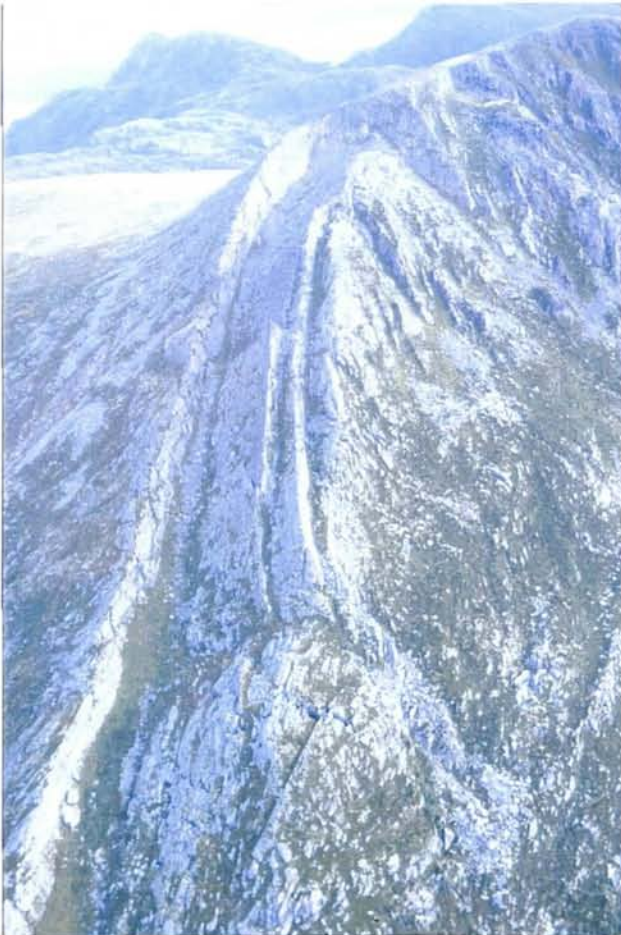
Figure 12. View from the southwest of the collapse field of Oppstadhornet. Note the bounding master fault and both strike-parallel and cross-fractures that subdivide the area into several blocks.

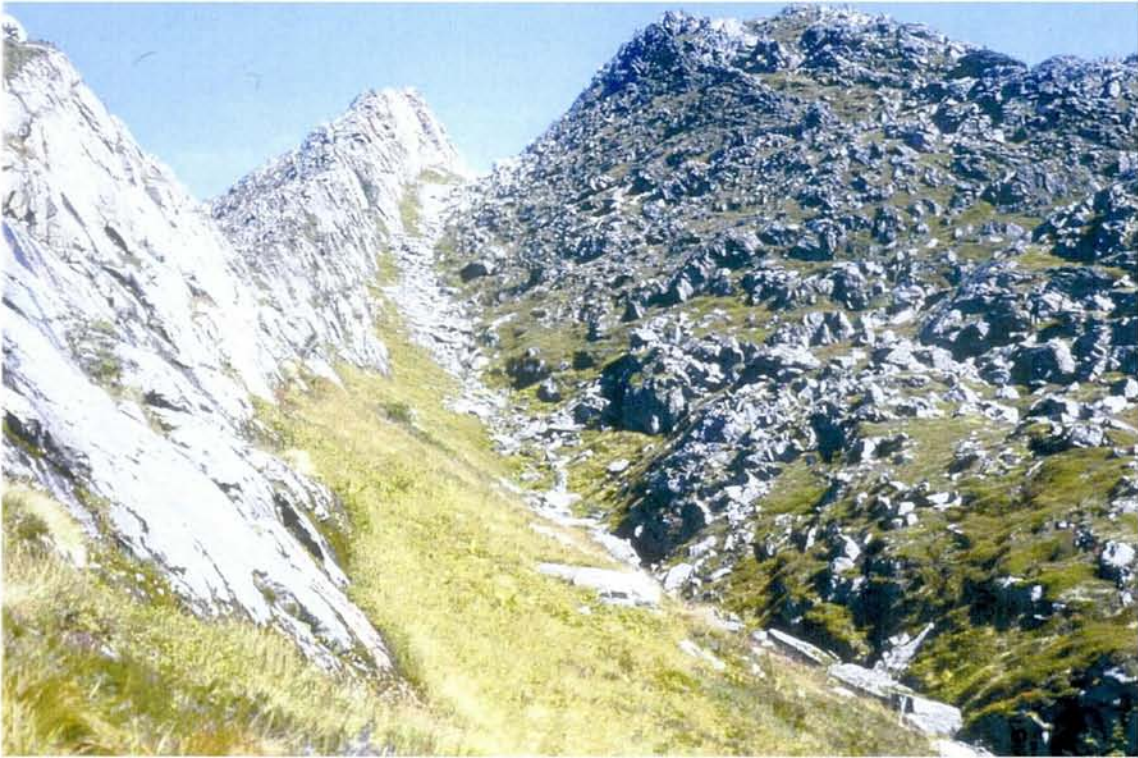
Figure 13. Close-up photograph of the master fault in the back of the collapse field. The rock-face, or escarpment, is 10-15 m high. The view is to the north.

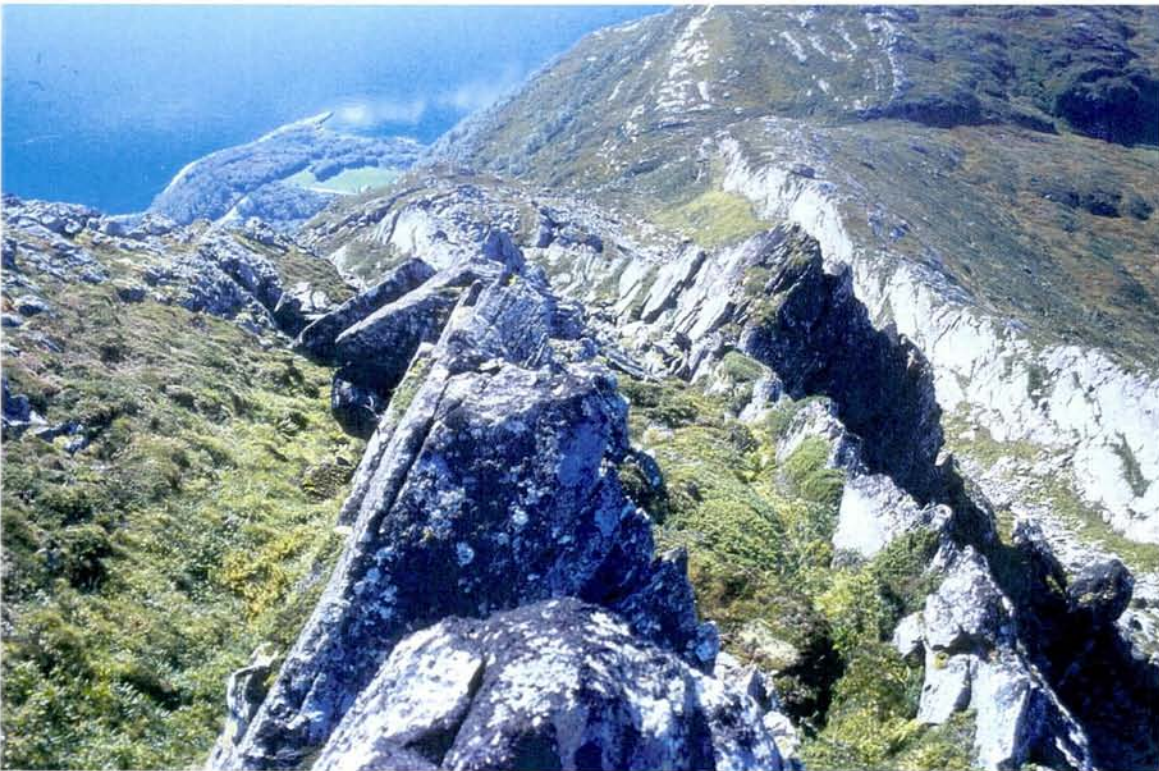
Figure 14. Internal foliation-parallel faults in block 3 of figure 10. View is down-hill to the southwest.

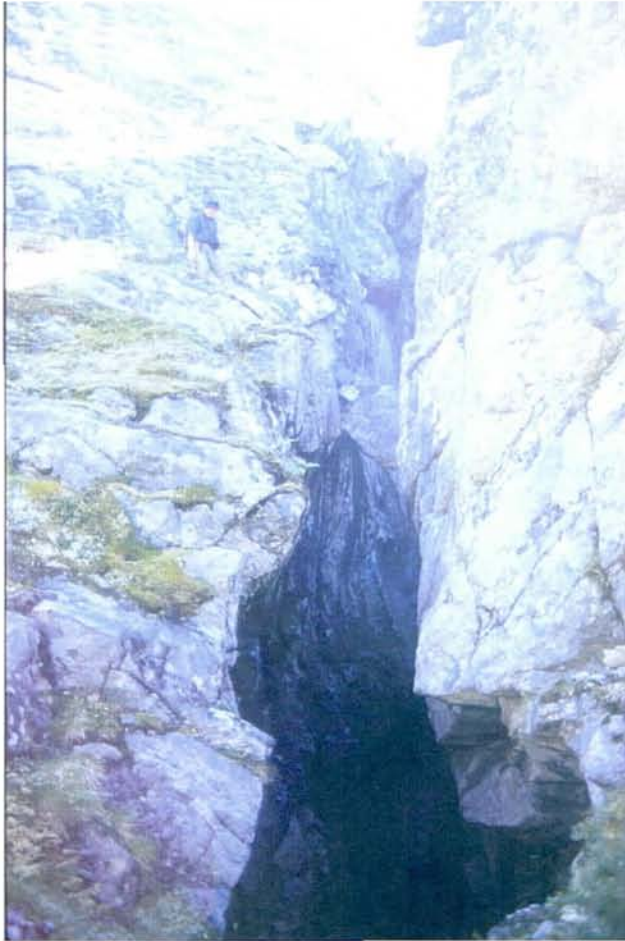
Figure 15. Open crevasse that link up as a cross-fracture to one of the foliation-parallel faults of block 3. Note person for scale. View is to the southeast.

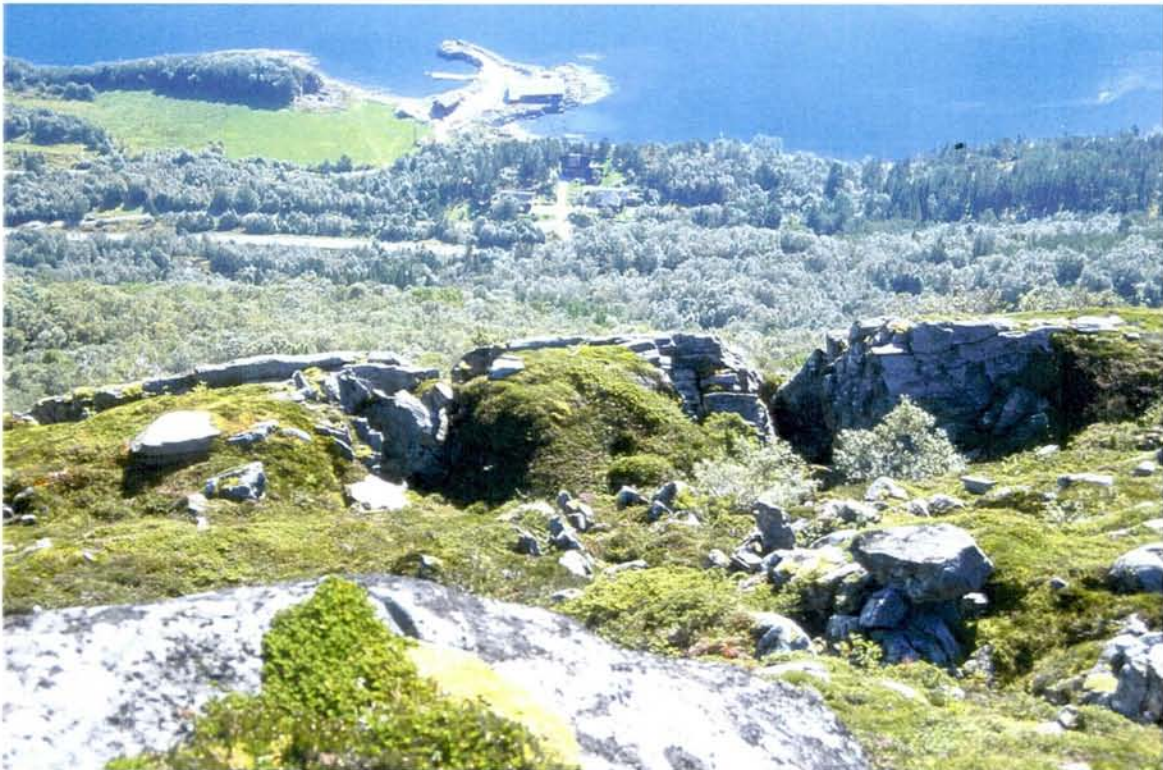
Figure 16. Internal fracturing of block 4 of figure 10. View is down-slope to the south.

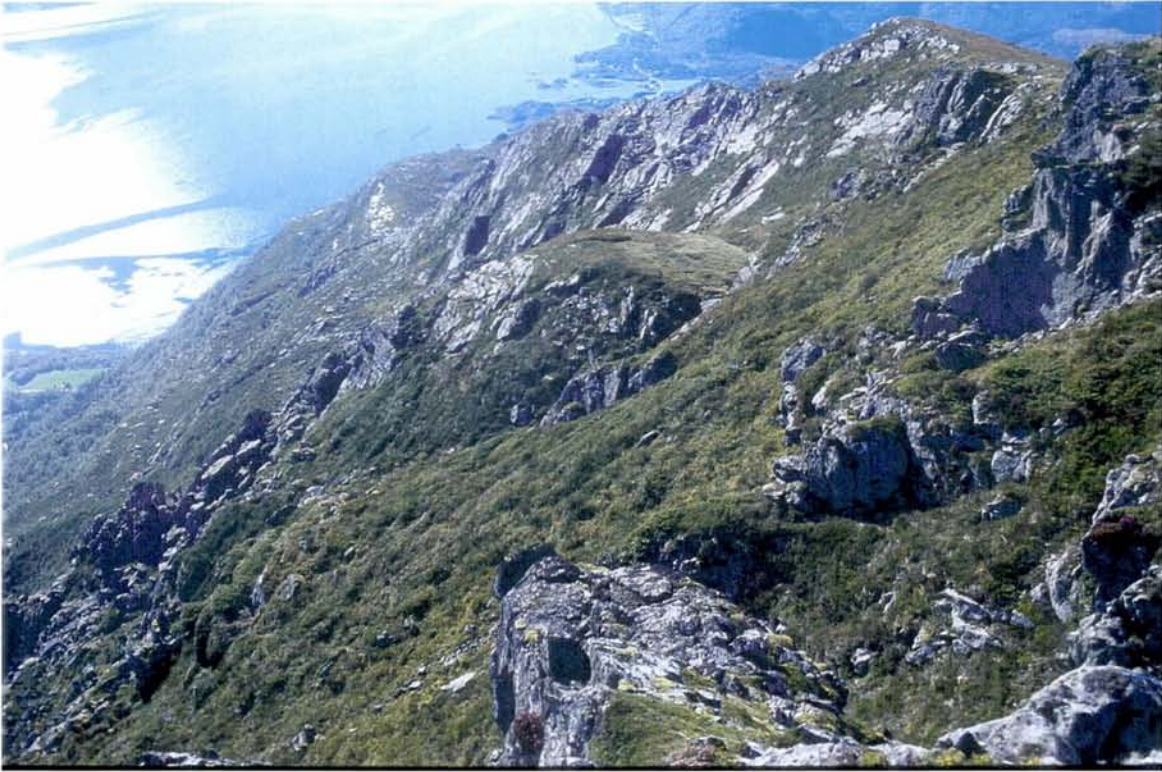
Figure 17. Photograph towards southwest down-slope the steep mountain side near Oppstadhornet. Note the large block in the centre, which has slid down without breaking apart.

The steep slope to the east is characterised by fractures and fissures that reactivate the steeply SSE dipping foliation, and that generate moderately sized blocks. In addition, several mega-blocks are identified (Fig. 9a). They are bound by similar fractures in the back, and some have slid 10-30 m down without being significantly internally shattered (Fig. 17).

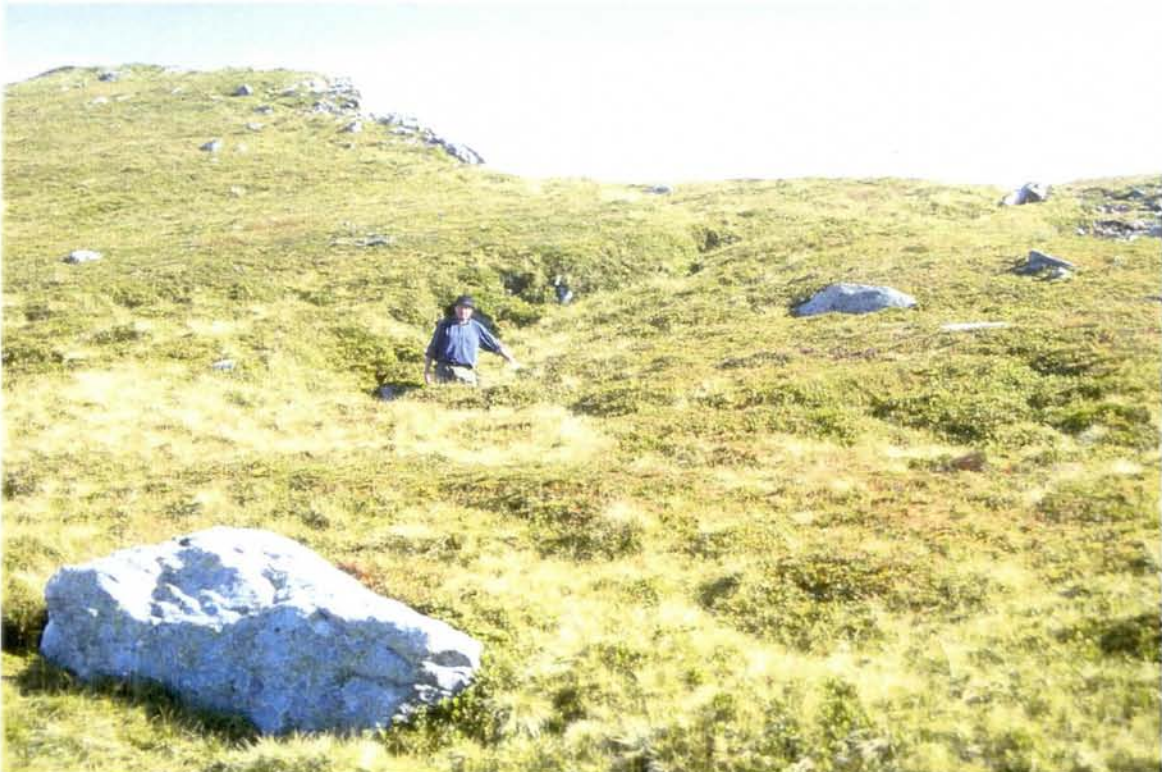
Figure 18. Small clefts at the ridge near Oppstadhornet. Such clefts reflect opening of crevasses/fractures in rocks below the topsoil. View is towards Oppstadhornet, from the WSW.

On the plateau around Oppstadhornet, there are several 1-2 m deep clefts in the soil and moraine. These relatively small structures indicate that fractures similar to those in and around the slide-block field are partly reactivated in this area as well (Fig. 18).

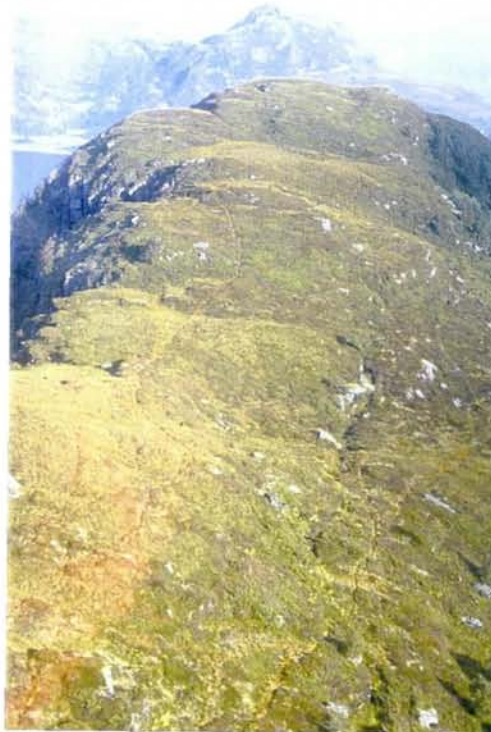
Figure 20. View from the south of the crevasses found along the ridge of Hellenakken. Oppstadhornet can be seen in the background.

The bedrock on Hellenakken consists of biotite gneiss with zones of amphibolite and with a subhorizontal foliation. The open fracture on the Hellenakken mountain ridge can be observed for about 500 m in length and is situated 35 to 75 m from the mountain edge to the west (Figs. 20 and 21). With an estimated thickness of the possibly unstable zone of between 100 to 200 m, this gives an estimated total volume of 2,5 to 5 mill m³. No detailed mapping of this structure has been performed.

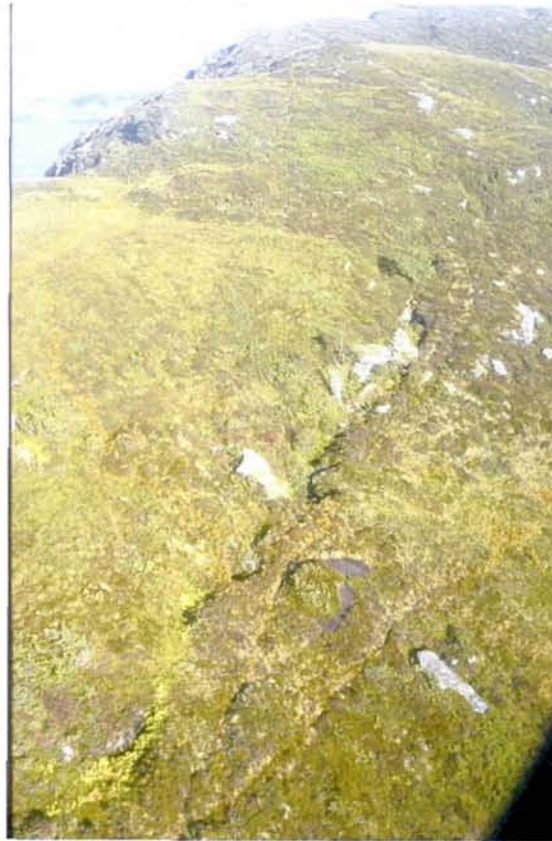
Figure 21. Close-up of photograph of figure 20, showing the cleft(s) to be several metres deep.

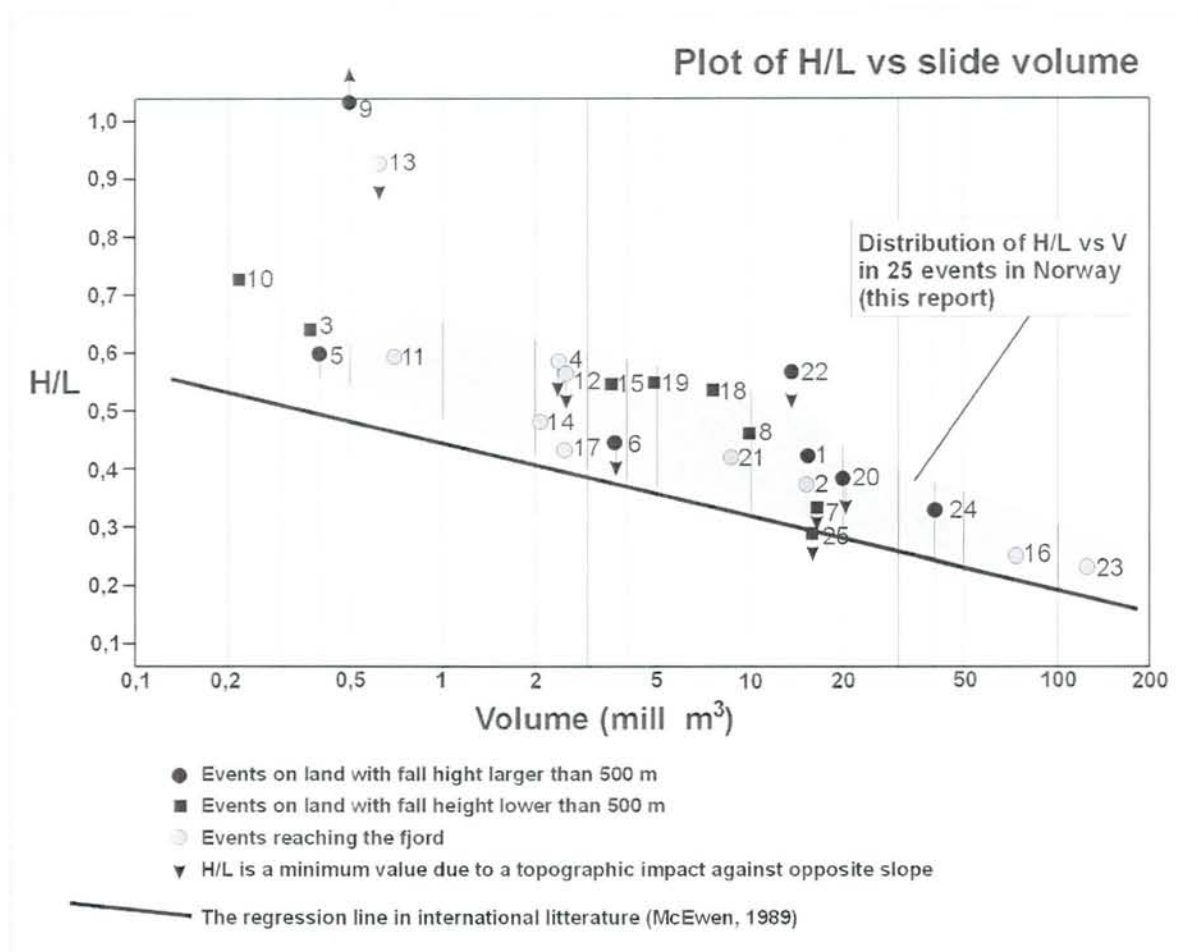
Figure 24. Plot of H/L (height of drop/length of run-out) vs. rockslide volume from the Norwegian data in Table 1.

Due to the reasons above, we have collected data from 25 geologically mapped rock-avalanche deposits in Norway, predominantly from the Western Gneiss Region (Table 1). These are plotted against the volume of the sliding mass and the H/L factor (Fig. 24). The individual events are divided into two groups based on the fall height; events found in the fjords are grouped in a separate category. The Norwegian examples plot above the regression line defined by the data of McEwen (1989). Another important factor exemplified in these data is that events with low fall heights and relatively small volumes plot very high in the diagram, also compared with other Norwegian examples in the gneiss region.

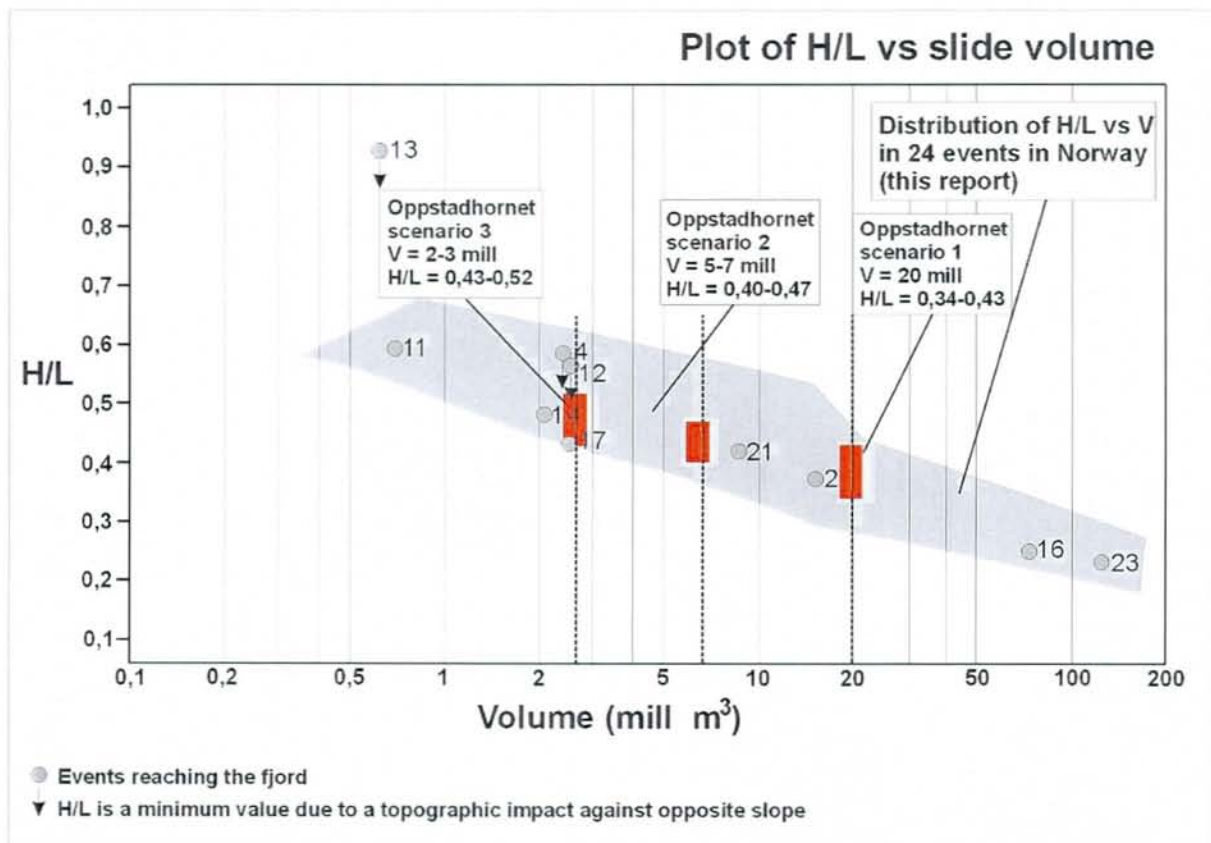
Figure. 27. Plot of H/L (height of drop/length of run-out) vs. rock-slide volume (Fig. 24) with the plot of possible slides from Oppstadhornet. The diagram also shows individual events most comparable with the situation at Oppstadhornet (rock avalanches entering the fjord).

H/L: 0,43-0,52

Estimated L (length of runout): 1.7-2,1 km (0,5-0,9 km into the fjord).

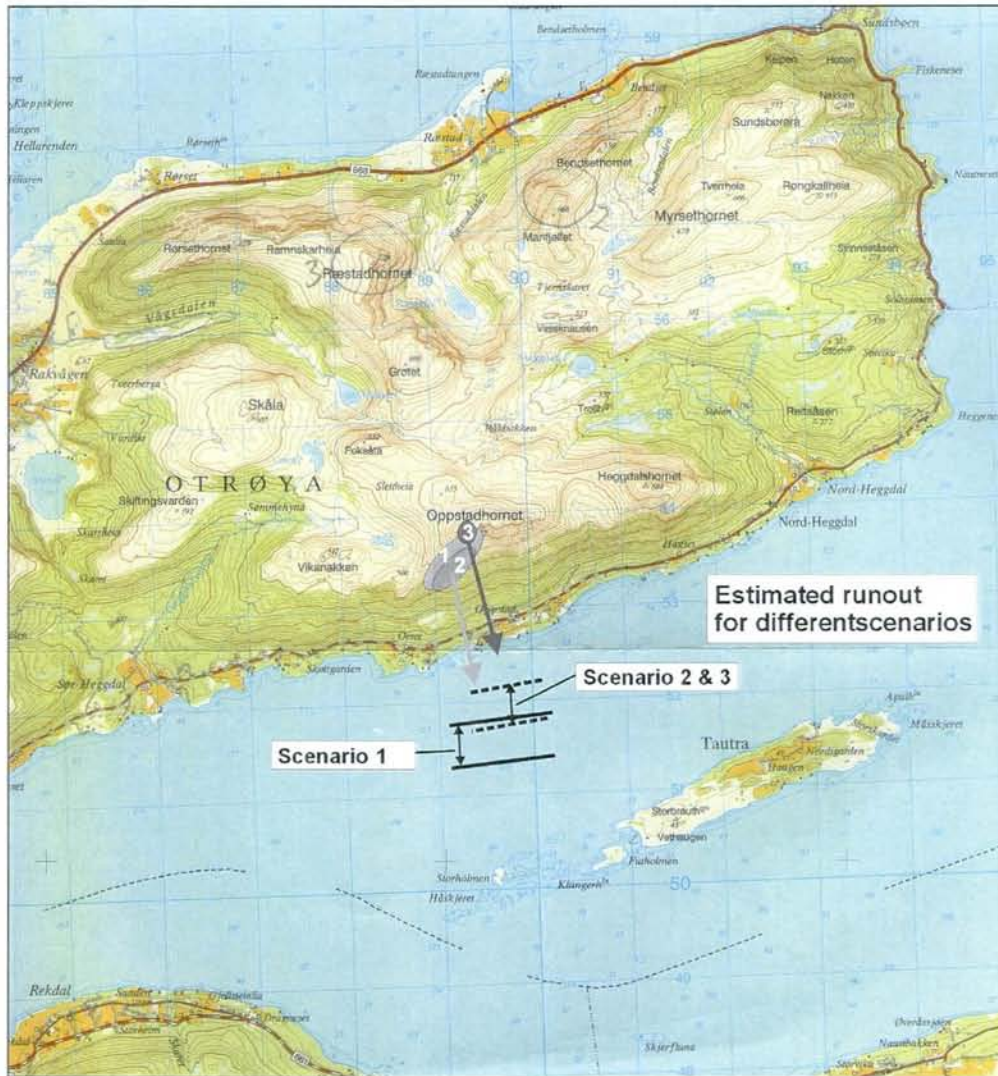
Figure 28. Estimates of possible run-out zones for three scenarios of sliding from the Oppstadhornet area. Each square of the map is 1 X 1 km in size.

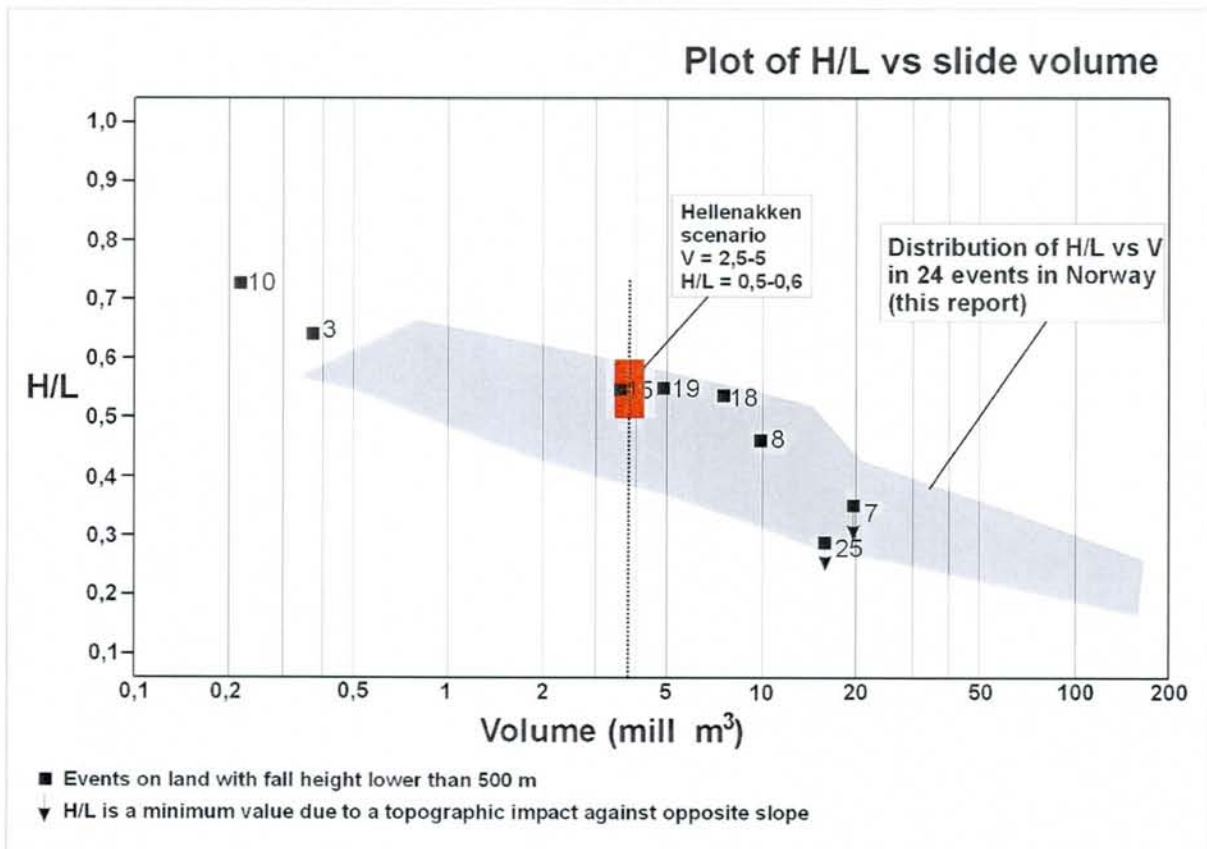
Figure. 29. Plot of H/L (height of drop/length of run-out) vs. rock-slide volume (Fig. 24) with the plot of a possible slide from Hellenakken. The plot also shows individual events most comparable with the situation at Hellenakken (small fall heights).
