NGU Report

**Structural mapping of potential rockslide  
sites in the Storfjorden area, western  
Norway: the influence of bedrock geology  
on hazard analysis**

| Report no.: 2006.052 | | ISSN 0800-3416 | | Grading: Open | |
| Authors:<br>Henderson, I.H.C., Saintot, A. & Derron, M.H. | | | Client:<br>Åknes/Tafjord prosjektet v/Stranda municipality | | |

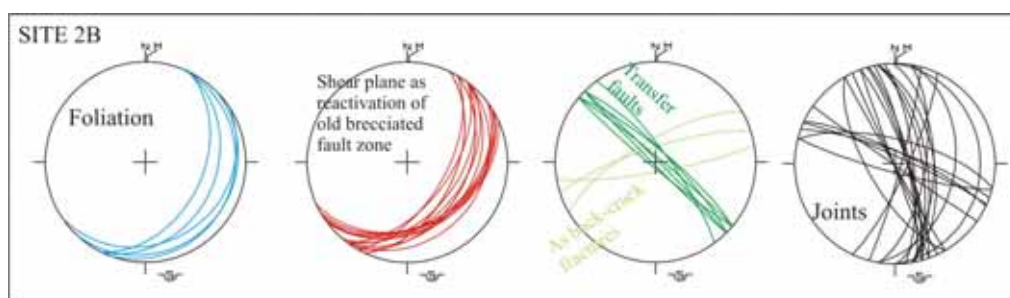
This site is close to Site 2 (see Figure 4) and lies on a prominent ridge approximately 900m above sea level. The foliation dips at approximately 37-50° to the east, towards the fjord (see stereonet data in Figure 6). Characteristic of this site is that very few steep extensional fractures are observed. For example, no extensional back-fracture was observed but potentially pre-existing joints that can play the role of such exist (they have trend of back-crack fractures; see Figure 6 and Figure 7). This site was therefore not identified as a potential rockslope failure site from the aerial photos. However, examination from the helicopter and on site showed an active movement on a large block. This movement appears to be occurring along a single, low-angle sliding plane at the base of the block. This is sub-parallel to foliation but cuts through the foliation and is slightly steeper than it (see Figure 8A). Examination of the fault plane has shown that it was indeed a pre-existing N-S striking brecciated plane (probably of Devonian age) which has been reactivated as a recent sliding plane, creating a new fault breccia. The low-angle detachment plane displays a very undulating surface and this is probably due to the localisation of the fault plane along an open anticline-syncline pair. This fault undulation has led to the development of several different types of secondary structures along the fault plane. Where there is an

**Figure 6: Stereonet data for Site 2b. Foliation dips SE towards the fjord at 20-40°. The Basal Shear Plane including other shear planes are parallel to foliation. Two sets of extensional joints are observed in the hangingwall.**

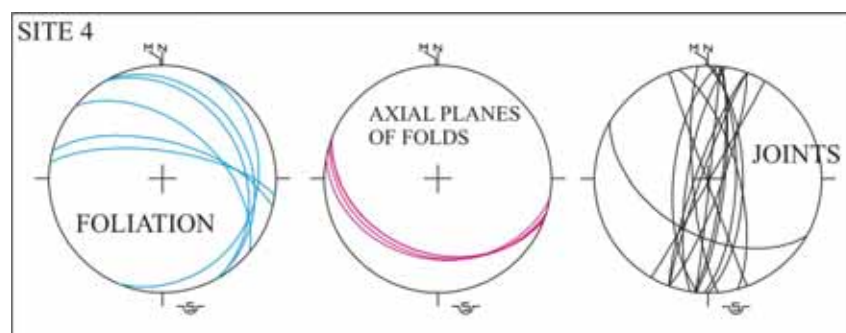
This site lies 1,5 km to the south of Åkneset on the same side of Sunnylvsfjorden, approximately 1000m above sea level. This site lies in a similar topographic position to Åkneset and displays remarkably very similar structures. A low-angle, fjord-dipping breccia zone is postulated at the base of the potential failure block although this has not been observed directly as the site was highly inaccessible. However, evidence suggests that an active sliding plane is present at the base of the block (Figure 11A). The potential failure block consists of at least seven column-shaped blocks. These are up to 50m wide and up to 80m high (Figure 11). These are separated by extensional fractures, which appear to have up to several metres of horizontal displacement. However, these are clearly inherited north-south striking structures, possibly of Devonian age (see Section 2.5.1) and may have been somewhat 'eroded-out' prior to displacement. Therefore several metres would be an upper limit to the horizontal displacement. Several metres of vertical displacement are also seen on some of the blocks (Figure 11B). A possible contributing factor to failure here is the presence of fjord-plunging small-folds in the granitic gneiss (see stereonet data in Figure 12). These have a trend of approximately  $100^\circ\text{N}$ , exactly parallel to the extensional direction of the column failure (i.e. perpendicular to the main set of

opened joints on Figure 12). They also have a plunge of 30-35° ESE, which is parallel to the supposed maximum dip and dip-direction of the low-angle sliding plane. The structural grain in this area therefore would promote a slippage of material at a moderate to shallow angle eastwards towards the fjord.

**Figure 12: Stereonet data for Site 4.**

However, at present no GPS measurement points have been set out on this site. This is because we have only circumstantial evidence that a basal breccia is present. Further work here should focus on gaining access to the basal fault zone. The presence of a basal breccia would be direct evidence that the mountainside here is undergoing movement.

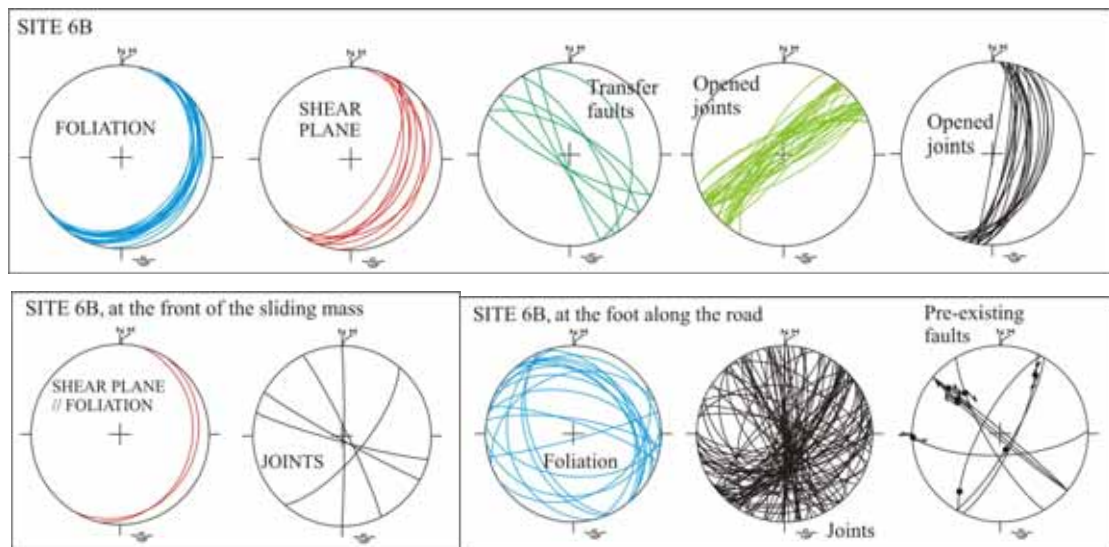
25-30° towards the fjord. However, in general the BSP cuts through the foliation at a shallow angle and a well developed 15cm thick fault breccia is observed (Figure 14B). It lies sub-parallel to the foliation (see stereonets Figure 15). NW-SE trending joints act as transfer faults (Figure 15). Two other systems of joints opened in the failure block (Figure 15); one trends NE-SW and the other trends N-S. The newly extensional structures are NE-SW (Y and Z on Figure 13A) with a trend perpendicular to the main slip direction (Figure 16). With the set of NW-SE fractures they form a system of joints geometrically consistent with the motion of the block (Figure 16). The main back-crack of 3 meters width (Figure 17) is an inherited extensional fracture, which trends N-S, similar to ultra-cataclastic fractures of Devonian age observed frequently in Vestlandet. Figure 17A shows one of these N-S epidotised faults reactivated as an extensional fracture. The extensional fractures detach onto the low-angle sliding plane suggesting their generation is related to movement on the plane (Figure 17C). Figure 18 is an example of newly formed NE-SW extensional shear structures in the failure block. To summarise, two trends of extensional fractures exist on site 6b (1) the first is a reactivation of old N-S trending structures and the main back-crack (X on Figure 13A) developed along such a trend and (2) the newly developed extensional structures trend NE-SW (Y and Z on Figure 13A) which is perpendicular to the movement. All of these extensional fractures within the hangingwall block detach onto the basal sliding plane and are not present in the footwall, suggesting that the hangingwall block is extending due to the movement on the basal shear plane.

Figure 15: Top-Stereonet data for Site 6B in the main potential failure block. Bottom-Stereonet data for Site 6B in the toe zone and at sea level directly in the fall-line to the main block.

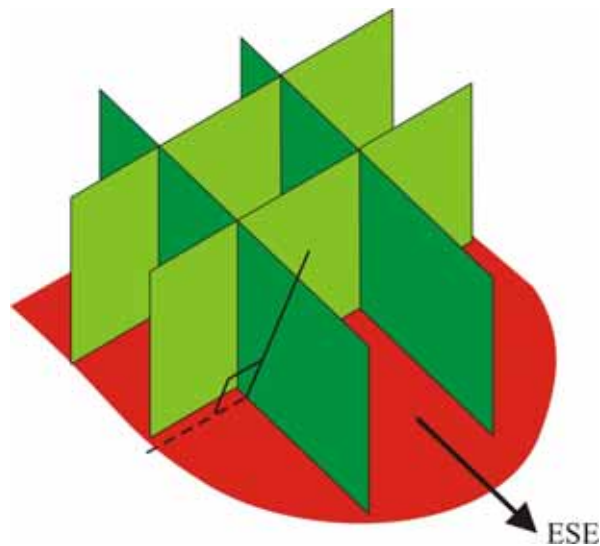
Figure 16: Scheme of the system of joints opened in the failure block at Site 6b.

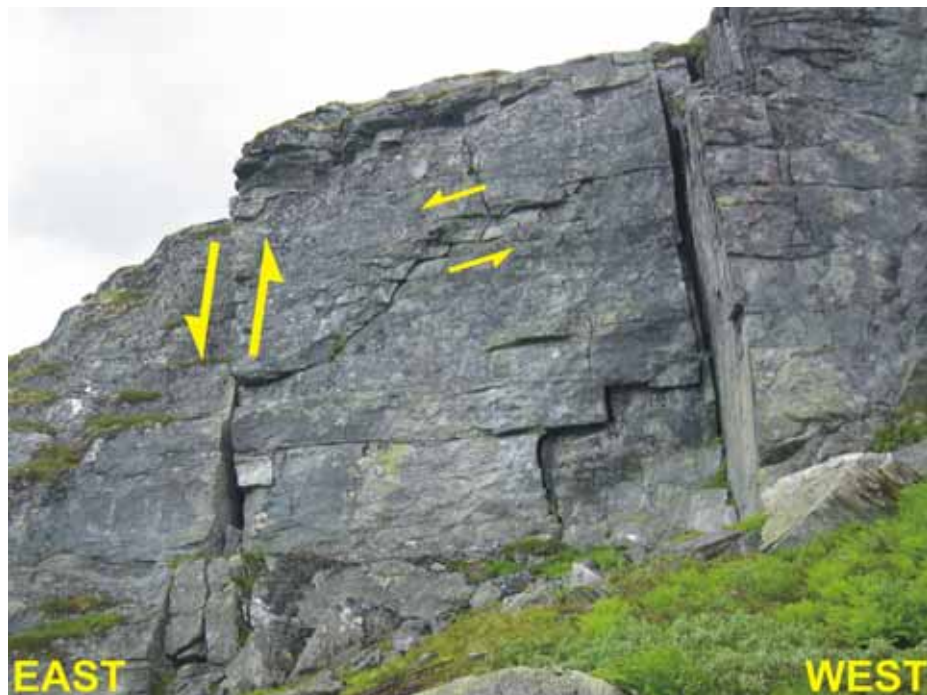
**Figure 18:** Example of the geometry and kinematics of relay zones on extensional shear structures from Site 6b. The movement direction of the segmented fractures is down towards the fjord (towards the left).

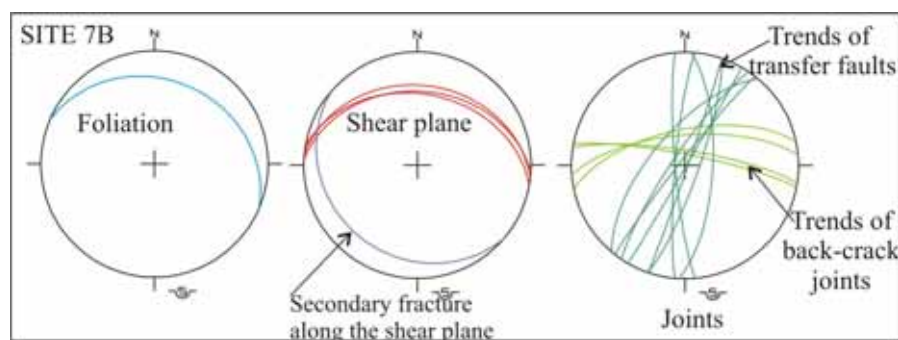
Figure 21: Stereonet data of structures observed at site 7b.

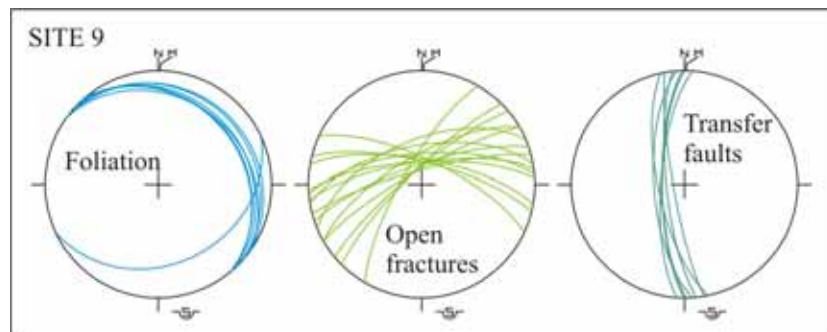
Figure 24: Stereonet for structures observed at Site 9.

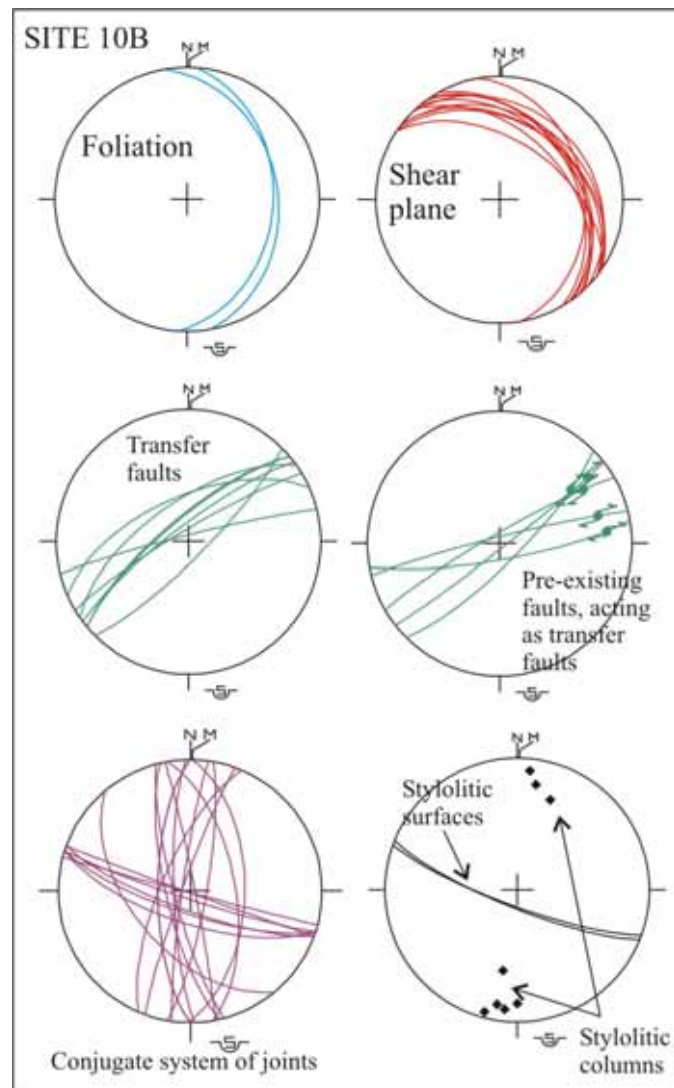
Figure 29: Stereonet data for structures observed at Site 10b.

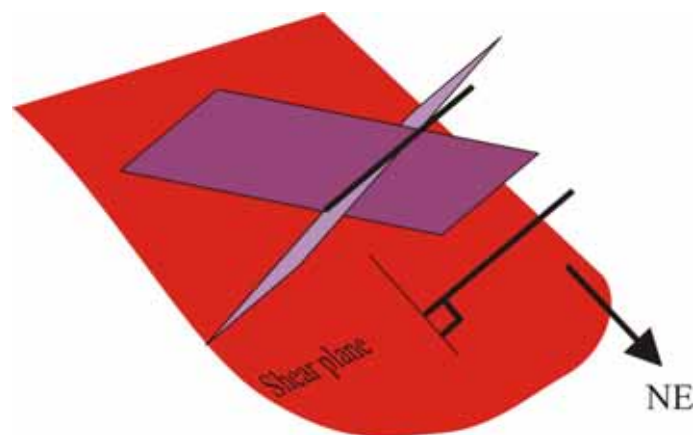
Figure 30: Scheme of conjugate system of joints which developed in the failure block at site 10b.

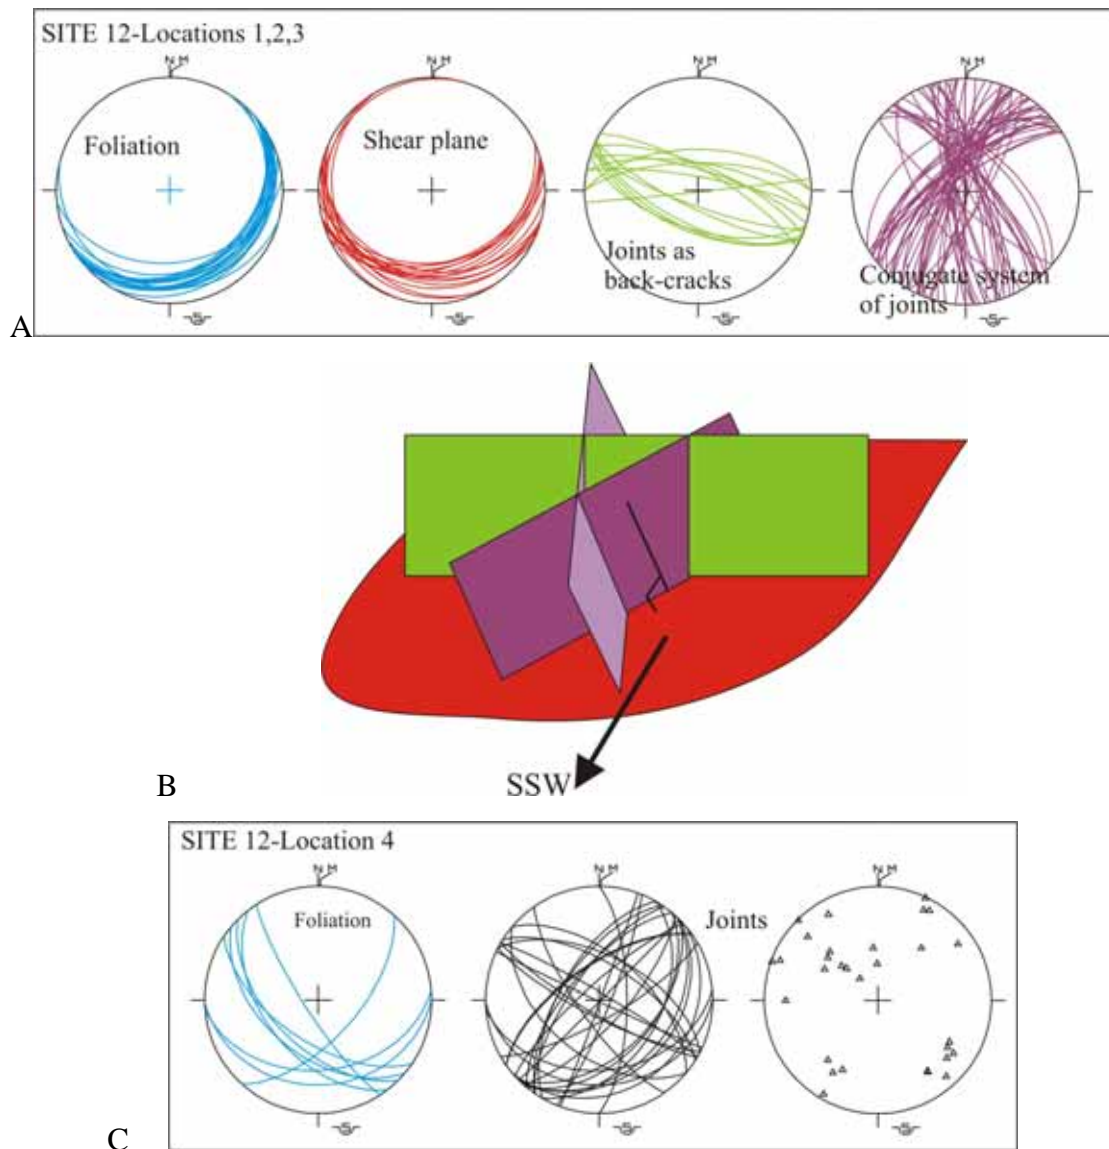
**Figure 34: A-Stereonet data for the structures present at Site 12, locations 1,2,3. B,-Scheme of joints developed into the block at locations 1,2,3. C,-Stereonet for the structures present at Site 12, locations 4.**

The basal shear zone appears to have an angular discordance with the foliation planes. In addition to the transfer faults which are the free borders of the block and the development of a basal shear plane (Figure 32 and Figure 33), spectacular systems of joints are developed at this site (Figure 34). First, we can recognise a conjugate system of joints (in purple on Figure 34B) with an intersection normal to the shear plane and vertical joints acting as 'back-crack' type fractures (in green on Figure 34B). These sets of joints are particularly consistent with newly-developed structures related

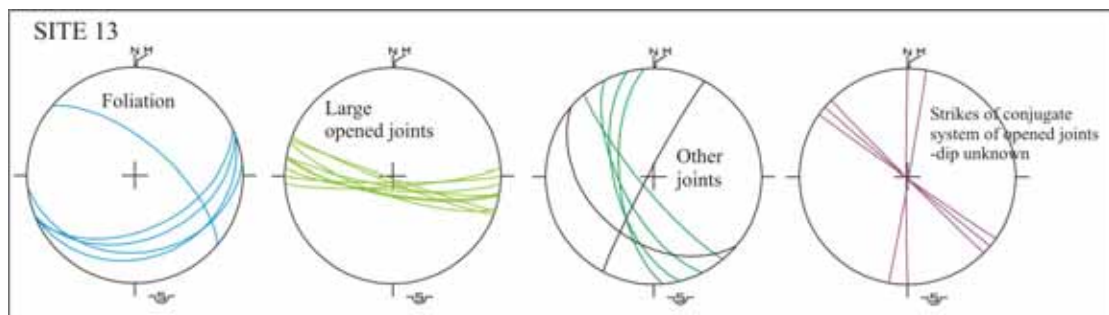
Figure 37: Stereonet data for structures observed at Site 13.

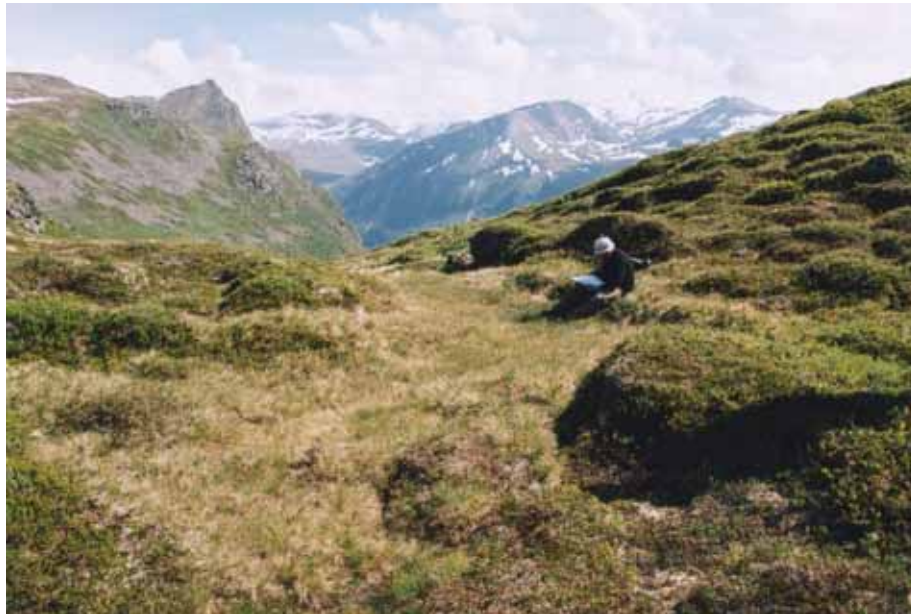
A

Figure 38: The observation of a 'back-crack' on the landscape at site 13 onto the plateau. A-An E-W depression is marked by the changing of vegetation. It is interpreted as an incipient back-crack. B-The back-crack is likely to develop if motion occurs along the sliding plane.

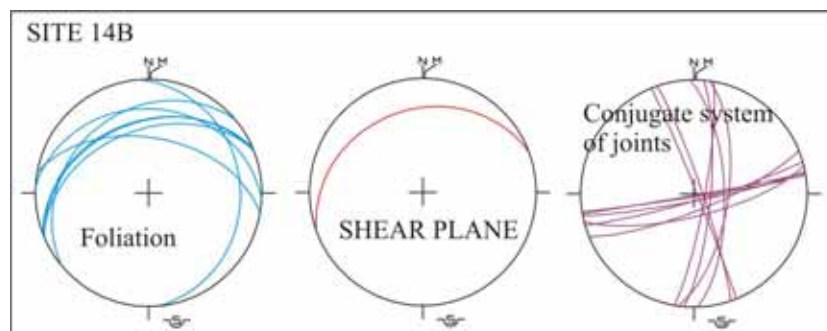
As with sites 10b and 12, a conjugate system of open joints developed into the sliding mass (purple on stereonet Figure 40). However, the outcrop is poor on this block and due the severe topography only the top surface of the block was accessible.

Figure 40: Stereonet data for Site 14b

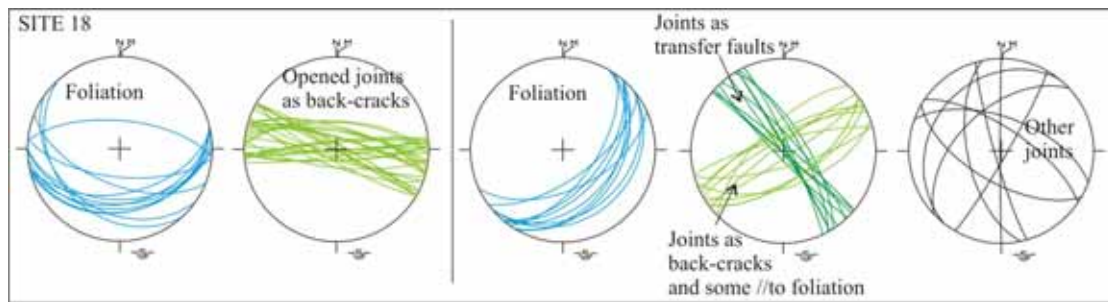
**Figure 43: Stereonet data for Site 18. Two different trends of foliation are associated with different trends of joints (as 'back-cracks' in both cases).**

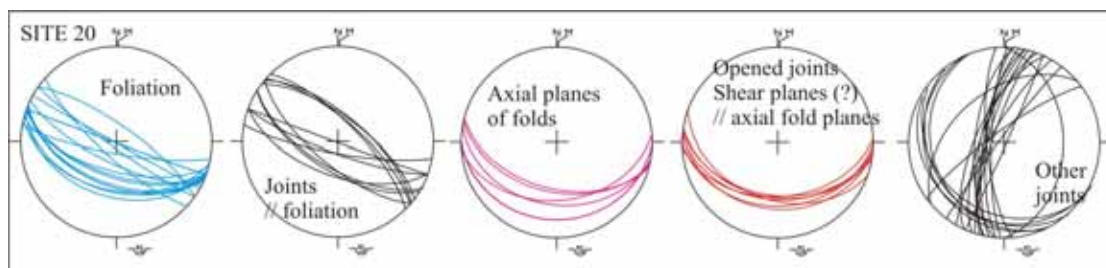
Figure 45: Stereonet data for Site 20.

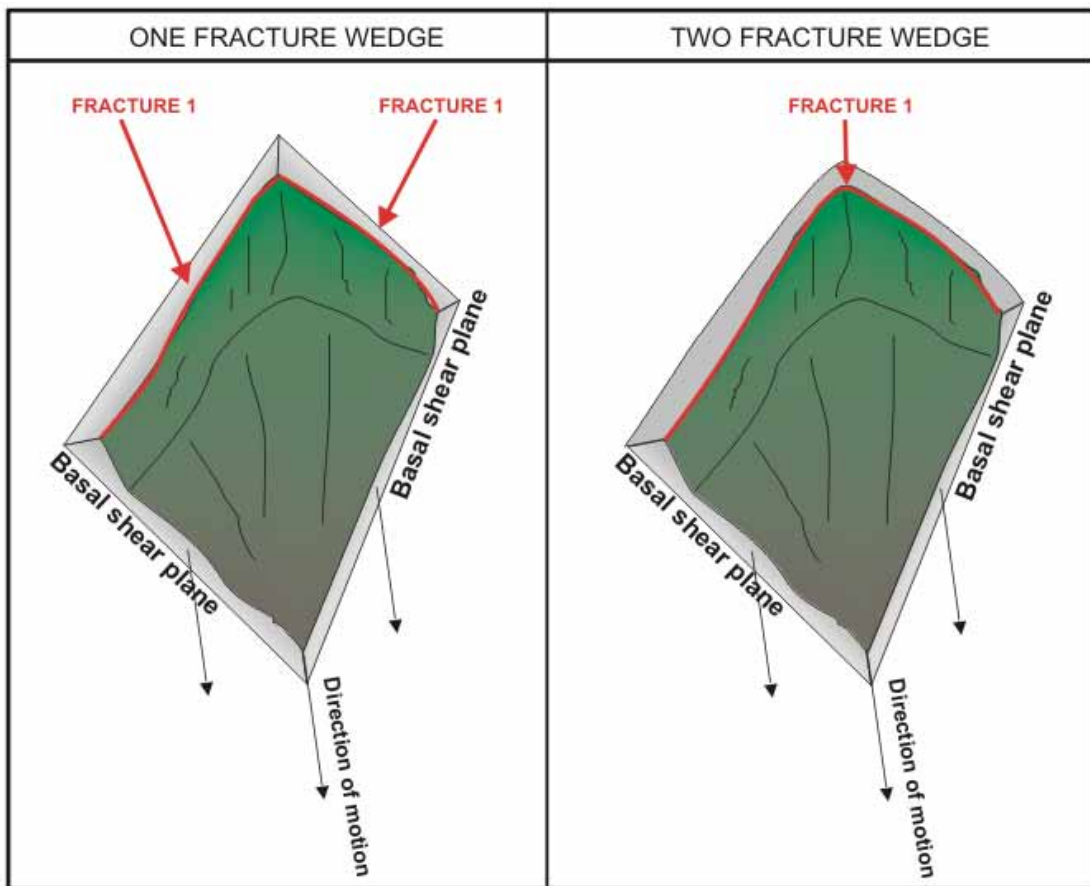
Figure 48: The geometry of the wedge at site 21. Two possible models: (LEFT) With two steeply dipping back-crack structures. (RIGHT) With only one steeply dipping back-crack.

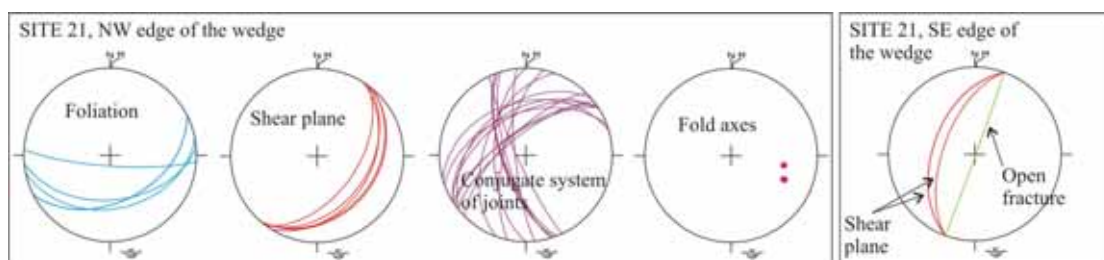
Figure 49: Stereonet data for Site 21.

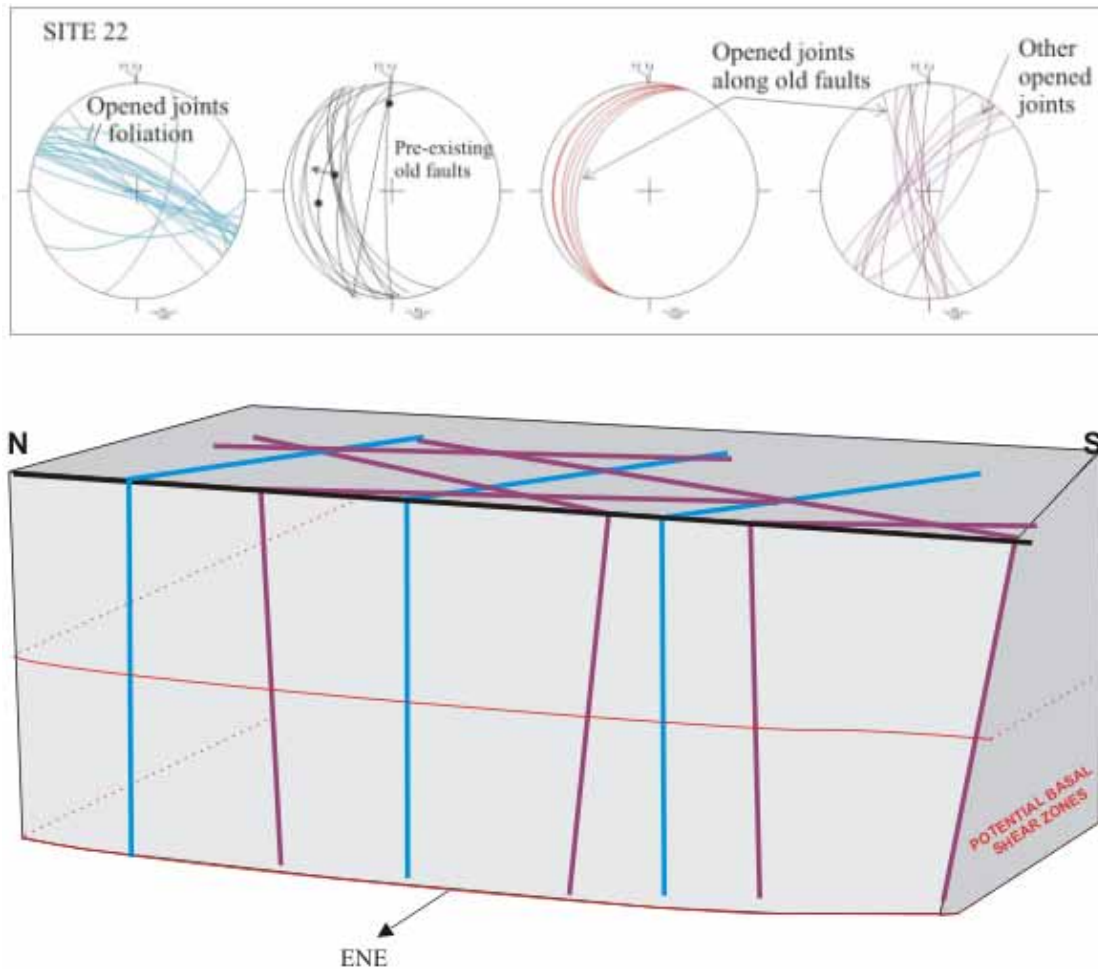
Figure 52: (TOP) Stereonet of data collected at site 22. (BOTTOM) Schematic drawing of the brittle structures developed at site 22. The scarp is trending N-S.

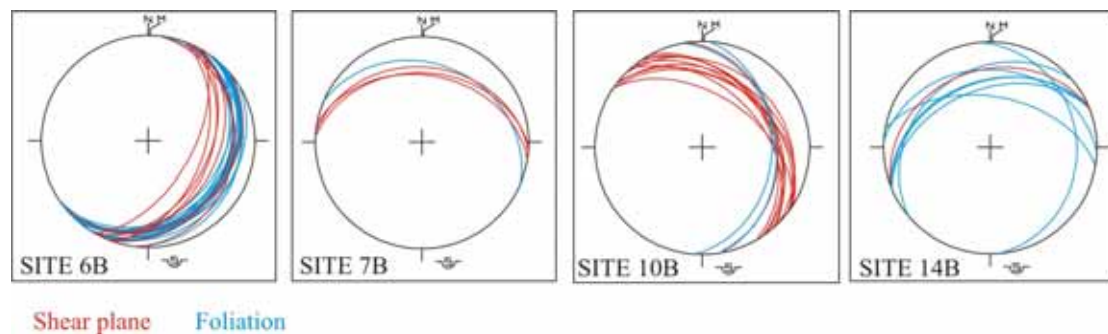
In many sites of Storffjorden area, we have noticed the importance of the orientation of foliation in regards to rockslide development. When the foliation dips towards the fjord (sites 2, 2b, 4, 5, 6b, 7b, 10b, 14b, 27) or towards the valley (site 38), we have commonly observed the development of the basal shear plane parallel to foliation (as shown by stereonets of measurements at sites 6b, 7b, 10b, 14b on Figure 56). In the gneissic rock mass of the Storffjorden area, foliation comprises alternating layers of feldspars, quartz and micas, each of various thicknesses. The mica-rich layers are

potential sites of enhanced basal shear plane development as the cohesion of micas is less than that of other minerals, such as feldspars and quartz.

**Figure 56: Examples of potential failure sites in the Storfjorden area where the basal shear planes are parallel to the foliation.**

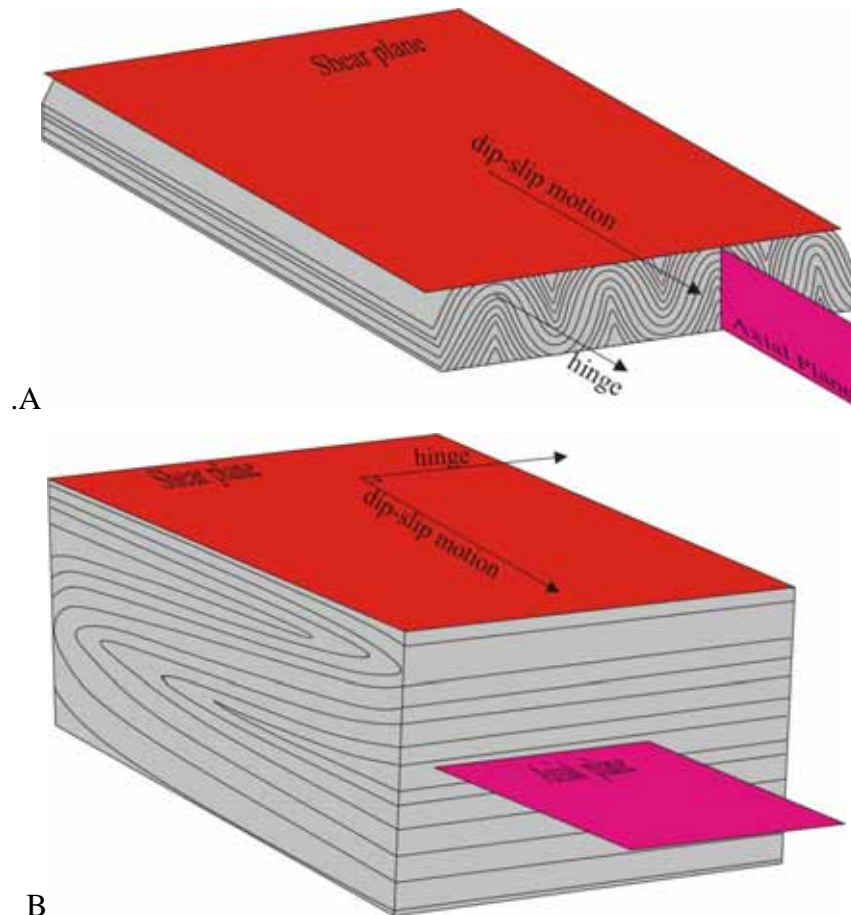
At several sites, shear planes developed according to the geometrical constraints of the pre-existing fold geometry. Several examples are shown in Figure 57. Figure 57a shows how the sliding mass movement direction is constrained to the trend and plunge of pre-existing ductile small-fold hinges. Figure 57b shows how shear planes are developed parallel to shallowly-dipping small-fold axial planes. These examples highlight the importance to systematically map the pre-existing geological structures in order to predict the complexity of the geometry of the basal shearing planes which ultimately define the volume of the block and the nature in which it is moving.

**Figure 57: A-Shear plane developed perpendicular to the axial planes of folds (as at Sites 2B, 4B, 21). B- Shear plane developed parallel to small-fold axial planes (as at Site 20).**

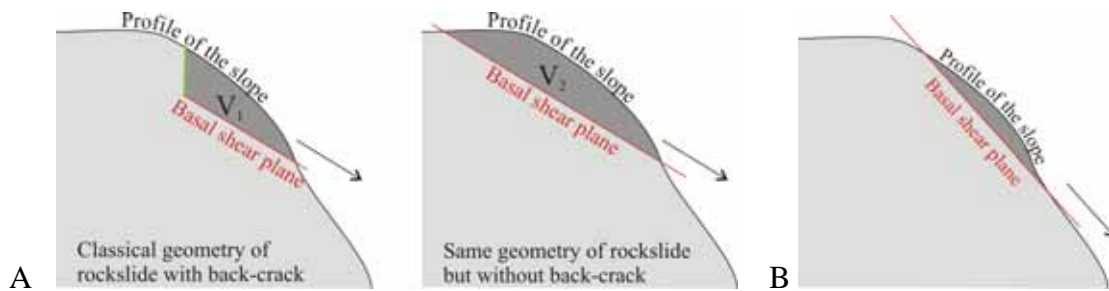
Irrespective of whether the landslide process involves toppling or sliding, large, open and steeply-dipping to vertical fractures usually form at the back of the unstable rockmass under tension (Figure 2A and B in section 1.2). However, there are some cases where back-crack structures are not observed. These exceptions are where the basal shear planes emerge at the surface and intersect the mountainside topography (Figure 58; and as on site 2b). This often involves much larger rockslides (compare the two volumes  $V_1$  and  $V_2$  on Figure 58). When the basal shear plane is steeply-dipping and roughly parallel to the slope surface, a 'thin' slice of the slope can easily detach and no back-crack forms in such a process (Figure 58B). A typical wedge structure is also without extensional back-cracks as the two basal planes emerge at the back of the block (Cf. Figure 2C in section 1.2). Note that the wedge we have observed at site 21, shows one or two back-crack plane(s) which render the geometry of the unstable block quite complex (Cf. Figure 48). In turn, when the process is toppling, such structures can be the primary structure involved in detaching the block from the slope.

**Figure 58:** A-The typical geometry of a rockslide along a basal shear plane: with the development of an extensional back-crack structure (left) and without a back-crack (right) (note the differences of involved volumes:  $V_1 < V_2$ ). B-No back-crack extensional structure develops when the basal shear plane is steep and close to the slope.

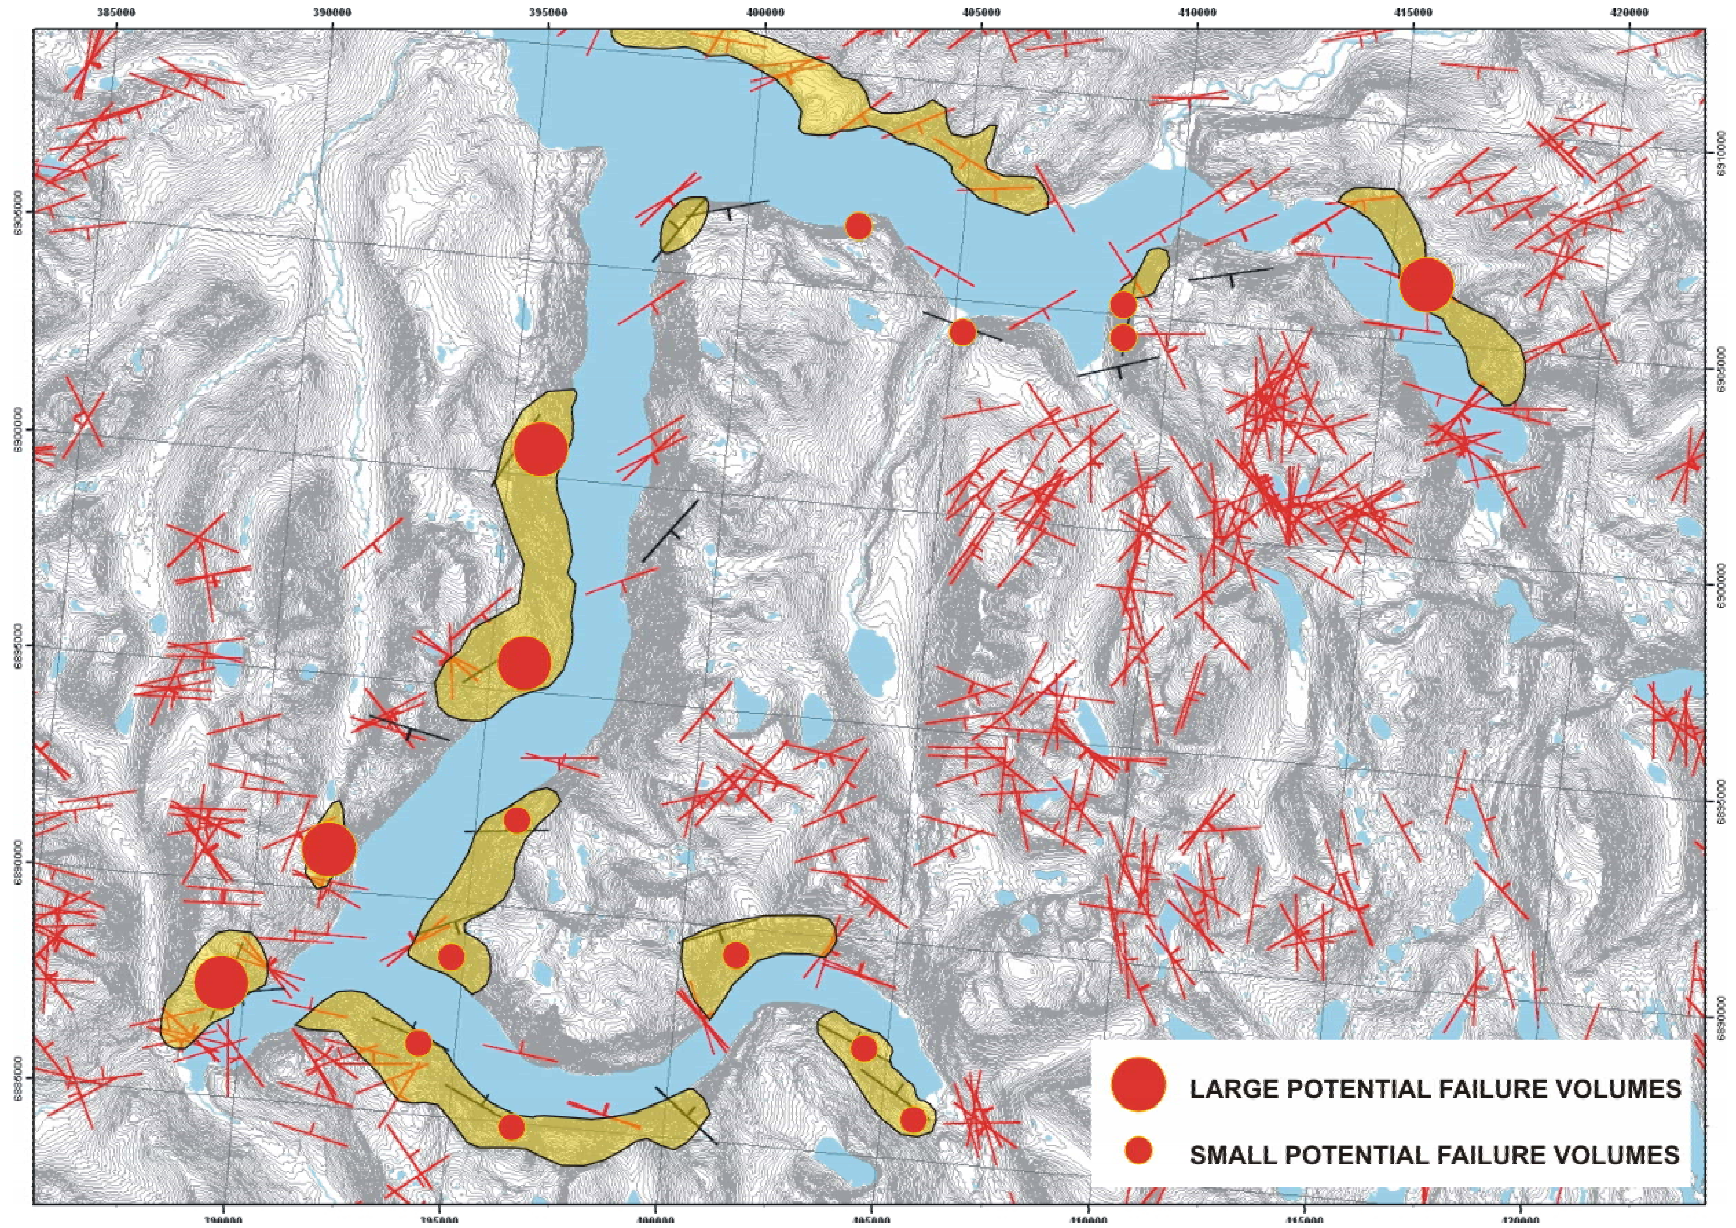
Figure 61 shows a map of the Storfjorden area and the areas in which the foliation is dipping towards the fjord between 20-40°. These areas are shown in yellow and the largest areas are located principally on the west side of Sunnylyvsfjorden, intermittently on both sides of Geirangerfjorden and on the north side of Tafjorden. The areas demarcated in red are those where the potential for large landslides with typical rockslide geometries may be possible based on our structural observations. We have qualitatively divided the potential failure blocks up dependent on volume into large and small volumes. Figure 61 clearly shows that there is a good correlation between sites that we have classified as potentially unstable and the relationship between fjord-dipping foliation and fjord trend, particularly where the largest volumes are concerned. Comparison of Figure 61 with the evidence for palaeo-instabilities from the bathymetry data in Figure 3 also shows a surprising correlation between the structural evidence from out field analyses of the location of instable fjord walls and the evidence for past events. Furthermore, it has been demonstrated in Section 3.1.3 that in at least 6 sites that the complex geometry of pre-existing small-fold structures has constrained the movement direction of unstable blocks. We therefore have attempted to further constrain those areas where foliation is fjord dipping by 20-40° with those areas in which small-fold hinges are lunging towards the fjord at a similar angle. The results of this are shown in Figure 62. These geometrical parameters appear to be constrained to the western side of Sunnylyvsfjorden and, with the exception of Tafjorden, contains all of the large potential rockslide failure sites (including Åkneset) we have identified from field analyses. This remarkable correlation suggests that the combination of structural features described in this report are essential to the development of large, potential unstable rockmasses in the Storfjorden fjord system. We therefore demonstrate the fundamental importance of incorporating structural analyses in the spatial and geometric delineation of susceptibility maps for Storfjorden.

Figure 61: Map of susceptibility based on geological information. Foliation is in red (NGU data) and black (our data) The potential rockslide sites based on orientation of foliation with respect to the fjord orientation are shown in yellow. This prediction method agrees remarkably well with the selected potential hazard sites in Figure 4.

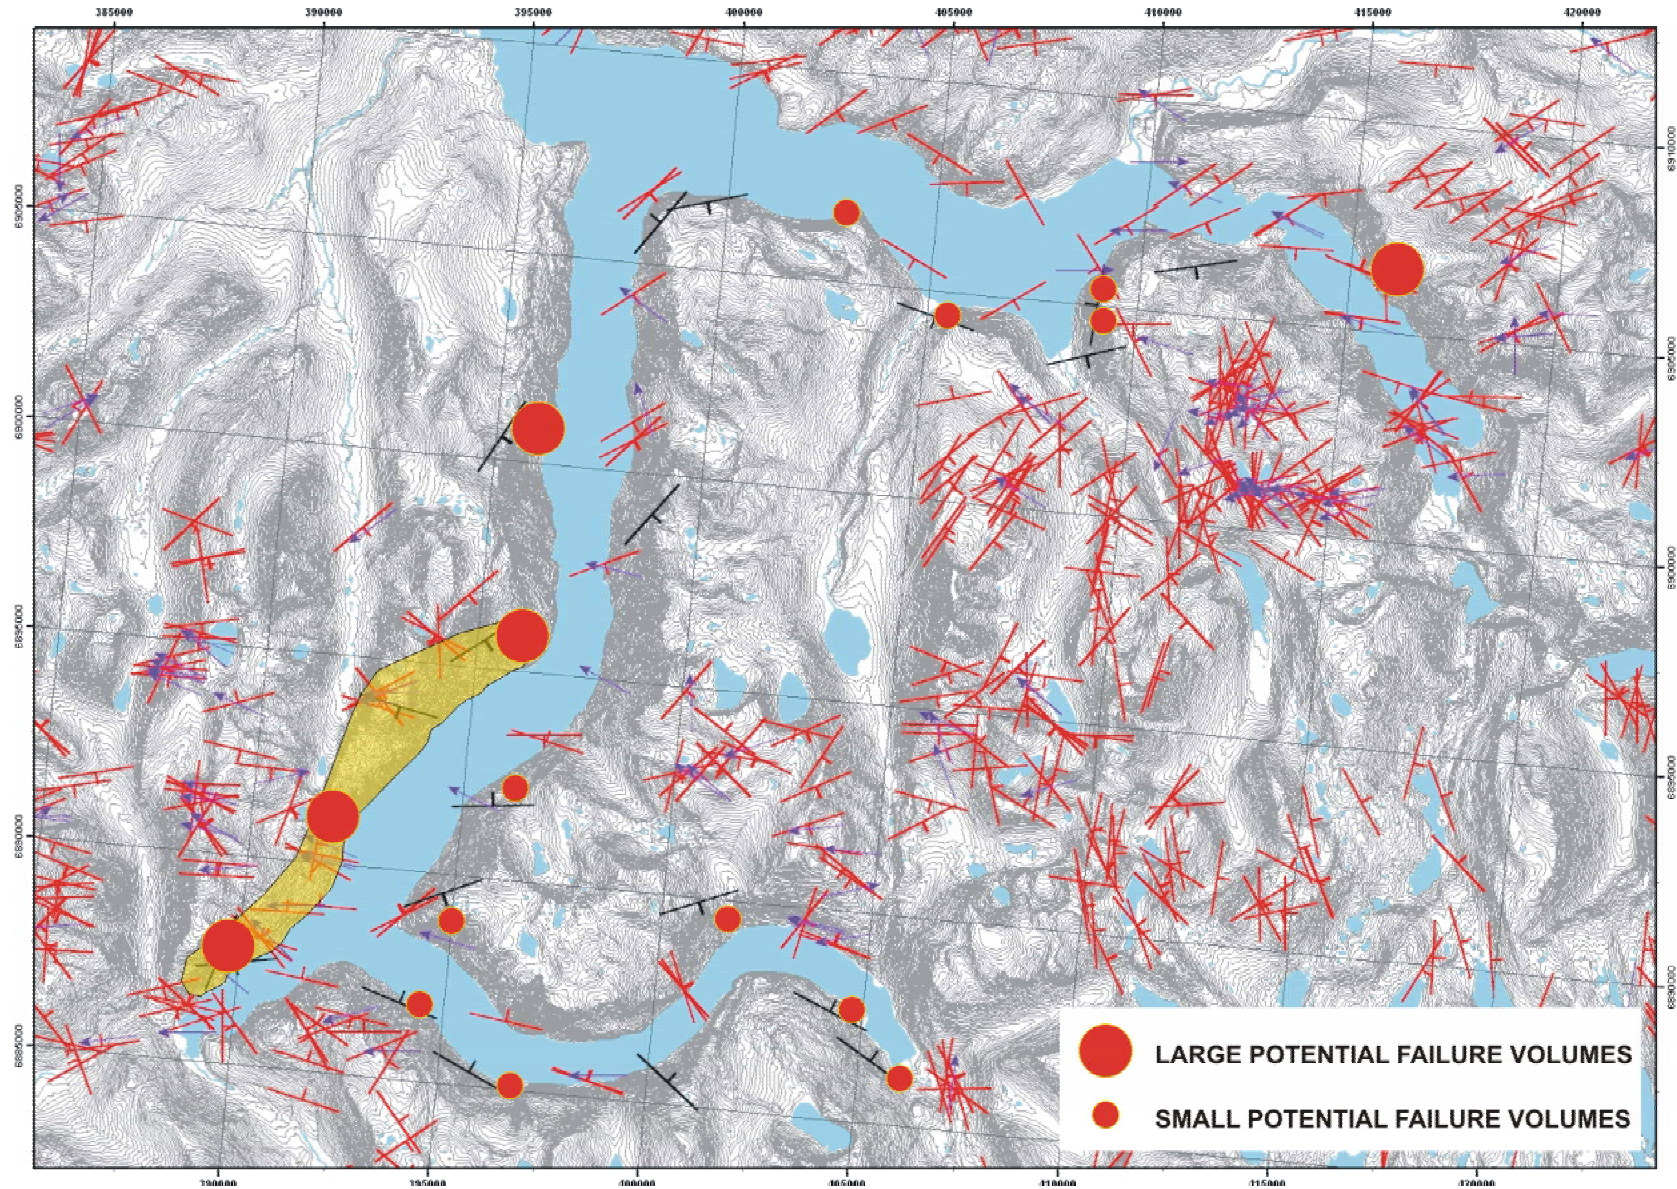
Figure 62: Map of susceptibility based on geological information. This is the same as Figure 61 but also includes small folds and lineation (in purple). The yellow areas show where the lineation-small fold plunges along the fall-line towards the fjord. It is interesting to note that the most impressive back-cracks and the most evidence for active block movement coincides with this western side of Sunnylvsfjorden.

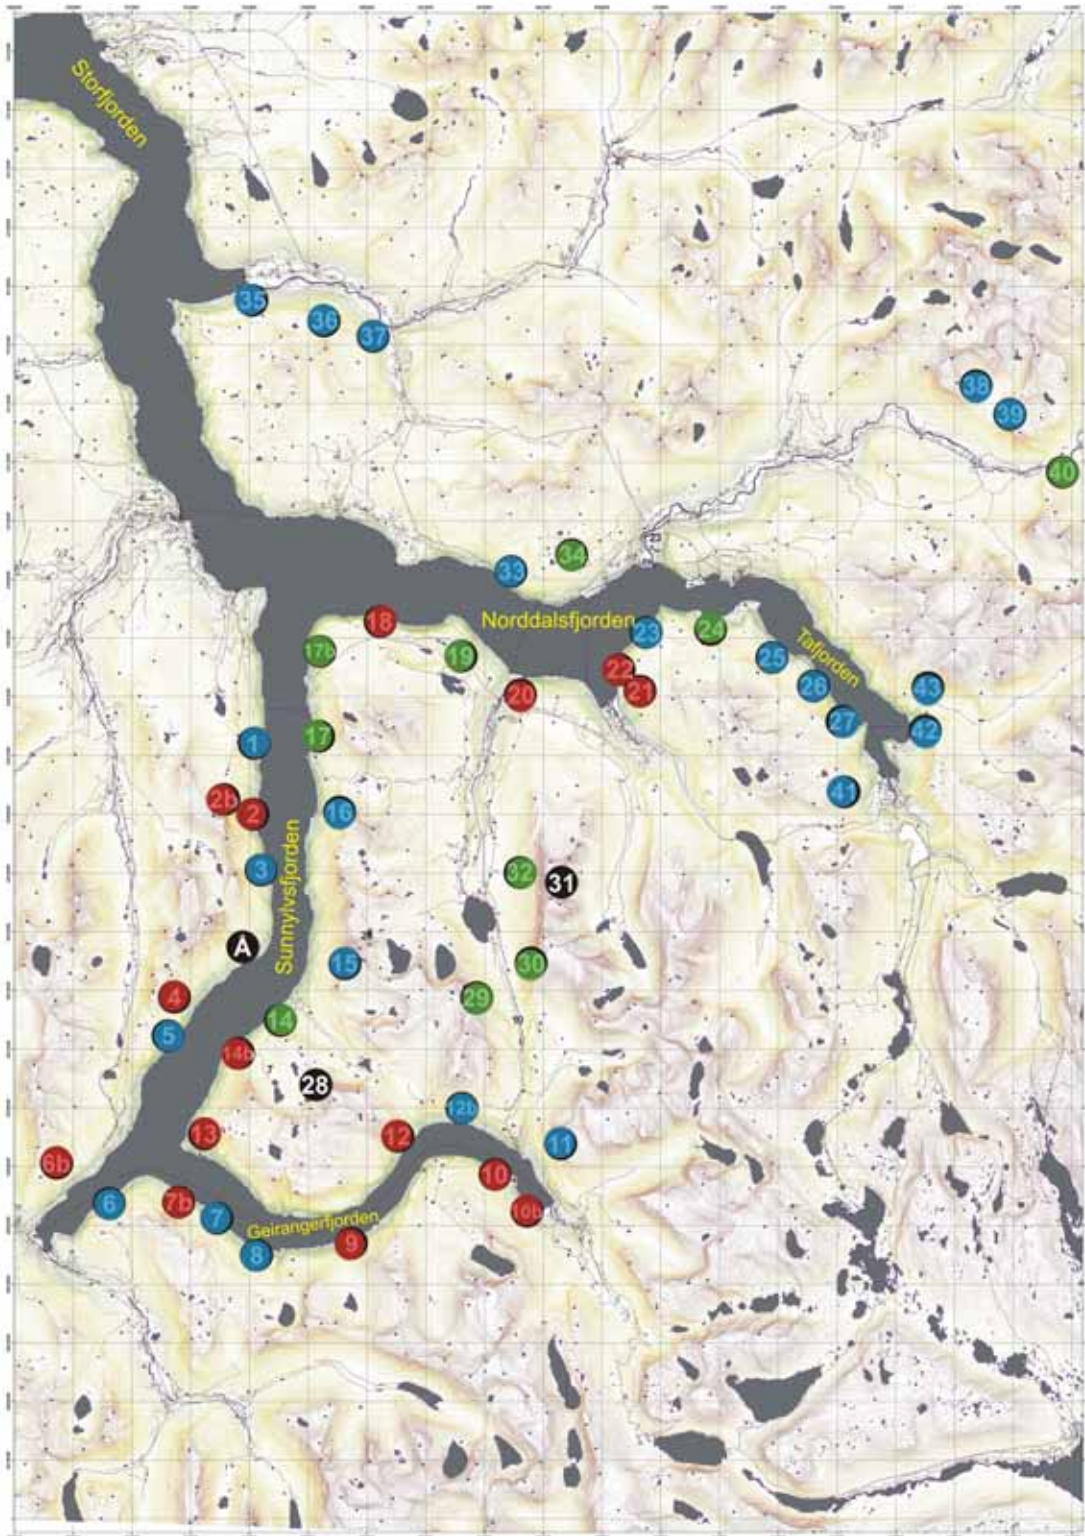
Figure 63 shows the status of the 49 different sites that were initially picked out from the aerial photo analysis prior to the field season in 2005. This shows the sites divided up into three types dependent on their status relative to the 2005 field season. Those shown in red have been visited on the ground and display significantly interesting structures. At many of these sites, several things are required:

**Figure 63: Summary of state of study for each sites. In red: field analyses is made and further studies are needed in the summer of 2006. In blue: field analyses should be in summer 2006, in green: the sites have been checked and do not display potential rock failures.**

Therefore, to summarise, extensive fieldwork is required in the 2006 field season to determine the possibility for instability in many sites that have not yet been examined in detail, GPS measurements need to be carried out on sites to determine if there has

been displacement during the winter 2005/2006 and GPS points need to be set out on new sites.

- Figure 63 summarises the state of the study made at each sites. Among the sites studied in 2005, 15 (in red on Figure 63) should be visited again in 2006 to collect more data and improve the knowledge of structures involved in the rockslides and to collect new GPS measurements to determine the magnitude and direction of displacement.
- Our study demonstrates that it is possible, through the analysis of field structural data to determine the evidence for movement activity in active fjord systems, to determine the likely areas of landslide activity and the different failure mechanisms that may be possible in different areas and thereby help to provide a better foundation for hazard analysis.
