NGU Report 2011.004

Resistivity measurements and structural geology
along the railroad tunnel transect Oslo - Ski.

Keywords:		Geophysics	Structural geology	
		Tunnels	Resistivity	
			Scientific report

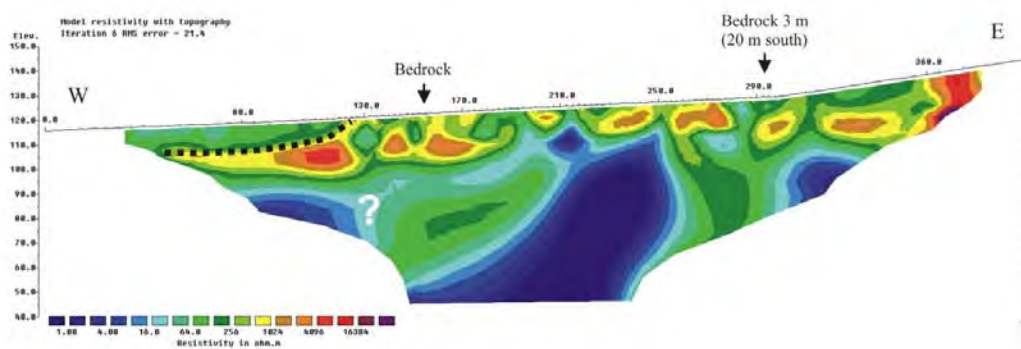
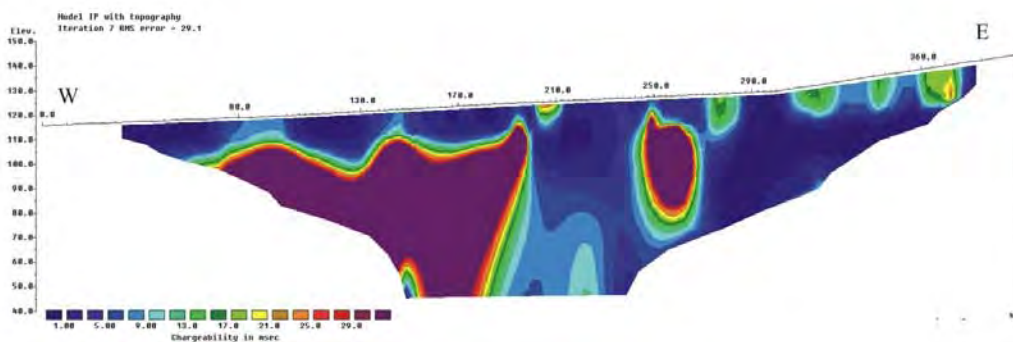
Figure 6. Profile 3, resistivity and IP with interpreted zones (fracture zones as thick dashed lines; soil cover limited at depth by a thin dashed line).

Along profile 3 presented in Figure 6, a soil cover is interpreted in the west end of the profile, where the soil cover becomes thicker westward, approximately of 10-15 m. Altogether 3 possible fracture zones are interpreted (for details see Table 3). High IP values may indicate that the general low resistivity can be caused by technical installations in the western part of the profile. However, the three interpreted fracture zones seem to be real, but the resistivity level is influenced by technical installations.

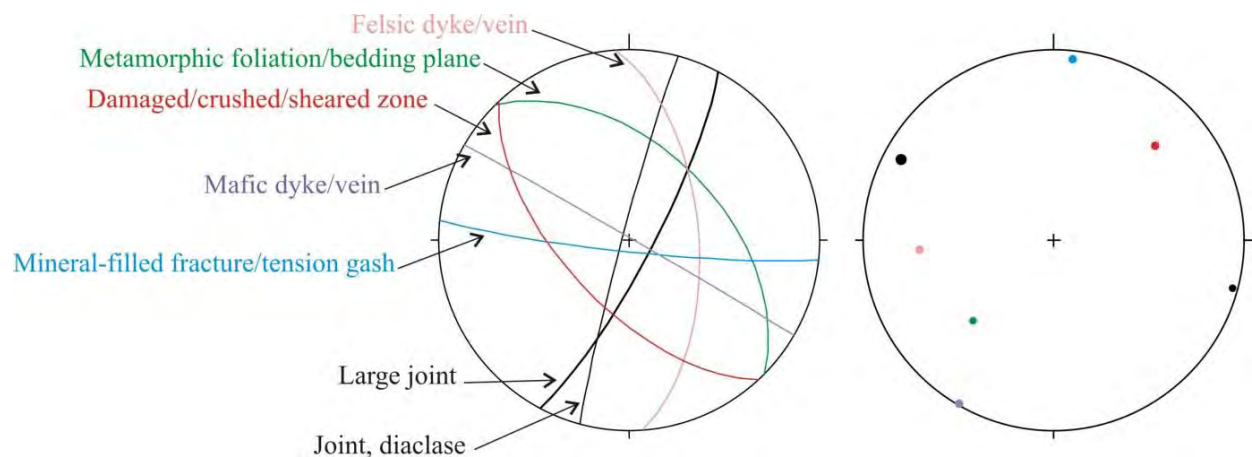
Figure 32. Example of stereonet for planar structures, Schmidt's projection, lower hemisphere (left, stereonet of planes; right, stereonet of poles of planes).

In following sub-sections, detailed analyses of fractures are given with representation of planes on stereonet (southern hemisphere, Schmidt's projection) with the convention below (Figure 32 and Figure 33).

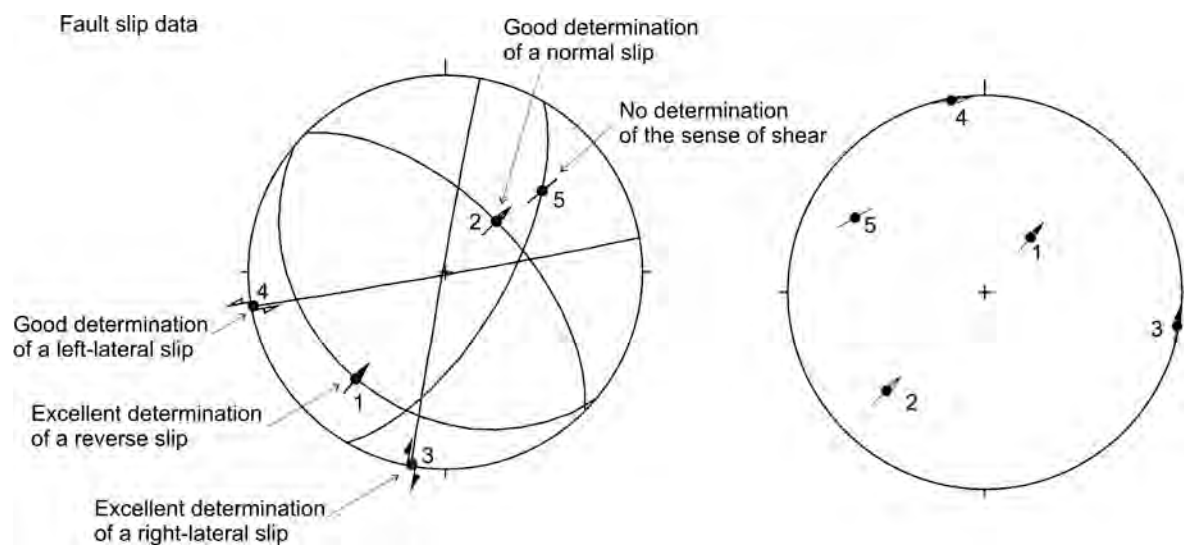
Figure 33. Example of stereonets for fault slip data, Schmidt's projection, lower hemisphere (left, stereonet of fault planes; right, stereonet of poles of fault planes). Keys for striae: An arrow indicates the sense of movement of the hanging wall block; inward directed arrow: reverse stria (number 1 on stereonet); outward directed arrow: normal stria (number 2); couple of arrows: strike-slip stria (numbers 3 and 4); full black arrow: excellent constrains on the sense of shear (numbers 1 and 3); empty arrow: good constrains on the sense of shear (numbers 2 and 4); thin line: no determination of the sense of shear (number 5).

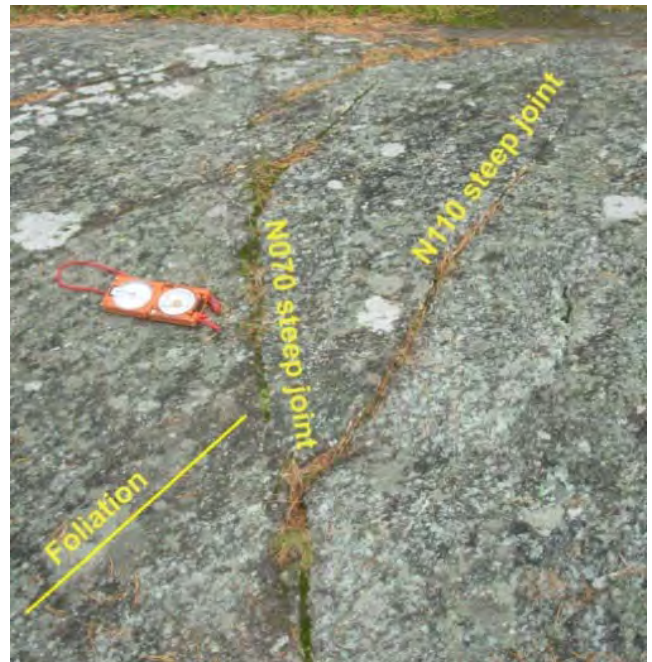
Ekeberg Rideskole

Figure 36. Structural field measurements displayed by rose diagrams and on stereonets at locality “Ekeberg Rideskole” close to resistivity profile 0 (keys to stereonets on Figure 32) and photograph of two fractures which belong to the two main sets of joints commonly found at the regional scale, which are the steep WSW-ENE and WNW-ESE orientated sets.

At the field locality “Ekeberg Rideskole” the outcrops are widespread flat surfaces on the ground. This locality is close to resistivity profile 0 (Figure 35). A high dispersion of joints is observed. However, the two main trends commonly displayed at the regional scale are present and correspond to the steep WSW-ENE and WNW-ESE orientated sets (Figure 35 and Figure 36). The metamorphic foliation has an average value of 70° dipping to the WSW. At field point “Ekeberg Rideskole_2” (located on Figure 35) the rocks are amphibolitic lenses and large pegmatitic bodies.

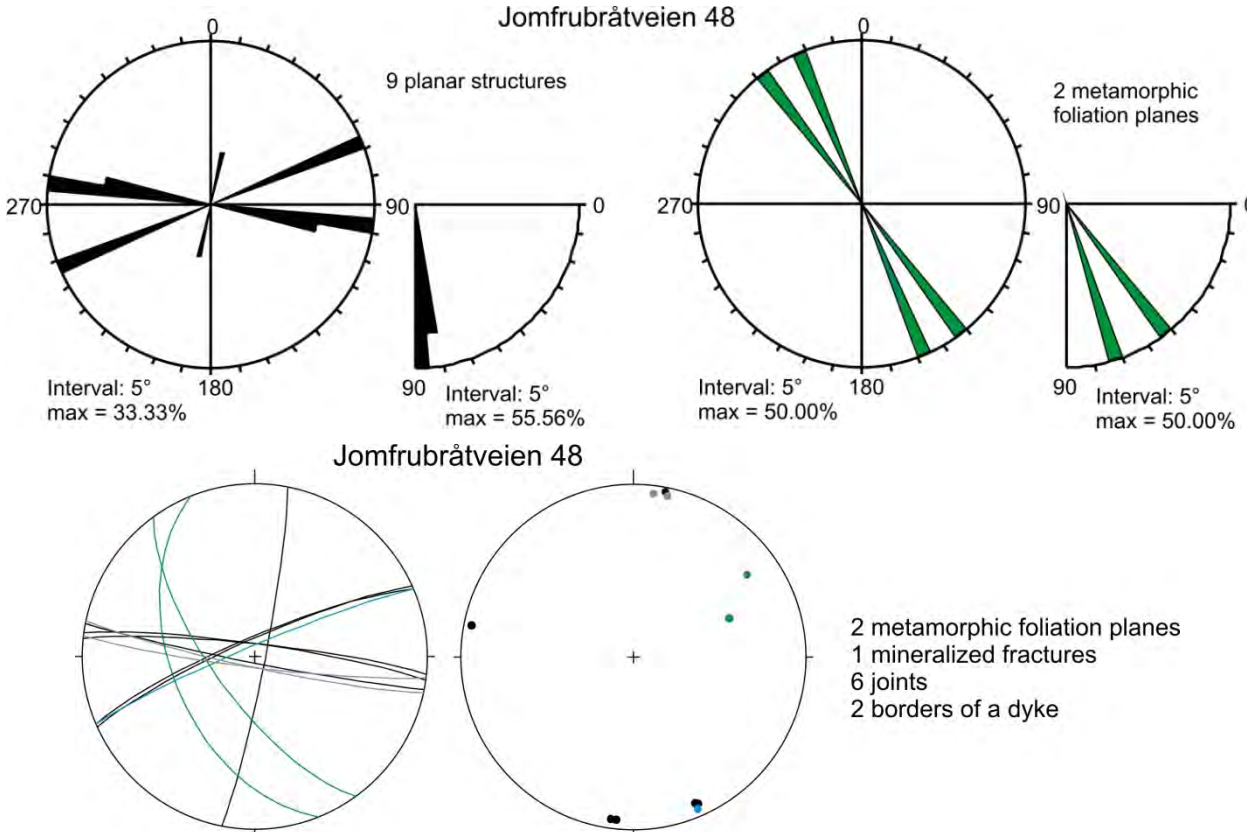
Figure 39. Structural field measurements displayed by rose diagrams and on stereonets at locality "Jomfrubråtveien, 48" close to resistivity profile 0 (keys to stereonets on Figure 32).

The field locality “Jomfrubråtveien, 48” is a small outcrop close to resistivity profile 0 (Figure 38). Of interest was the presence of 30 cm wide, nearly vertical basaltic dyke trending approximately E-W (Figure 38 and Figure 39). It trends parallel to a set of joints (Figure 38 and Figure 39). The other structures correspond to (1) a steep ENE-WSW fracture set with one fracture displaying an important chlorite-coating and to (2) the foliation dipping moderately to steeply toward the SW and WSW (Figure 38 and Figure 39).

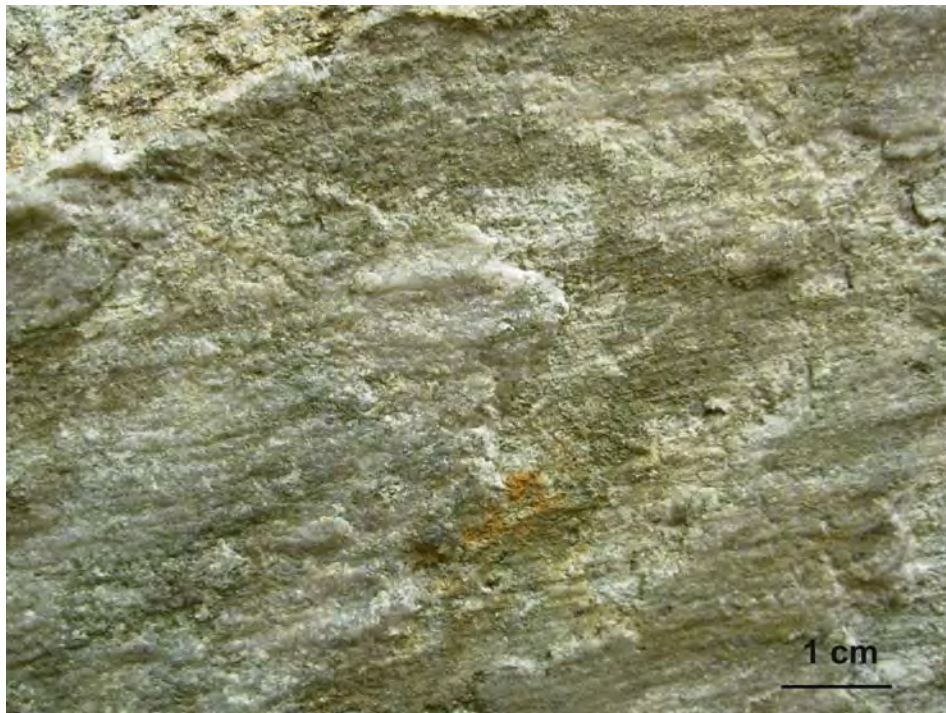
Figure 42. Illustration of the striated surface of a sinistral fault (strike/dip 285/46; pitch: 20W) which extends several meters at locality “Sportsplassen, Jomfrubråtveien”.

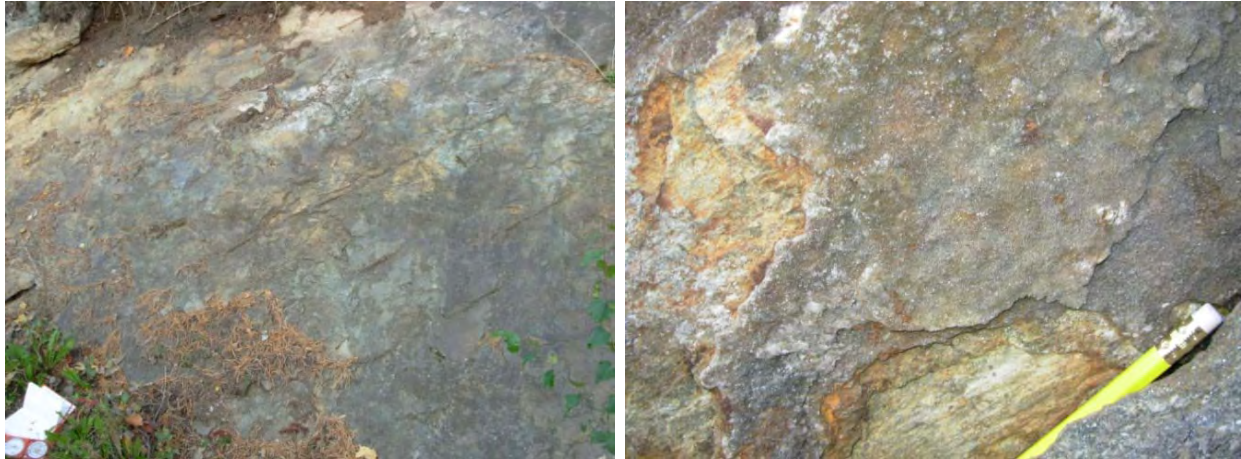
Figure 44. Left: weathered surface along a 55° WSW-dipping foliation plane observed at field point “Kongsveien_1”; right: steep north-dipping quartz-coated fracture at field point “Kongsveien_2”; (location of field points on Figure 38).

The field locality “Kongsveien” is west of resistivity profile 0 and the field point “Kongsveien_2” is aligned with one of the anomalies along the profile (Figure 38). The outcrop is discontinuous from field point “Kongsveien_1” to field point “Kongsveien_2” but each of them has large extent. The metamorphic foliation is moderately dipping toward the WSW at field point “Kongsveien_1” and severely flattens toward the field point “Kongsveien_2” (Figure 38 and Figure 43). The metamorphic foliation planes at field point “Kongsveien_1” displayed weathered features and a dip-slip faulting occurred along one of these surfaces (Figure 38, Figure 43 and Figure 44). The joints are quite dispersed both in terms of orientation and dip angle with, however, a preferential steep WSW-ENE trend. This trend corresponds to a regional geometry, which is perpendicular to the regional metamorphic foliation (Figure 38 and Figure 43). Chlorite- or quartz-coated fractures developed along the metamorphic foliation surface as well as along the main set of steep WSW-ENE joints (Figure 43 and Figure 44).

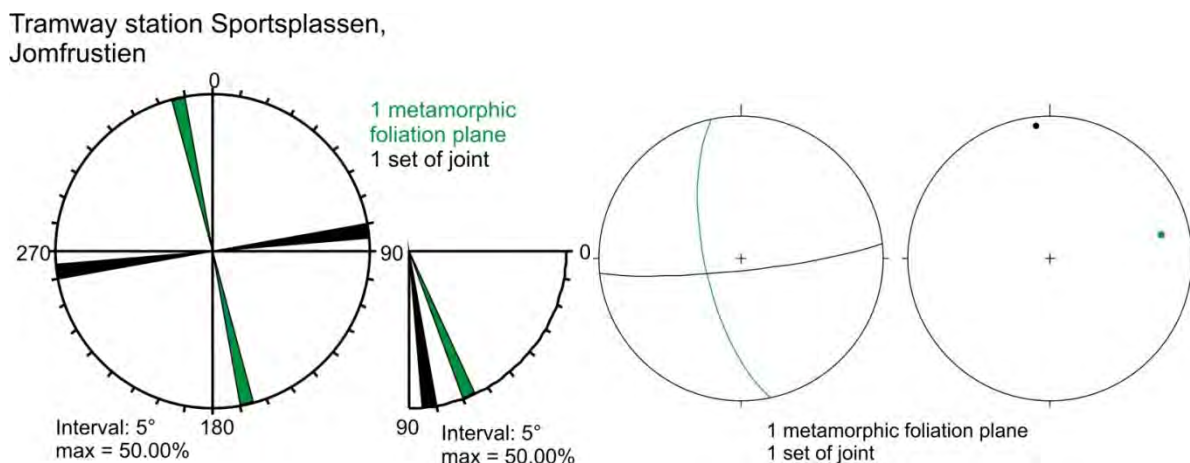
Figure 45. Structural field measurements displayed by rose diagrams and on stereonets at locality “Tramway station Sportsplassen, Jomfrustien” close to resistivity profile 0 (keys to stereonets on Figure 32).

The field locality “Tramway station Sportsplassen, Jomfrustien” is a poor outcrop visited because of its close vicinity to resistivity profile 0 (Figure 38). The observation allows confirming the regional trends of the steeply WSW-dipping metamorphic foliation and of the main set of vertical ENE-WSW orientated joints (Figure 38 and Figure 45).

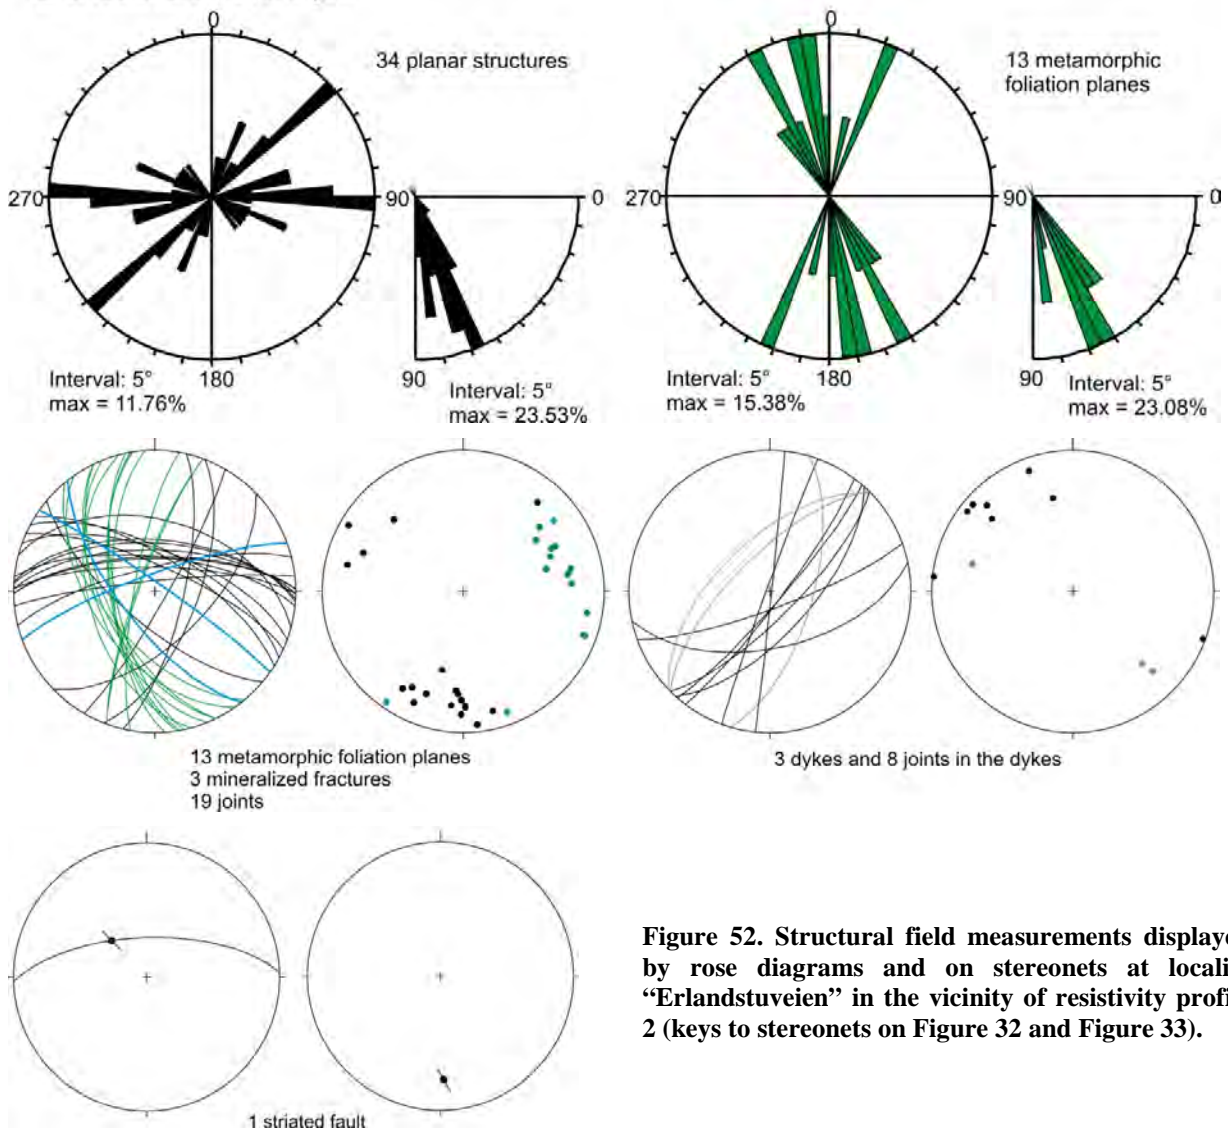
Figure 52. Structural field measurements displayed by rose diagrams and on stereonets at locality “Erlandstuveien” in the vicinity of resistivity profile 2 (keys to stereonets on Figure 32 and Figure 33).

The metamorphic foliation is slightly disturbed and from the regional steeply WSW-dipping trend, it is deviated toward a vertical NNE-SSW trend (Figure 52). The presence of large amphibolitic bodies along the outcrop and in the area in general (Figure 51) may explain the disturbance. In addition to the amphibolitic lenses, several NE-SW trending basaltic dykes (Figure 52) crop out, and they are more fractured than the gneissic host rock (Figure 53). The fractures within the dykes form a main set of steep brittle structures (Figure 52), while the other main set of fractures is moderately to steeply N-dipping and includes a striated fault (Figure 52 and Figure 53). This latter trend is parallel to the trend of a mapped lineament south of this field locality (Figure 51).

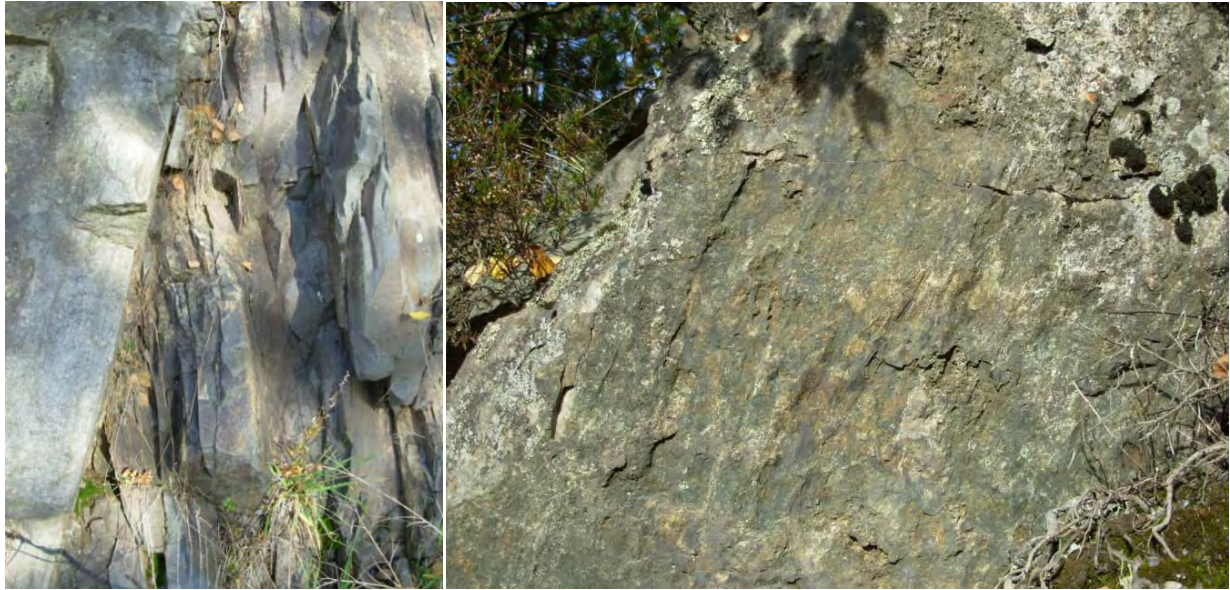
Figure 53. Left: western border of 5 m wide, steep NE-SW basaltic dyke at field point “Erlandstuveien_3”; note the high frequency of vertical NE-SW joints within the dyke; right: the north-dipping striated fault observed at field point “Erlandstuveien_4”; (field points are located on Figure 51).

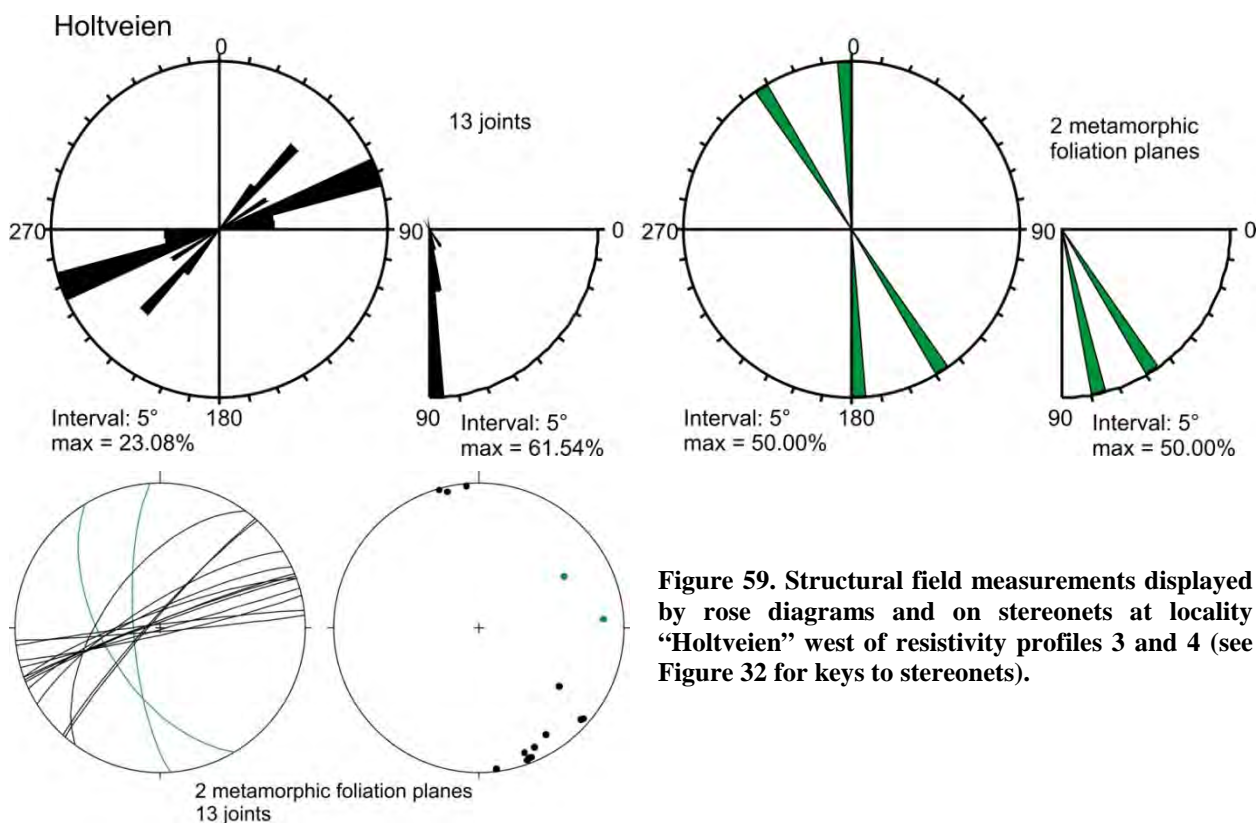
Figure 59. Structural field measurements displayed by rose diagrams and on stereonets at locality “Holtveien” west of resistivity profiles 3 and 4 (see Figure 32 for keys to stereonets).

The Field locality “Holtveien” (Figure 58) gives a particular good view of the structural pattern of the region. The two regional structures are solely represented, which are the steep foliation dipping to the WSW and W, and the perpendicular set of nearly vertical ENE-WSW joints (Figure 58 and Figure 59). The frequency of this unique joint set is of about 2/m.

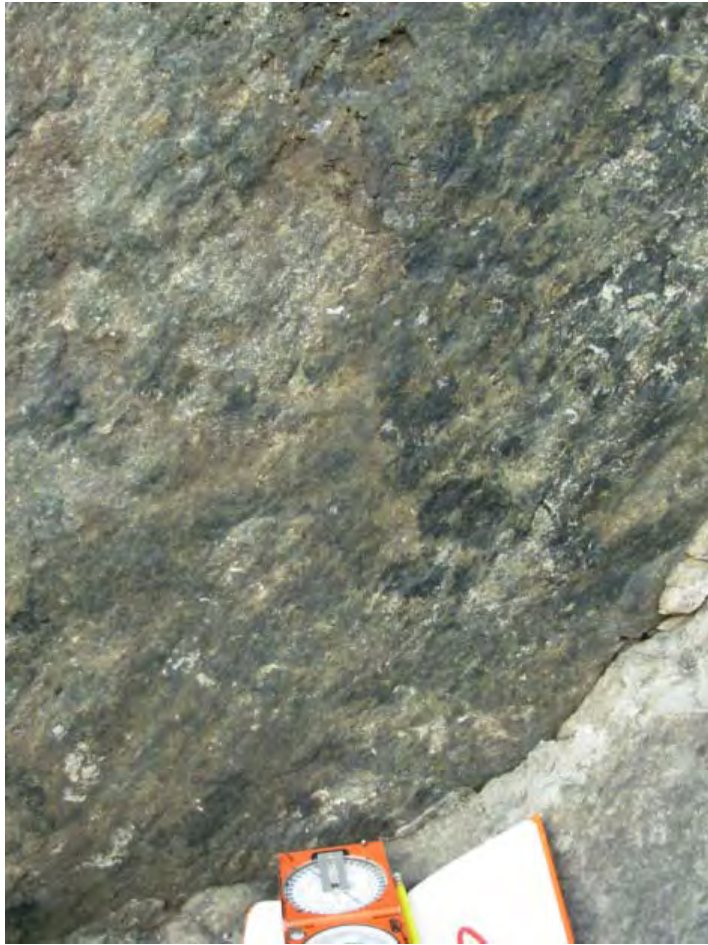
Figure 71. Photograph of a calcite- and chlorite-coated striated normal fault observed at field point “Munkerudåsen_4” (see location on Figure 69)

The metamorphic foliation follows the regional trend that is about 60° dipping to the WSW (Figure 69 and Figure 70). Other structures are also rather steep and roughly E-W trending including two large pegmatitic veins of 60 cm and 2 m wide, at field points "Munkerudåsen_2" and "Munkerudåsen_5" respectively (Figure 69 and Figure 70). Two striated faults dipping steeply to the north are observed and they are underlined by a set of mineralized fractures (Figure 69, Figure 70 and Figure 71).

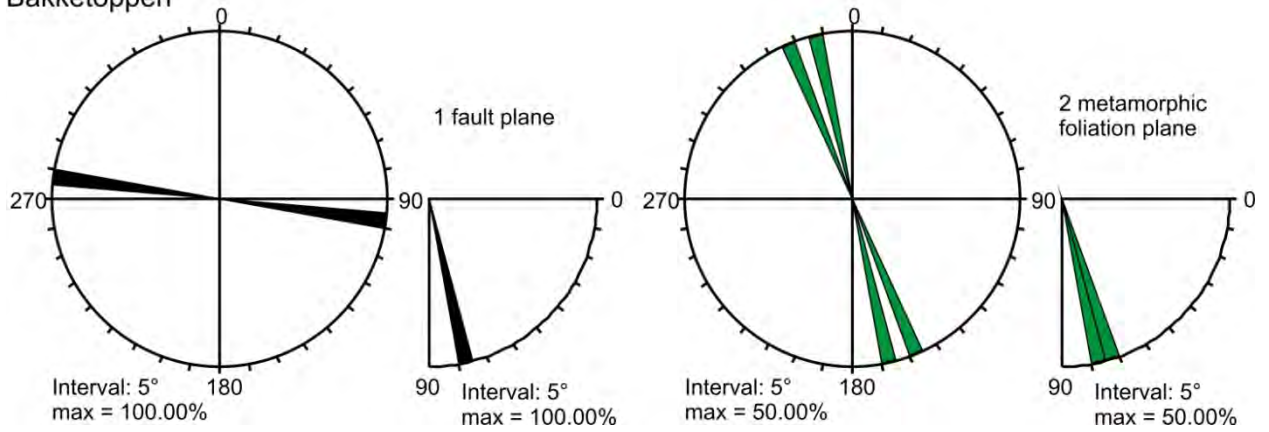
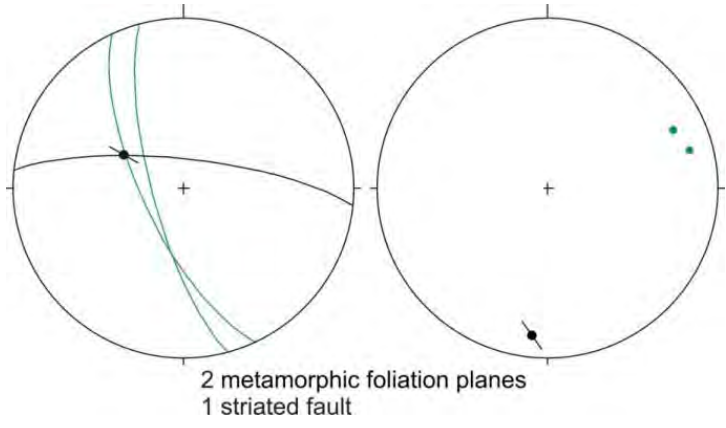
Bakketoppen

Figure 72. Structural field measurements displayed by rose diagrams and on stereonets at locality “Bakketoppen” close to resistivity profile 8 (keys to stereonets on Figure 32 and Figure 33).

2 metamorphic foliation planes
1 striated fault

The field locality “Bakketoppen” is a discontinuous 100 m long outcrop along the resistivity profile 8 (Figure 69). One of the anomalies along the profile 8 obviously corresponds to the regional 20m wide rhomb porphyry dyke (Figure 69). The metamorphic foliation steeply dips to the WSW and one steep north-dipping striated fault is observed (Figure 72) that mirrors the faults found at the field locality “Munkerudåsen” close by (see preceding section and Figure 70).

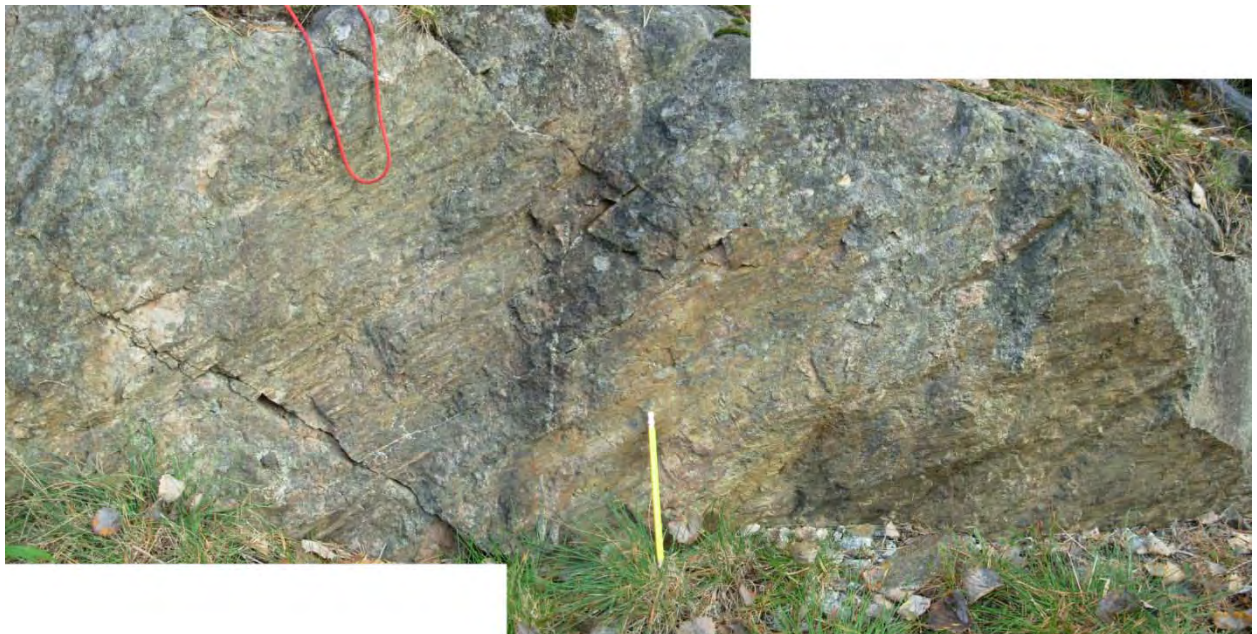
Figure 78. Photograph of a sinistral WNW-ESE steep fault at field point “Ljabru_1” (located on Figure 76).

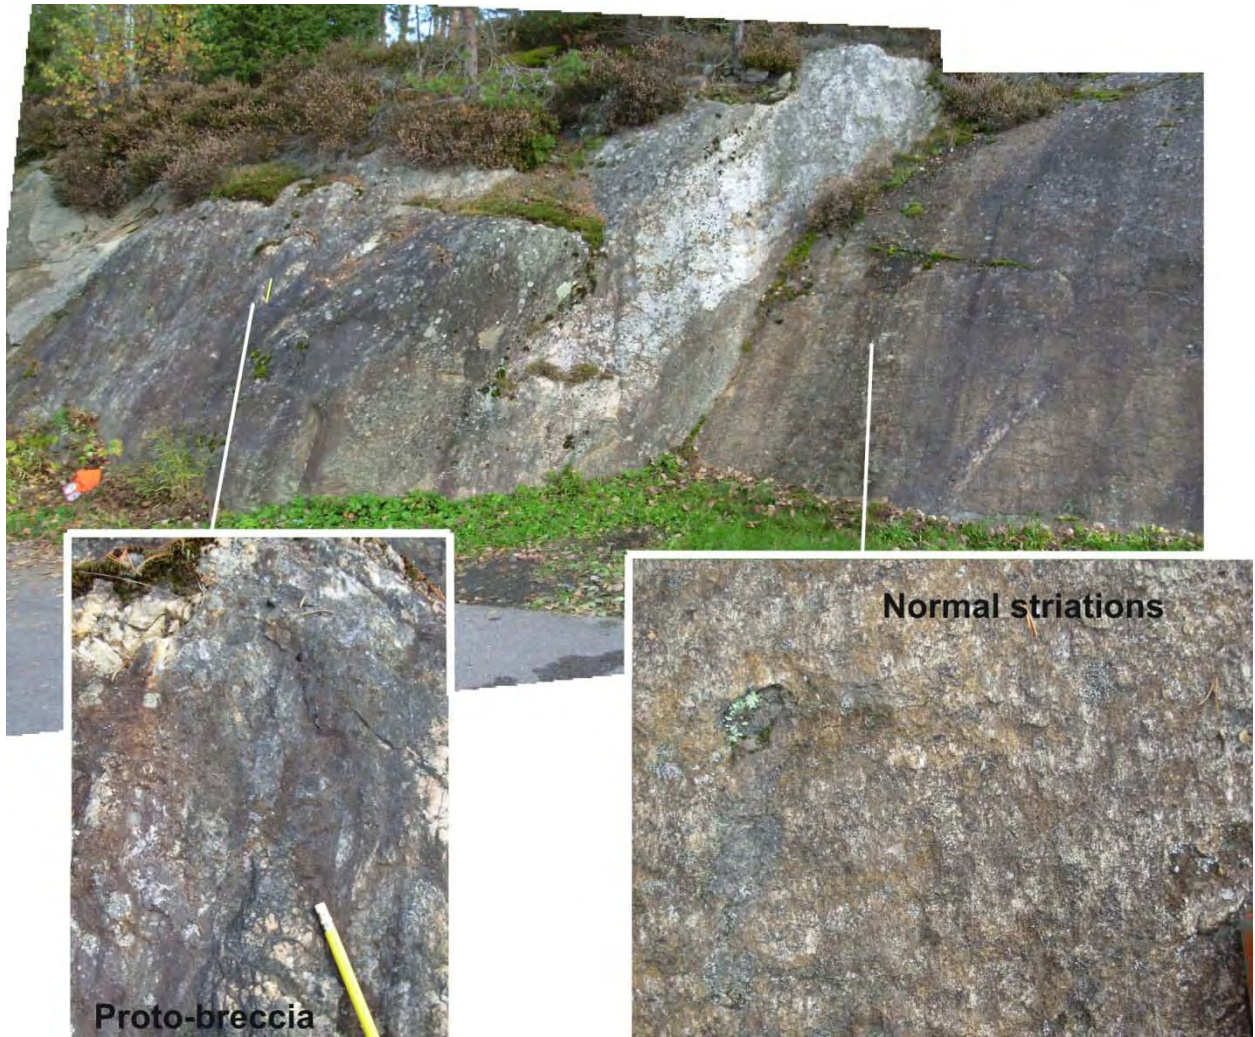
Figure 79. Photographs of normal faults which developed along the metamorphic foliation between field points "Ljabru_1" and "Ljabru_2" (located on Figure 76).

The field locality “Ljabru” is just south of a resistivity anomaly detected along profile 8, which is also in line with a NNW-SSE lineament (Figure 76). From field point “Ljabru_1” to field point “Ljabru_2” a continuous, several meters high outcrop of garnet-rich gneiss is exposed. The metamorphic foliation is steeply dipping to the WSW in agreement with its regional attitude (Figure 76 and Figure 77). Steep to vertical WNW-ESE trending fractures form the main set of joints, which also corresponds to oblique – and strike-slip faults (Figure 77 and Figure 78). They are located on field point “Ljabru_1” and reflect the trend of the lineament mapped some 50 m farther south (Figure 76). Two other sets of joints are well defined: one dips about 60° to the north and the other one is vertical and striking ENE-ESE. The most remarkable structures along the outcrop are two large normal faults that developed along the foliation with, on one of the plane, the observation of a proto-breccia (Figure 77 and Figure 79).

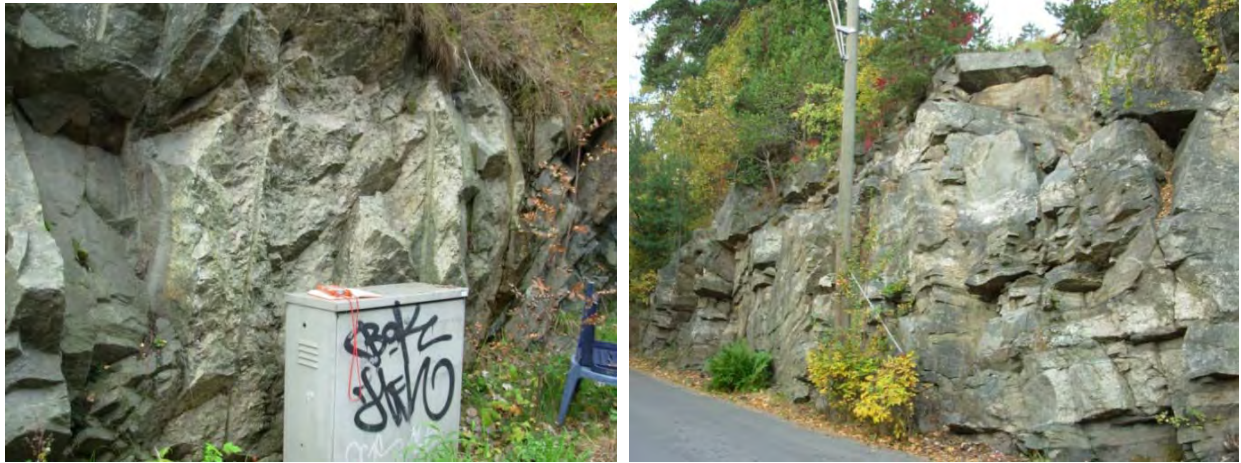
Figure 80. Photographs of the outcrops at field point “Knud Øyes vei_1” displaying a large pegmatitic body juxtaposed to the shallow-dipping biotite-rich gneiss (left) and at field point “Knud Øyes vei_3” (view to W) where the foliation is close to horizontal (right), note the presence of large E-W trending and vertical joints; (field points located on Figure 76).

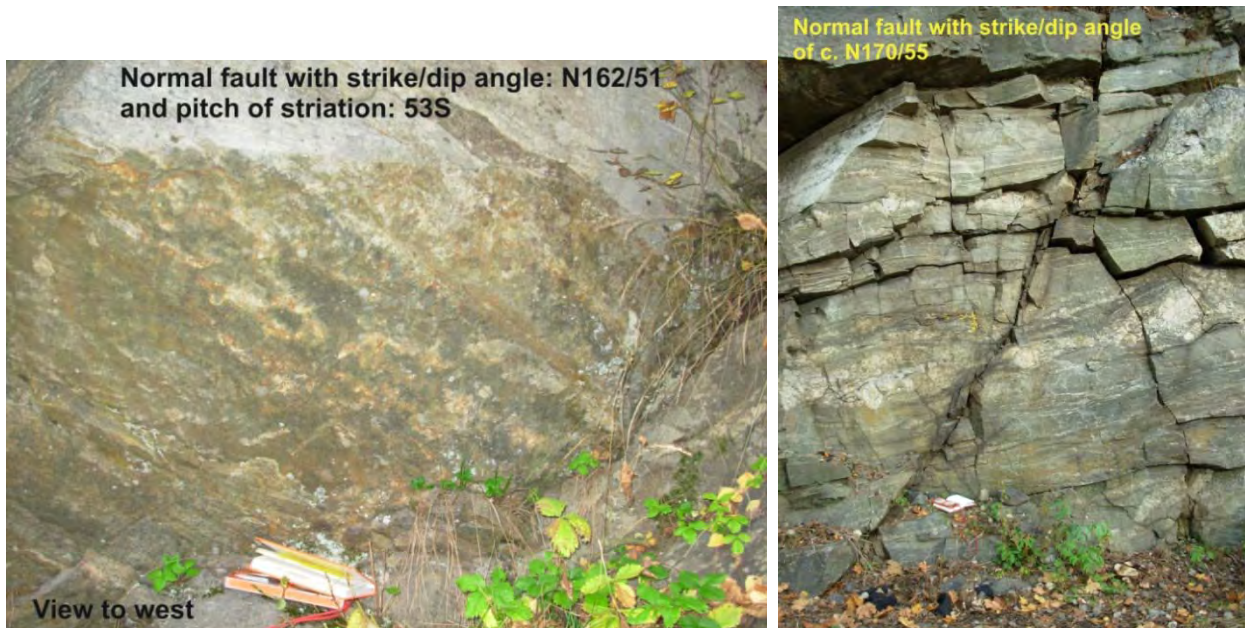
Figure 82. Photographs of normal faults at field point “Knud Øyes vei_2” displaying intense striations (left) and at field point “Knud Øyes vei_3” with an intense vertical fracturation in the vicinity of the main fault plane (right); (field points located on Figure 76).

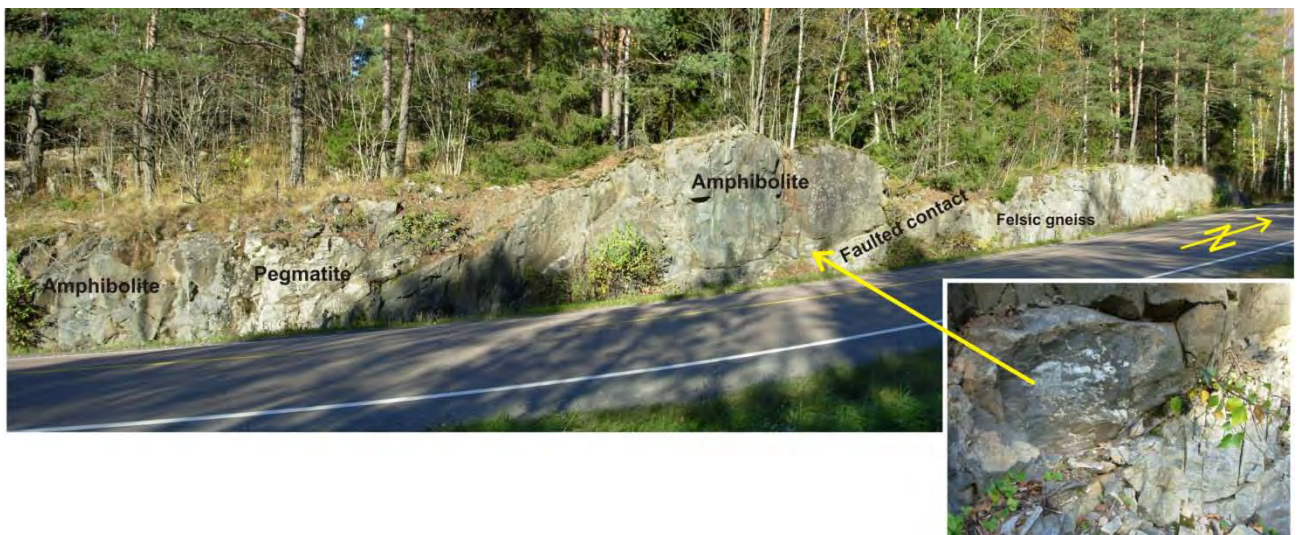
Figure 92. Faulted contact between a amphibolite and a felsic gneiss at field point “NE-Vevelstadveien_4” (located on Figure 90) and encapsulated photograph of the related calcite-stepped sinistral fault.

The rocks alternate between felsic gneisses and amphibolites. The metamorphic foliation is gently dipping toward the west and WSW (Figure 90 and Figure 91). At field point “NE-Vevelstadveien_4” the contact between an overlying amphibolite and a felsic gneiss unit is faulted (Figure 92). The fault displays an undulated surface from a NE-SW vertical geometry to c. 50° WNW-dipping geometry corresponding to the two measurements of fault slips shown on Figure 90 and Figure 91. The two fault slips are sinistral as indicated by well-developed calcite steps (Figure 92). The fault measurements also correspond to the NNE-SSW mapped lineament (Figure 90). South-dipping 2 m and 5 cm wide pegmatitic veins are observed, respectively north and south of field point “NE-Vevelstadveien_4” (Figure 90, Figure 91 and Figure 92). Otherwise, the geometry of fractures is widespread and mineral coating is common on all direction (Figure 90 and Figure 91). NNW-SSE fractures, which are steeply dipping toward the WSW, form the most abundant set and commonly display zeolite- and calcite-coating (Figure 90 and Figure 91)

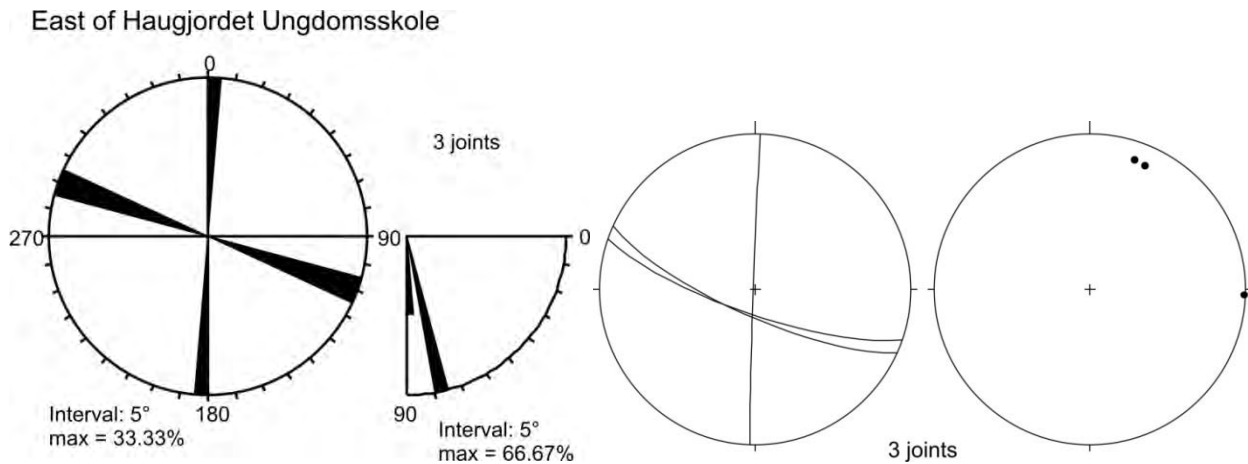
Figure 96. Structural field measurements displayed by rose diagrams and on stereonet at locality “East of Haugjordet Ungdomsskole” close to resistivity profiles 13 and 15 (keys to stereonet on Figure 32).

The field locality “East of Haugjordet Ungdomsskole” corresponds to a narrow, deeply incised, N-S striking gully from which issued the extraction of a N-S lineament (Figure 93). Although this location is accurate to determine the structural nature of this lineament, the outcrop is really difficult to study because of a widespread moss and lichen cover. Two main sets of steep joints are identified; one strikes N-S and the other, WNW-ESE (Figure 93 and Figure 96). Only three joints were measured but it was qualitatively observed that they were representative for the two sets at the outcrop.

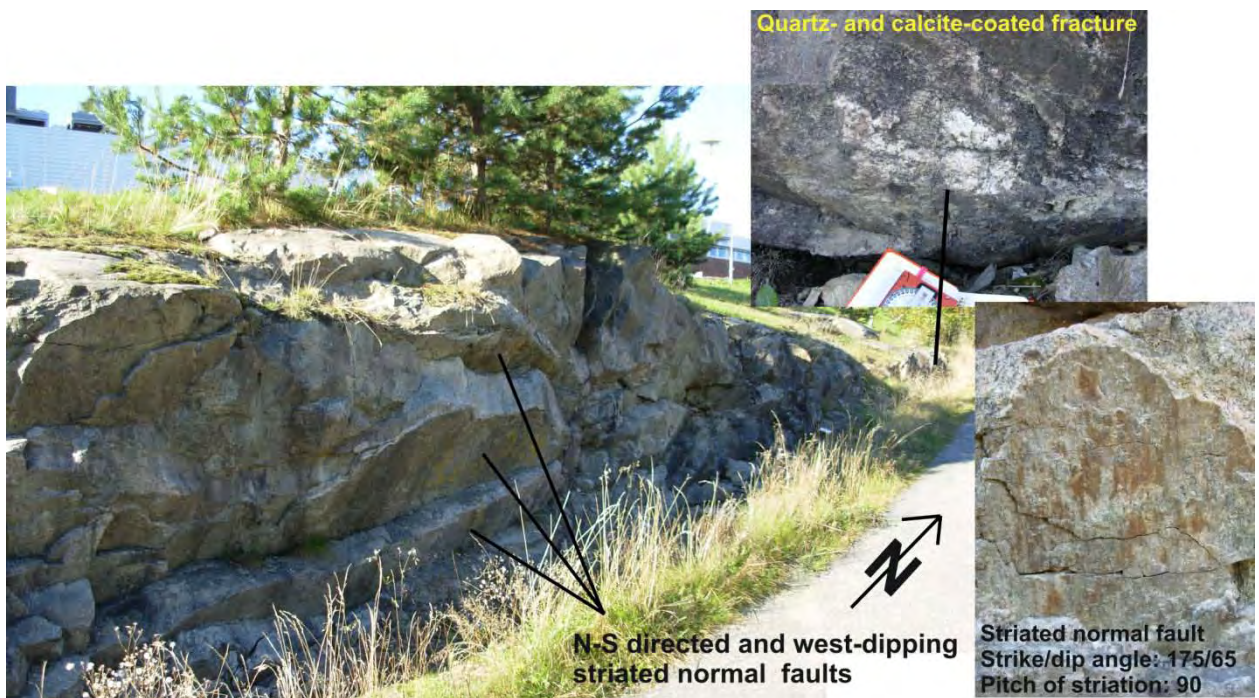
Figure 99. Photographs of the high density of faults at field locality “South of Haugjordet Ungdomsskole” (left), of a quartz- and calcite-coated NNW-SSE fracture (top right) and of normal striations on one of the fault plane (bottom right).

The outcrop at the field locality “South of Haugjordet Ungdomsskole” is several tens of meters long and c. 1 m high. The metamorphic foliation is WNW-ESE directed and vertical; it differs from the WSW-dipping trend found in the studied northern region and from the NW-dipping trend that characterises the eastern and western regions (see Figure 87). Nevertheless, the main structures observed at this field locality are steep NNW-SSE fractures, which commonly displayed mineral coating and moderately west-dipping normal faults with a 10 to 20 cm spacing between the fault planes (Figure 97, Figure 98 and Figure 99).

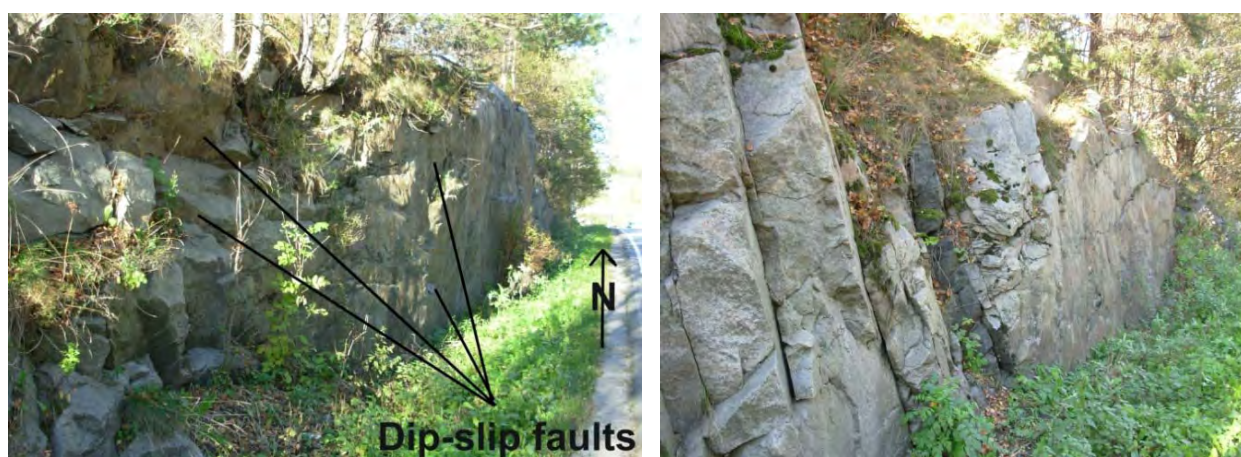
Figure 101. Left: photograph showing the high density of dip-slip faults on the western side of the road “Vevelstadveien” at field point “Vevelstad_1” (located on Figure 97); right: 70-75° NE-dipping, 30 cm wide, gabbroic dyke at the same field point.

The outcrops of “Vevelstad” field locality comprise several tens of meters long and meters high road cuts, which are exactly along a N-S lineament (Figure 97). The metamorphic foliation shows a strong dispersion. A mean value corresponds to a NE-SW direction moderately dipping to the NW (Figure 97 and Figure 100), which strongly deviated from the NNW-SSE/NW-SE directed regional pattern found in the northern areas. The main important structural features at this field locality correspond to a very dense pattern of striated faults trending from NNE-SSW to N-S (Figure 97, Figure 100, Figure 101 and Figure 102). The NNE-SSW set dips 70° in average toward the WNW and the N-S set is nearly vertical. This observation strongly suggests that the N-S lineament mapped at this field locality (see Figure 97) correspond to a large fault zone. Another remarkable structure observed at field point “Vevelstad_1” is a 70-75° NE-dipping, 30 cm wide, gabbroic dyke (Figure 97, Figure 100 and Figure 101).

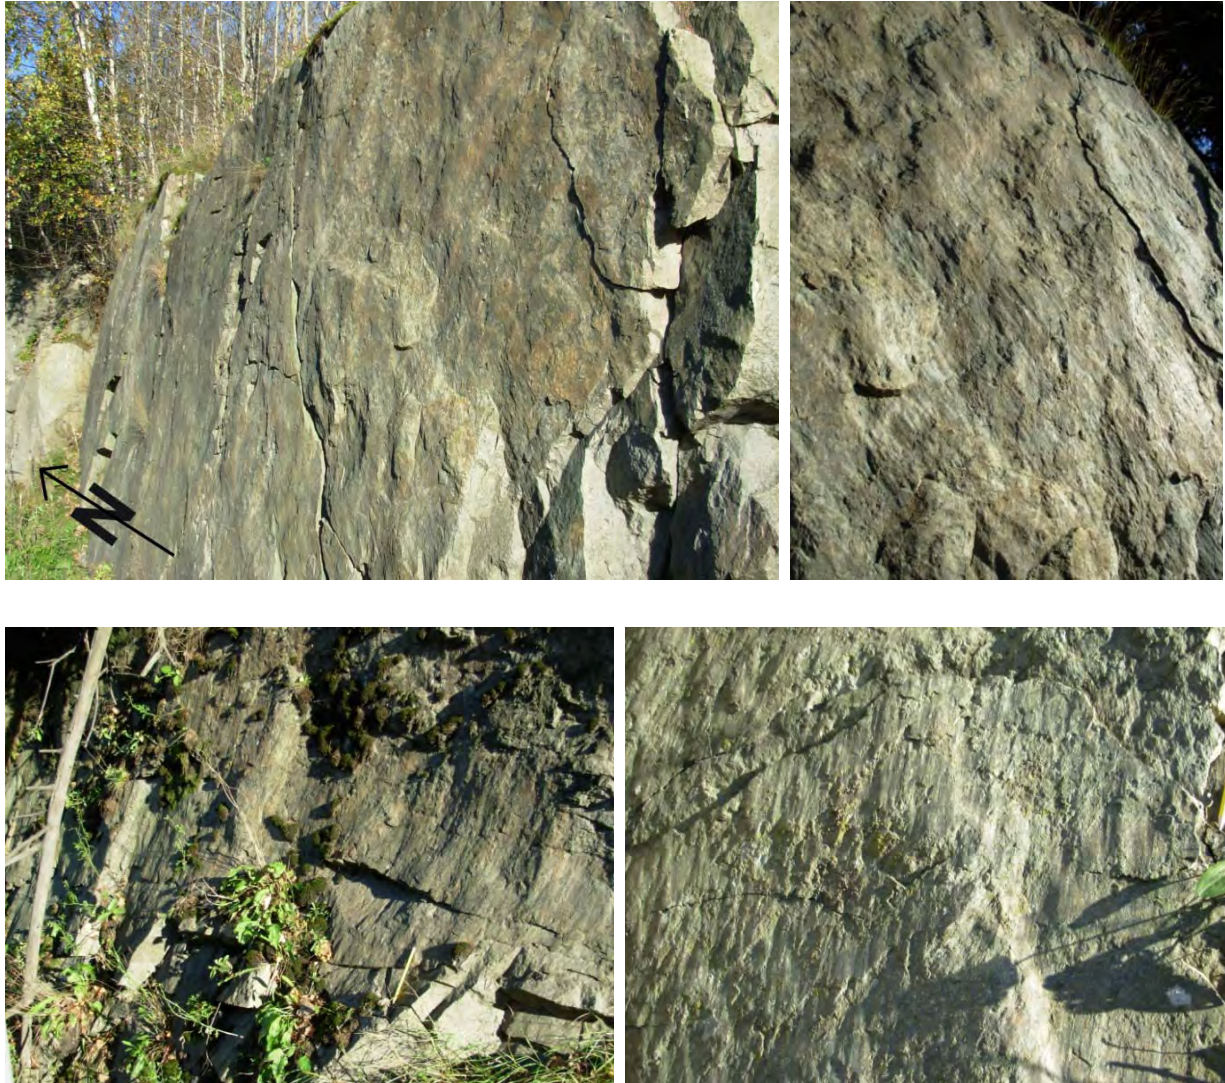
Figure 102. Top left: photograph of a large striated N-S nearly vertical fault observed on the eastern side of the road “Vevelstadveien” at field point “Vevelstad_2” (located on Figure 97), the other photographs show striated fault surfaces also observed at the same field point.

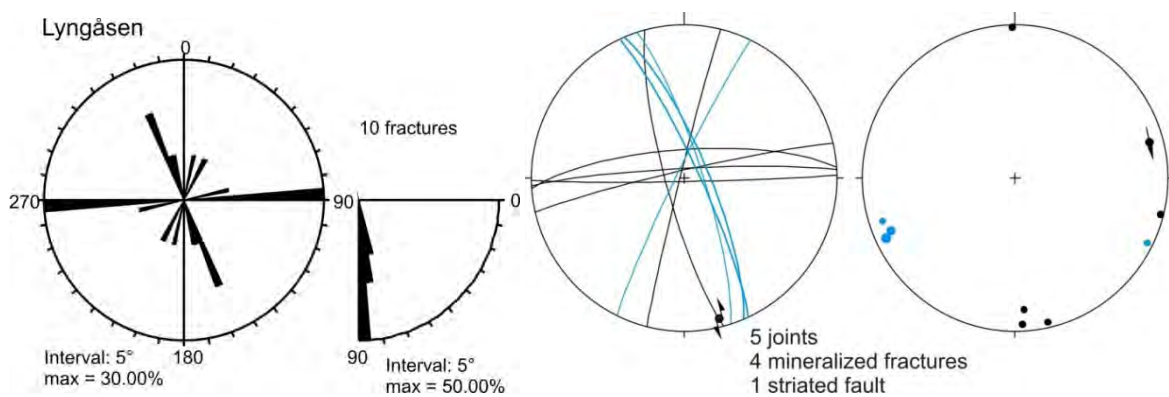
Figure 104. Structural field measurements displayed by rose diagrams and on stereonets at locality “Lyngåsen” close to resistivity profile 14 (keys to stereonets on Figure 32 and Figure 33).

The outcrop of the field locality “Lyngåsen” is of limited extent and mainly comprises amphibolitic rocks. The main set of fractures corresponds to joints and is vertical and E-W striking (Figure 103 and Figure 104). Two other vertical sets are identified trending respectively NNE-SSW and NNW-SSE (Figure 103 and Figure 104). Both of them comprise quartz-, chlorite- or hematite- coated fractures. The set trending NNW-SSE also contains a sinistral striated fault (Figure 103, Figure 104 and Figure 105).
