NGU Report 2011.004

Resistivity measurements and structural geology
along the railroad tunnel transect Oslo - Ski.

Keywords:		Geophysics	Structural geology	
		Tunnels	Resistivity	
			Scientific report

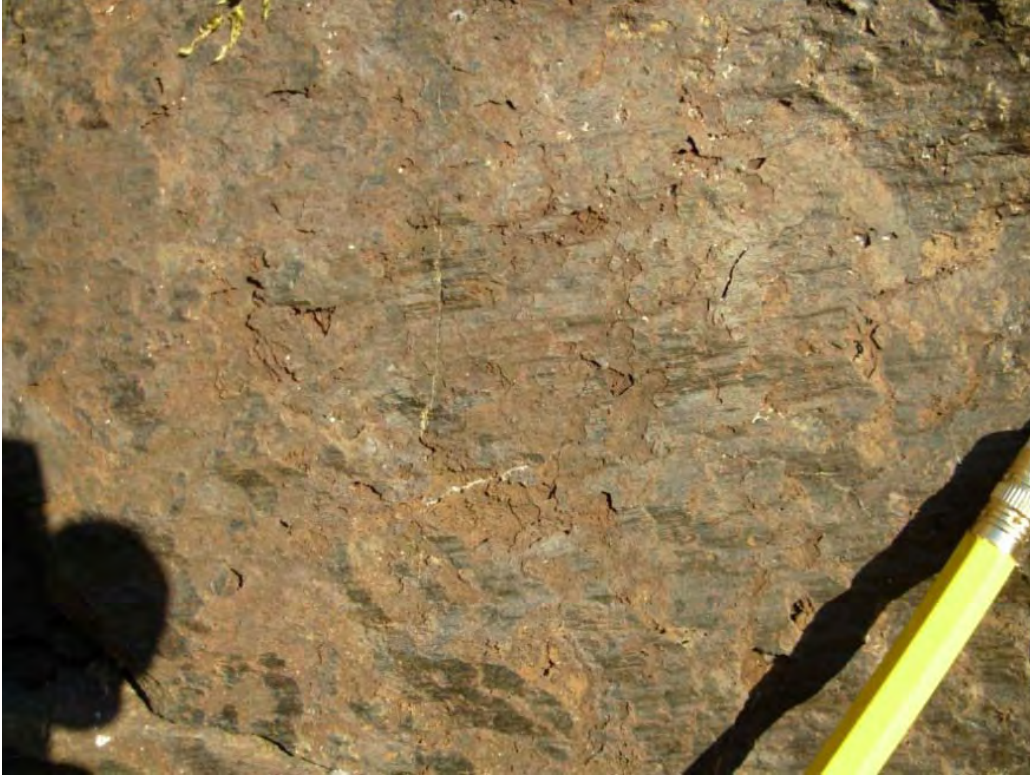
Figure 105. Very steep, NNW-SSE trending, hematite-striated, sinistral fault at field locality “Lyngåsen”.

The outcrop of the field locality “Lyngåsen” is of limited extent and mainly comprises amphibolitic rocks. The main set of fractures corresponds to joints and is vertical and E-W striking (Figure 103 and Figure 104). Two other vertical sets are identified trending respectively NNE-SSW and NNW-SSE (Figure 103 and Figure 104). Both of them comprise quartz-, chlorite- or hematite- coated fractures. The set trending NNW-SSE also contains a sinistral striated fault (Figure 103, Figure 104 and Figure 105).

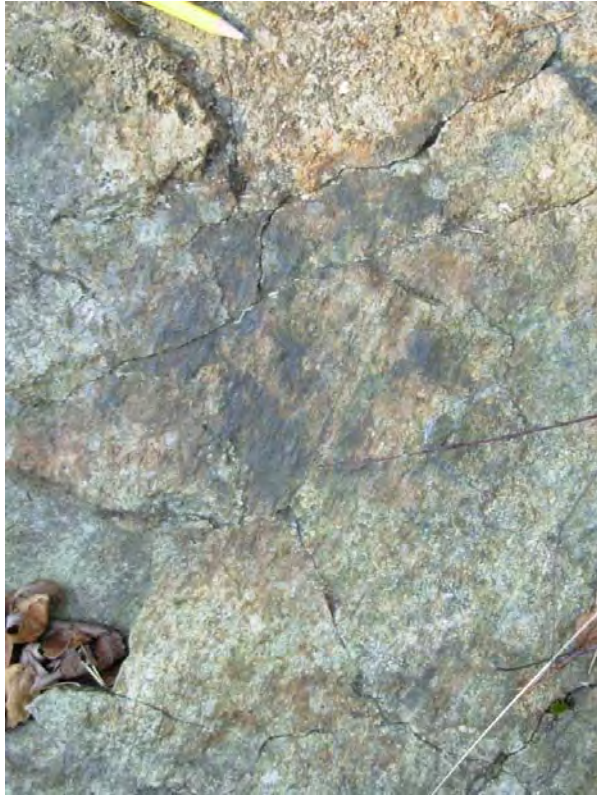
Figure 108. Photograph (view to N) of a striated fault measured at field point “Skoglia_1” (located on Figure 103) with strike/dip angle: N090/52 and pitch of striation: 80W.
