NGU Report 96.141

The Hydrochemistry of Selected Coal Mine
Drainage and Spoil-Tip Run-off Waters,
Longyearbyen, Svalbard

Report no.: 96.141		ISSN 0800-3416	Grading: Open
Title: The Hydrochemistry of Selected Coal Mine Drainage and Spoil-Tip Run-off Waters, Longyearbyen, Svalbard			
Authors: D. Banks		Client: NGU	
County: Svalbard		Commune:	
Map-sheet name (M=1:250.000)		Map-sheet no. and -name (M=1:50.000)	
Deposit name and grid-reference: Longyear Coal		Number of pages: 22	Price (NOK): 60,-
Fieldwork carried out: July 1996		Date of report: 31/12/96	Project no.: 2717.00
		Person responsible:

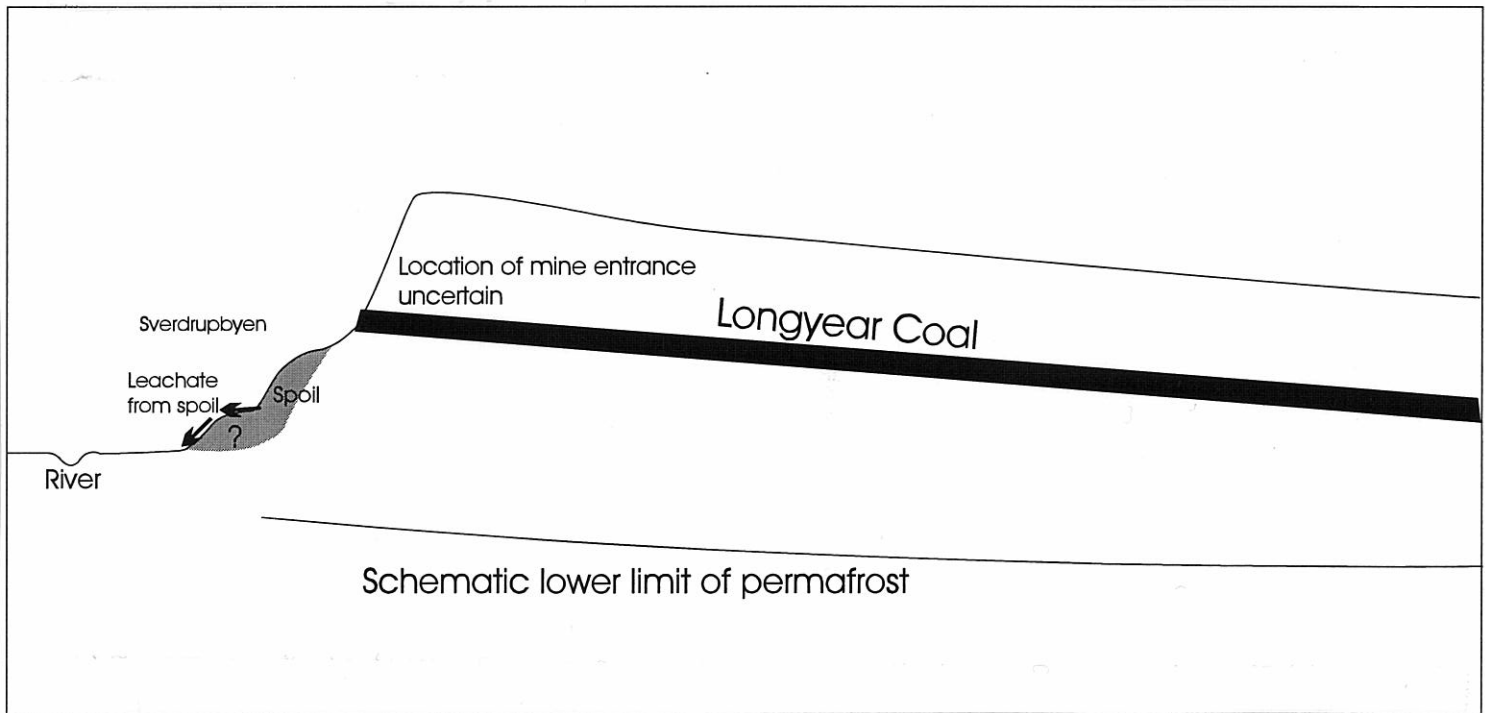
Figure 2. Highly schematic cross-sections of likely hydrogeological situation at (a) Mine 3, where deep mine water leakages are pumped out in the vicinity of the spoil tip and (b) Sverdrupbyen, where the mine is not pumped. The mine structure shown is based on the most likely interpretation of information available to the author

The location of the sampling sites is documented on Figure 1 and schematic cross-sections are indicated in Figure 2.

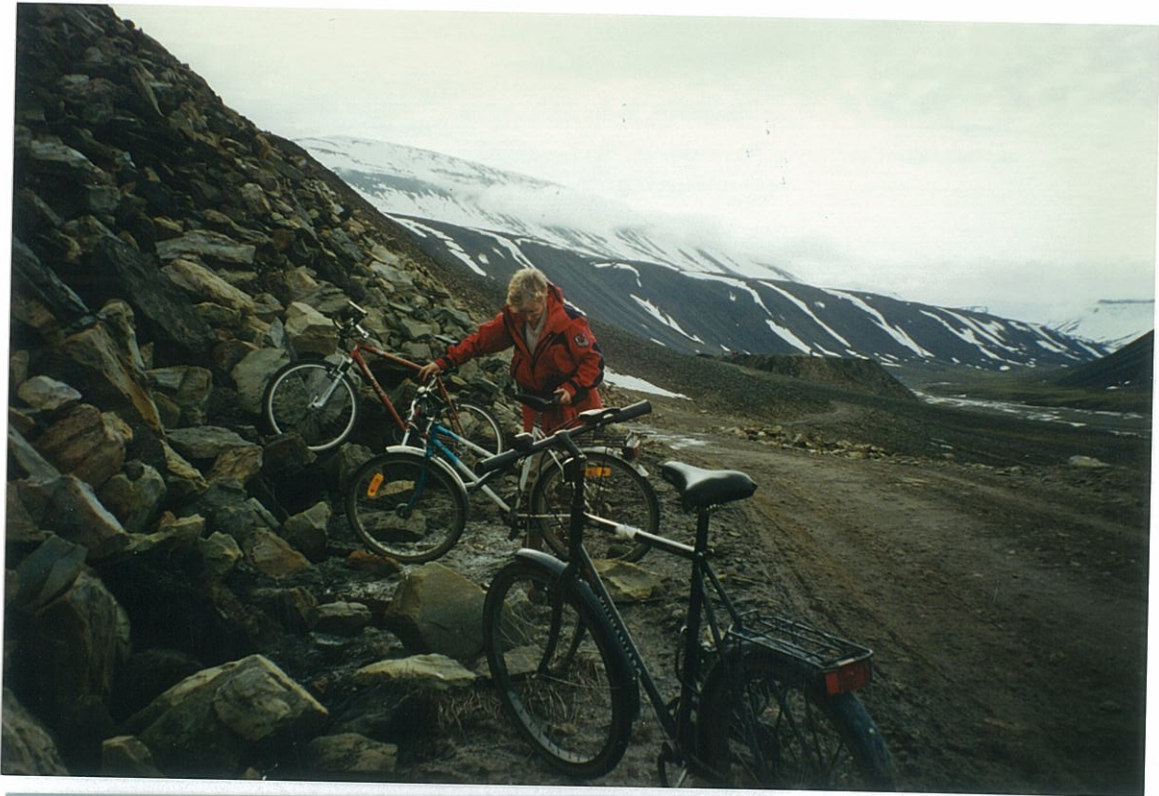
Figure 3a. Bjørndalen, looking south. The flat-topped spoil heap where samples were taken from Mine 3 is seen in the background.

In the lower part of Bjørndalen are several areas of mine spoil derived from Mine 3. The surfaces of the shaley spoil fragments are frequently coated with a yellow mineral, possibly iron sulphate or jarosite derived from subaerial oxidation of pyrite.

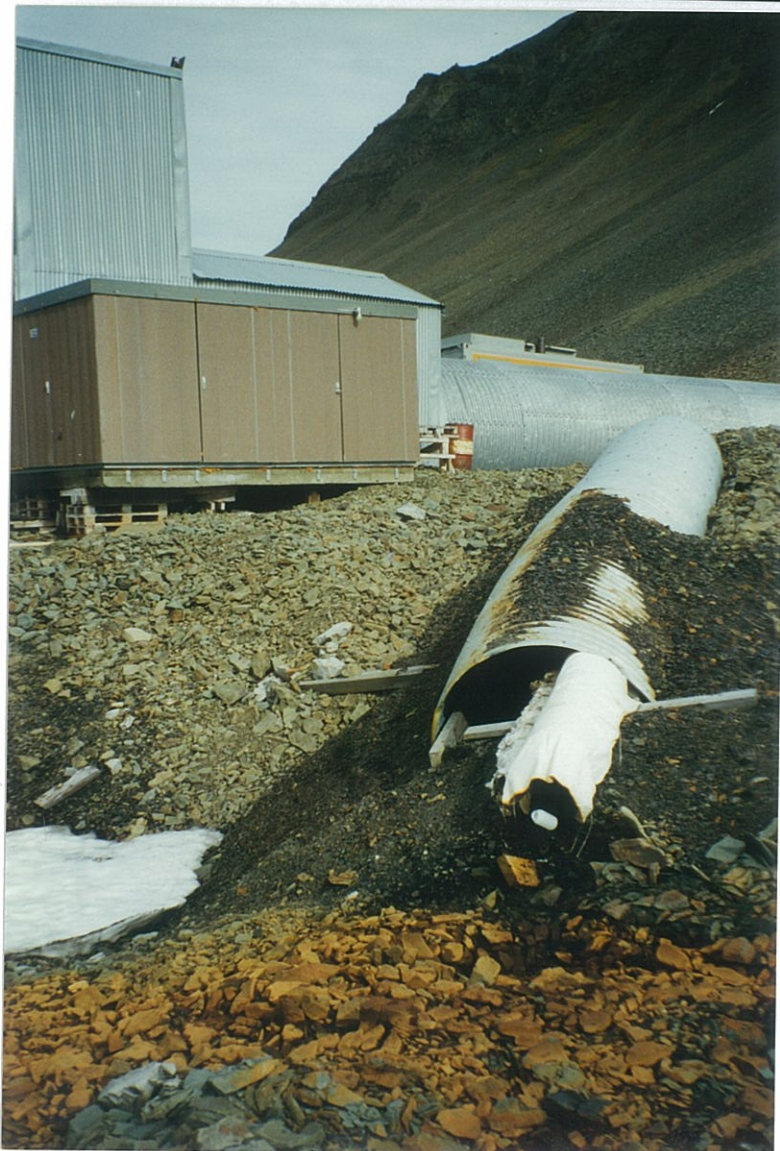
The pumped mine discharge occurs from an 8" diameter pipe just below a double access / ventilation tunnel. A small area of ground below the discharge pipe is stained orange (Figure 3b), which probably indicates that the discharge of pumped water and the content of iron may at certain times be greater than that observed in the current study. The water pumped from the mine is believed largely to be derived from inflow of limited amounts of sub-permafrost groundwater leaking into the mine's deepest levels. It is possible however, that a component of the water may be derived from very shallow, supra-permafrost summer thaw water or from water introduced into the mine for dust damping. The water's chemistry may be influenced by chemicals introduced into the mine, e.g. lime dust.

Figure 3b. The minewater discharge point from Mine 3 in Bjørndalen.

On the 20th July 1996 at the start of sampling, the water flow was measured as a modest 0.056 l/s, but reduced during the course of sampling to 0.01 l/s. The pumping regime during sampling is not known; it is possible that sampling took place at the end of a pumping episode.

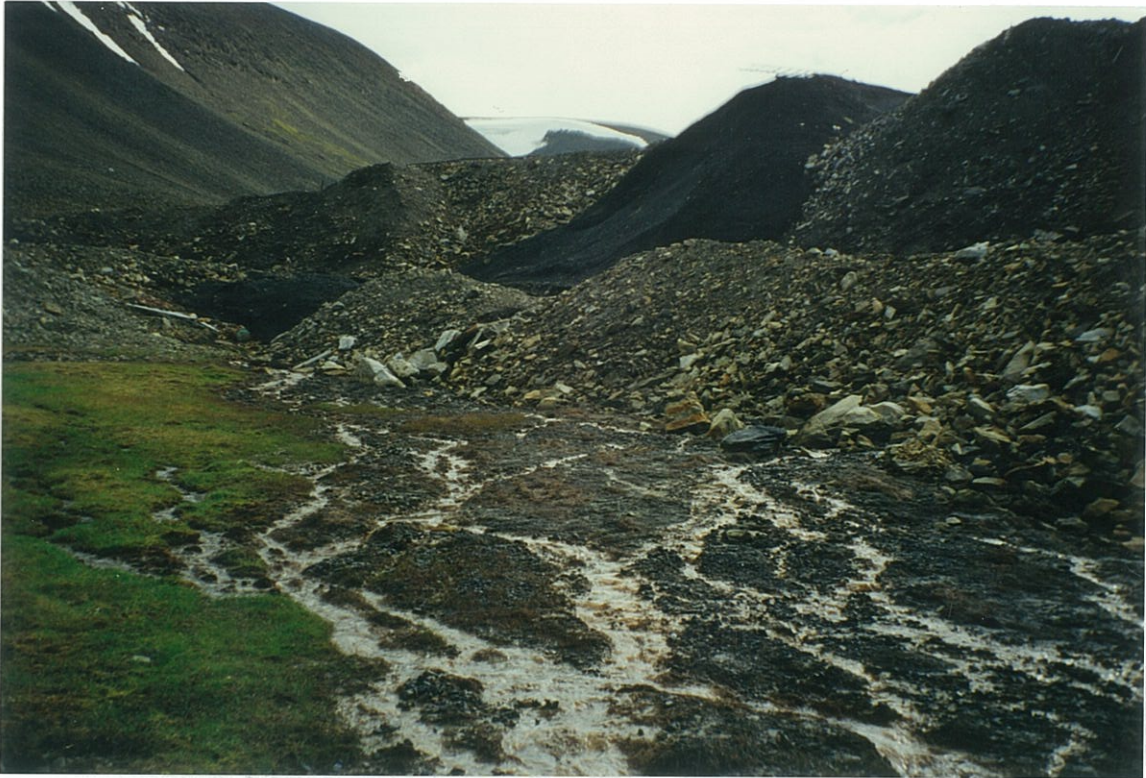
The ventilation and access tunnels emerge from the mountainside at the top of a spoil tip. The pumped water emerges at the top of the southern side of the tip. The sample of spoil leachate was taken from the northern side of this tip. It is possible that some of the leachate, particularly on the southern side of the tip, contains a component of infiltrated mine water, but the leachate seep on the northern side (i.e. that sampled) is thought to largely consist of rainfall infiltrating the tip and thawing porewater within the tip. The sampled seepage of leachate was estimated as some 0.1 l/s, although other seepages emerged from other locations around the base of the tip. It was noted that the spoil appeared to contain a significant component of coal fragments in addition to the shaley and greenish sandstone fragments comprising the bulk of the spoil.

Figure 3c. Leachate from the spoil tip at Mine 3 in Bjørndalen. The sample point was at the head of the seep on the left of the picture.

The spoil tip at Mine 3 generates a run-off which falls in the same range for most parameters as other spoil tip leachates in Table 2, although is somewhat aggressive, with a pH of 3.73 and a concentration of aluminium of 1.8 mg/l. The concentration of Fe (1.6 mg/l) is rather low for such an aggressive water; in fact it is lower than Al. The Si concentration is also puzzlingly low (< 1 mg/l) and may be indicative of a relatively short residence time in the spoil (mine waters typically show a negative correlation of Si and many other elements with pH, indicating elevated weathering of silicate and carbonate phases at low pH - Banks et al. 1996). The sample contains elevated Zn (0.49 mg/l) and Cu (0.014 mg/l) concentrations. The chloride concentration (4.5 mg/l) can realistically be accounted for by marine salts in rainfall, although the sulphate concentration (76.6 mg/l) is clearly indicative of pyrite oxidation:

This equation implies a release of 2 moles sulphate for every mole iron. The observed molar ratio of 28:1 indicates that iron is being retained by precipitation, adsorption or ion exchange somewhere within the spoil.

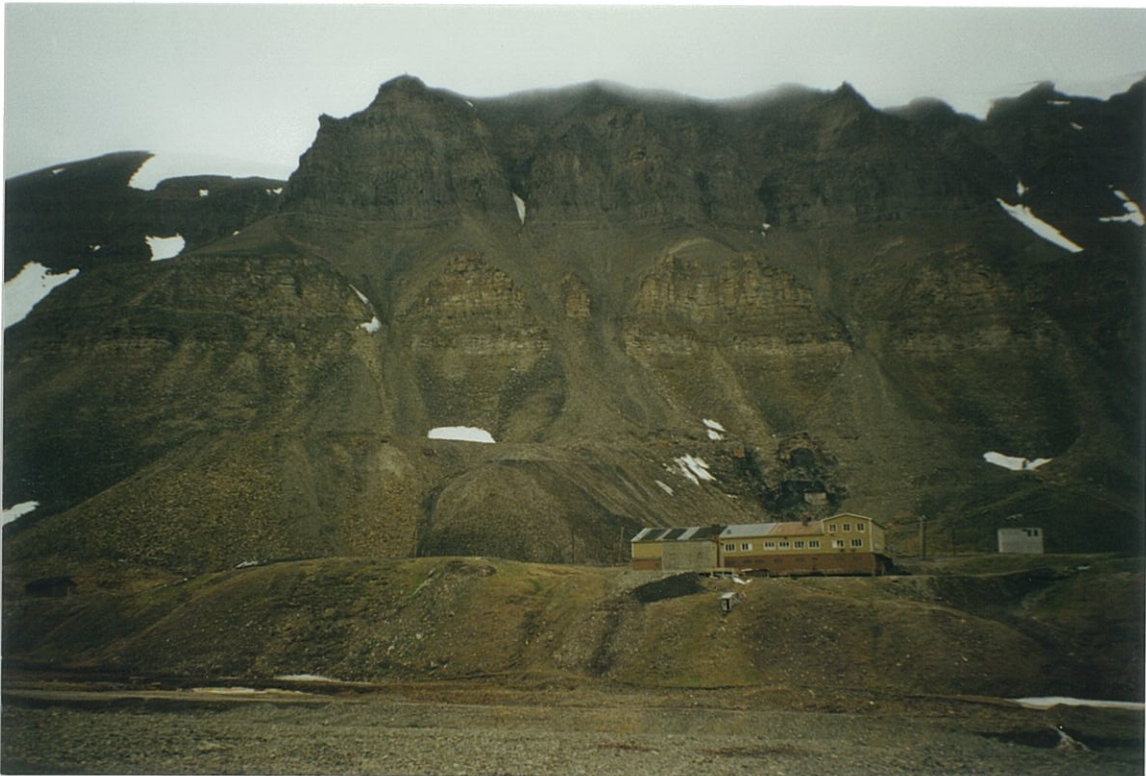
A major spoil tip, derived from the so-called Mine 1b, lies against the western mountainside of Longyeardalen, above the buildings and core store of Sverdrupbyen. The leachate from this tip runs down the hillside by a somewhat tortuous route and enters the Longyear River. The leachate emerges from a limited number of seeps from the tip, totalling possibly as much as a few l/s. That sampled appeared to be the most chemically aggressive (i.e. lowest pH) of the seeps, and had an estimated flow of some 0.25 l/s. At the point of sampling there was very little orange ferric oxyhydroxide precipitate, possibly due to the leachate being so acid. A few metres further down the channel (which the leachate forms in the spoil), on meeting another leachate stream, a classic orange ochre precipitate could be observed persisting in the bed of the leachate channel until the point of entry in the River.

The spoil itself consists of dominantly shale fragments, although with a significant component of coal. The shale fragments often have a yellow coating of presumed ferric sulphate or jarosite, while the coal fragments were observed more frequently to have a gelatinous orange ochreous coating.

Figure 3d. The old mining area at Sverdrupbyen. The leachate sampled is derived from the spoil tip to the left of and behind the yellow building.

The spoil tip at Sverdrupbyen again shows a chemistry which is typical for pyritiferous spoil and indicative of intense pyrite weathering, although the chemistry is more environmentally aggressive than the other waters detailed in Table 2. The pH of 2.7, iron content of 179 mg/l and sulphate concentration of 1077 mg/l indicate intense pyrite weathering. The acid conditions promote further weathering and dissolution of aluminosilicates and carbonates resulting in elevated concentrations of major cations, silica, aluminium and many "trace" components, including zinc at 1.3 mg/l, Cu at 0.17 mg/l and, interestingly, Be at 0.14 mg/l.

A sulphate : iron molar ratio of 3.5:1 again indicates that some of the iron generated by pyrite oxidation is being withheld in the spoil, though proportionately much less than at the spoil tip at Mine 3.
